St. Andrew's Chapel

Preservation Plan

Preservation Studio, Fall 2010

Graduate Program of Historic Preservation,
University of Pennsylvania

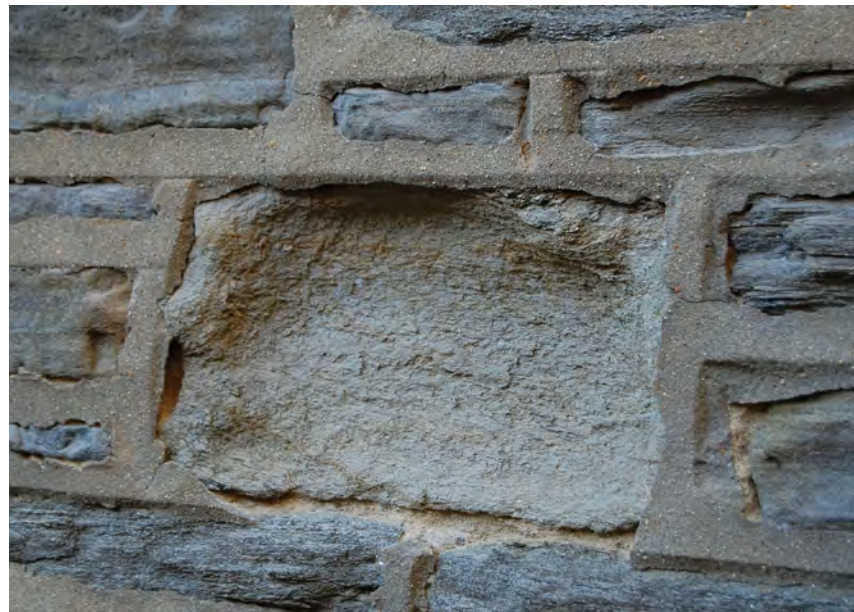
The exterior walls of the chapel and deanery are generally in fair condition. The walls are plagued by such conditions as stone delamination, failure of mortar joints, water saturation and staining, and biological growth. The most threatening condition is the deterioration of schist observable on all elevations of both the deanery and chapel. Delamination is the decay process in which the face of the stone peels away layer by layer. Areas of delamination are particularly concentrated in areas of high moisture content adjacent to gutters and downspouts, but individually delaminating stones can also be observed in a random pattern on all facades. This is attributable to the highly variable nature of the schist wherein the degree of hardness varies greatly among individual stones, resulting in different rates of decay. Another contributing factor is the

Figure 1 Delaminating schist

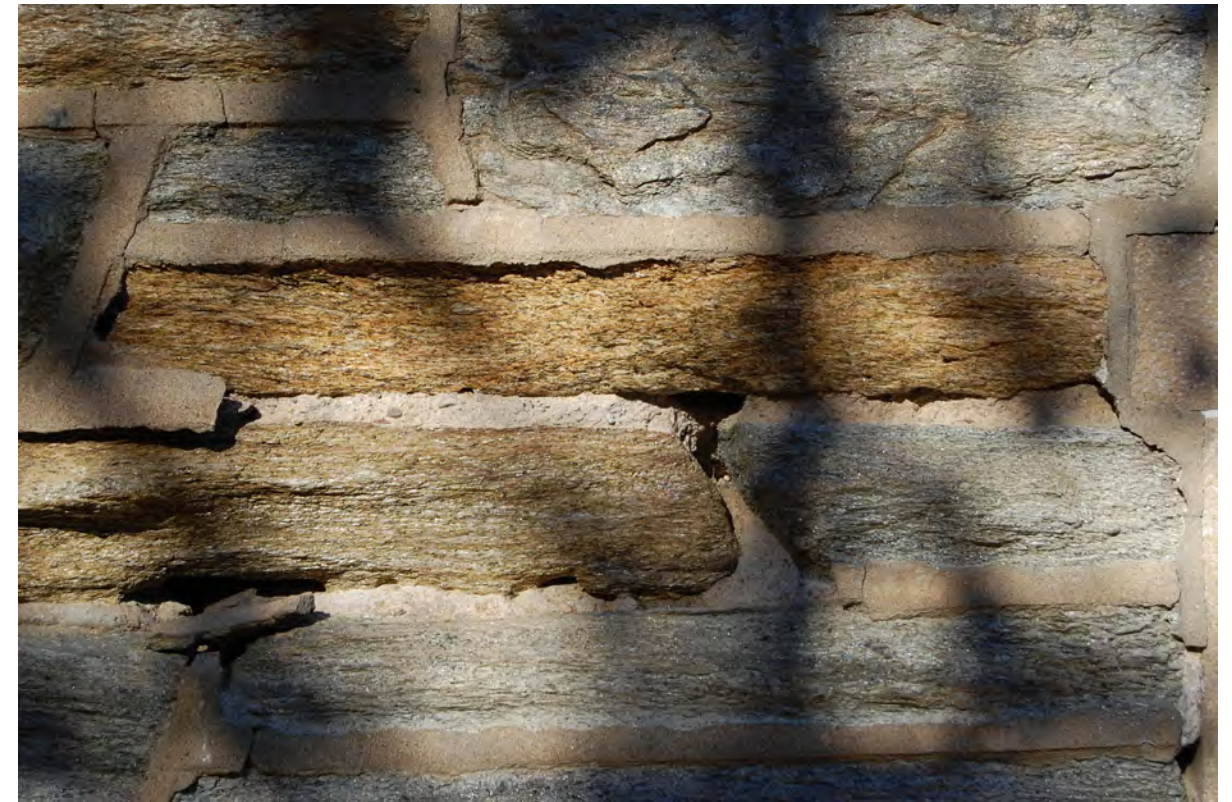
Another factor contributing to the deterioration of stone is the failure of mortar joints to perform adequately on all elevations of the chapel and deanery. In some areas, particularly along the wall facing onto Spruce Street at street level, the mortar is severely deteriorated leaving open joints susceptible to the weather. The mortar throughout most of the buildings is incompatible with the Wissahickon schist because it is too hard

Figure 2 Deteriorated mortar and inappropriate repointing with hard Portland cement mortar

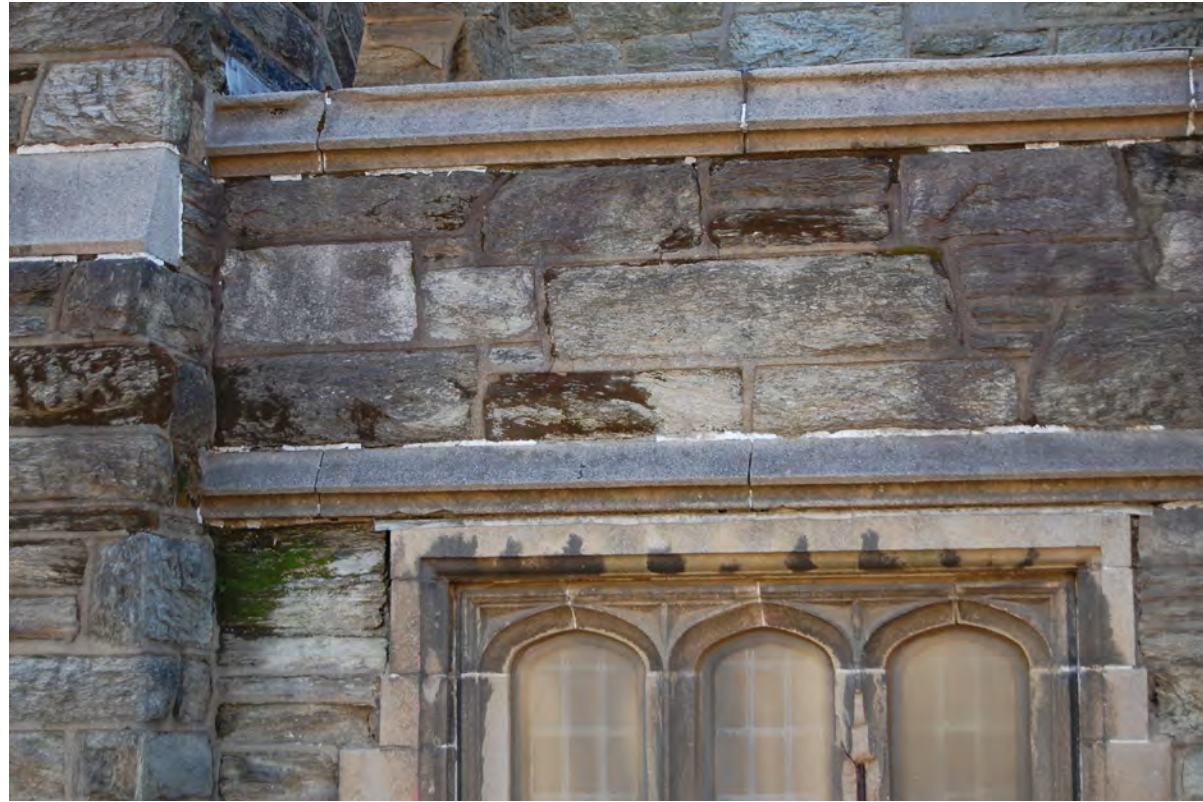
Other conditions affecting the exterior walls of the chapel and deanery include water saturation and staining and biological growth. Water has saturated the stones, particularly in areas around gutters and downspouts, because of poor drainage. This has created areas of constant dampness, a factor contributing to deterioration of stone and mortar joints. Water saturation also encourages biological growth, which needs moisture as a condition for growth. The presence of mosses, algae, and mold is noted on all elevations of the chapel in areas that

Figure 3 Biological growth, moisture staining, and inappropriate repointing on north elevation

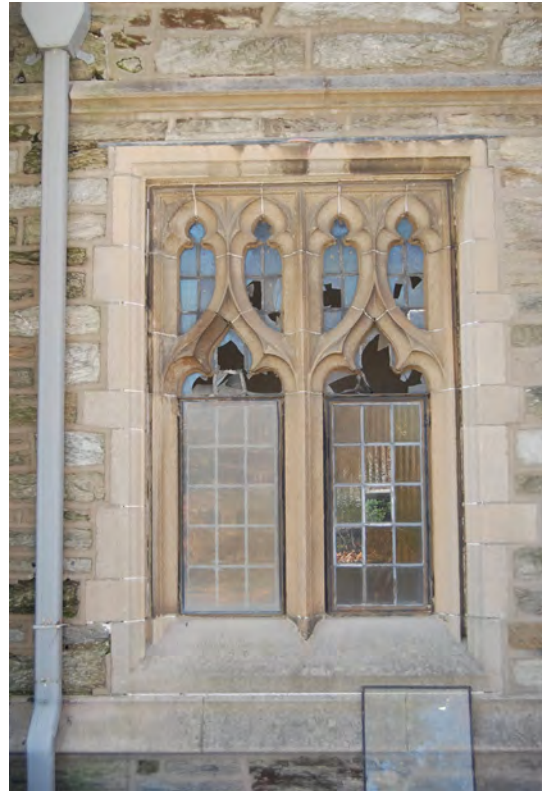
Figure 4 Broken glass, east ambulatory window

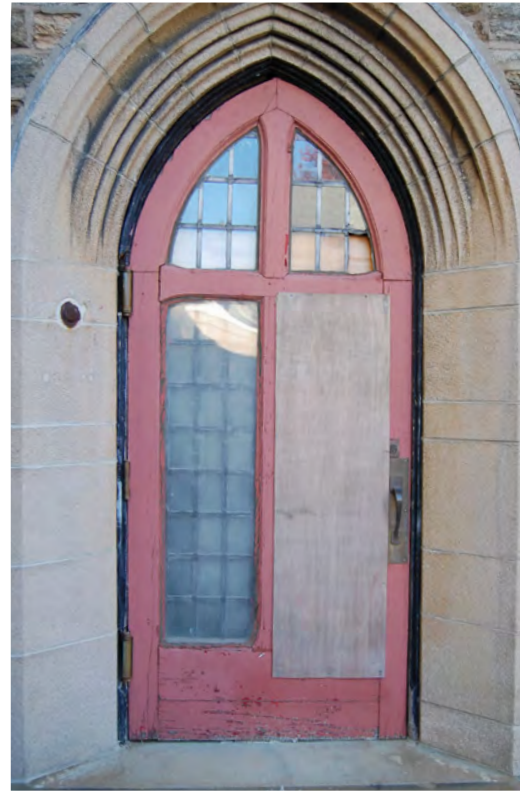
Figure 5 Vandalized deanery door

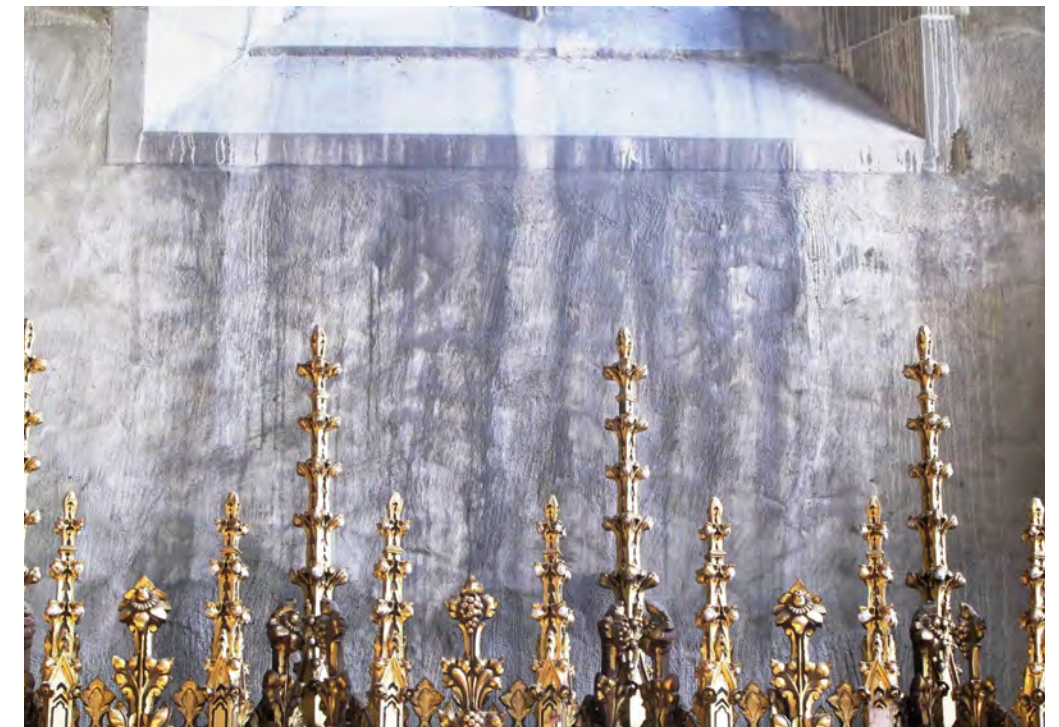
The walls of the interior of the nave are covered in grey cement stucco. The greatest risk to the integrity of the chapel's interior is water damage, due to the building not being water

Figure 8 Water staining on cement stucco wall.

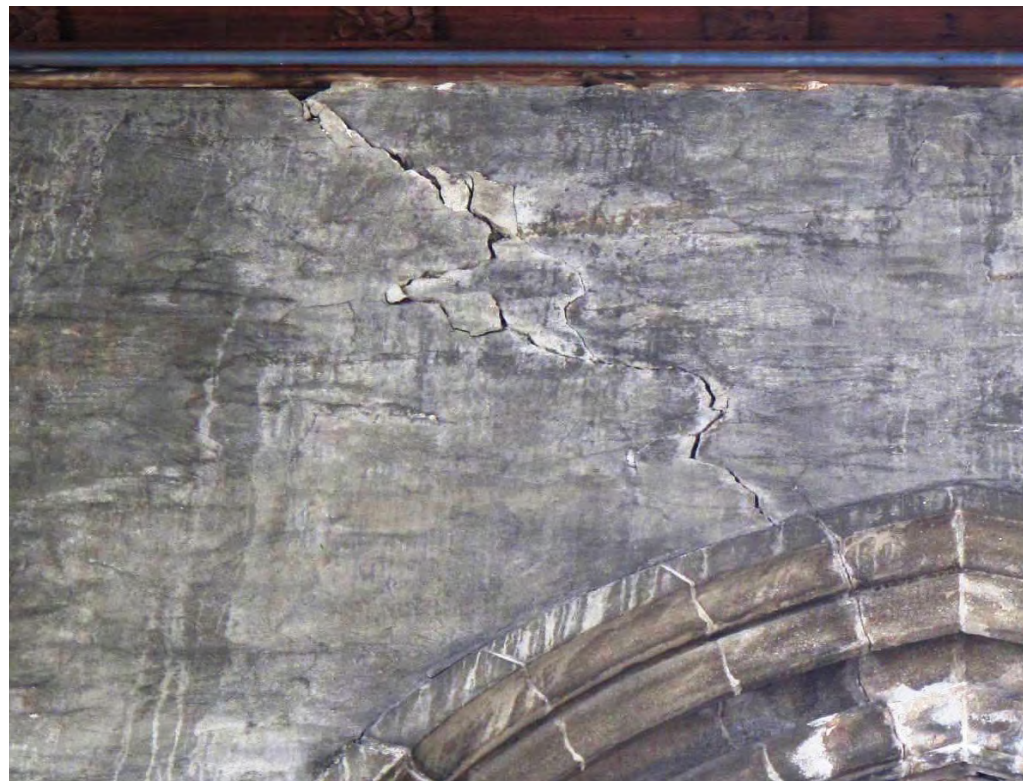
Another condition present on the cement stucco walls are cracks. These are located in different areas on the east and west walls. The report of 1993 stated that movement due to differential thermal expansion of steel and masonry, and downward deflection of trusses due to the weight of the slate are pushing the east and west walls outward resulting in cracking of the wall cement. It was found, however, that they did not adversely effect the performance of the building structure. The cracks are mostly vertically oriented and most prevalent in areas where different materials

Figure 9 Crack on top of wall

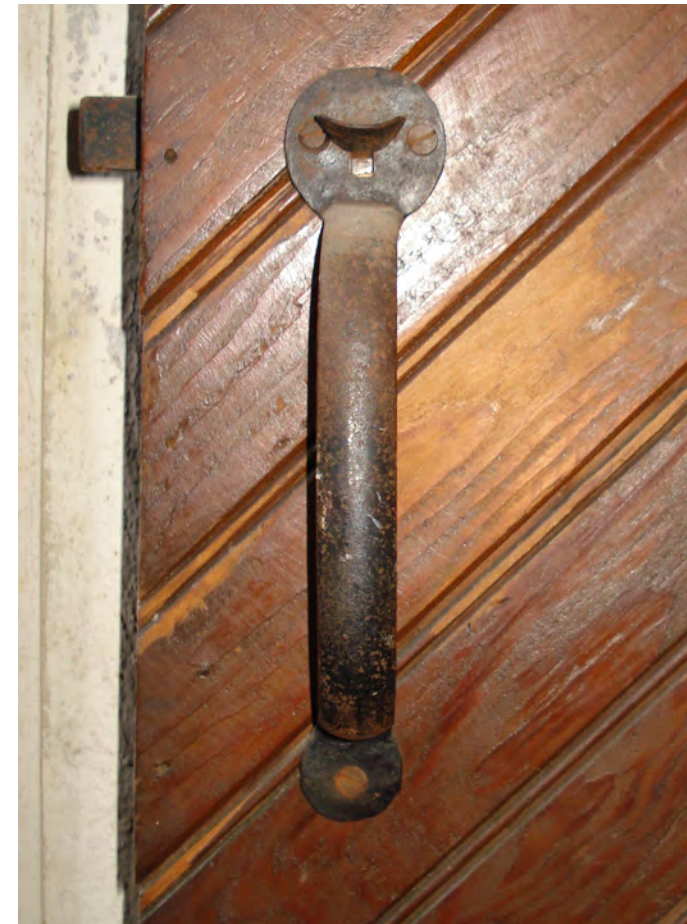
Figure 10 Interior door showing rusted hardware and loss of wood finish

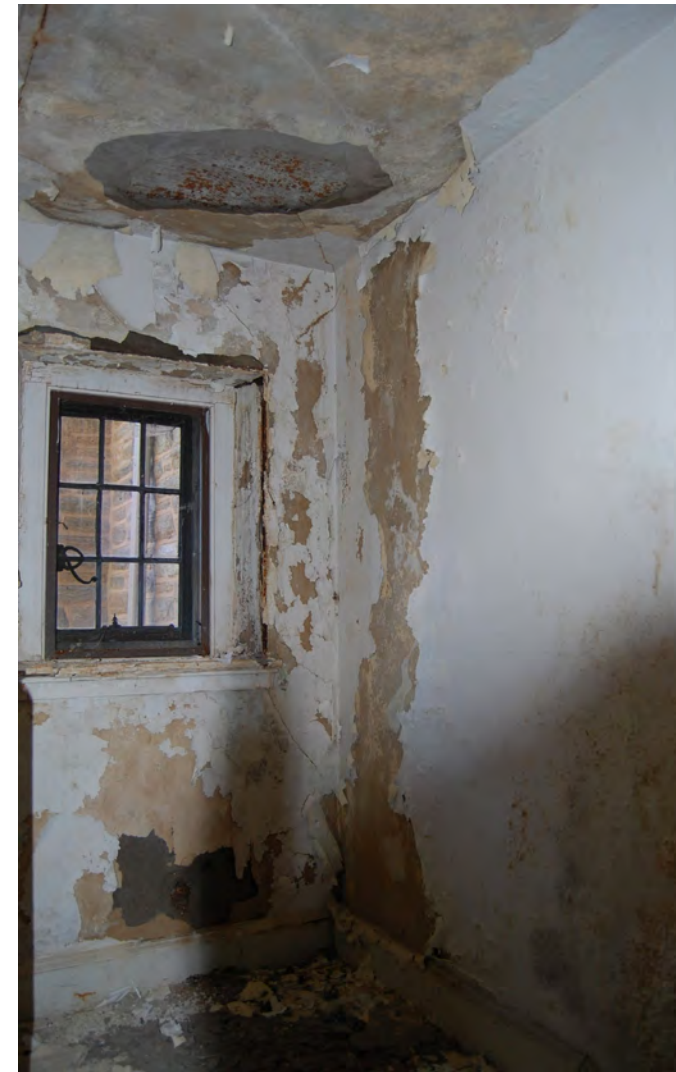
Figure 12 Plaster and finish deterioration due to water damage

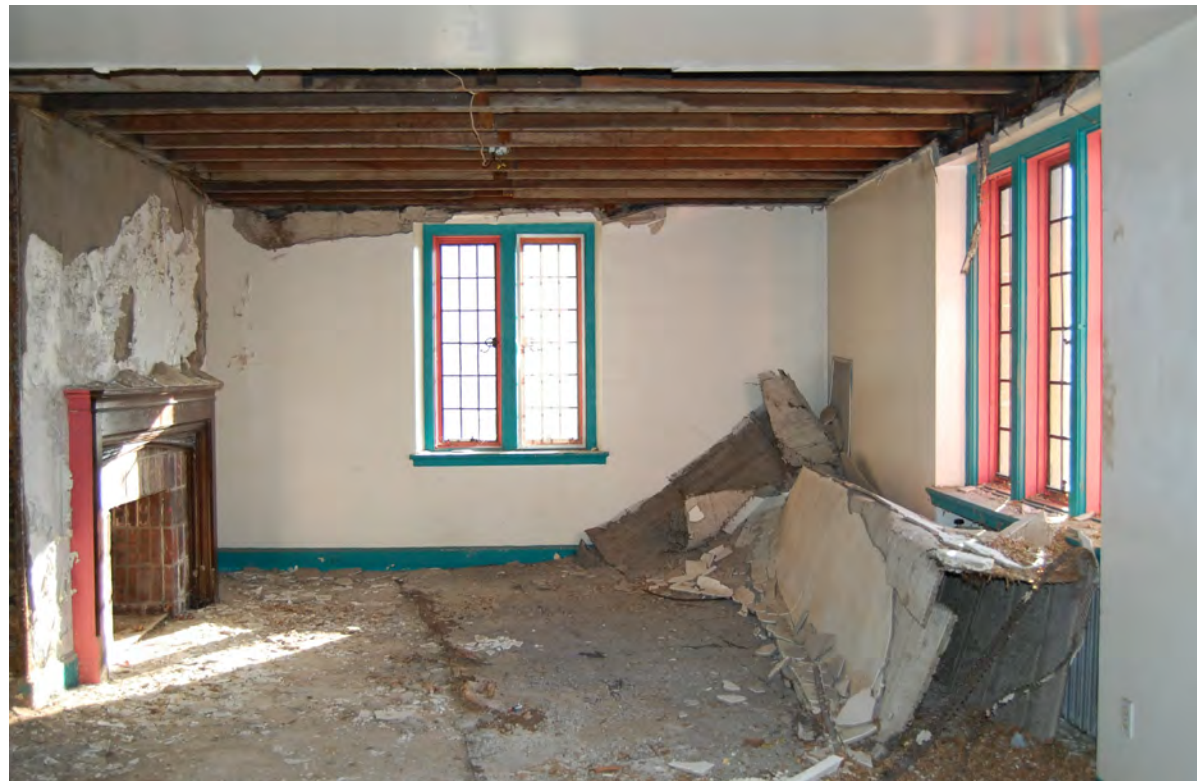
Figure 13 Collapsed plaster ceiling in southwest room, second floor

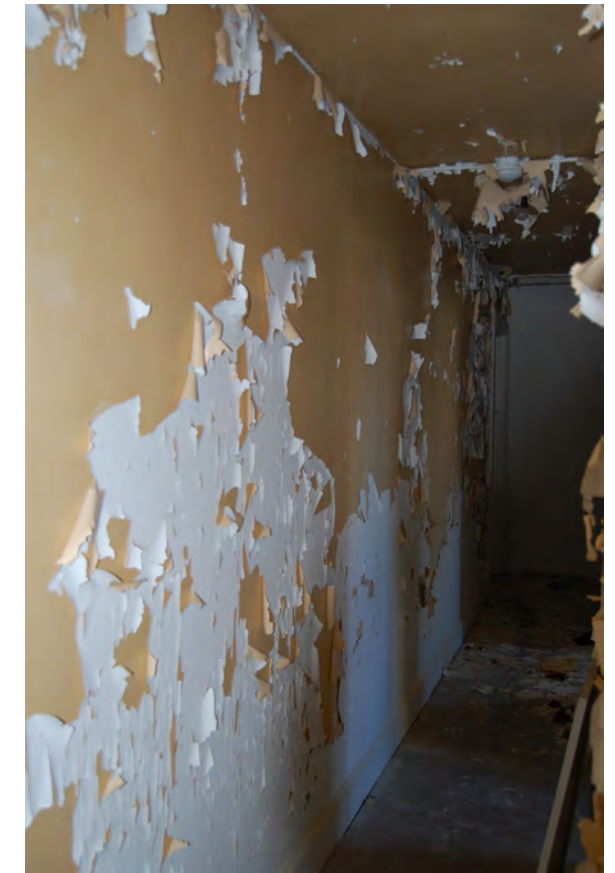
The paint finishes throughout the deanery are in very poor condition. The finishes exhibit damage from moisture and also widespread peeling and blistering, as paint peels from the walls and ceilings in large sheets. This is likely a result of incompatibility between paint layers resulting in loss of adhesion between layers. This is not of great concern, as the building's interior has likely been painted

Figure 14 Peeling paint in third floor hall of deanery

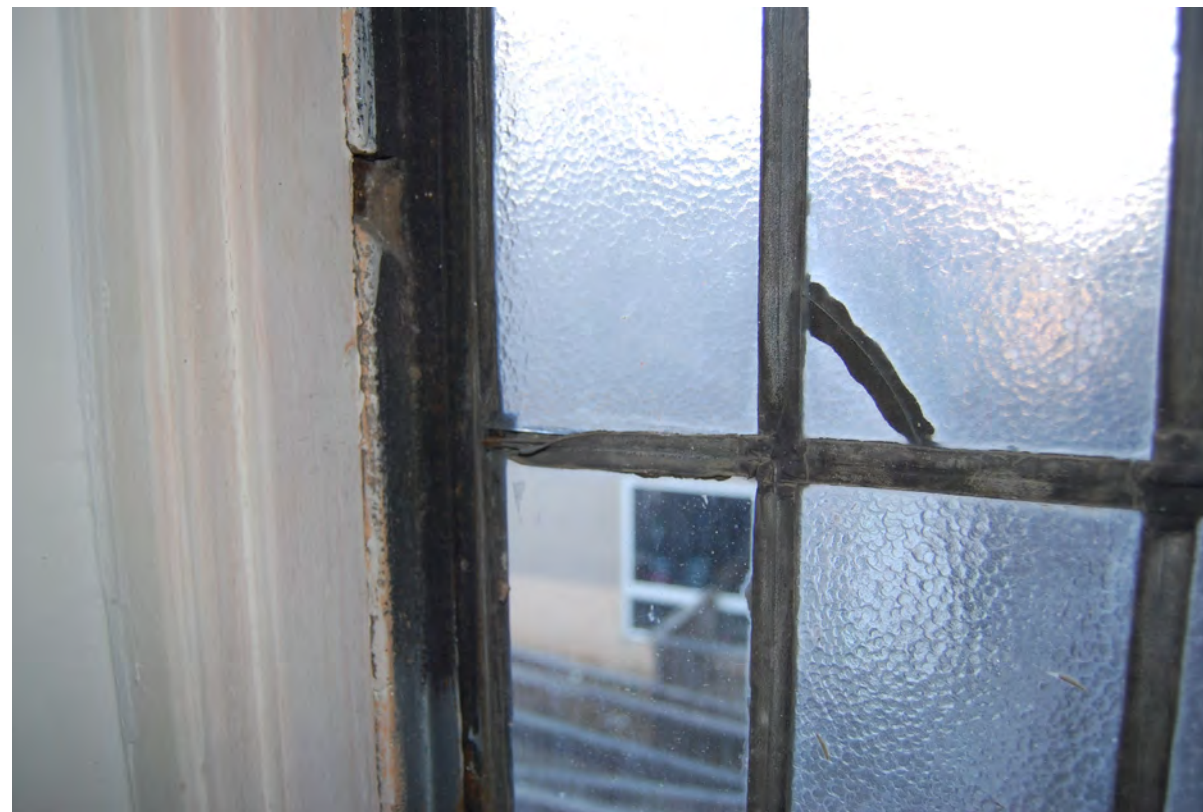
service life in the majority of the windows. Lead is an extremely soft and malleable material that, after years of weathering combined with wear from opening and closing, begins to deteriorate and lose its capacity to effectively support the weight of glass panes. It has little tensile or compressive strength and is also subject to cycles of thermal expansion and contraction that cause fatigue of the metal. Lead's coefficient of thermal expansion is three times that of steel, so the lead came's expansion within the steel frames have caused buckling and bowing, resulting in glazing panels that do not properly fit into the frames.

Figure 3 Deterioration of lead comes

The condition of the lead comes in the majority of the deanery windows is poor to fair, with a few that are in good condition (probably because they have received repairs). Deterioration and warping of lead is common, as well as breaks at the soldered joints, (Figure 3). In some of the most deteriorated windows, the lead comes have detached completely and are missing from the glazed panel.

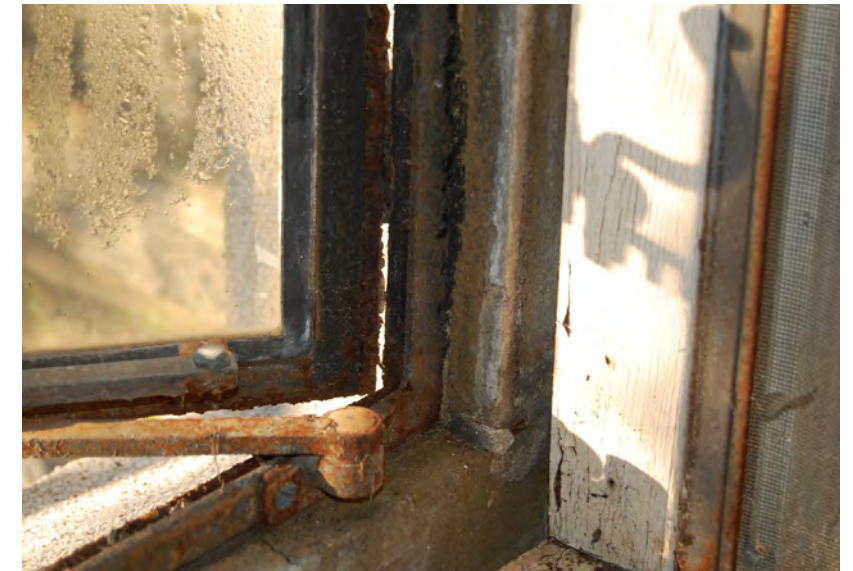
Figure 4 Rusting of frame and subframe

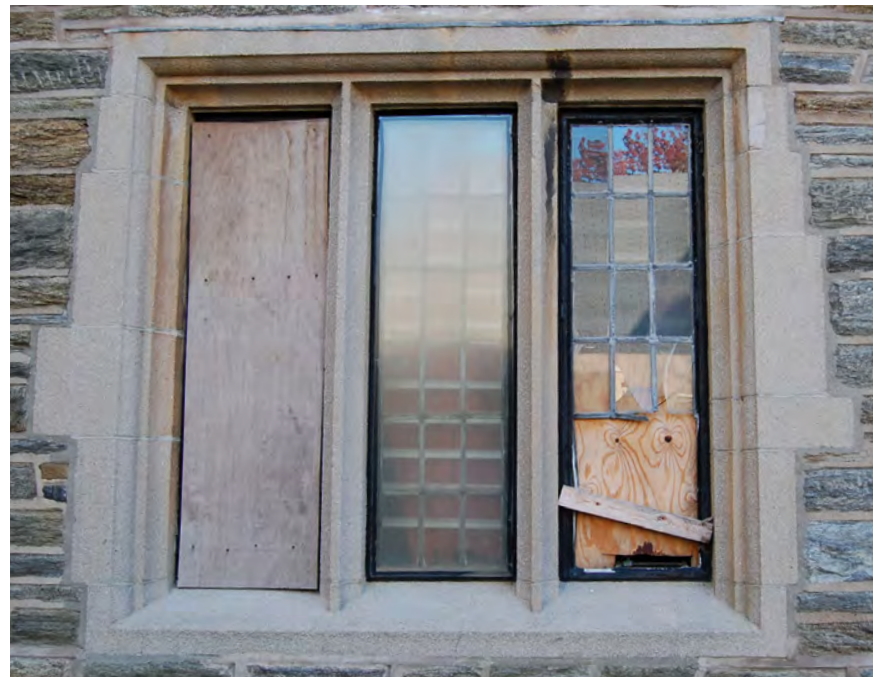
Figure 6 Center window has received additional glazing for protection from vandalism

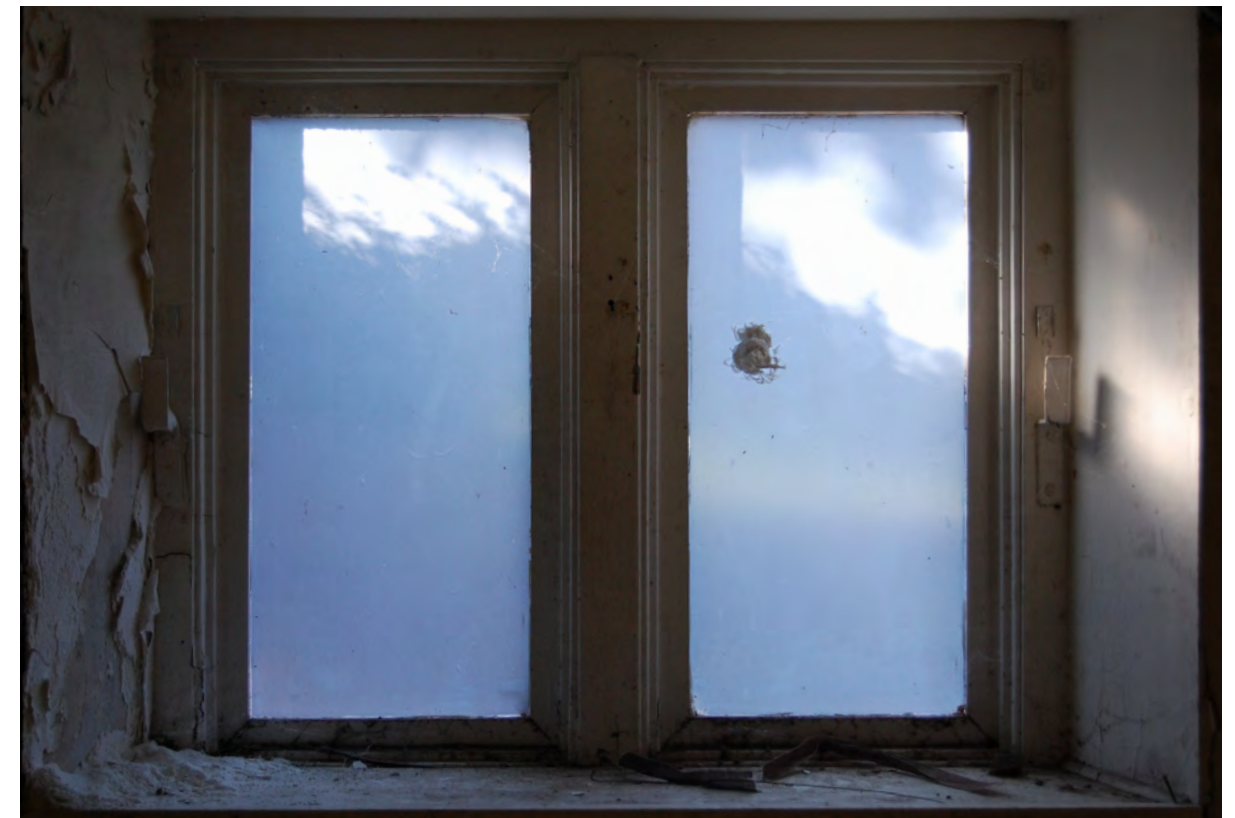
Figure 8 Casement replaced with insulated sash and glass in deanery basement

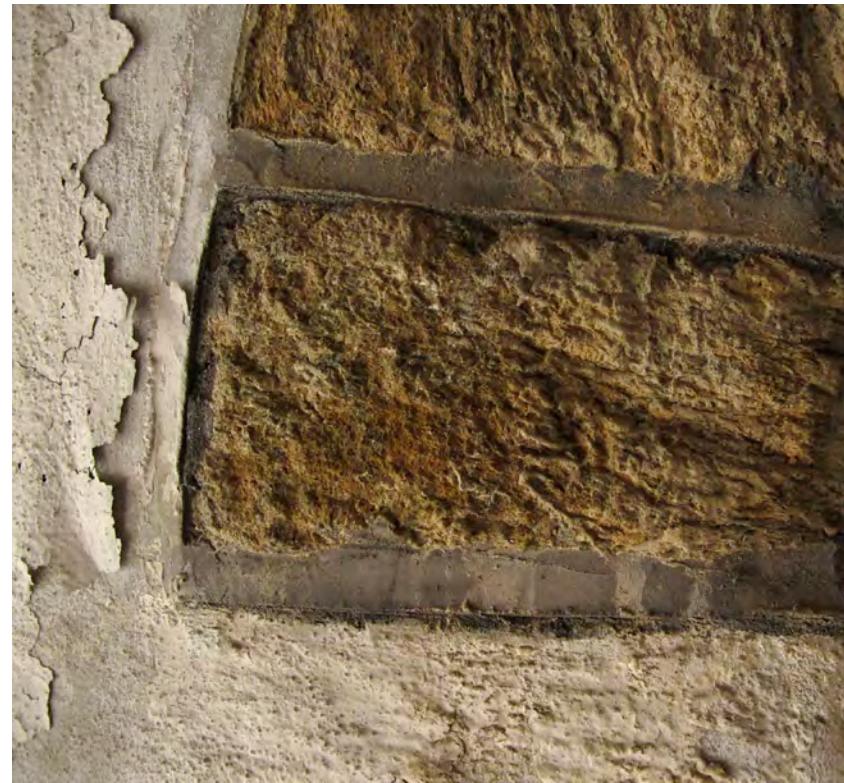
Figure 4 The texture and color of the schist changes as the feldspars decompose.

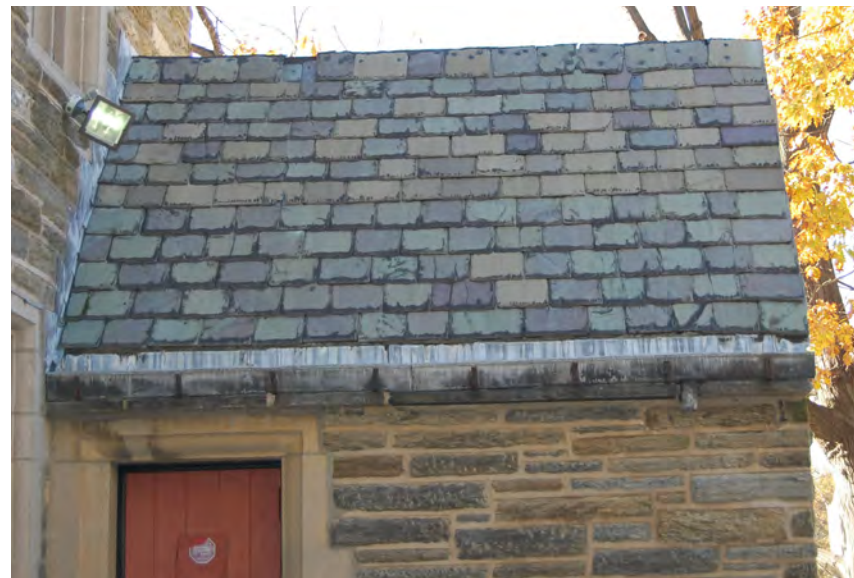
The existing roof on St. Andrew's chapel is the original and has not undergone any replacement or repair since installation. The roof's construction consists of a metal truss system supporting a wooden roof deck covered by felt membrane and slate shingles. The roof is currently leaking where it contacts the walls due in combination to damage to the roof fabric and the copper gutters and flashings. In order to make the interiors occupiable these issues must be addressed.

Figure 1 Section of St. Andrew's roof showing, chipped, cracked, broken, and delaminating slates.

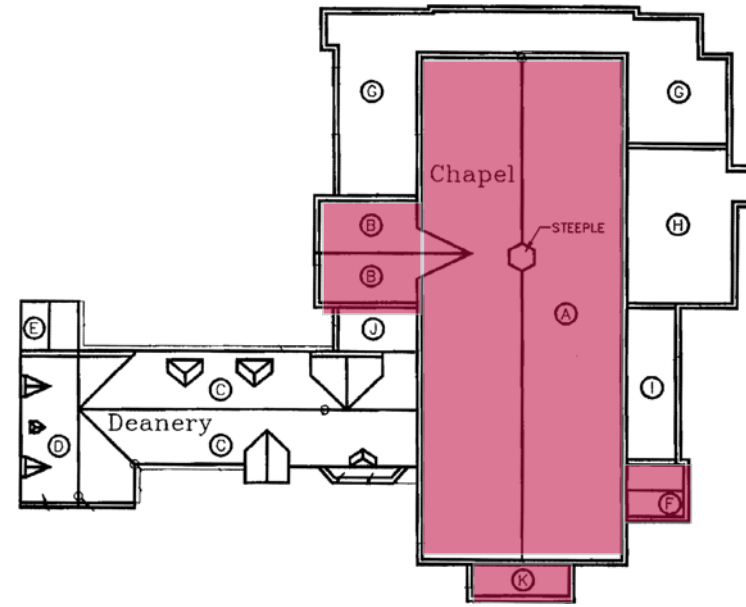
Figure 3 Roof plan showing areas needing reroofing

1. Reroof the Chapel.
2. Restore copper flashing, gutters, scuppers and downspouts.
3. Restore decorative leaded elements in gutters.
4. Restore spire.
5. Figure 3

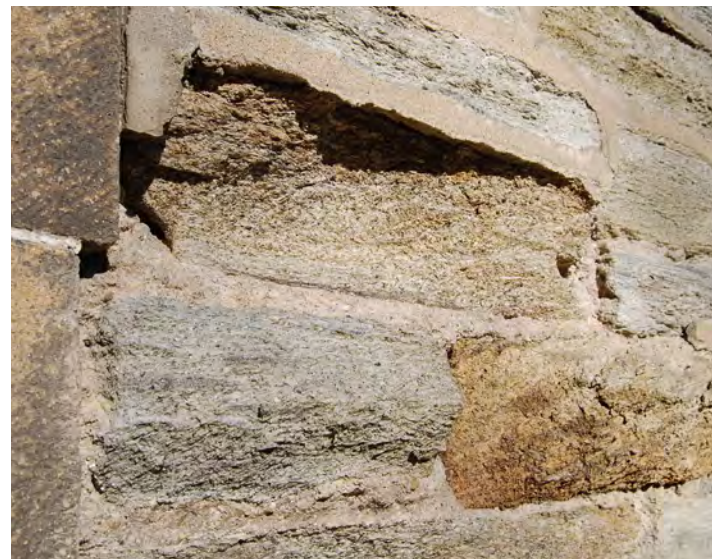
Figure 4 Severely deteriorated schist on the exterior

2. All caulk from the west and north elevations of the Chapel should be removed from the joints of the cast stone trim and replaced with a mortar that is appropriate in terms of aesthetics and strength. Missing joints and failing Portland cement mortar throughout the building's exterior should be repointed with an appropriate mortar with high lime content.
3. Reset coping stones on west and north elevations of the Chapel.
4. Biological growth and staining should be cleaned from the surfaces of schist and cast stone on the west and north elevation of the chapel using water and gentle brushing possibly combined with a mild biological solution such as D2 by Cathedral Stone, (Use natural bristle brushes or soft car brushes. Have several brushes starting with a soft brush and proceed with stiffer brushes if needed. Do not use metal or wire brushes since they will damage the stone).

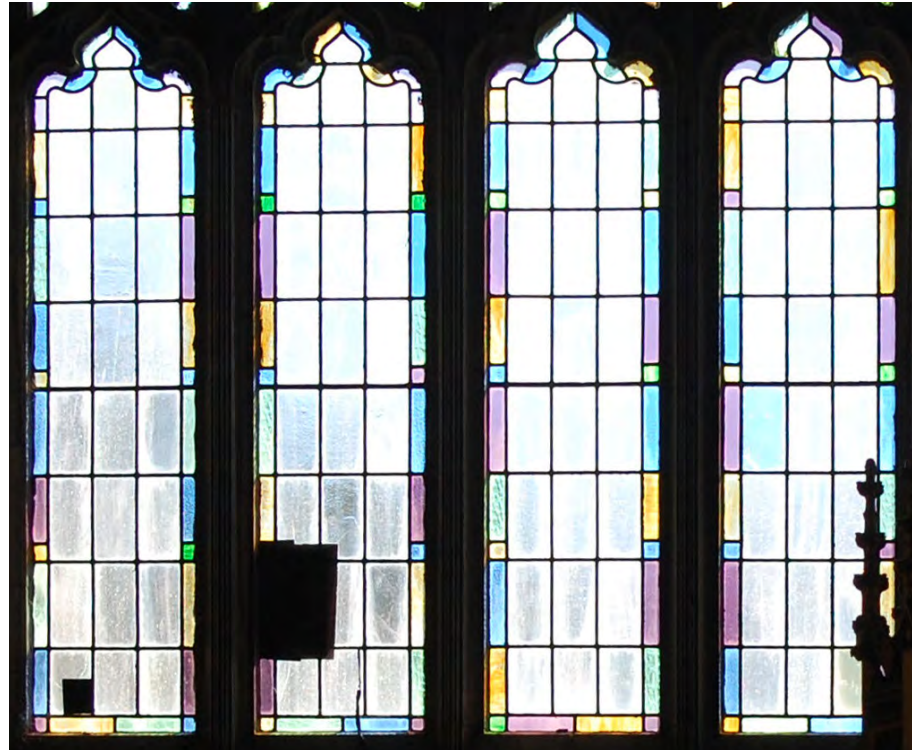
Figure 7 Missing glazing on south end of the Chapel

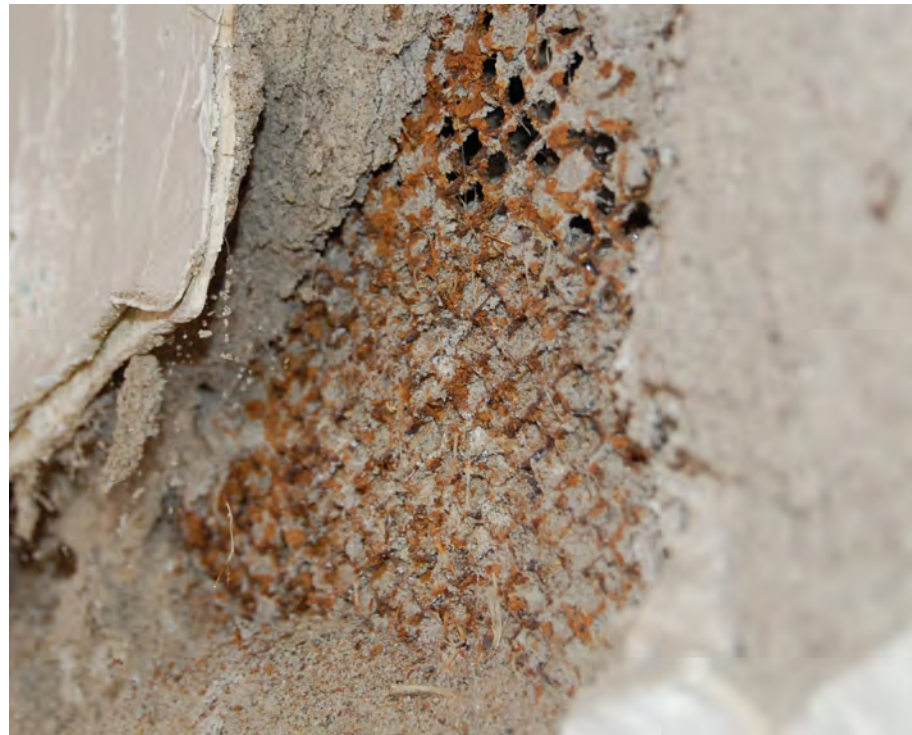
Figure 8 Failing metal lath and plaster system

1. Metal lath and plaster ceiling on the east side of second floor of the Deanery has collapsed and should be replaced.
2. Metal lath and plaster systems exhibiting signs of eminent failure should be inspected and replaced where needed. Replacement cost would vary depending on materials chosen. This estimate was calculated replacing with similar metal lath, but other less expensive materials are available.
3. Restore interior doors in the Deanery. The level of repair varies according to the condition of each door. These include sanding, priming and repainting, glazing replacement, and hardware replacement. Assume 28 doors.
4. Clean and restore architecturally significant elements on the Deanery such as staircases and brick fireplaces and woodwork.
5. Failing metal lath and plaster system, (Figure 8).

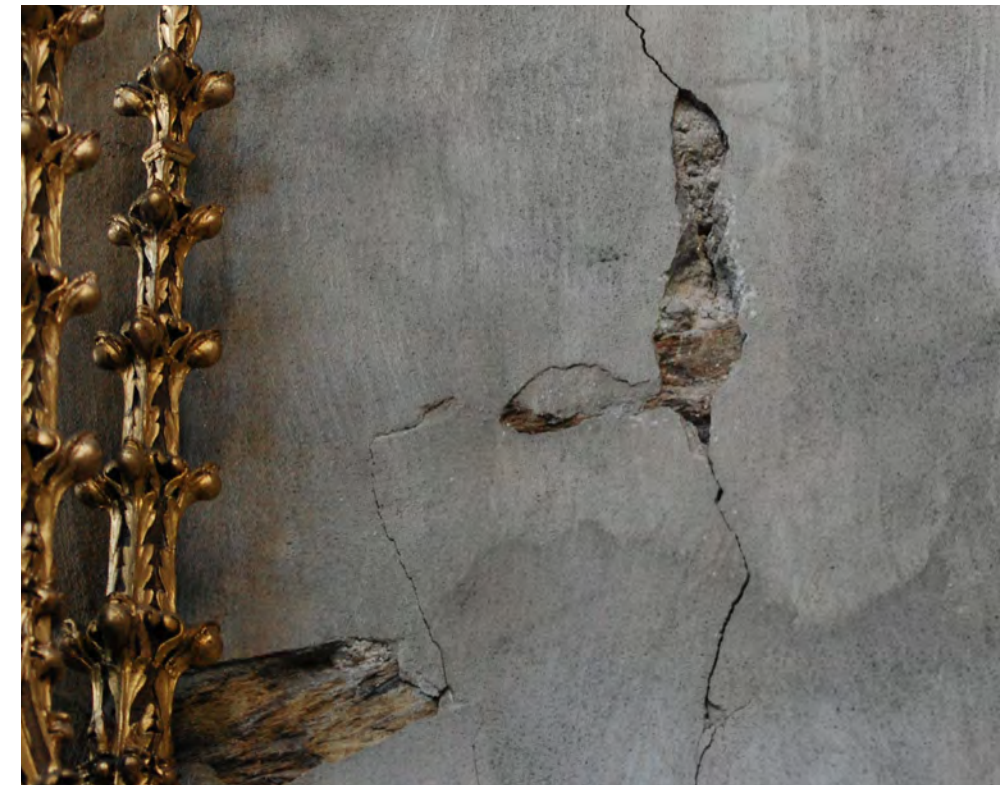
Figure 9 Cracks and cement detachment on walls

6. Perform analysis on the composition of interior cement of the Chapel. Swelling and cement wall render bulging due to water infiltration should be corrected. Fill interior cracks and patch areas detached with compatible cement with respect to mechanical as well as aesthetic properties according to analysis. New cement must be weaker and more permeable than surrounding original fabric, (Figure 9).

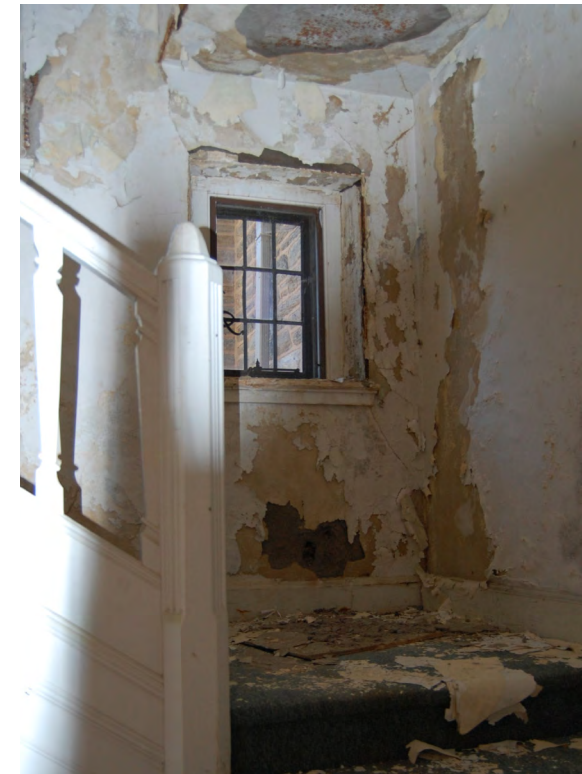
Figure 1 General deterioration surrounding a window in the Deanery

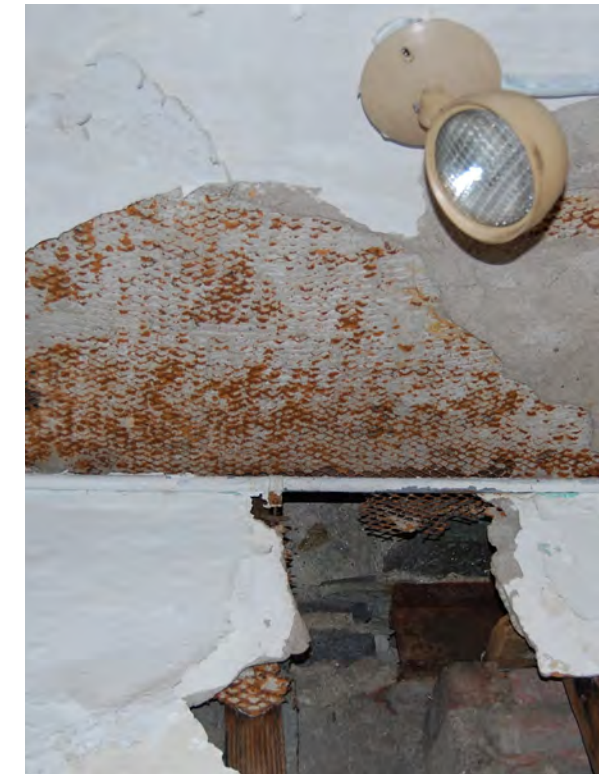
Figure 2 Deterioration surrounding plaster and metal lath in the deanery

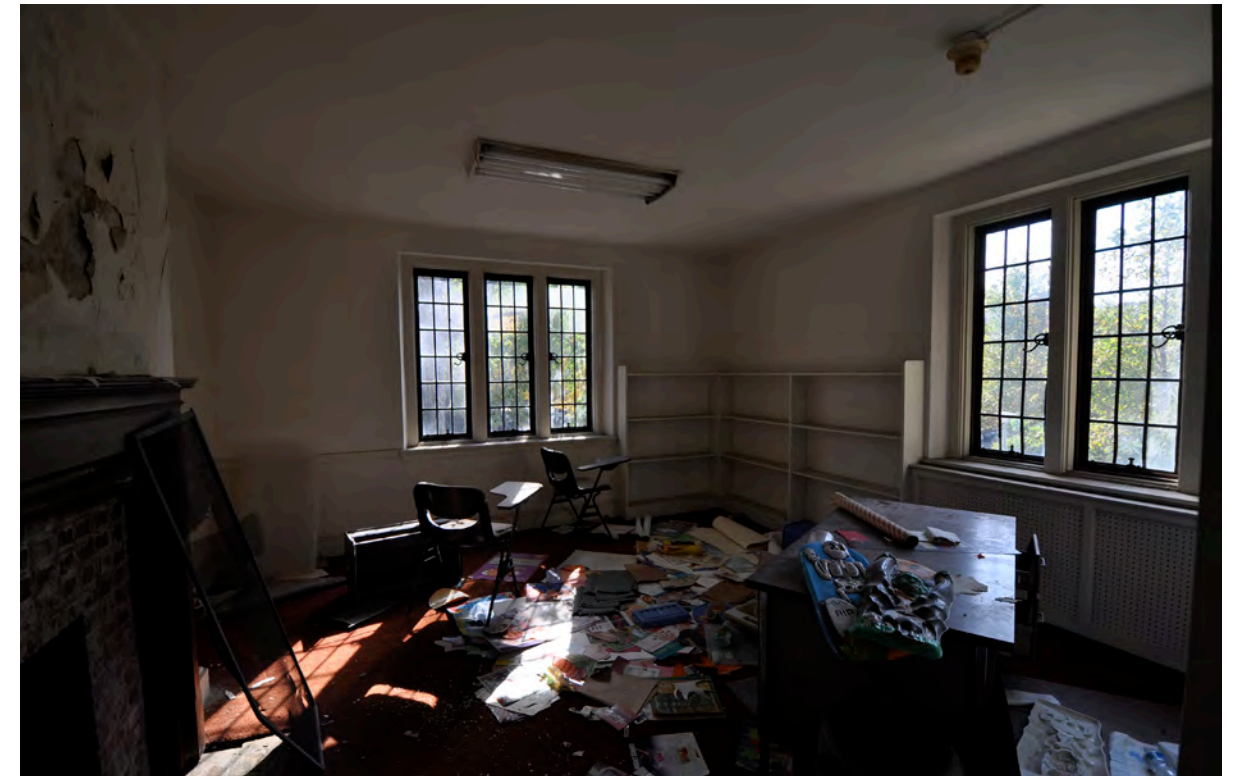
Figure 3 View of the condition of one of the rooms on the second floor of the Deanery
