A DESCRIPTION AND CONDITIONS SURVEY  
OF THE  
MONASTERY BUILDING OF THE  
FORMER AUGUSTINIAN HERMITAGE OF SANTA LUCIA  
LOCATED ON THE SPANNOCCHIA ESTATE  
ROSIA, ITALY

Prepared by  
Participants in  
"PRESERVATION PRACTICE IN ITALY"

Co-sponsored by the  
Graduate Program in Historic Preservation  
University of Pennsylvania  
and  
The Etruscan Foundation

Summer 1987

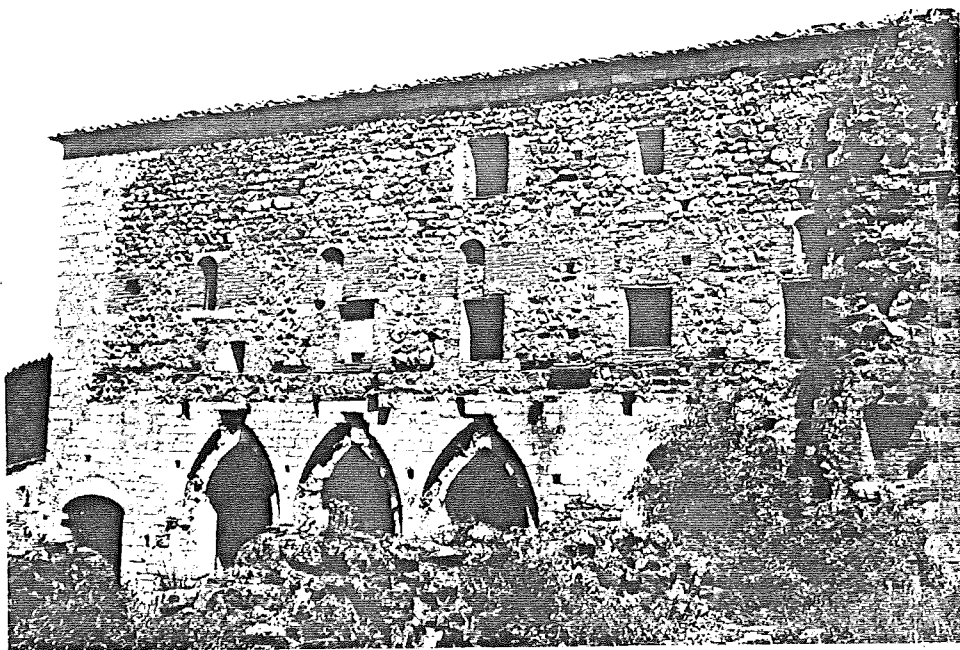
Photo 1. Santa Lucia monastery building/casa colonica, west facade, and foundation remains and corner of north apse wall of the third church of Santa Lucia (Appendix C, BUILDING PLAN, Nos. 7 and 10).

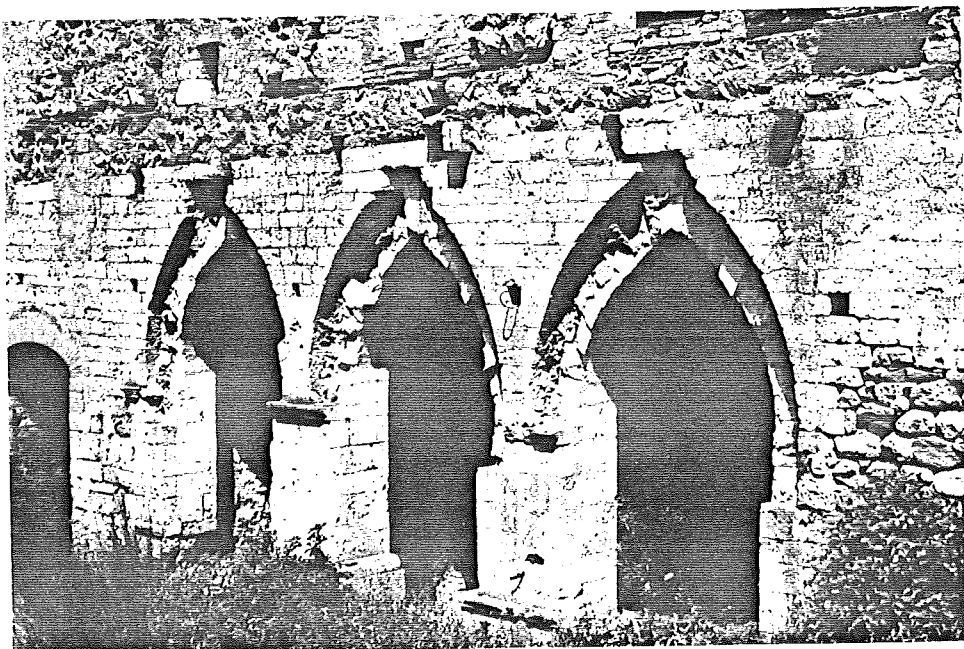
There is little evidence of any exterior facade render left on the building, which means all mortar joints and stone are exposed to the elements. Fragmentary patches of polychrome and render appear on the intrados of the gothic arcade, indicating that at one time this was covered with a decorative render. The facing voussoirs of these arches have all been plundered, exposing the inner, broken limestone to the weather.

Photo 2. Gothic arcade (lacking voussoirs and keystones) of west facade of casa colonica (Appendix C, BUILDING PLAN, No. 8).

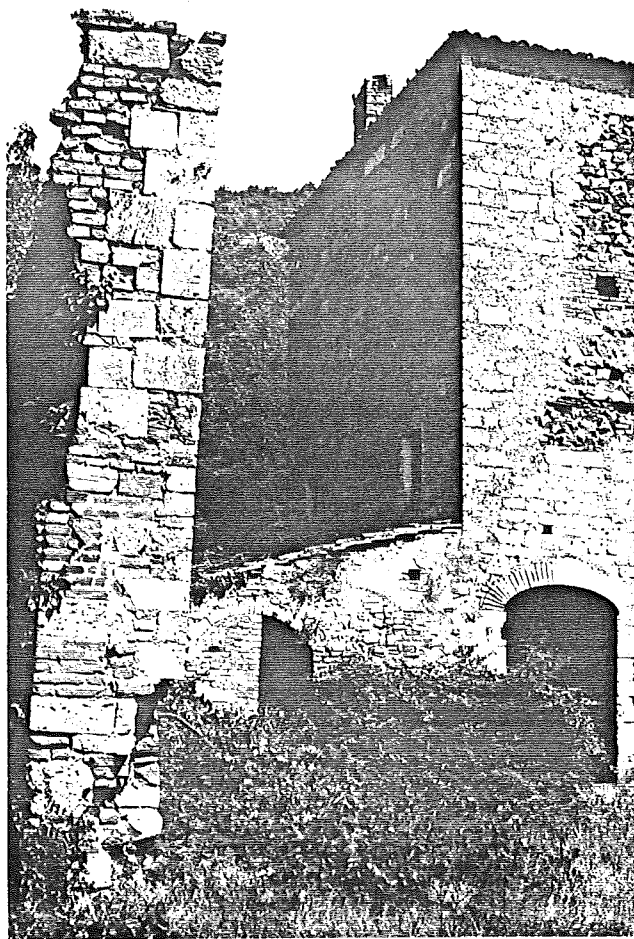
Photo 3. North facade of casa colonica plus attached shed roof structure and south corner remnant of adjoining, unidentified building to the northwest (Appendix C, BUILDING PLAN, Nos. 21 and 15, respectively).

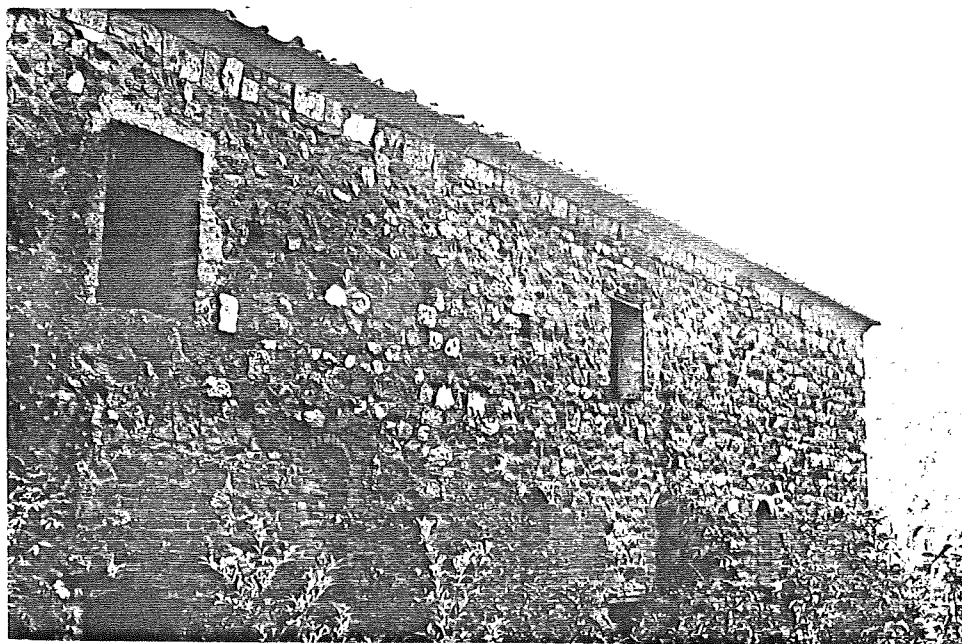
Photo 4. East facade of casa colonica, northern end (Appendix C, BUILDING PLAN 9).

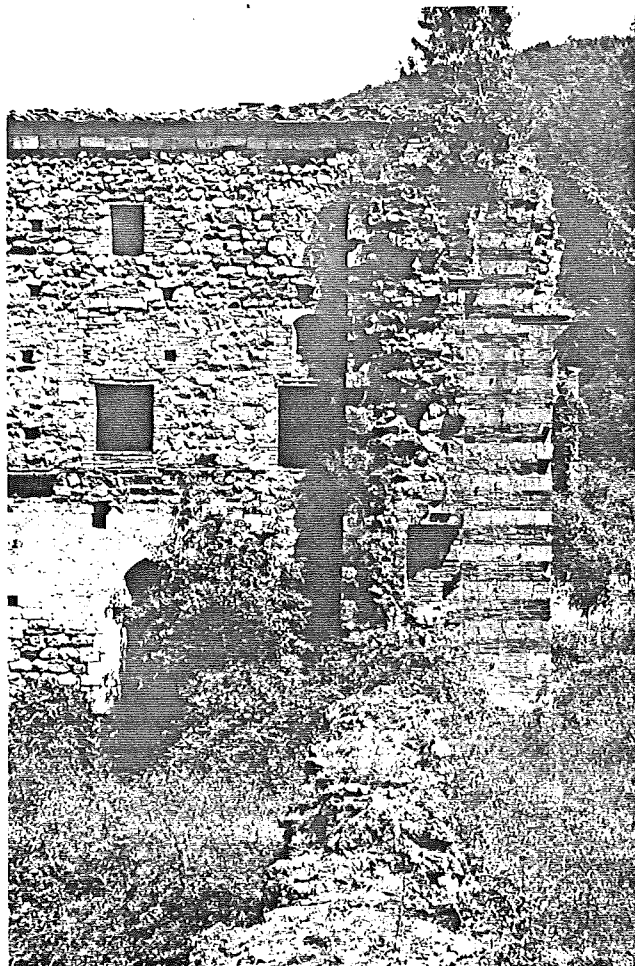
Photo 5. Ruins of north nave wall and north apse wall of the third church of Santa Lucia showing its integration to the southwest corner of the casa colonica (Appendix C, BUILDING PLAN, No. 10).

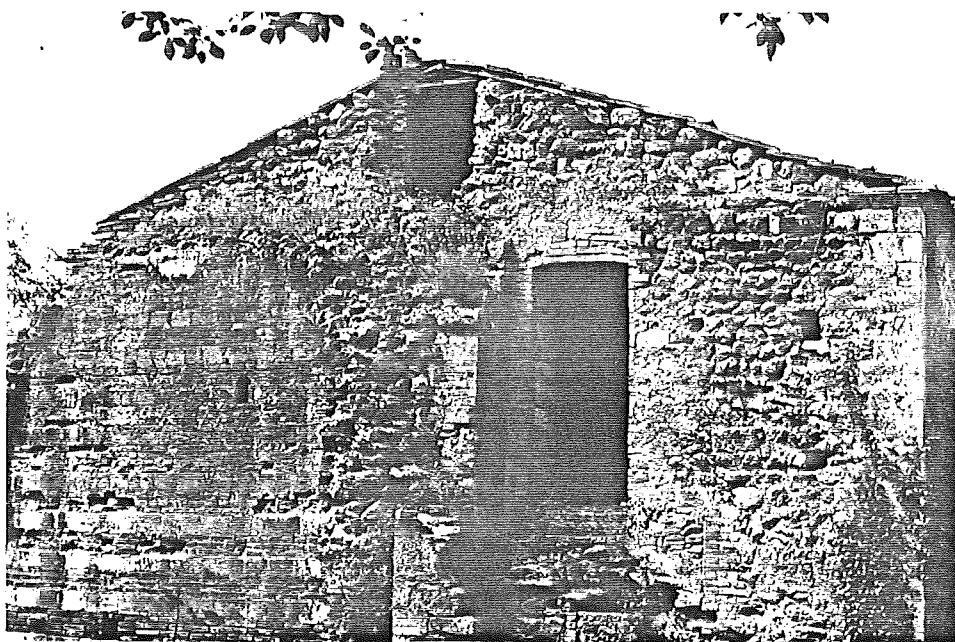
Photo 6. South facade of casa colonica showing gable roof, second floor entrance, location of a former staircase, and remains of the north apse wall of the third church of Santa Lucia (Appendix C, BUILDING PLAN, No. 11).

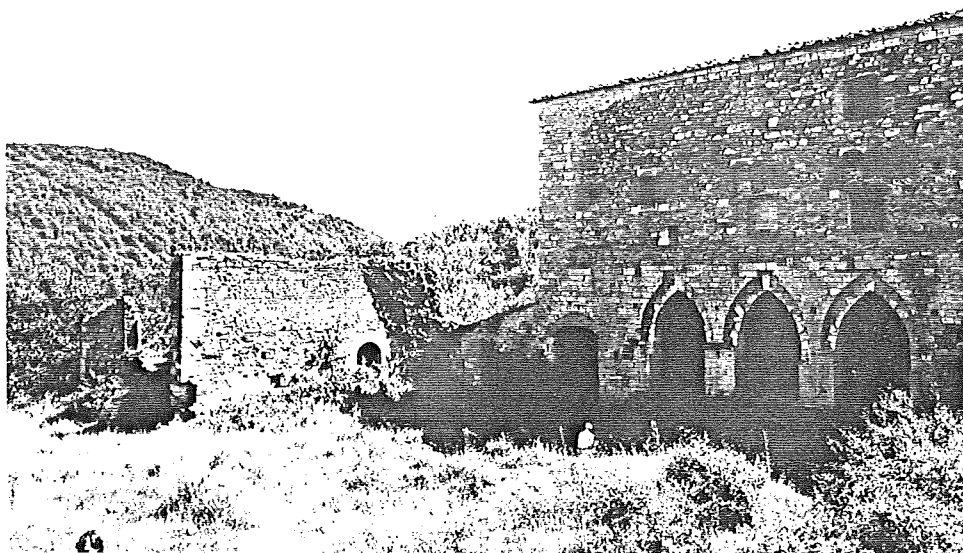
Photo 7. West facade of casa colonica and unidentified, fragmentary building attached at the northwest corner (Appendix C, BUILDING PLAN, No. 15).

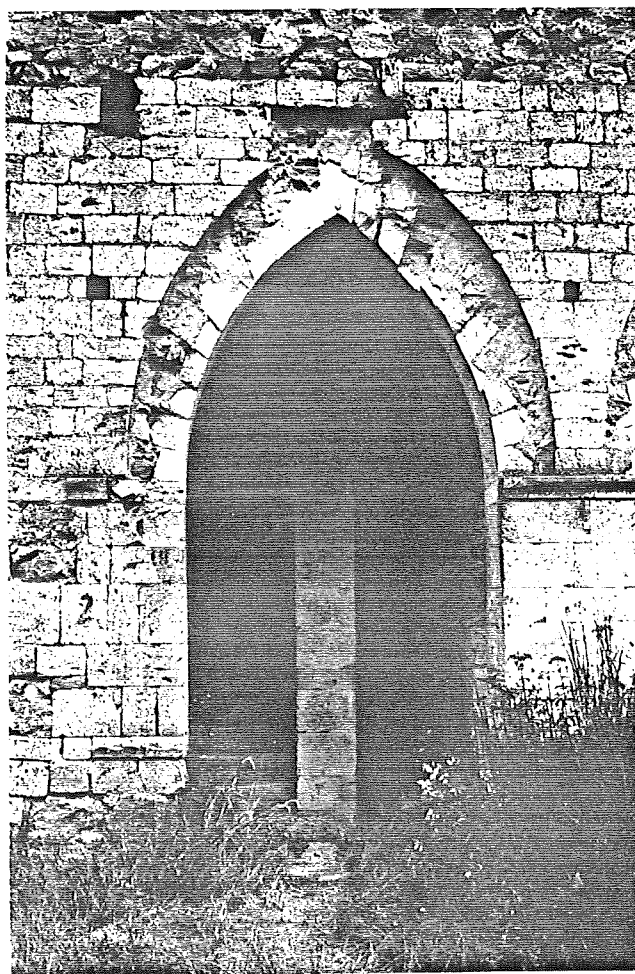
Photo 8. Northern arch of arcade of west facade of casa colonica that leads to staircase to upper floors (Appendix C, BUILDING PLAN, No. 12).

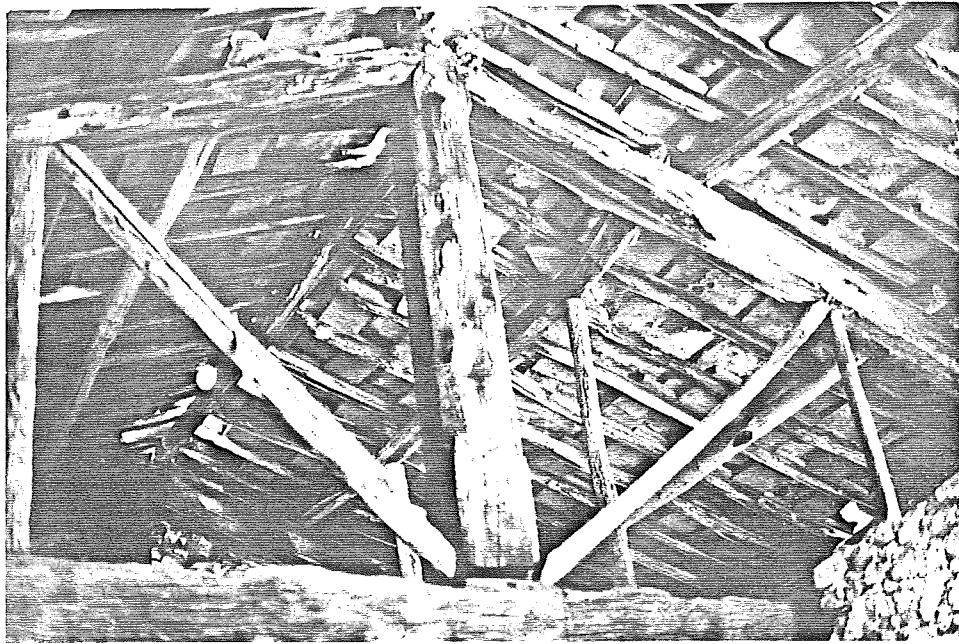
Photo 11. A-frame, mortice and tenon trussed roofing structure of south gable end (Appendix C, BUILDING PLAN, No. 13). View from second floor, southeastern room, showing west side of north-south dividing wall and holes in roof (Appendix C, BUILDING PLAN, No. 19, roof, east side).

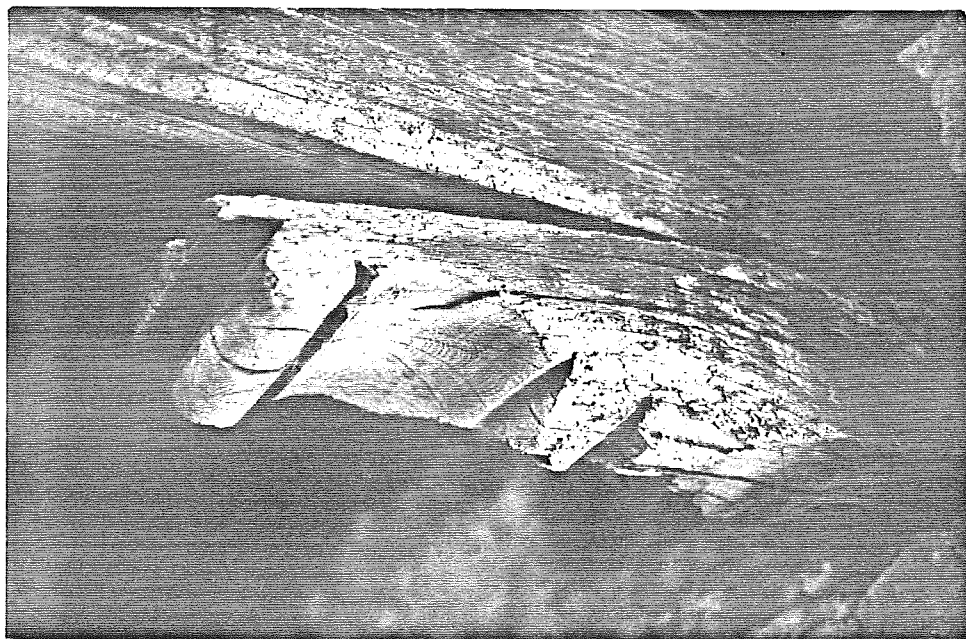
Photo 12. Carved wooden corbel imbedded in east wall to support roof timber of truss construction (Appendix C, BUILDING PLAN, No. 14).

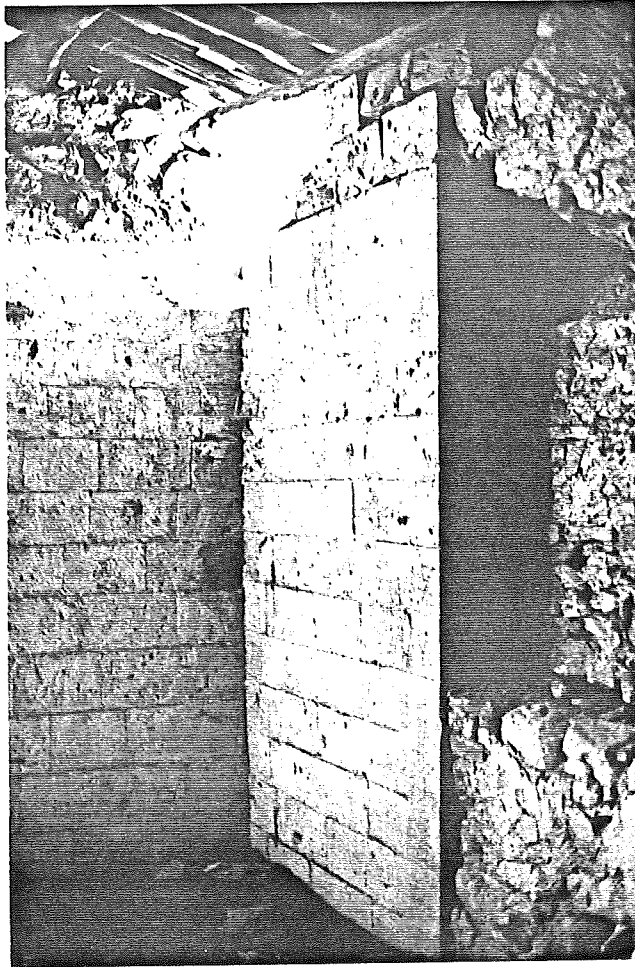
Photo 9.

Ashlar walls (possible remnants of sacristy of second church of Santa Lucia) of second floor, southeast corner of casa colonica plus abutted rubble wall and window infill of west facade (Appendix C, BUILDING PLAN, No. 22); note hole in roof and cornice (Appendix C, BUILDING PLAN, No. 19, roof, southeast corner).

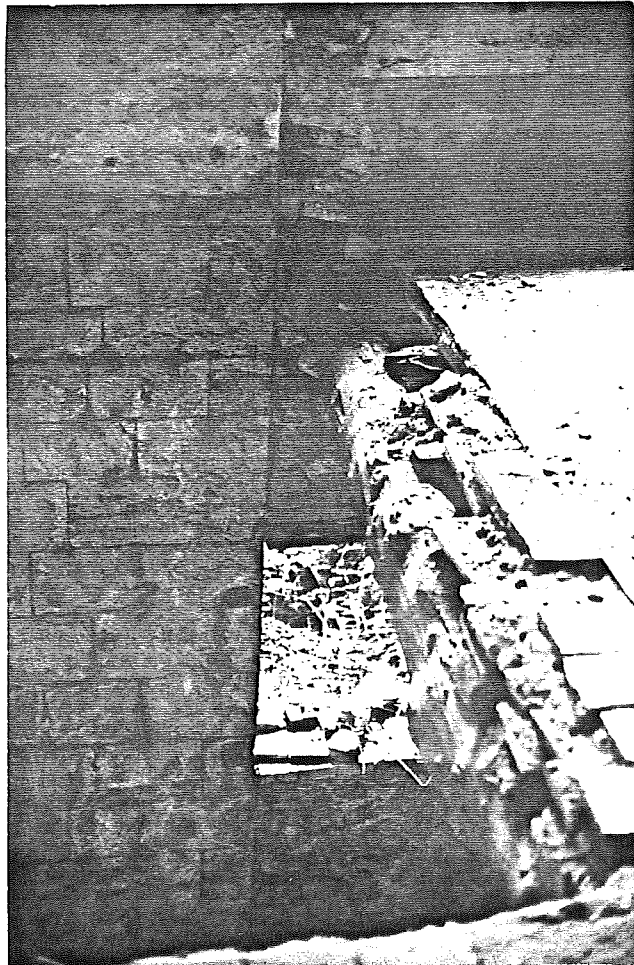
Photo 10.

Interior walls of the building are composed of rubble stone, whole or broken ashlar blocks, and brick, as evidenced by the exposed staircase walls and the walls on the ground floor. The upper rooms are faced with render of various qualities and deterioration. Ceilings are of hewn or timber beams with thinner unhewn joists running perpendicular and spaced approximately 21 cm. apart. In several instances the orientation of the beams and joists is reversed in adjacent rooms. All floors except the top floor have double thicknesses of paving brick laid roughly parallel or in a herringbone pattern and secured by mortar between beds and joints (see Photo 10).

Ashlar walls of southeast corner of casa colonica and abutted west facade at first and ground floor levels (Appendix C, BUILDING PLAN, No. 23). Hole in first floor level shows two layers of paving tile with top layer laid in herringbone pattern (Appendix C, BUILDING PLAN, first floor, No. 6).

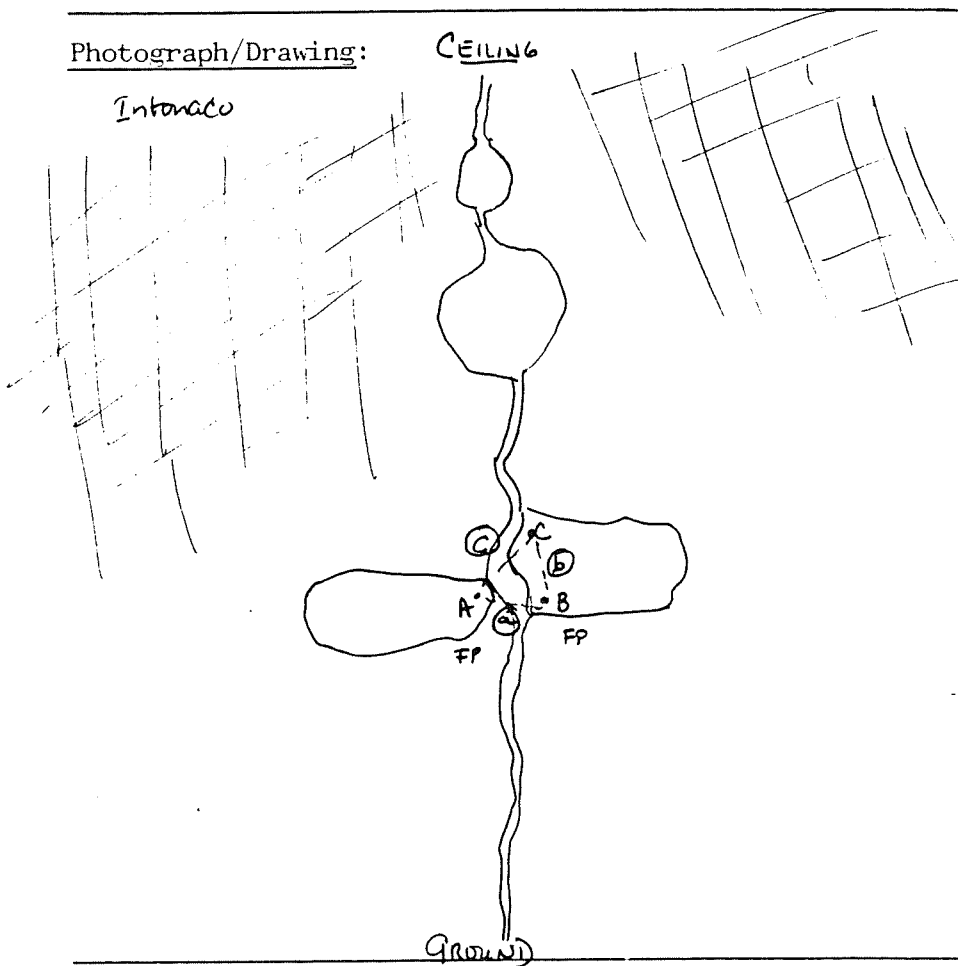
DISC SET N°. : Lucia #1LOCATION : Santa Lucia Monastery Bldg.Ground Floor open LoggiaDESCRIPTION : Crack descends frompresent Ceiling level(ca. 11 m.) to ground level.A large hole exists about  
1/4 way down the crack.Monitoring disks are  
about 50 cm. below hole  
and 2 m. from ground.Wall constructed of large  
undut stones, some rubble  
infill + different mortars.Upper portion of wall  
shows plastering in brownish-  
Sand like intonaco.

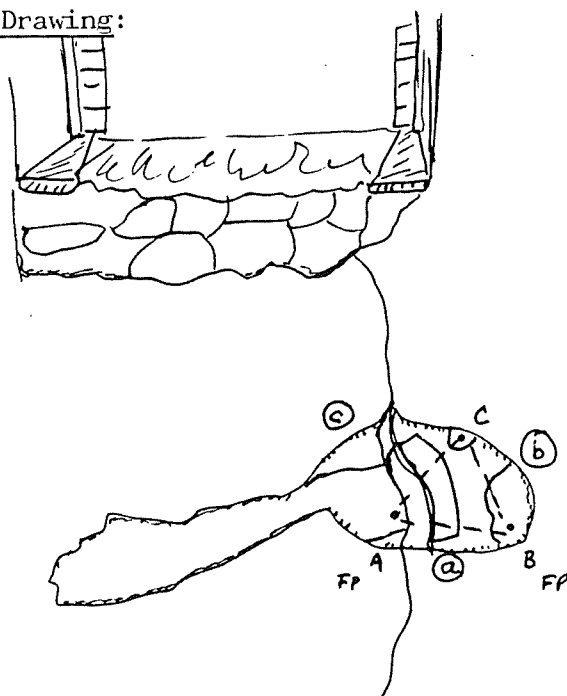
This crack descends  
from sill of NE window  
2/3 of way down to floor.  
Wall appears to be  
constructed of rubble  
brick & stone & covered  
with a thick plaster.  
Discs are located on  
three separate stones.  
Widest portion of crack  
goes along the curved  
brick in the center of  
the A.

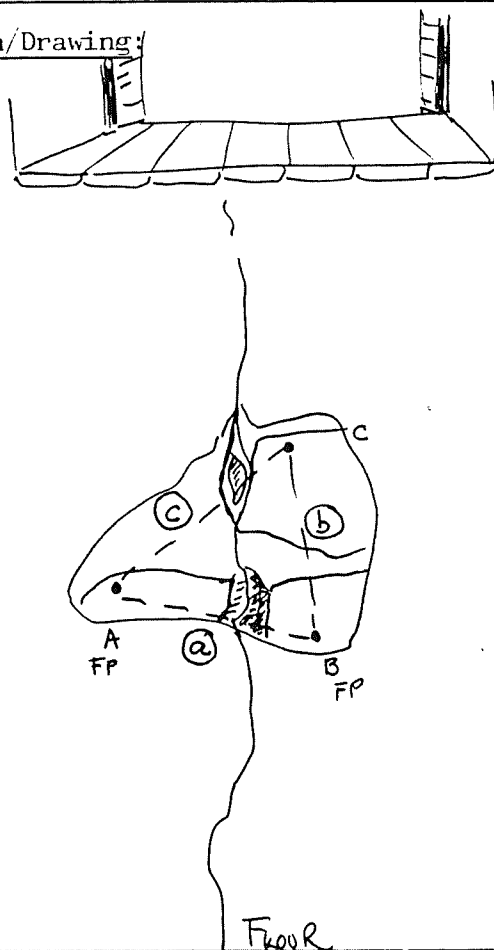
DESCRIPTION : Crack descends to

floor from sill of  
NW window.

points are  
on 3 separate  
stones located  
by cleaning back  
plaster. Considerable  
grouting occurs  
around each, with  
some mortar missing  
in shaded area.
