PADULE
SPANNOCCHIA 1987

VISUAL INSPECTION OF PADULE

SPANNOCCHIA, ROSIA, ITALY

Submitted by PAD 1 Team
"Preservation Practice in Italy"
Graduate Program in Historic Preservation
University of Pennsylvania
July-August, 1987

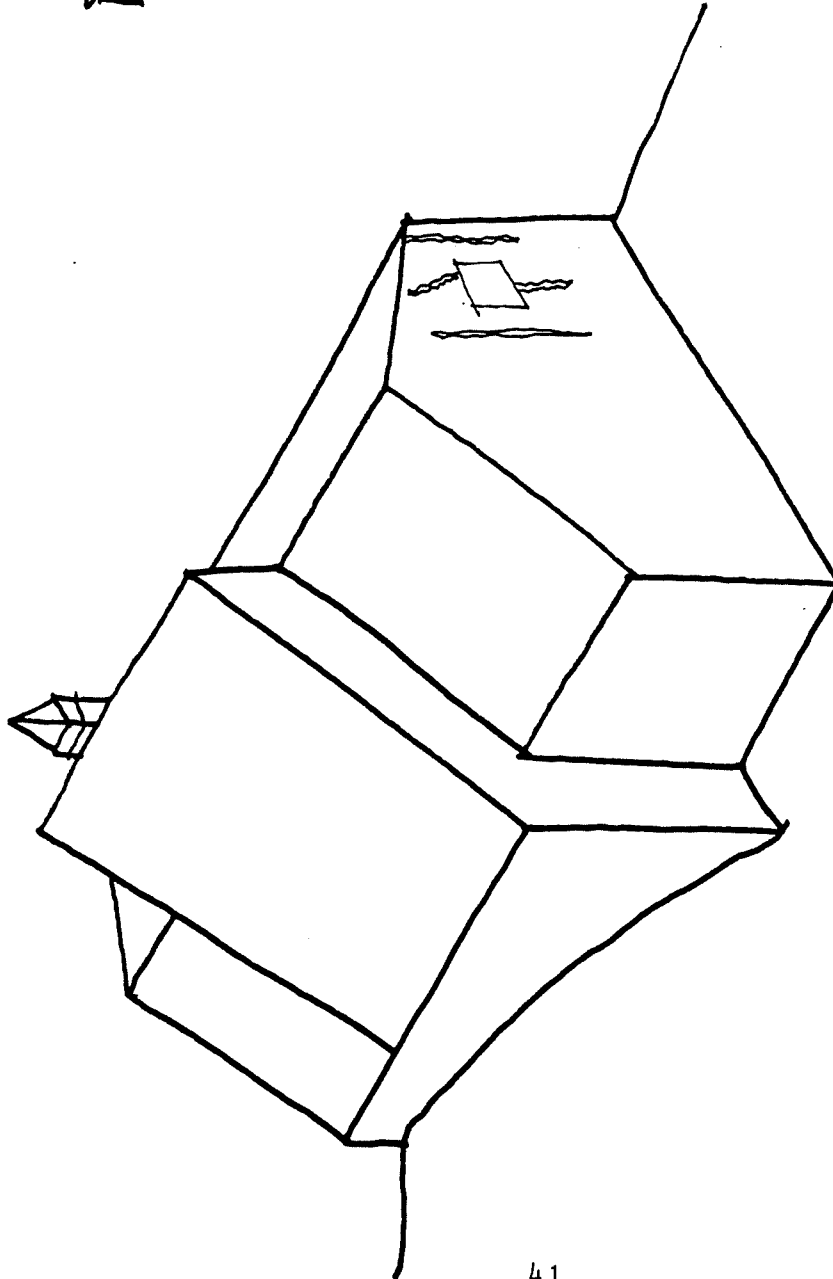
APPENDIX A

During the visual inspection of Padule a series of cracks were found in the northeast room. One large single crack was found in the east wall of 5A which penetrated into the basement. Two large cracks found in 3A which extended down into 2B were monitored with a DEMEC gauge for 5 days.

Preliminary and inconclusive findings indicate that cracks on the east wall seem to be stable while the large crack on the north wall seems to be moving. This movement may be due to thermal changes and may not indicate progressive movement in the building. Continual monitoring of these structural cracks must continue. Test results are found in Appendix B, Demec Readings.

MAJOR CRACKS INDICATED BY // IN PLAN. ALL CRACKS TO BE ASSESSED BY PROFESSIONAL.

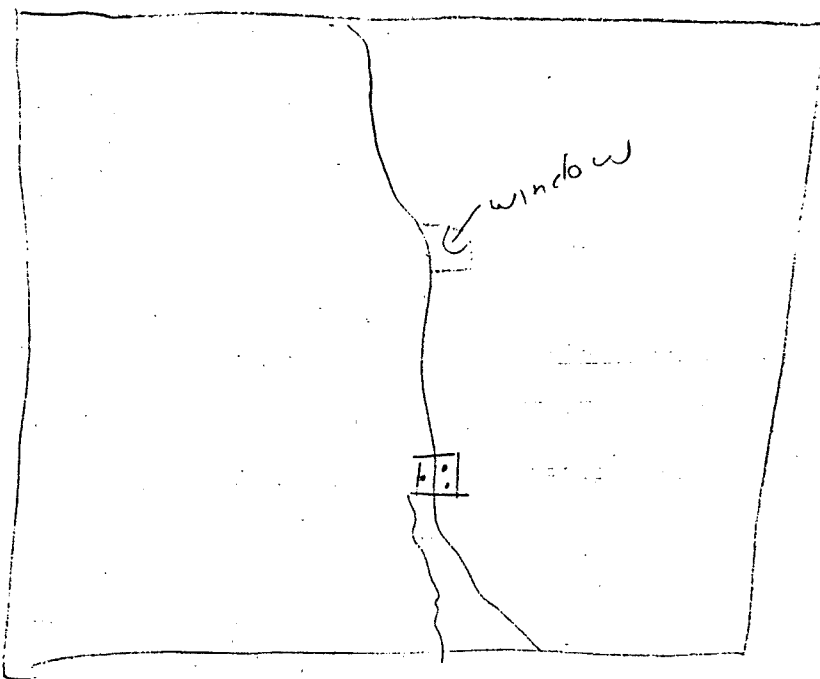
DESCRIPTION : Crack runs from floor to ceiling

The north wall of the northeast room at floor on smaller crack develops beside this one
The crack transverses through a small window now covered over with stucco and moves along a large arch at the base of the house
Crack has been repaired many times.

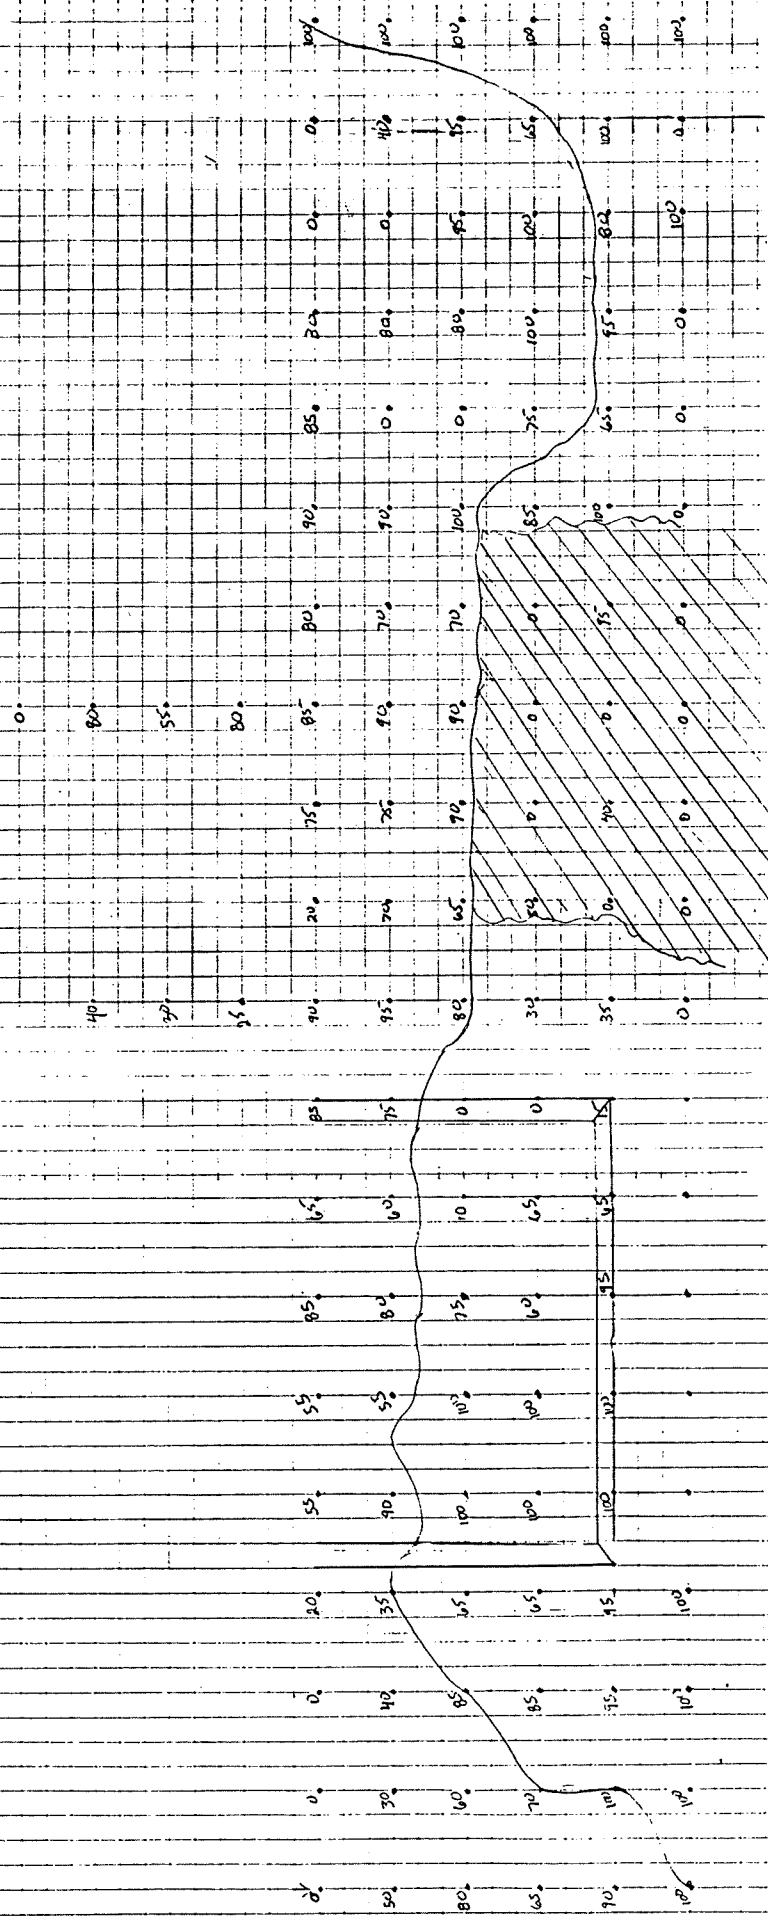
WEST WALL, ROOM 7A

The team chose the west wall of room 7A for testing with a Protimeter for moisture. Patches were found on the wall containing 100% moisture content. These high readings corresponded closely with the discoloration and spalling of the interior plaster surface (see attached Humidity Study report).

Index 14, 15, 17, 17, 1967
 numbers: Indicate % humidity in wall.
 line: percent humidity of H₂O damage
 on wall indicated by discoloration.

From this brief study it is evident that certain areas of Padule are being seriously damaged by water penetration. Steps should be taken immediately to eliminate the source of the water damage.

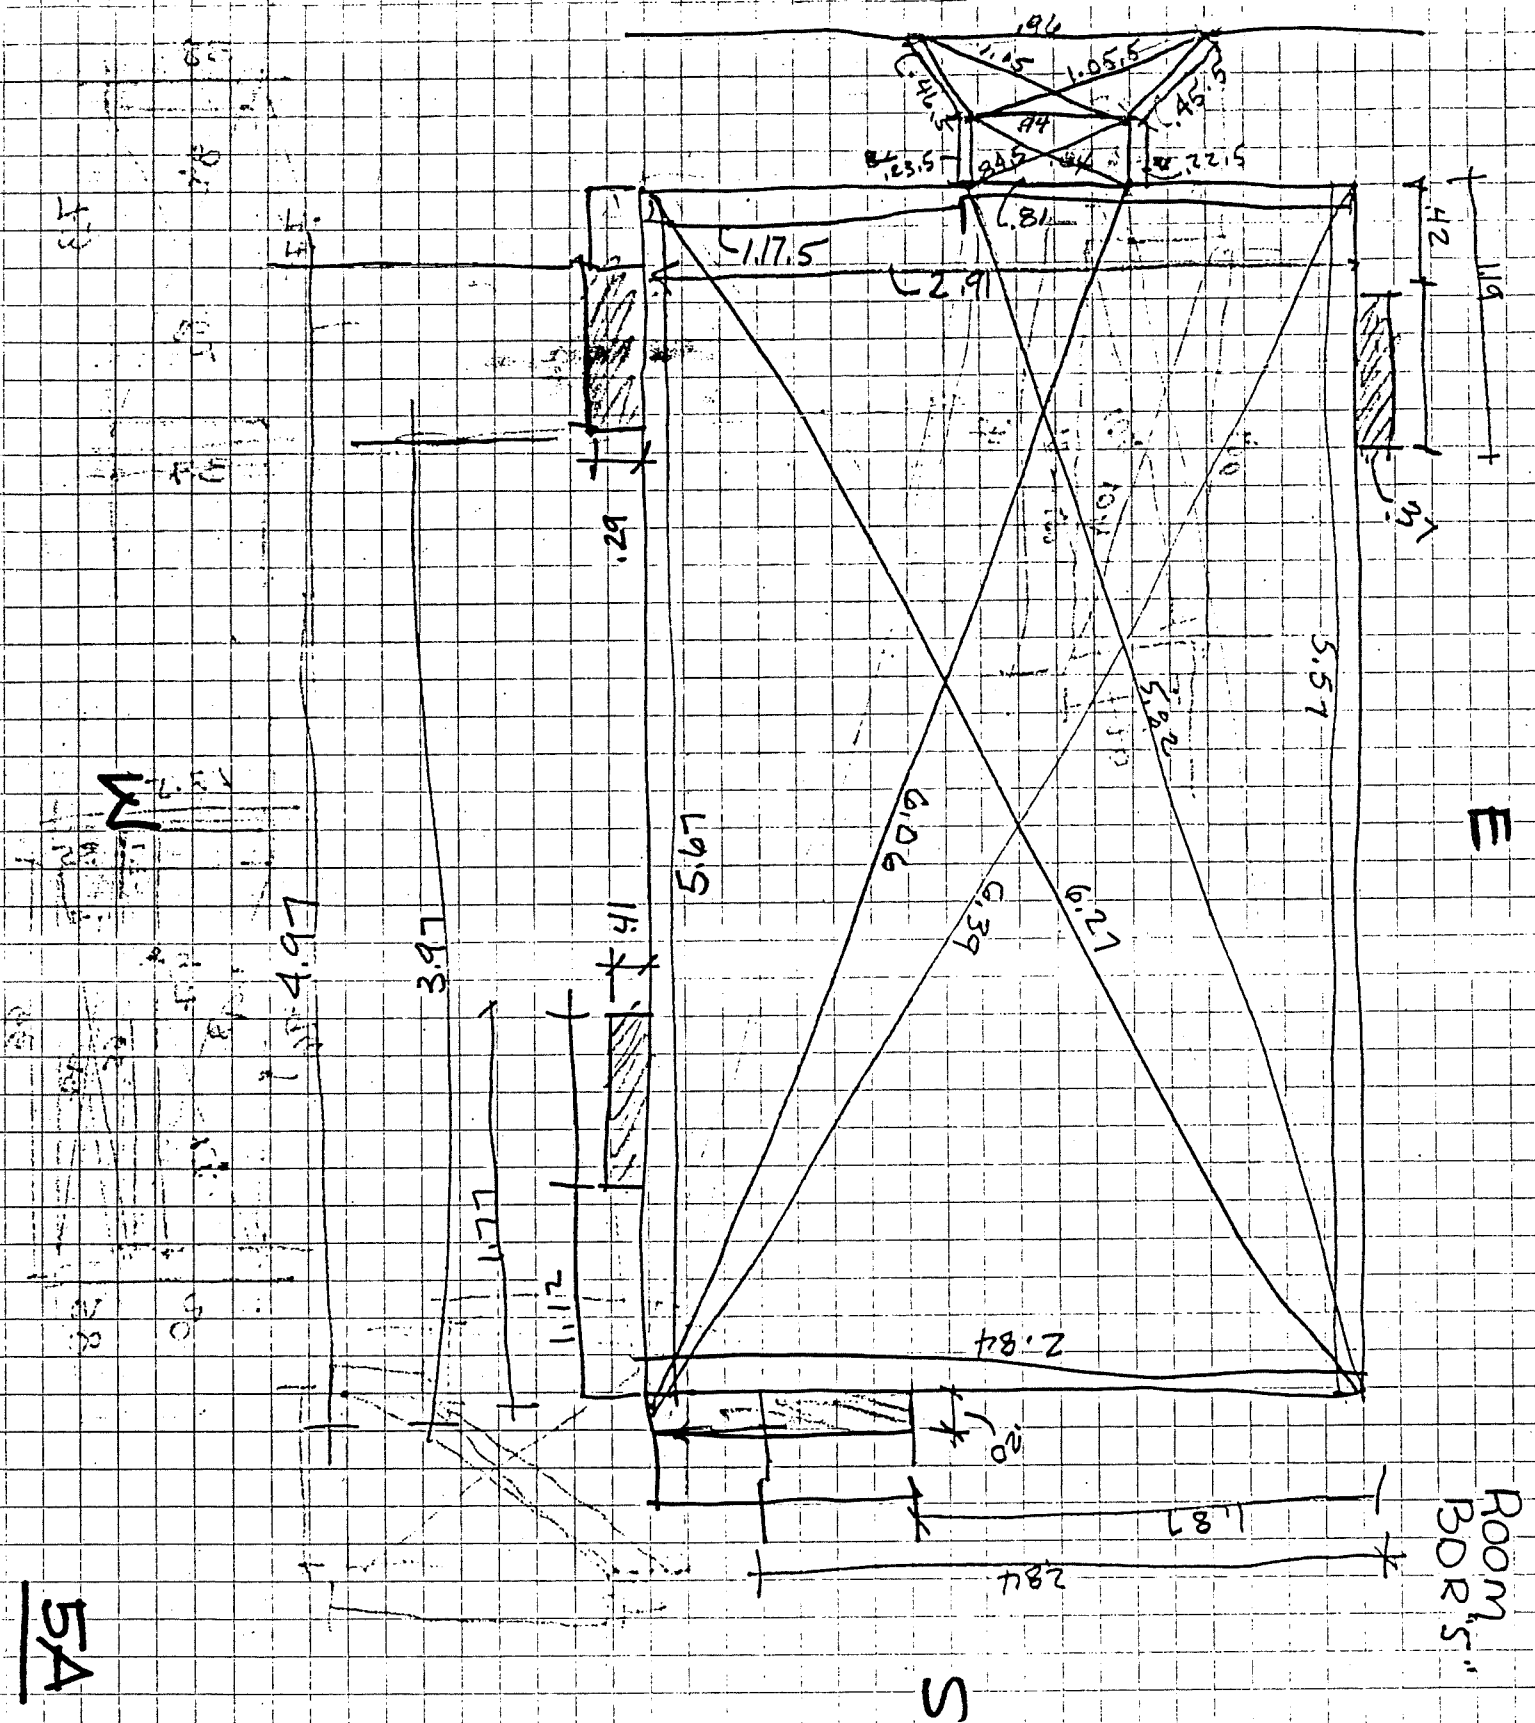
ROOM 5A, SOUTH CENTRAL ROOM

- The lower portion of the walls are a rough laid render, revealing the rubble work structure underneath.
- Several minor cracks appear throughout the room.
- There is a large floor to ceiling crack in the east wall.
- There are cracks from floor to ceiling in the NW and SE er.
- A patch of plaster is missing from beneath the niche on the westwall.
- Brown patches are evidence of possible water damage on the ceiling beams.
