THE COLTRANE CULTURAL CENTER:

AN ADAPTIVE USE PROJECT

AT ARNEST

HSTPV 700 Studio

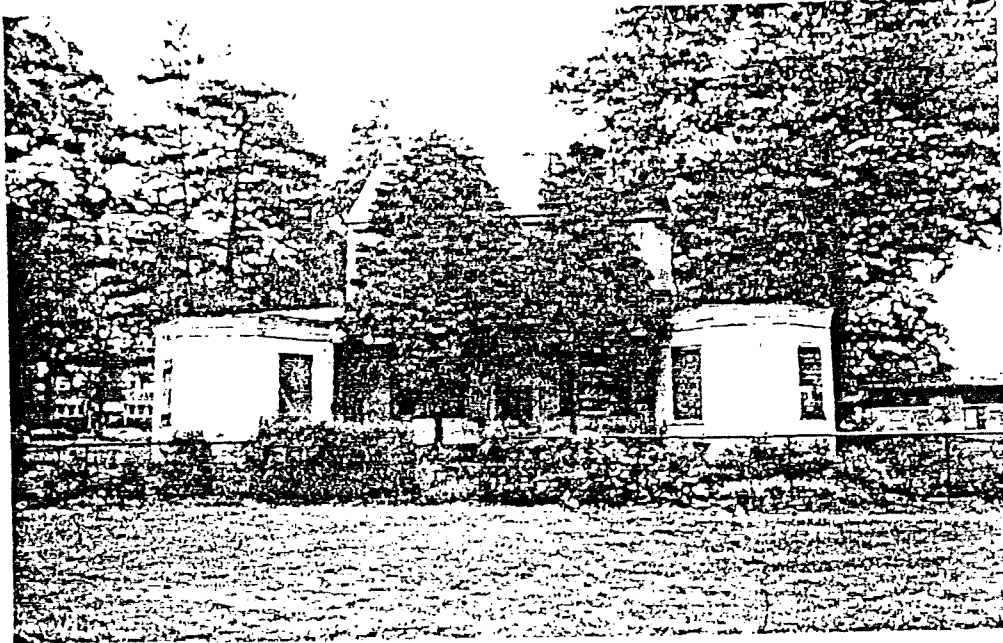
✓ 1. West facade.

The west facade of Arnest faced Log House Lane and provided the primary entrance to the house. A survey made in 1868 shows that a drive led from the road and featured a turnaround between the two octagonal bays. The central part of the house dates to c. 1798-1808 and is of stone, while the octagonal bays were added c. 1865 and are brick. Neg. 18-18.

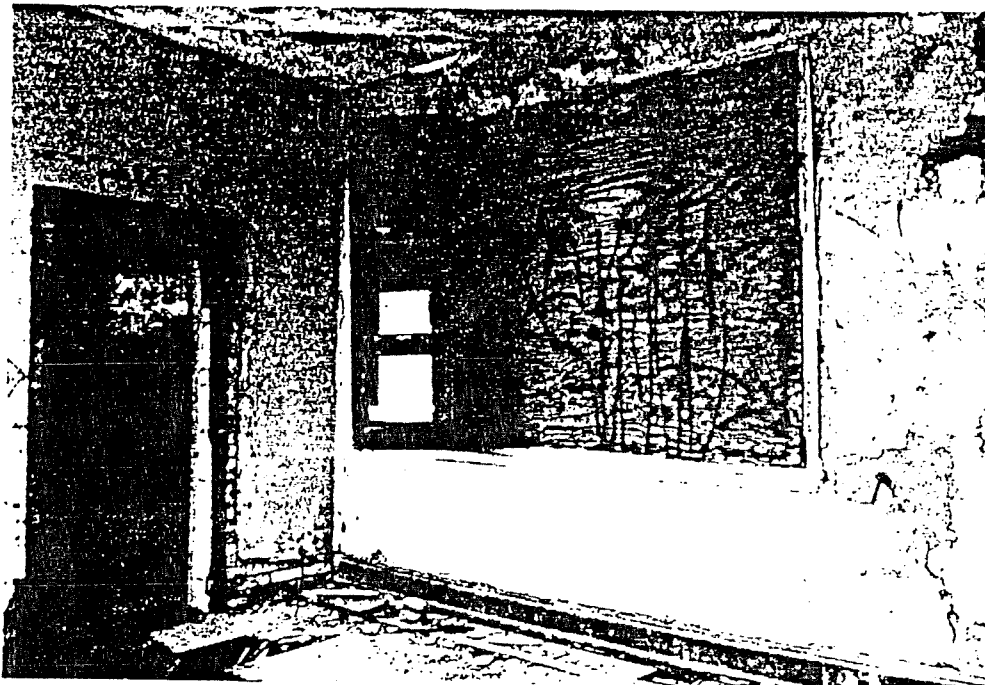
7. East facade, north window and door to octagonal bay.

The brick construction of the bay addition is visible where the wood door frame has been removed. The door to this entrance has fallen inside the bay. The oversize window is probably original and features unusual double-hinged shutters. Neg. 2-0.

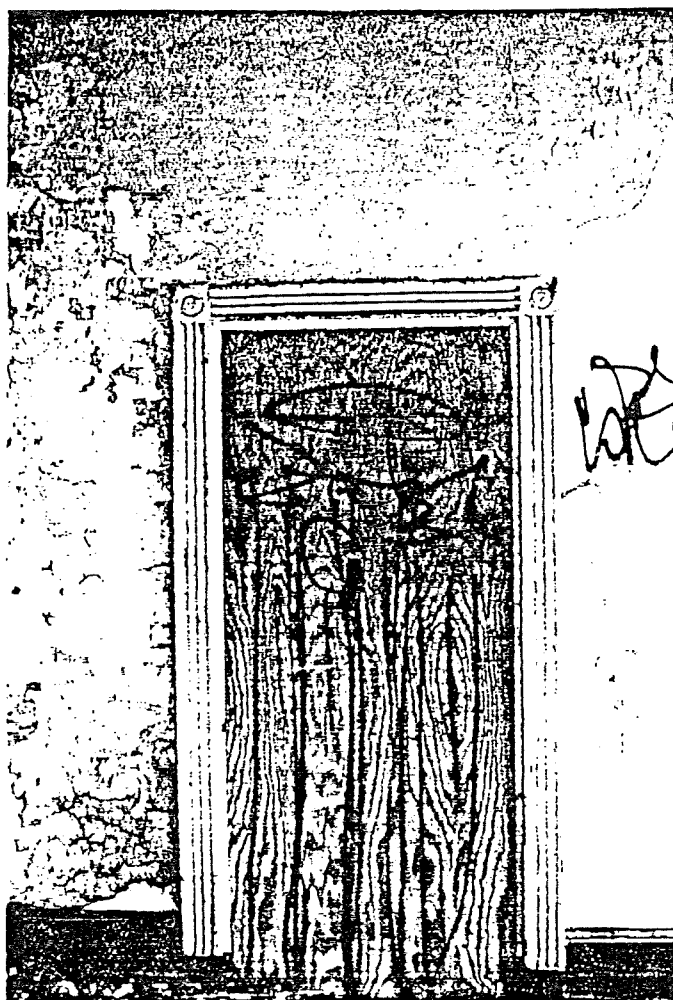
✓ 9. Door, south octagonal wing.

The molding for the entrance to this addition is intact and is a rather careful copy of that on the original front door. The molding profiles are not identical, however, revealing that they were fabricated at different dates. Neg. 2-2.

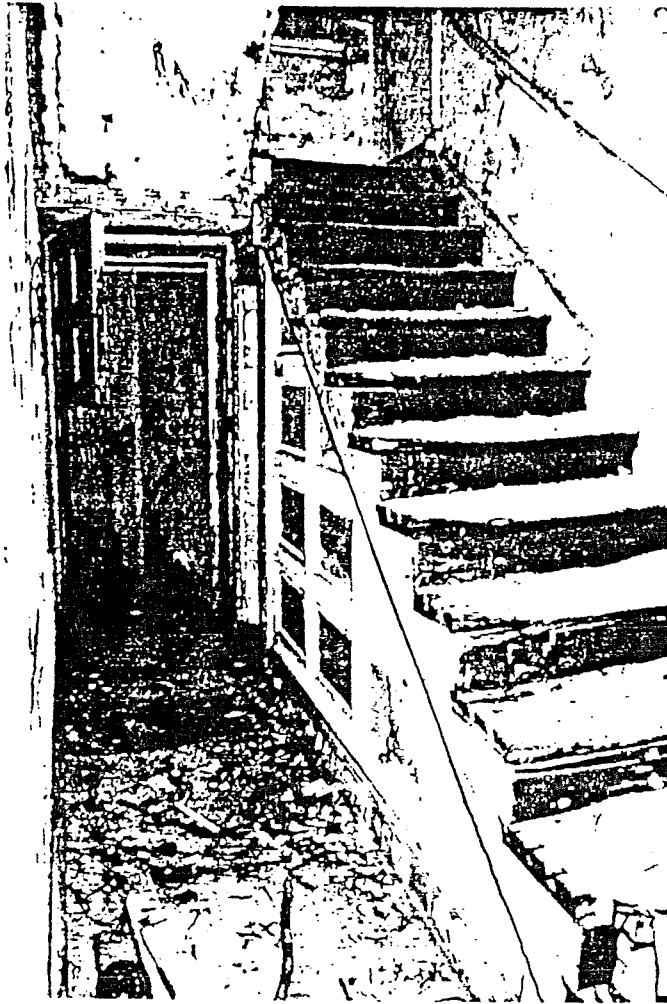
10. First floor, hall, looking east.

Arnest has a central hall that is slightly south of the true center of the house. This placement creates a larger room to the north, the parlor, and a narrower room to the south, the dining room. The paneling under the stairs is in a style more often associated with the Colonial Revival of the late nineteenth century than with the early nineteenth century. Paint and structural analyses are needed to determine whether it is original to the house and, therefore, highly unusual, or whether the paneling is an attractive addition. The banisters and stair rail are missing, but their appearances are documented in the series of photographs taken in 1979 by John C. McIlhenny of the Fairmount Park Commission staff; see Appendix for representative examples. (The series of photographs is on file in the Historian's Office, Fairmount Park Commission.) The hand rail along the wall is original and somewhat crude in its execution, evidence that the carpenter for the house had his share of limitations. The door to the cellar is beneath the stairs, and the east door to the exterior is adjacent to them. Neg. 2-4.

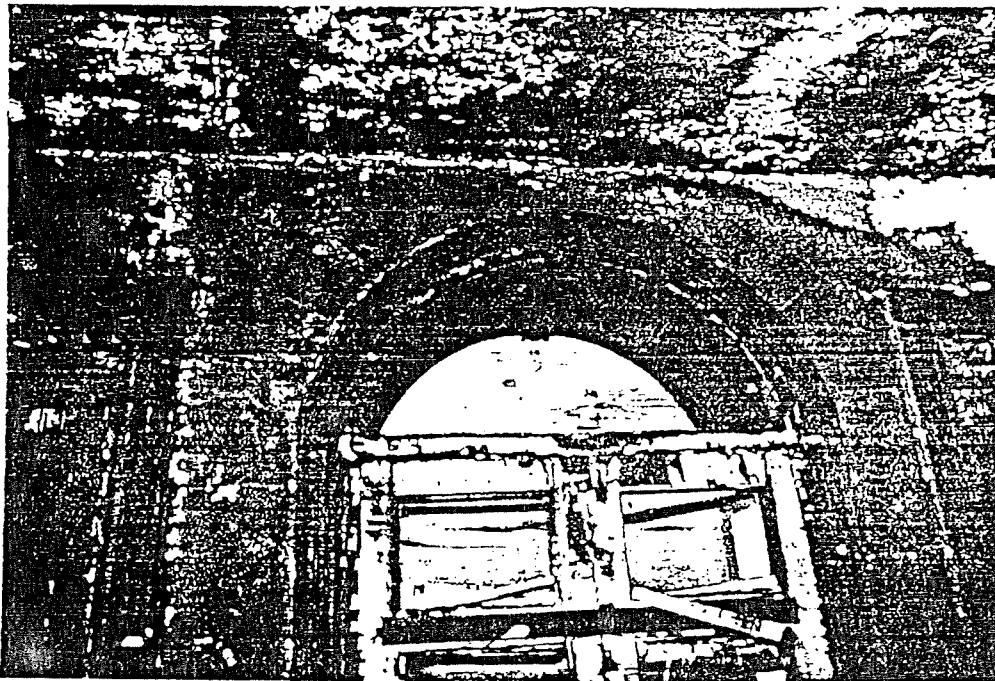
✓ 14. First floor, north parlor, paneled fanlight.

Note particularly the contoured ribbed molding at the center. It is identical to that on the fanlight of the front door, Photograph 15. Neg. 21-15.

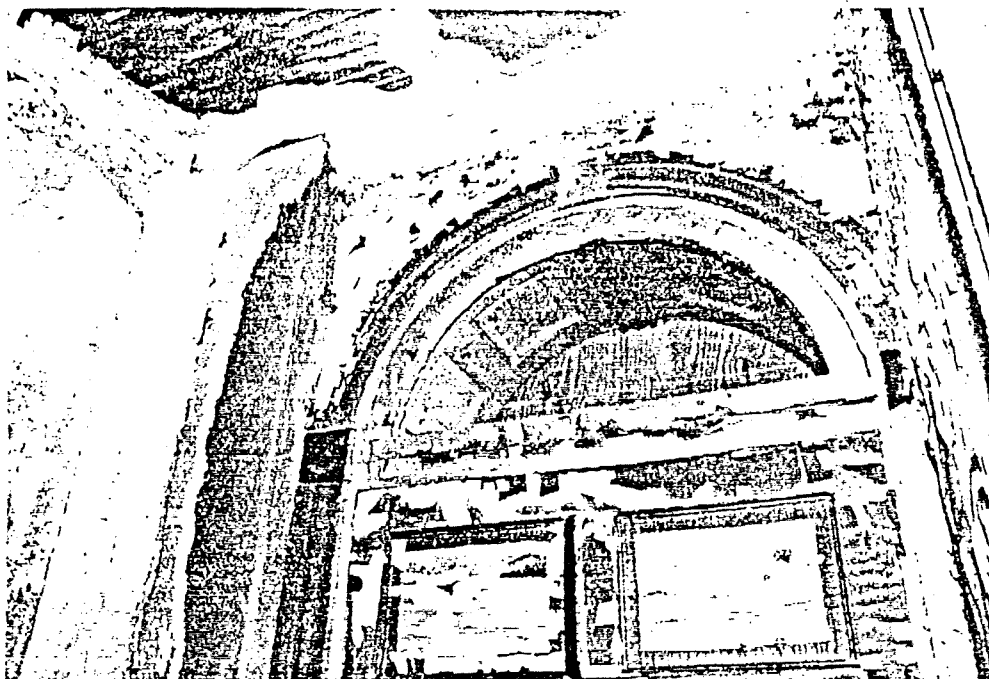
15. First floor, paneled fanlight, west door.

The contoured molding used at the center of the fanlight is carried through to the molding surrounding the door frame. This contrasts with the flat, grooved molding surrounding the parlor door frame. Neg. 21-13.

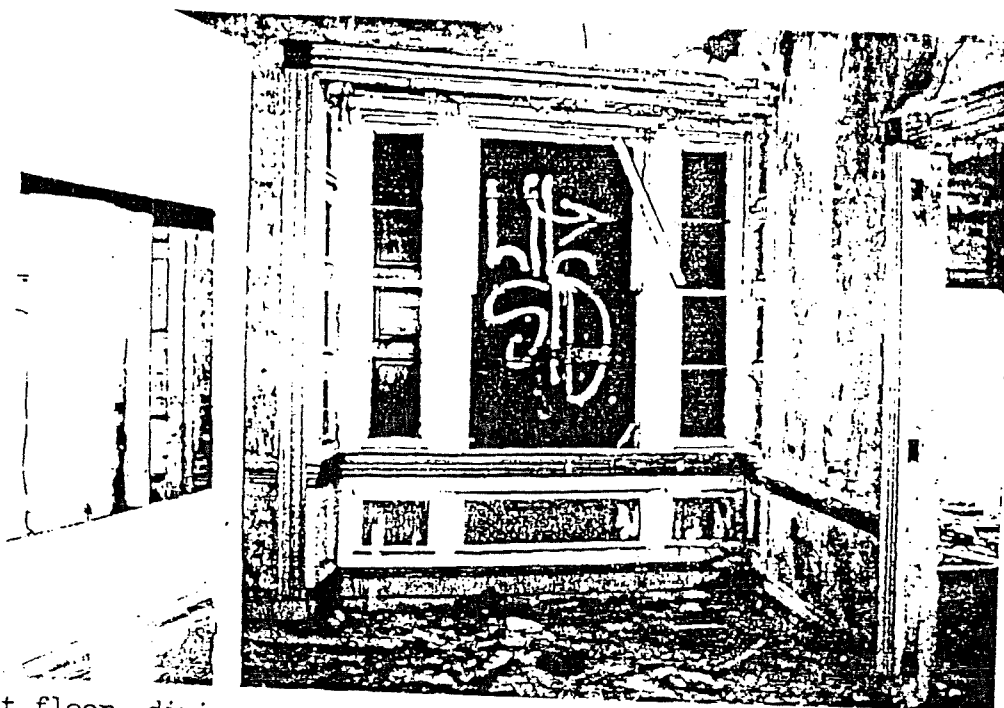
21. First floor, dining room, west wall and window.

The three-part window is like that in the parlor except for the moldings and the plainer paneled wainscoting. The moldings match those of the front door, and the fielded panels are more typical of the style used in the eighteenth and early nineteenth century; therefore, the window treatment may be original to the house. Again, paint and structural analyses are required. The awkward crowding of the window frame and the partition wall provide further evidence that there has been some alteration of that wall. Neg. 2-9.

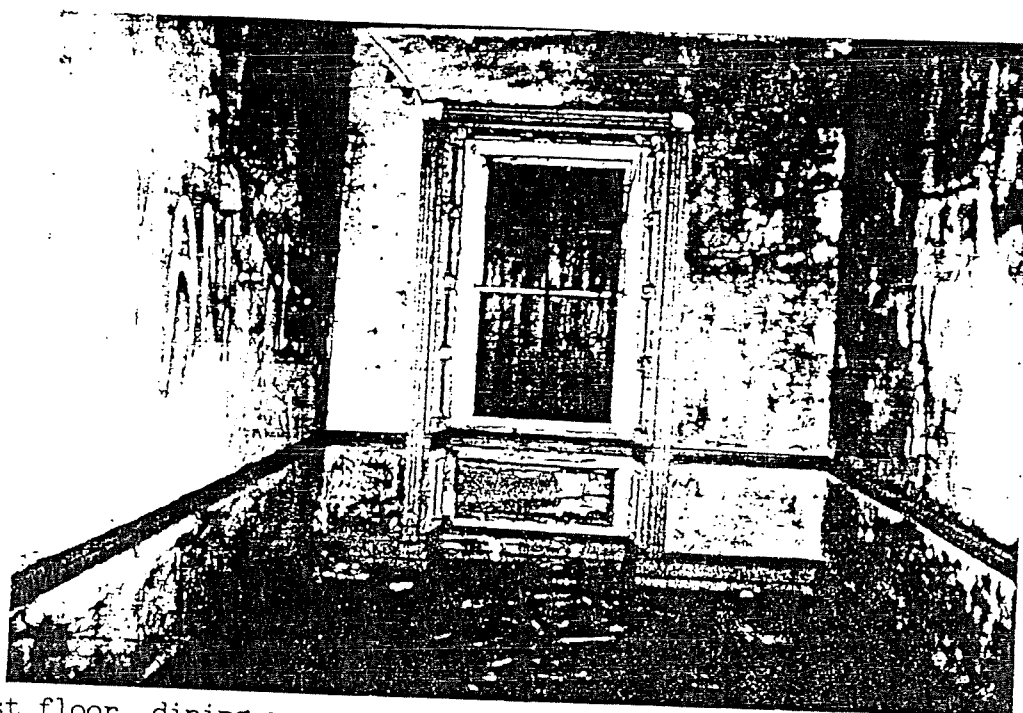
22. First floor, dining room, east wall and window.

The moldings and wainscot paneling are unlike those used on the west window the dining room, once again indicating an addition or alteration. Neg. 2-10.

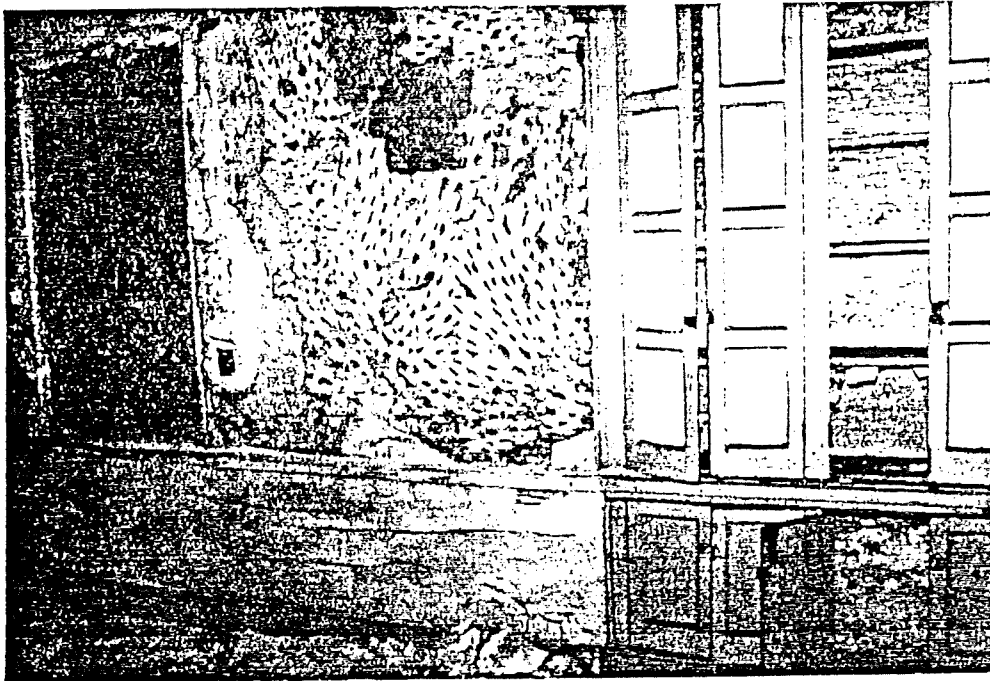
✓ 23. First floor, kitchen, south wall.

The kitchen wing to the south is a likely addition to the original house made before 1868 when it appears on the field survey. It is built of stone rather than brick used in the bays, suggesting different periods of construction. The built-in cupboards were a common feature in eighteenth and nineteenth century Philadelphia kitchens and pantries. Neg. 21-17.

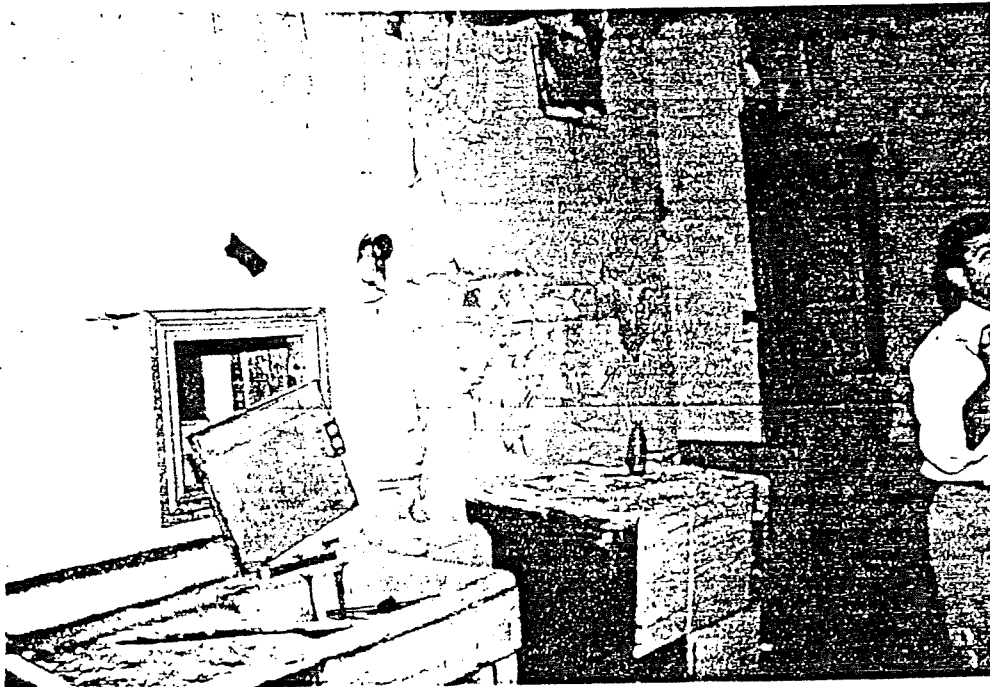
24. First floor, kitchen, north wall.

The traces of a mantle on the fireplace wall indicate the location of the cooking fireplace. The opening would have been enclosed later in the nineteenth century with the installation of a cook stove. Neg. 21-25.

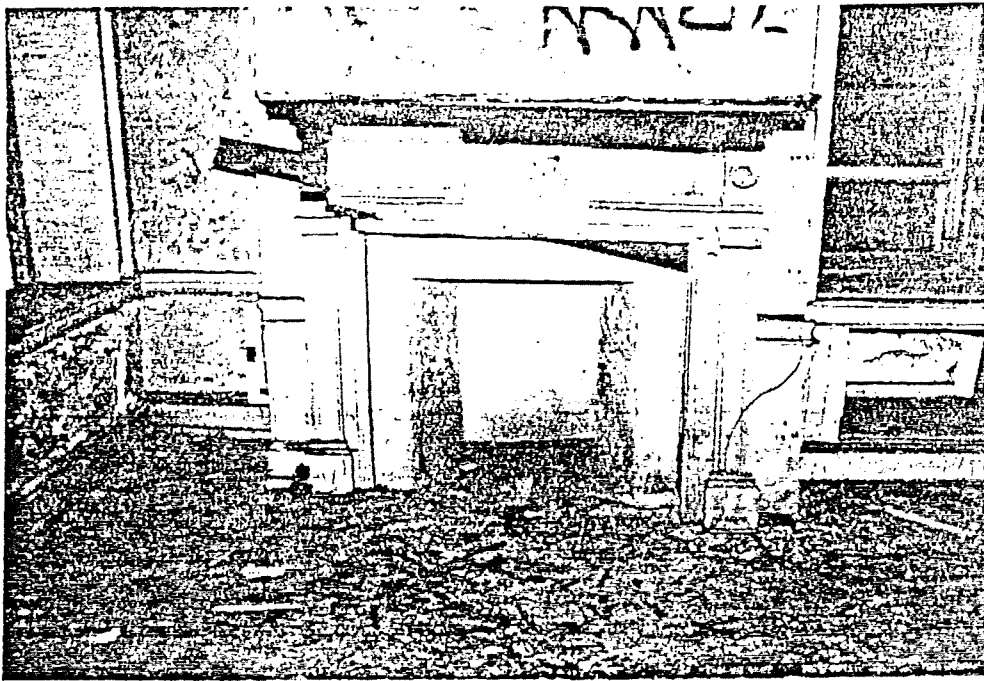
26. Second floor, north bedroom, east wall.

The lovely carved mantle, together with the detailing of the staircase, represents the best of the original woodwork that survives in the much-altered and sadly deteriorated Arnest. The shallow reeding of the central keystone is typical of Philadelphia mantles between 1790 and 1810. The neoclassical round rosettes point to an early nineteenth rather than an eighteenth century date. This stylistic evidence is corroborated by the machine-cut nails with handmade heads which the carpenter used to construct the mantle and to attach it to the brick flue behind it. These "transitional" nails were made with a combination of handwork and machine work and can be tightly dated to 1800-1810, offering structural evidence of when Arnest was built.

The molding immediately surrounding the fireplace opening shares the contoured shape of that used on the door frame of the main entrance and the west window in the dining room. The window to the right of the fireplace is a post-1868 addition as is the window on the first floor immediately below it. The large size of the room, the elaborate mantle and its position above the main parlor suggest that this north chamber served as a master bedroom/second floor parlor, a relatively common practice in small Philadelphia houses of the period. Neg. 21-21.

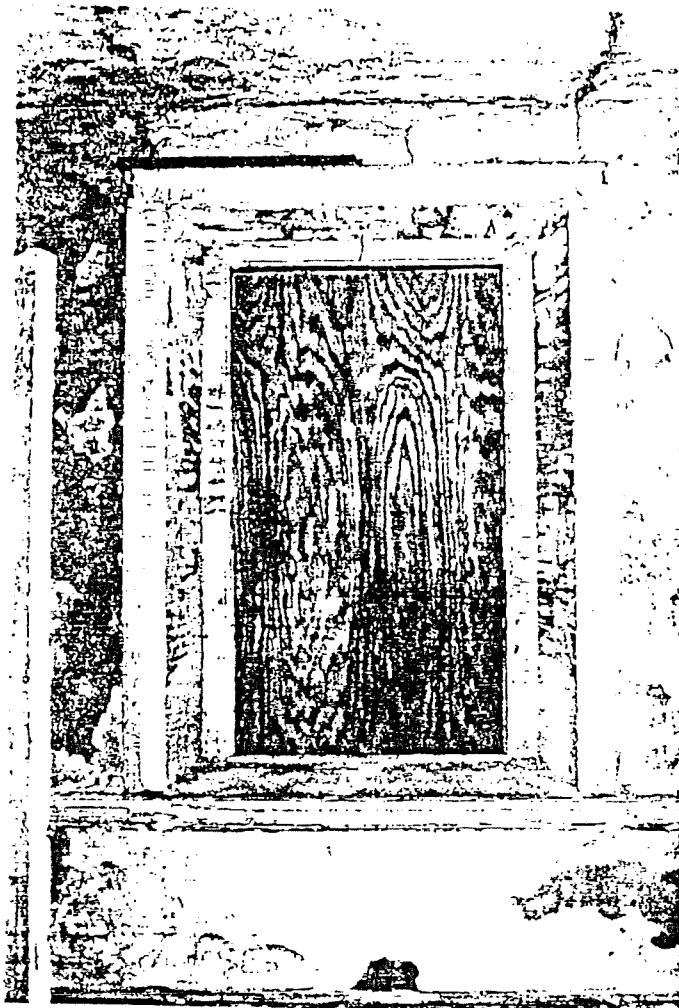
27. Second floor, north bedroom, west wall.
Yet another molding style on the window frame provides further evidence that Arnest is a house that has evolved and has been altered over time.
Neg. 21-22.

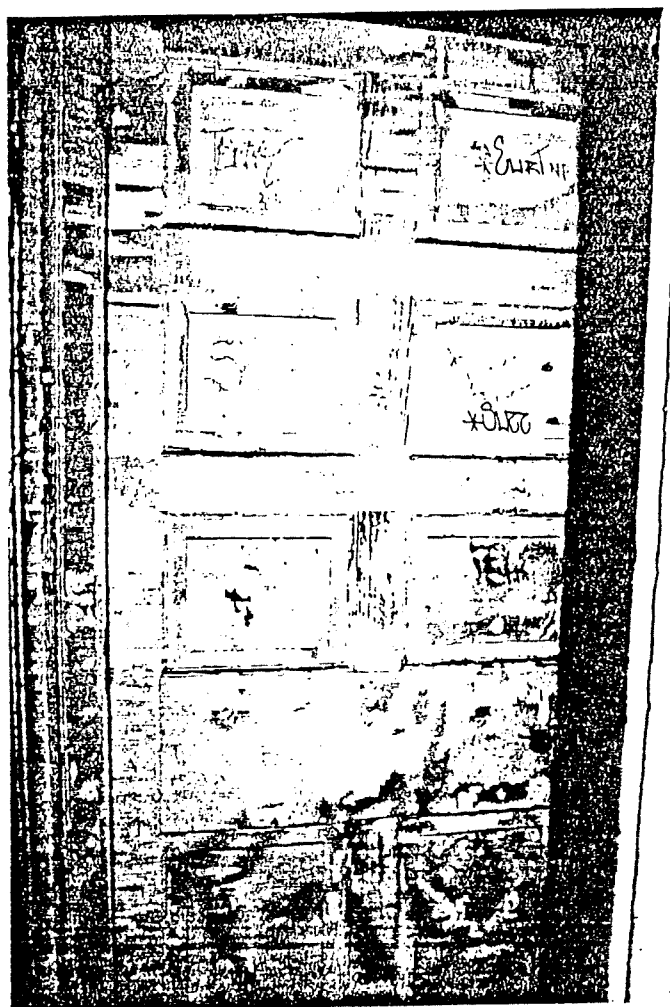
28. Second floor, door to small chamber between the north and south bedrooms.

The 1868 plan shows that this door opened to a chamber that once included the central and southern window on the west facade. Currently there is a partition between the two windows so this door opens to what is now a small bathroom directly above the center hall. The door features raised panels with beveled edges, typical of the style used by Philadelphia carpenters during the eighteenth and early nineteenth centuries. The molding profile of these panels contrasts with that of the flat panels found on first floor doors such as that to the basement and in the door frame to the east exterior entrance; see Photograph 12. It is likely that the door illustrated is original to the house and that its general style, if not its specific execution, was copied later in the nineteenth century when the first floor was altered. Neg. 2-16.

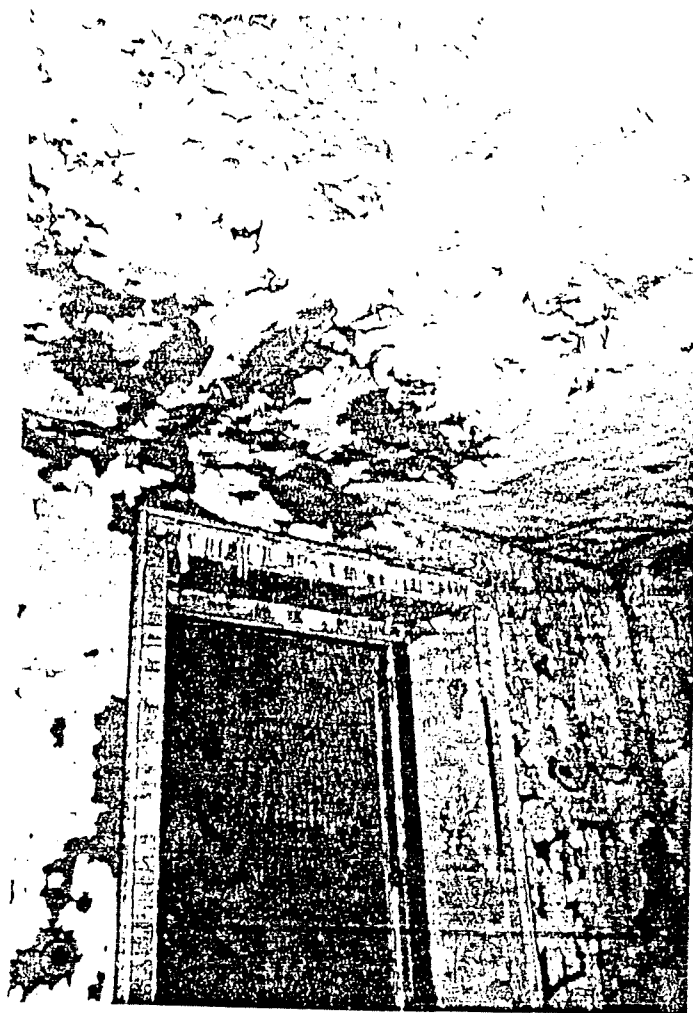
29. Second floor, south bedroom, south window.

Another window, another molding, this in a simpler style more like that found on the third floor. The ceiling shows evidence of the partition that once separated the space now occupied by the south bedroom and the small chamber shown in Photograph 28 into two rooms of similar size. After 1868 this partition was replaced by the current one, creating the large south bedroom and small bathroom. There was once a fireplace to the left of this window. Neg. 21-23.

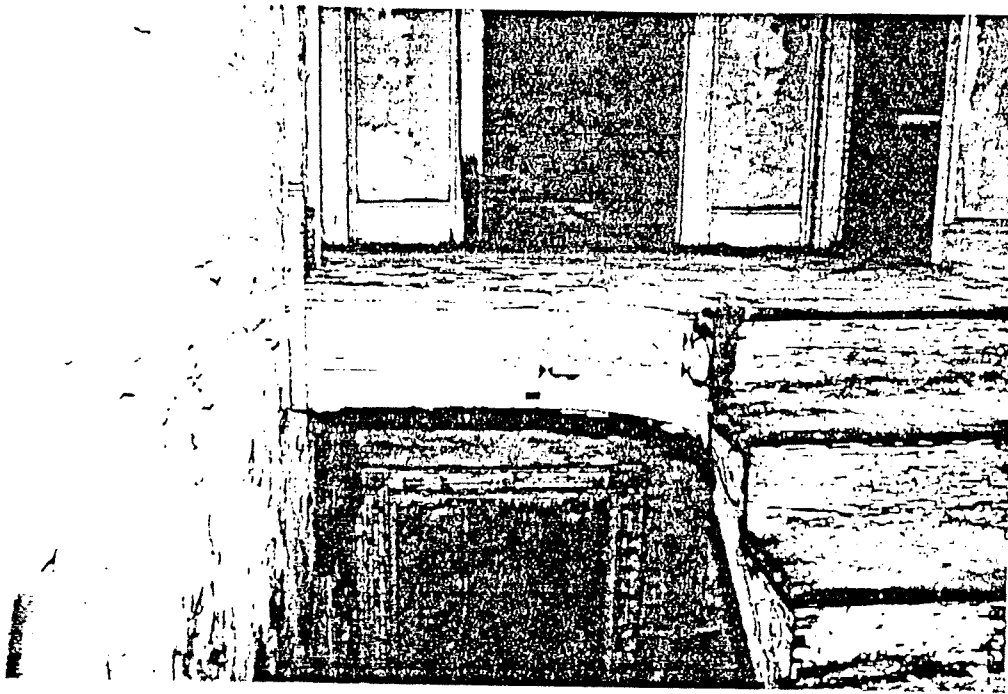
Third floor, staircase landing.

The delicate fretwork trim on the frame of the landing is one of the most elegant features at Arnest. Both the style and execution of the fretwork conform to patterns popular at the turn of the nineteenth century. Curiously, the conspicuous stylishness of the third floor fretwork is allied more closely with the neoclassical molding surrounding the door frame on the second floor (lower section of picture) than the plain molding of the third floor (upper section of picture). Neg. 2-18.

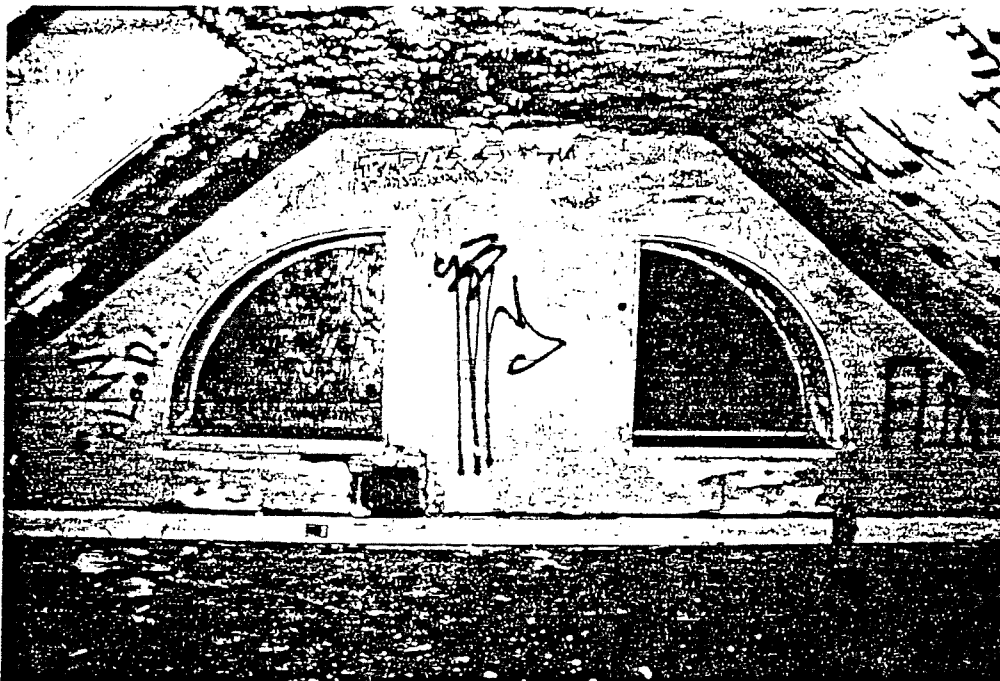
Third floor, north room, north wall.

Half lunette windows were a stylish way to light an attic, c. 1810-30. The opening is punched into a flue, likely installed for a central heating system. Neg. 2-19.

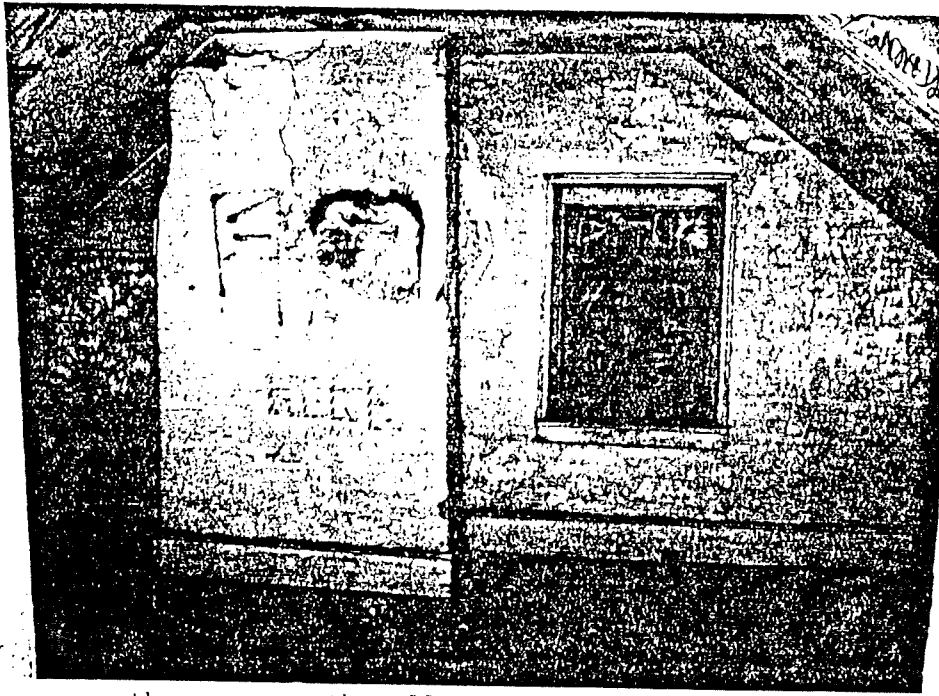
32. Third floor, south room, south wall.

This wall contains the sole exposed evidence of the original chimneystack that once extended with fireplaces through to the first floor, heating the dining room and the southeast bedroom (now the south bedroom) below. Both third floor chambers would have been used as bedrooms for children and/or servants. Neg. 2-20.
