Architectural Investigations and Archival Research

English Garden House and

French Garden House

Mount Edgcumbe House and Country Park

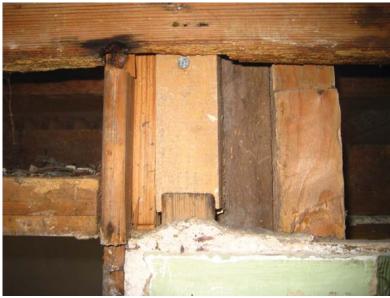
Figure I.14: View from the south of the original eastern jamb board showing the rebate to receive the wood paneling (now missing) and the ³/₄" edge bead. *Source: University of Pennsylvania*

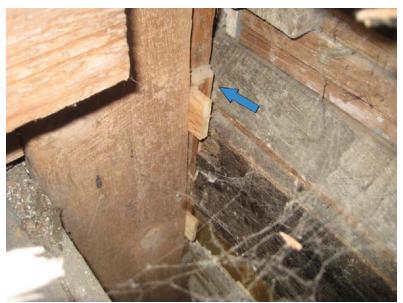
- A fragment of wood paneling was found under the cornice on the south face of the stud partition near the east wall (*Figure I.15*).

Figure I.15: View from the attic space above the center partition showing a fragment of original paneling in place (facing the Outer Hall) at the eastern end of the partition. *Source: University of Pennsylvania.*

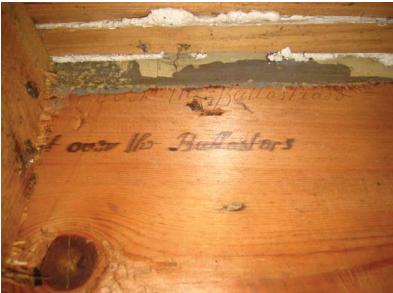
• The words "soffit over the balusters" are written on both the east and west ends of the soffit (in the locations of the missing brackets) (*Figure I.31*).

Figure I.31: View looking up at the soffit of the balustraded opening revealing writing in the area of the soffit covered by the original bracket. *Source: University of Pennsylvania.*

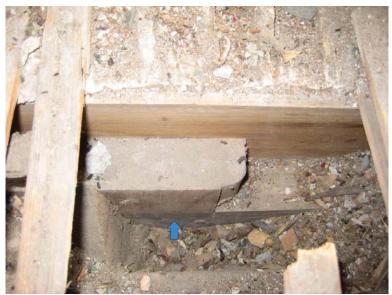
Figure I.36: View looking down from the attic space above the Inner Hall at the top of the paneled wall to the east of the fireplace mass. The paint line indicates the point of intersection of the original cornice moulding (now missing) and the paneling. *Source: University of Pennsylvania.*

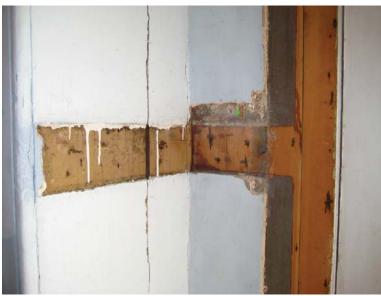
Figure I.38: View from the south east at the intersection of the east face of the chimney mass with the eastern paneled wall showing evidence of the earlier chair rail. *Source: University of Pennsylvania.*

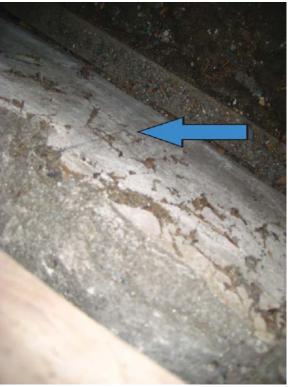
Figure II.1: View looking down at the top of the south (parapet) wall from the north side of the attic space above the West Room. The surviving scored stucco exterior finish is visible. *Source: University of Pennsylvania.*

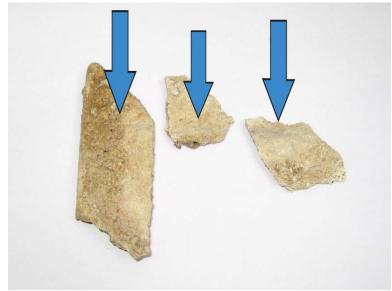
Figure II.2: Fragments of stucco exterior finish were found on the northeast corner of the north stone wall of the East Room, behind the overlaid brick east wall. These fragments are evidence of the fact that the stone wall was actually the south exterior wall of a wing (now missing) constructed in Phase II to the north of the East Room. *Source: University of Pennsylvania.*

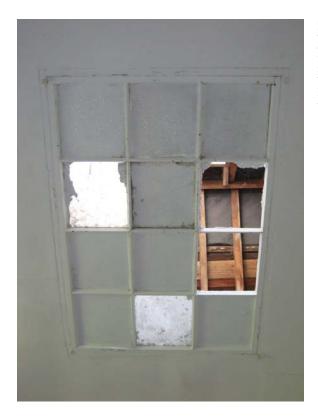
Figure V.3: View looking up at the glazed sash in the ceiling of the Bathing Room that borrows light from a skylight in the roof. The roof framing is visible through the missing window pane. *Source: University of Pennsylvania.*

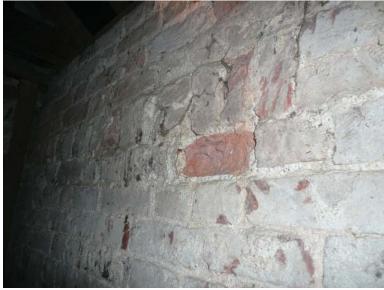
Figure II.2: These courses of brick, the bottom row containing the broken faced brick and the course above it containing the bricks laid on edge, indi¬cate the section of the wall that was infilled. *Source: University of Pennsylvania.*

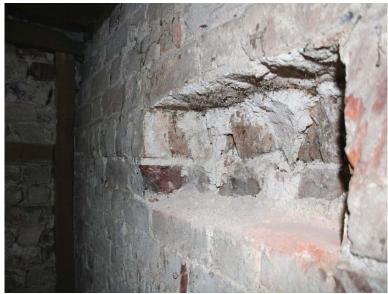
Figure II.3: Wall with portion of infill bricks removed. There are no obvious plac¬es where the removed bricks would have keyed into the wall, indicating that they were later infilled. *Source: University of Pennsylvania.*

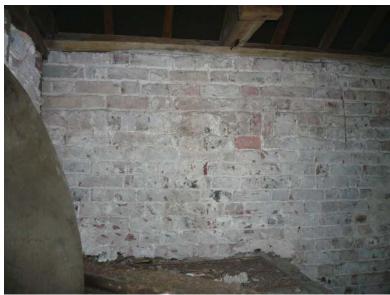
Figure II.4: The clean Flemish brick work is clearly visible above the infill layer. The bottom course of the infill contains the broken faced brick. To the right of this brick, the infill portion contains three courses and to the left only two. *Source: University of Pennsylvania*.
