Historic Structure Report The Cabaret at Taliesin West

12621 N Frank Lloyd Wright Blvd, Scottsdale, AZ 85259

Prepared for: The Frank Lloyd Wright Foundation
Fred Prozzillo, Vice President of Preservation

HSPV 7210 Capstone Studio: Materials + Materialities
University of Pennsylvania, Stuart Weitzman School of Design
Contributors: Yi-Ju Chen, Priyanka Gorasia, Yuxuan Wu, Anyuan Ji
Advisor: Irene Matteini, Frank Matero
Spring, 2023

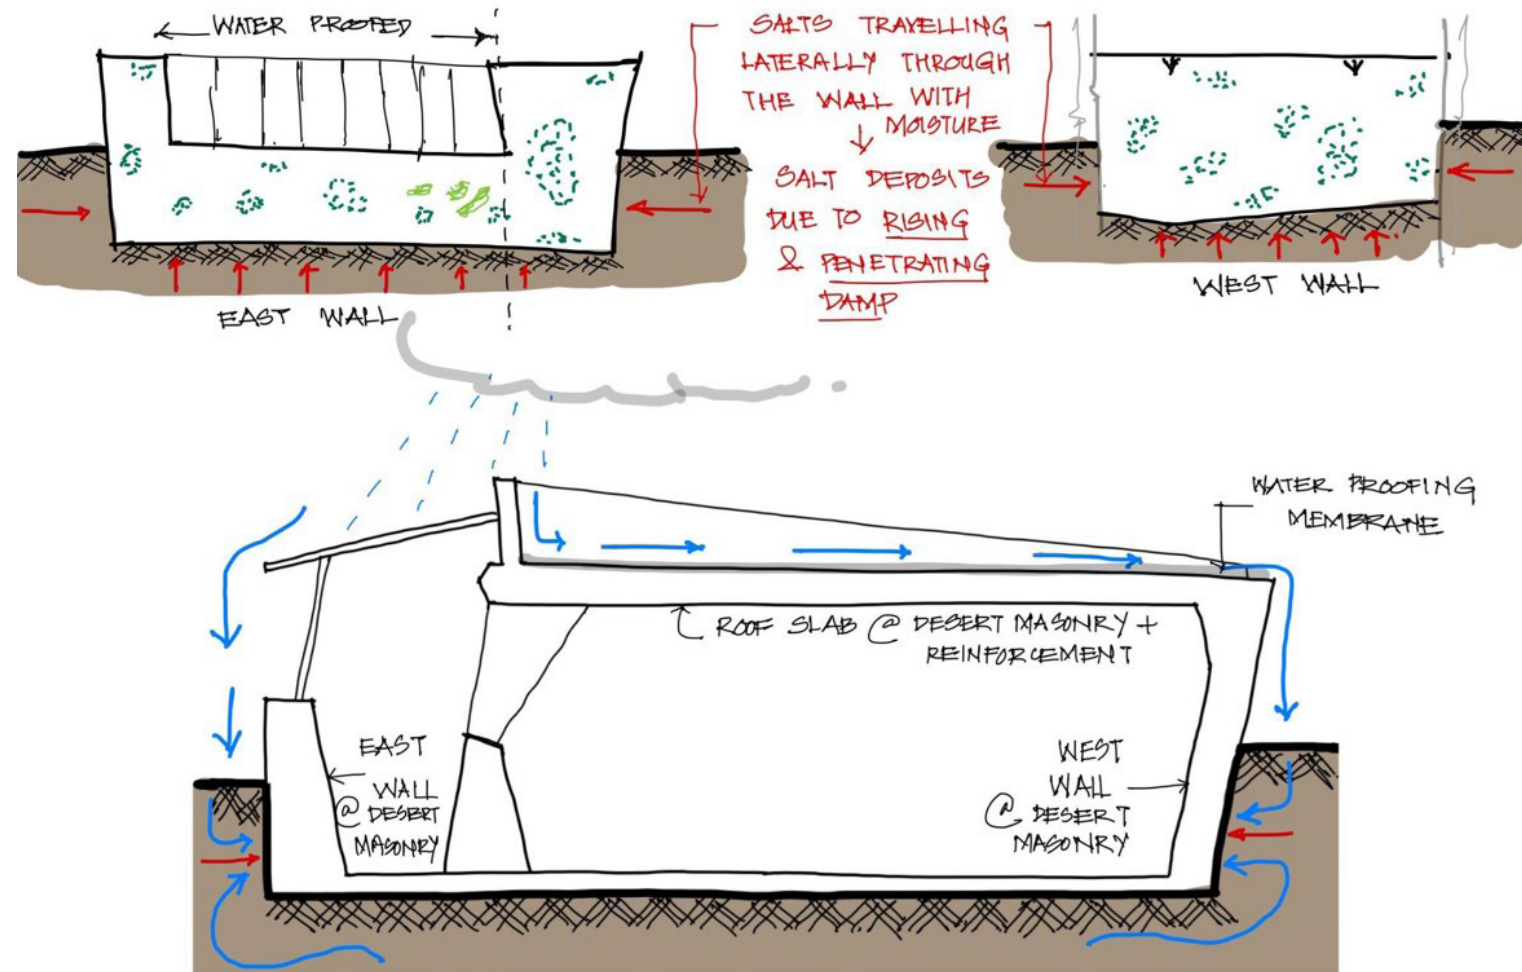
Most of the interior walls exhibit large, localized areas of efflorescence, with this condition being most notable in the west, north and the east walls corresponding to A, B-C and D. Salts are mainly located in the mortar as opposed to the stone of the desert masonry walls (Figure

Figure 4.3 Condition Assessment Analysis of the Cabaret Walls
 Diagram: Priyanka Gorasia

4.4). As mentioned earlier, the structure is partially below grade. As such, the west and east face walls have direct contact with the soil below ground. The salts in this case can be attributed to rising and penetrating damp. While rising damp is caused by capillary action causing moisture to be drawn up through porous elements of a building’s fabric,¹ penetrating damp is the moisture that travels laterally through the fabric of the building from the outside.² Salts travel along with the moisture and crystallize on the surface upon evaporation (Figure 4.3)

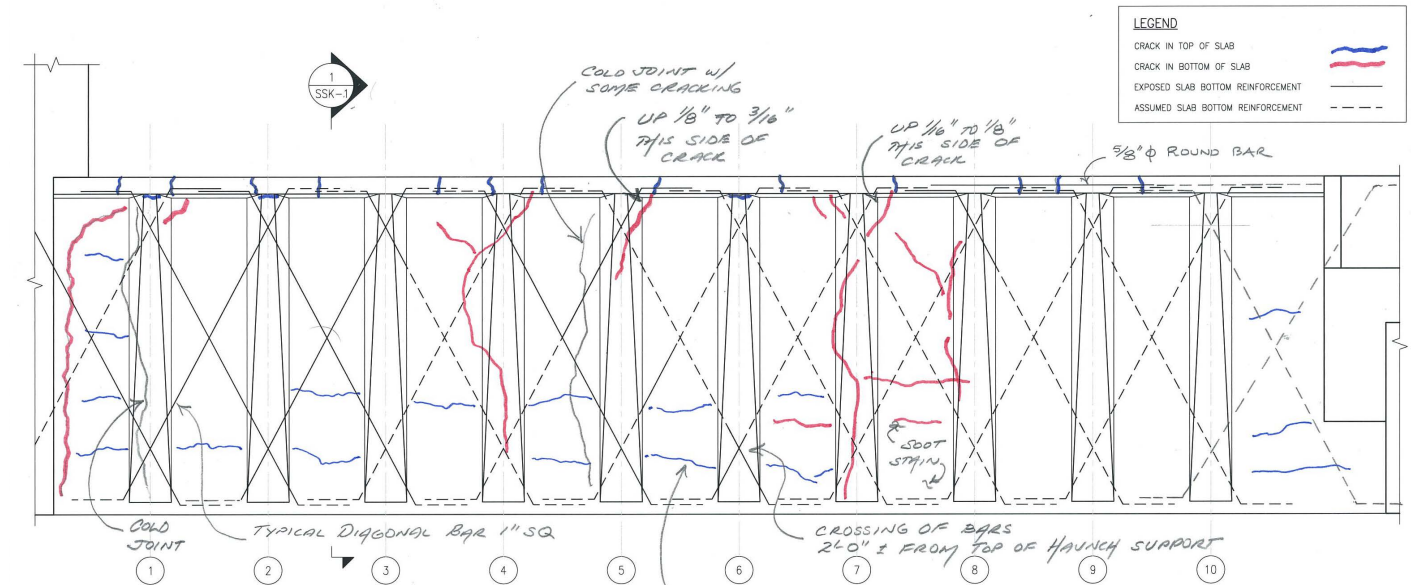
The cracks on the ceiling were recorded after the first year of construction which led Wright to install the reinforced exterior roof beams. The team compared the cracks documented in our field analysis to those mapped out in the 2013 Structural Report (Issued by I200 Architectural Engineers) and found that the crack pattern has not changed significantly over time (Figures 4.8 & 4.9).

Figure 4.8 Cracks mapped on the Cabaret Roof Plan
 Source: I200 Architectural Engineers, 2013 Field report

Although none of the cracks could be confirmed as through roof slab cracking, we recommend continued monitoring to ensure that they do not worsen over time. This will be further expanded upon in the Recommendations section of the report (See Section 5.2) Other conditions observed include exposed rebars which are mainly seen in the slab next to the interior decorative piers. According to the structural report by I200 Architectural Engineers, it is implied that the square reinforcing rebars were laid directly on the formwork as in some areas the reinforcement is exposed and visible on the ceiling.

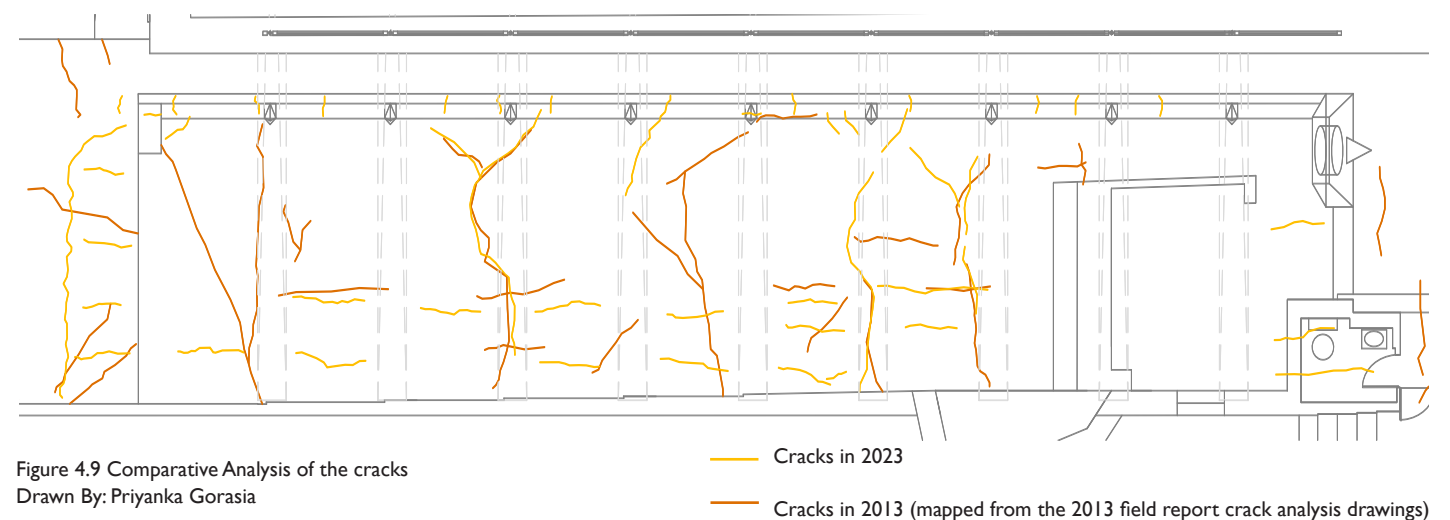
Figure 4.9 Comparative Analysis of the cracks
 Drawn By: Priyanka Gorasia

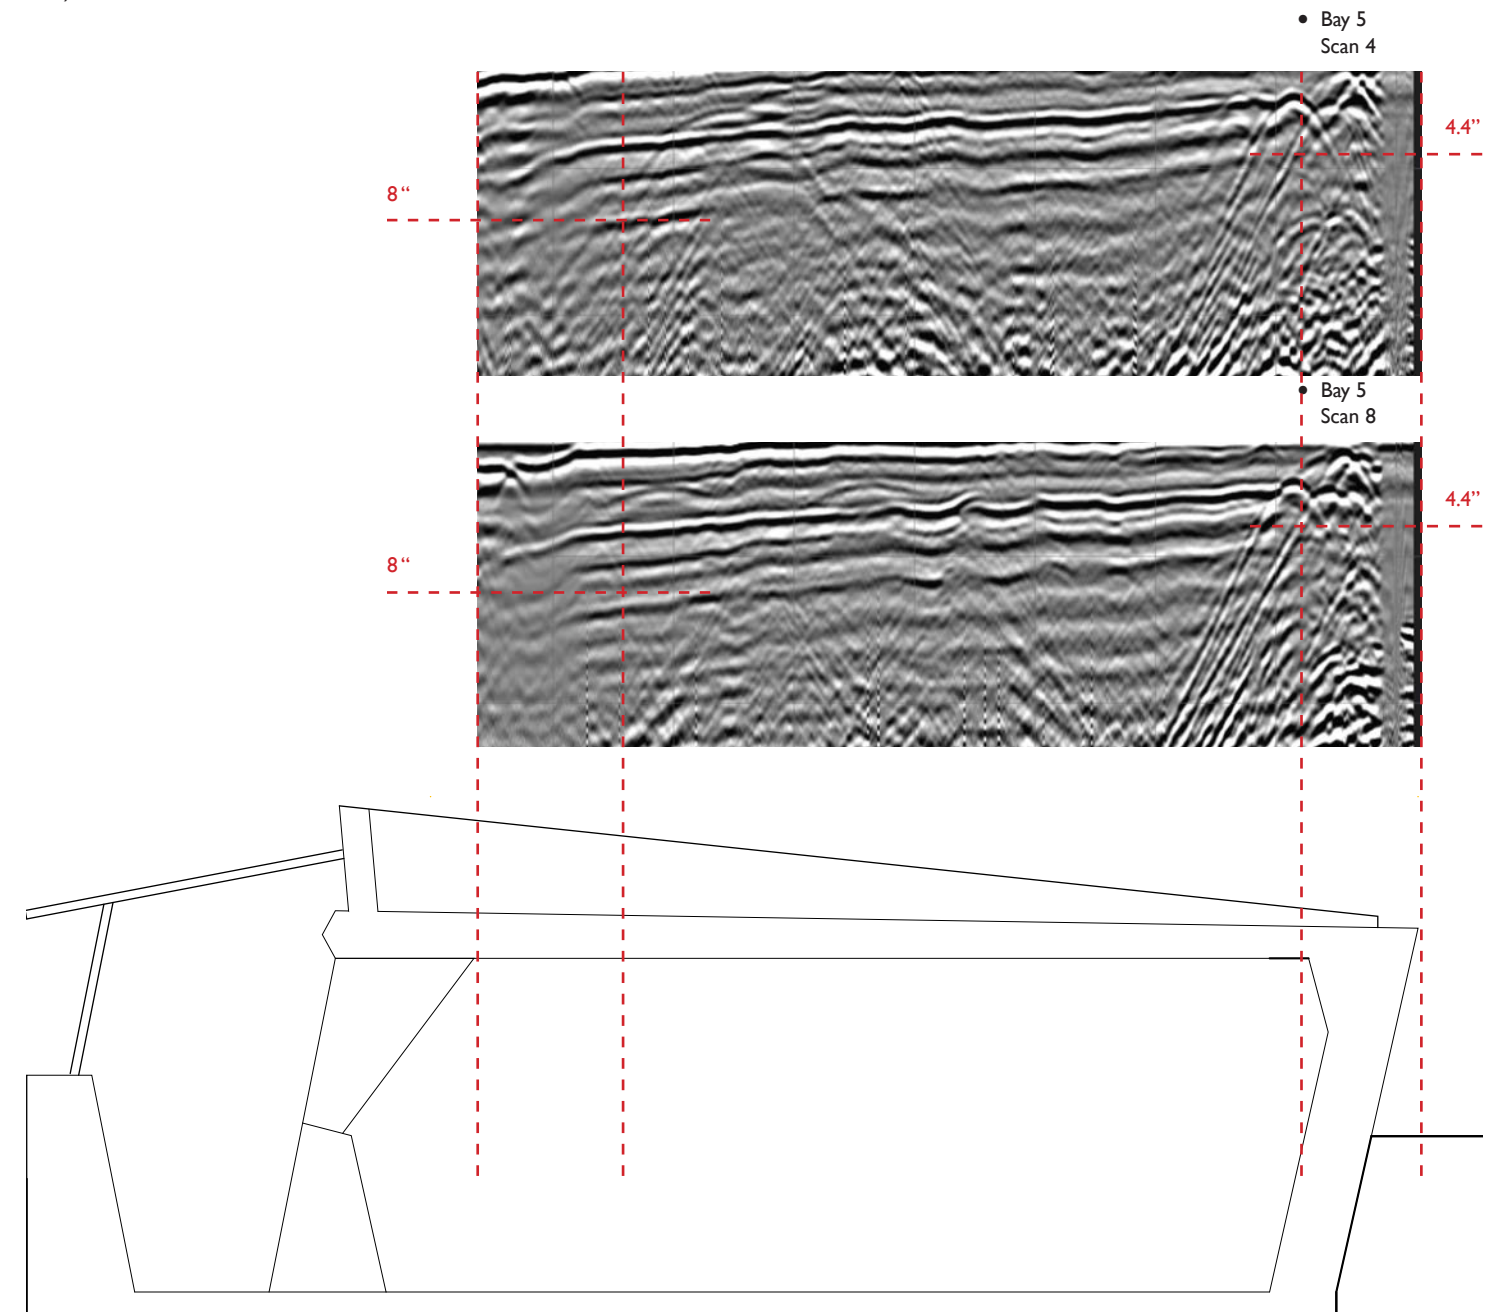
According to the data, the slab thickness ranges between 4.4” to 8”. The thickness is not consistent; the slab is thicker at the east end and thinner towards the west end. The “noise” in the east end of the scan could be associated with the presence of the decorative piers located below, and the hyperbola in the west end could be the result of steel reinforcement located at end of the roof slab (Figure 4.11).

Figure 4.11 The Cabaret section overlapping with longitude scans in Bay 5

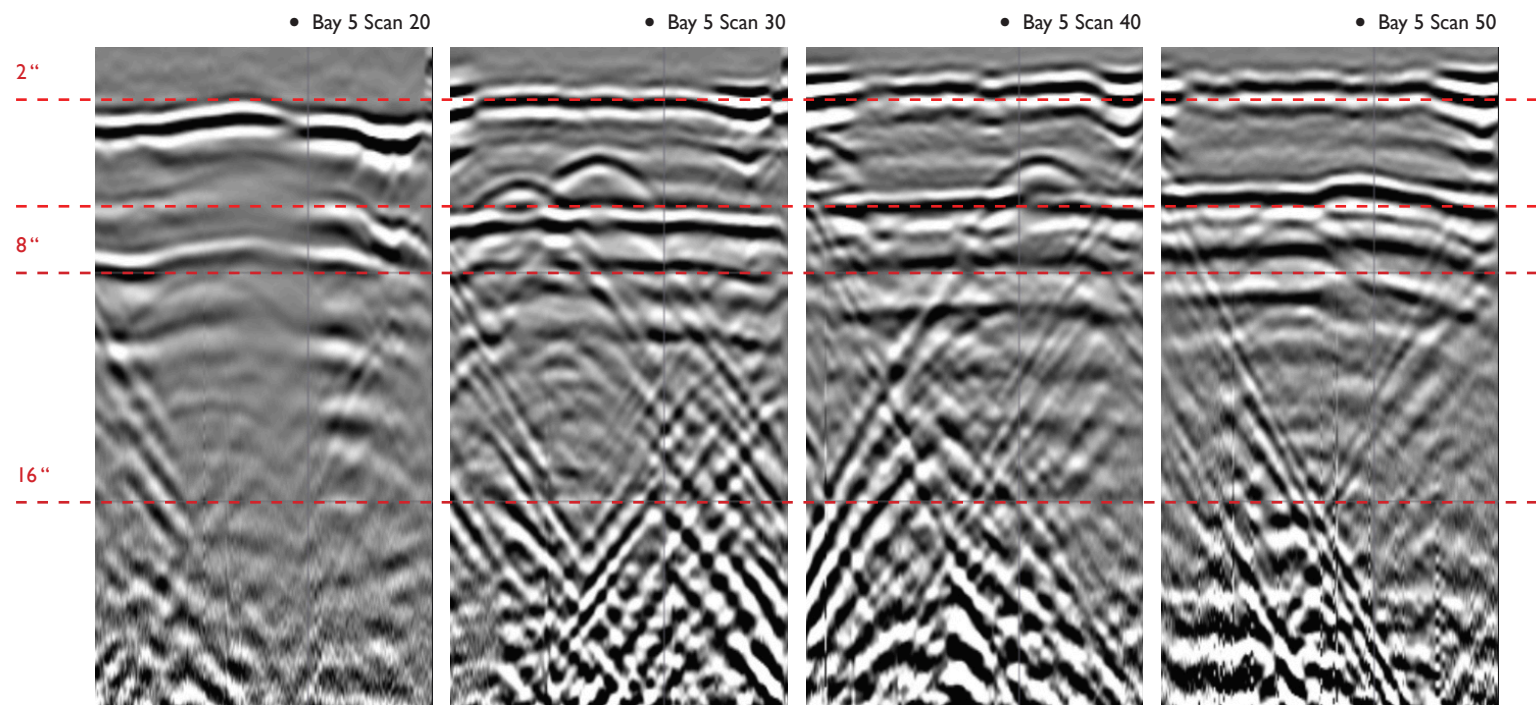
The data collected by the GPR allowed us to determine the concrete cover. The majority of the steel reinforcement shows a cover of more than 3” from the topside (Figures 4.13, 4.14 & Table 4.1). From the inside, several of the squared original rebars are exposed (Figures 4.15 & 4.16). This condition could potentially lead to further deterioration of the steel reinforcement. This should be addressed and is included in our Recommendation section of the report.

Figure 4.12 Latitude scans in Bay 5

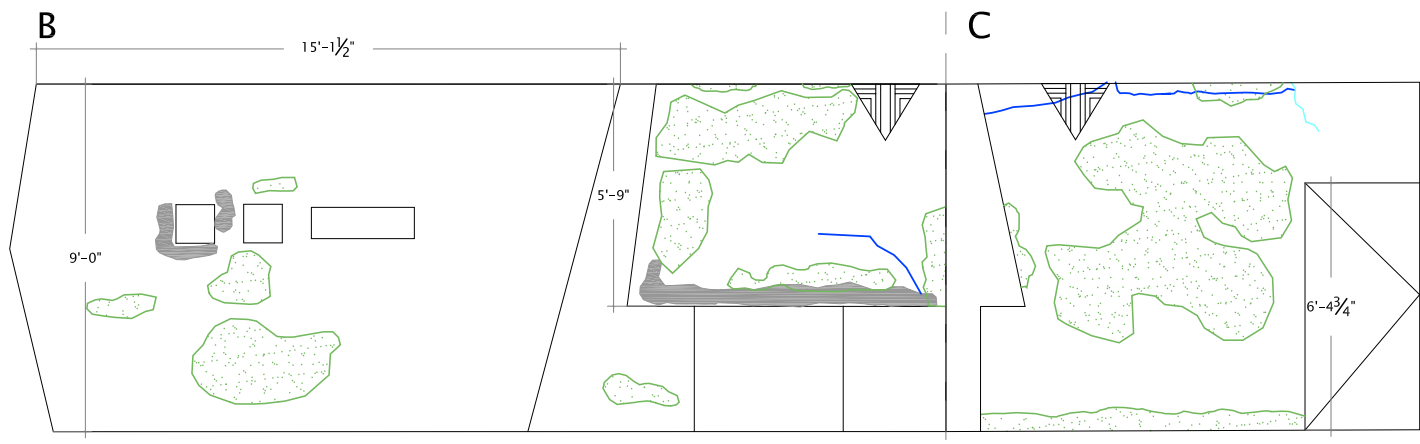
01 Wall B & C - Condition Mapping
 Scale: 1/4"=1'-0"
 Drawn By: Priyanka Gorasia

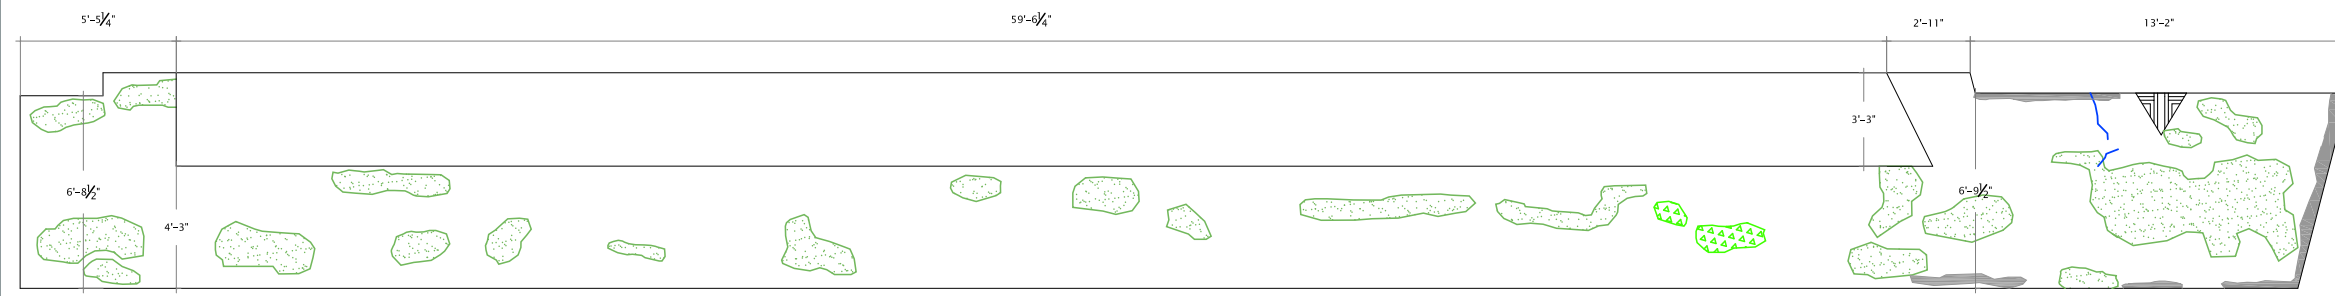
01 Wall D - Condition Mapping
 Scale: 3/16"=1'-0"
 Drawn By: Priyanka Gorasia

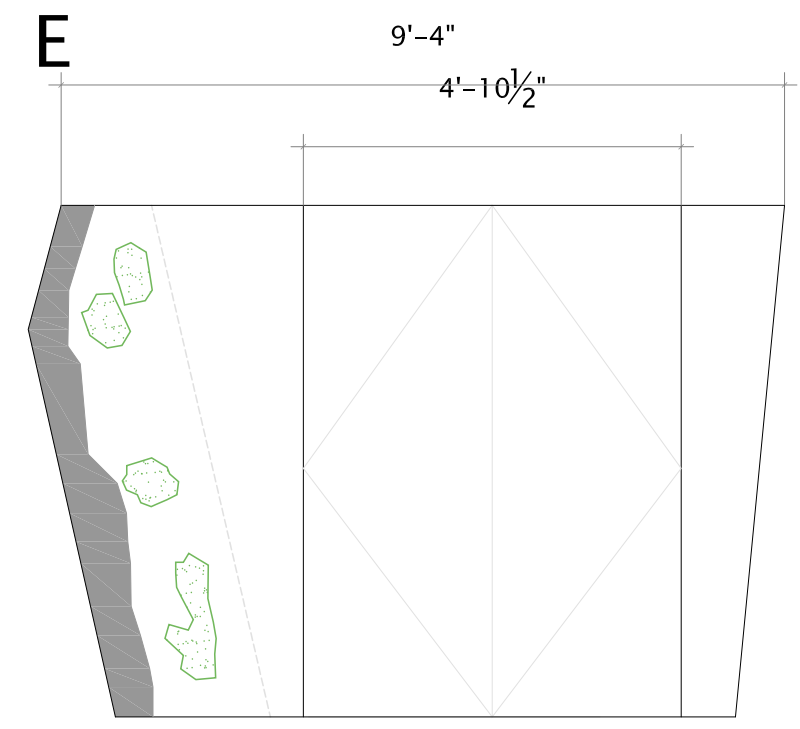
01 Wall E - Condition Mapping
 Scale: 1/2"=1'-0"
 Drawn By: Priyanka Gorasia

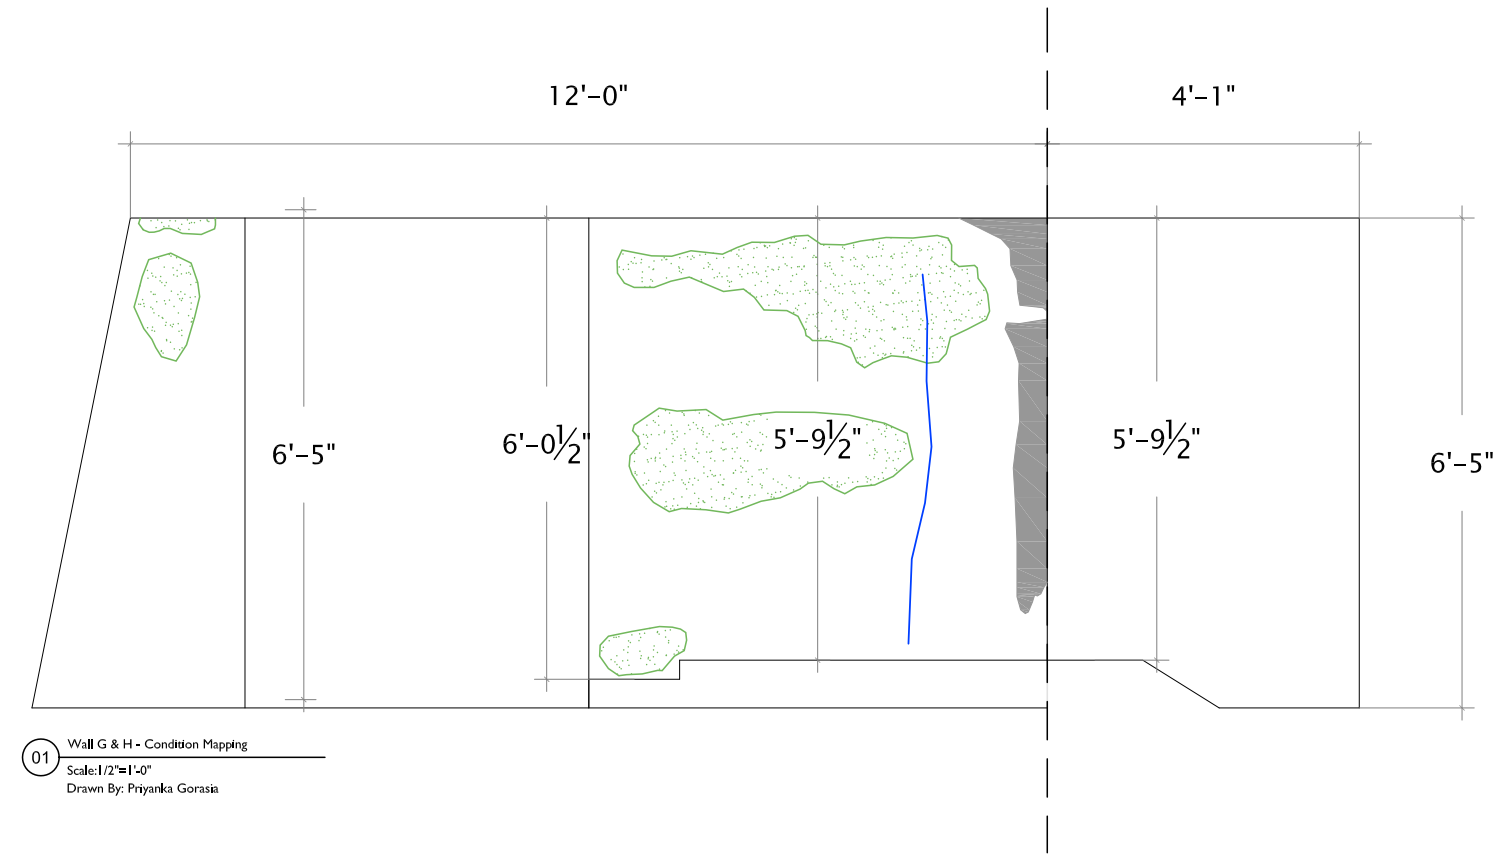
01 Wall G & H - Condition Mapping
 Scale: 1/2"=1'-0"
 Drawn By: Priyanka Gorasia

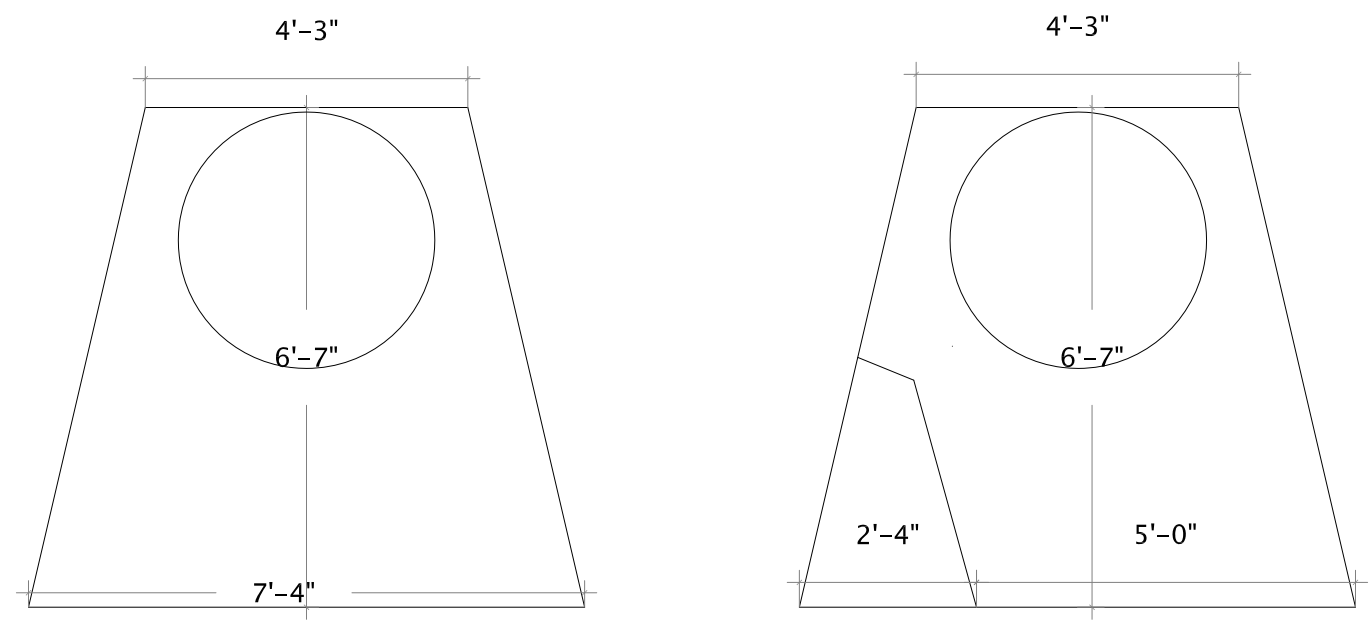
01 Wall I & J - Condition Mapping
 Scale: 1/2"=1'-0"
 Drawn By: Priyanka Gorasia

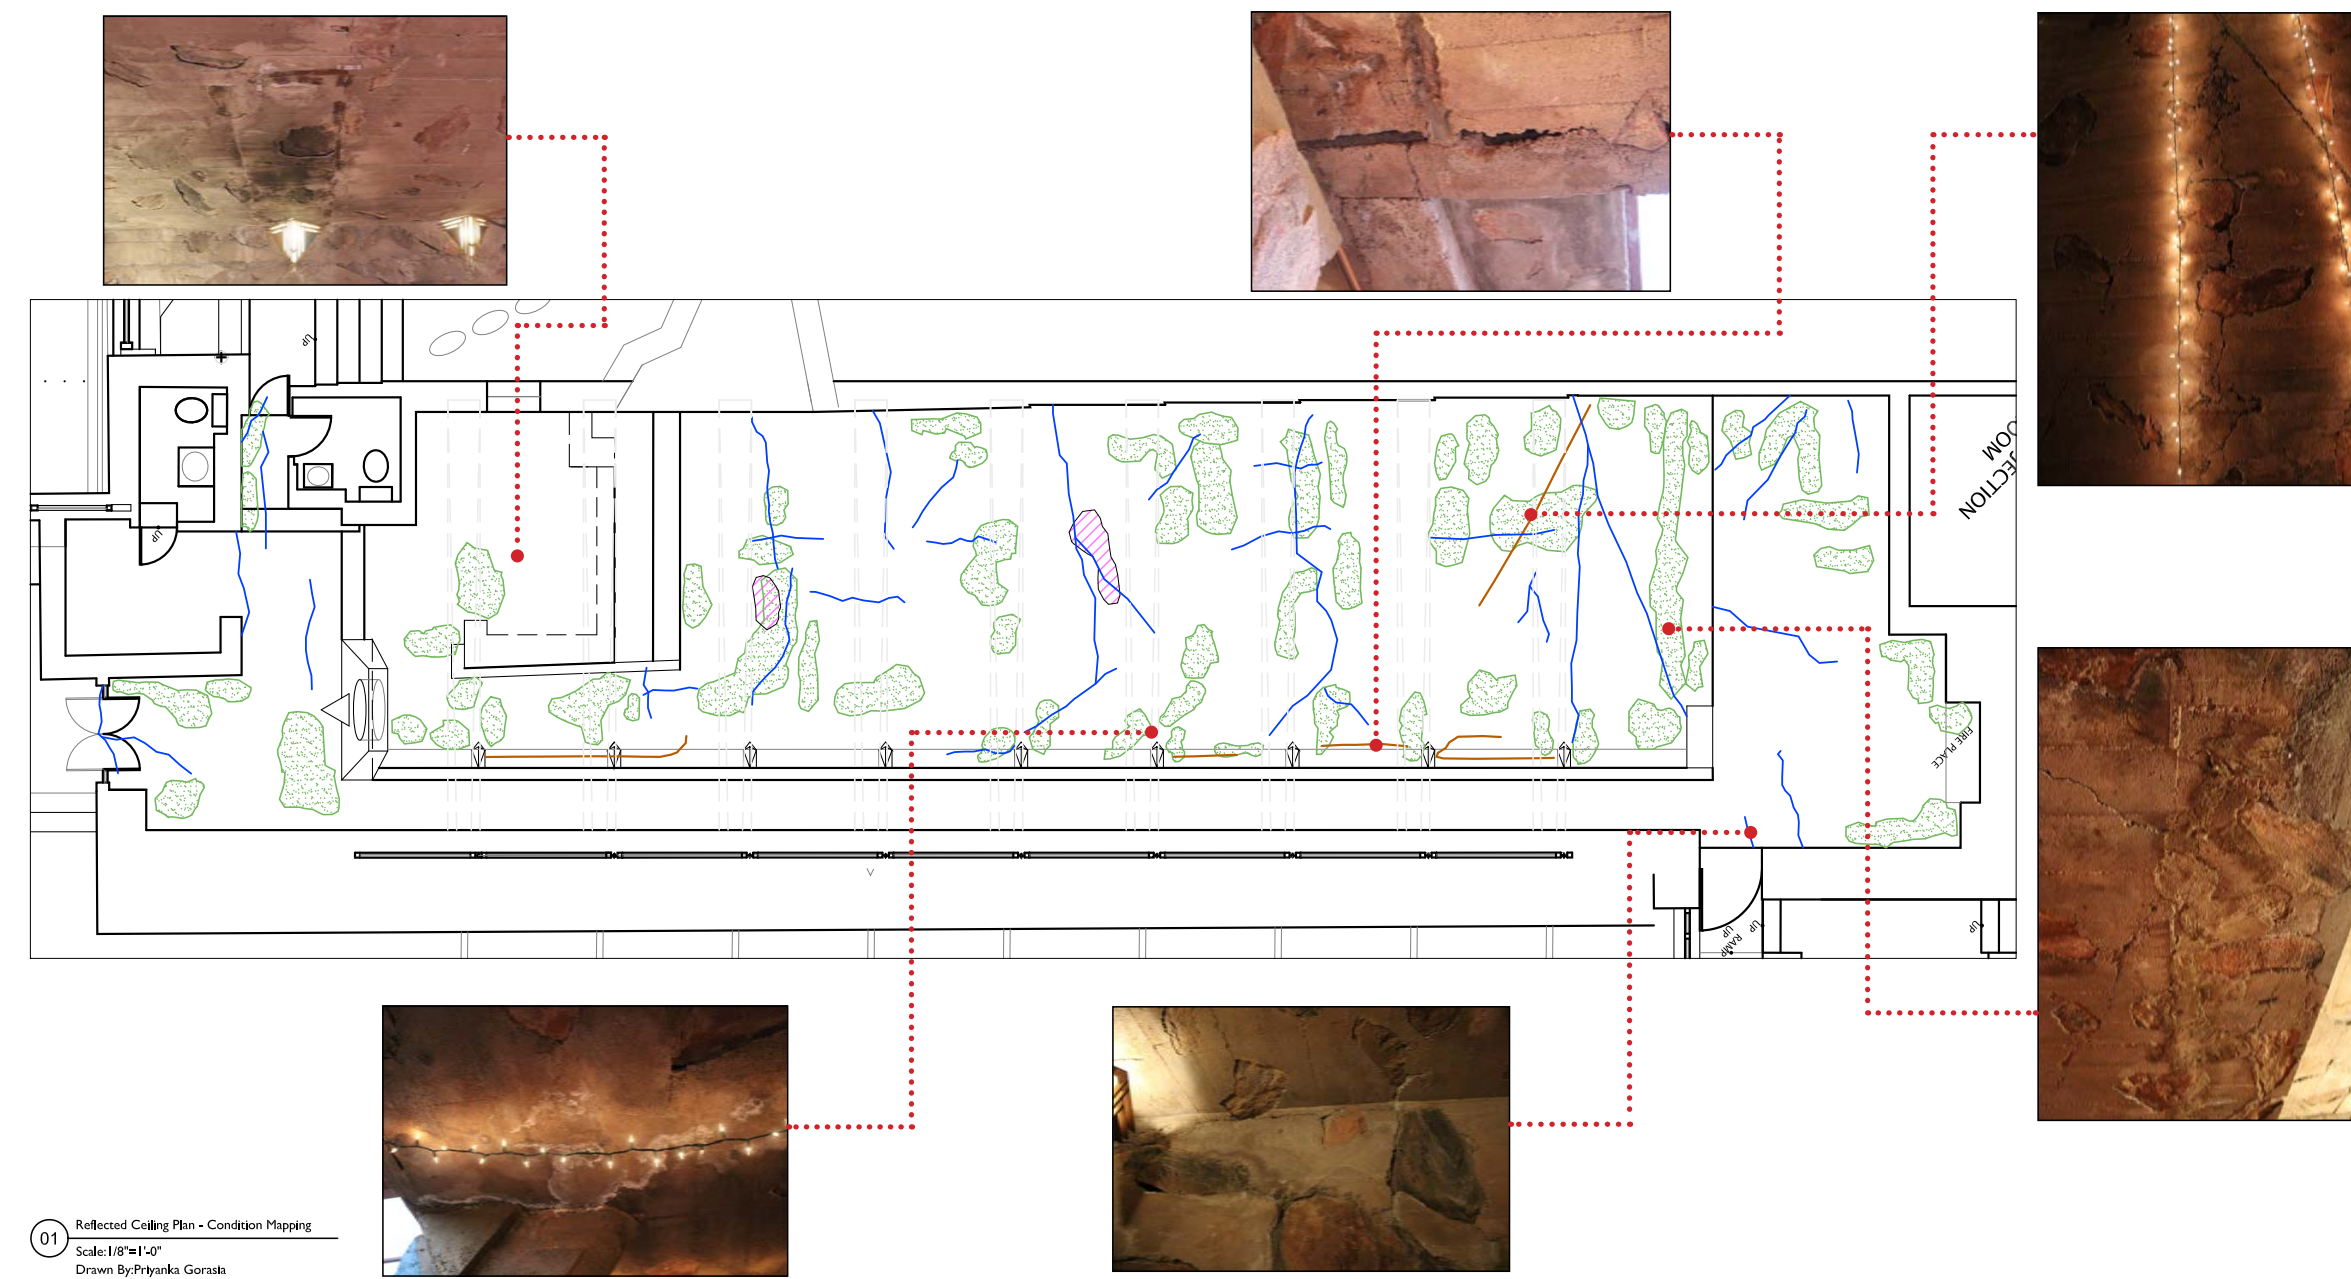
01 Reflected Ceiling Plan - Condition Mapping
 Scale: 1/8"=1'-0"
 Drawn By: Priyanka Gorasia

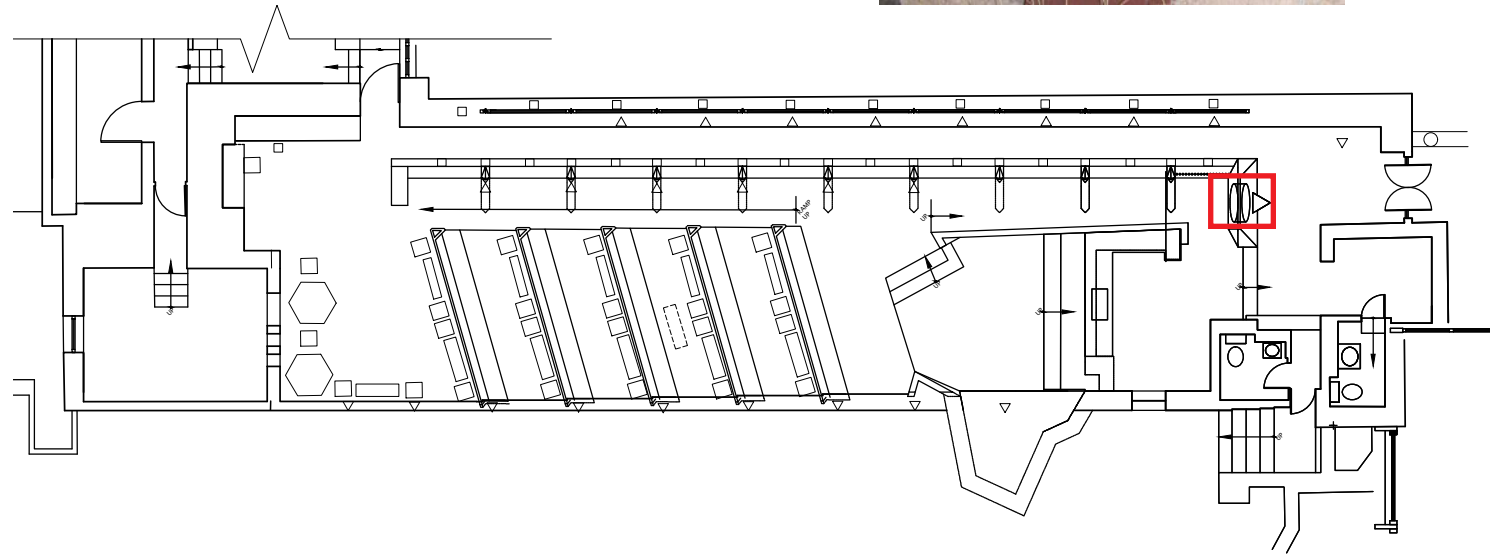
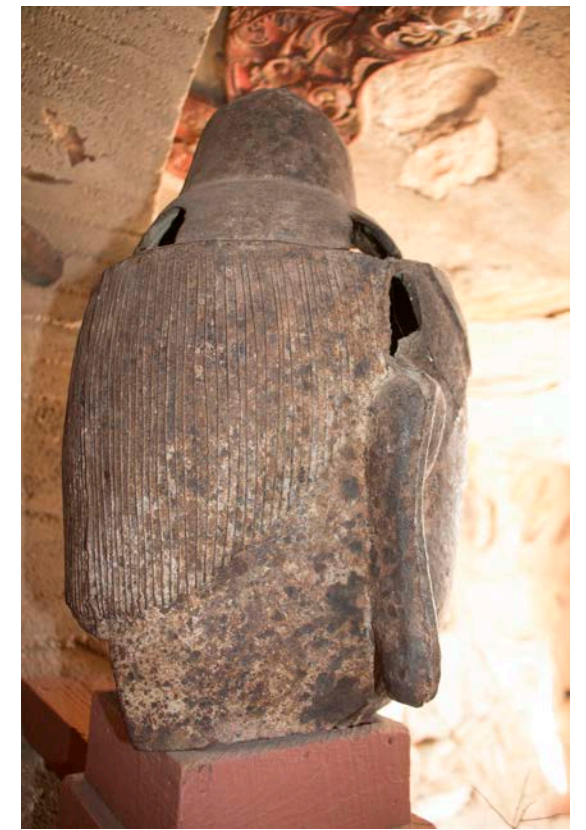
Object Name: Studio Buddha
Quantity: 1
Date of original installation: 1951
Current Location: Center behind the entry door
Material : Cast Iron
Condition: Three cracks can be observed on the surface and have been restored with some kind of glue on the interior side

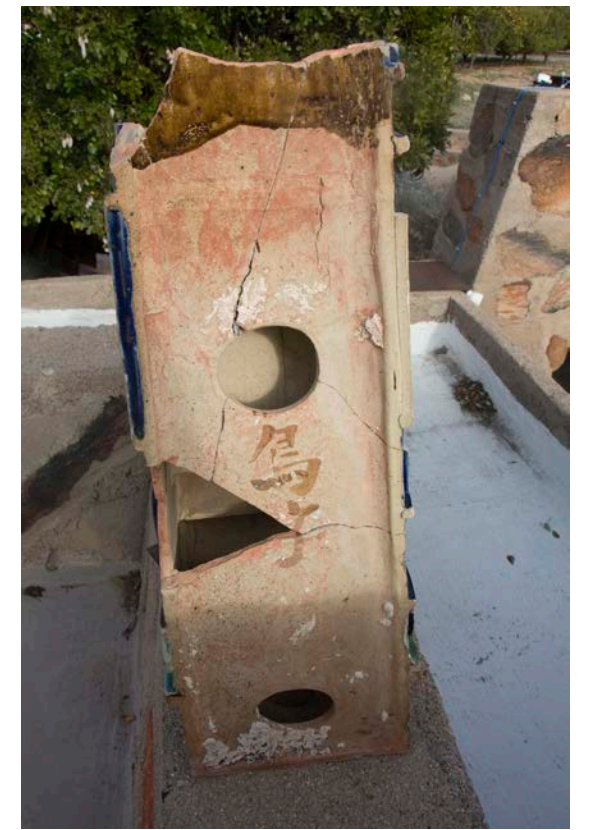
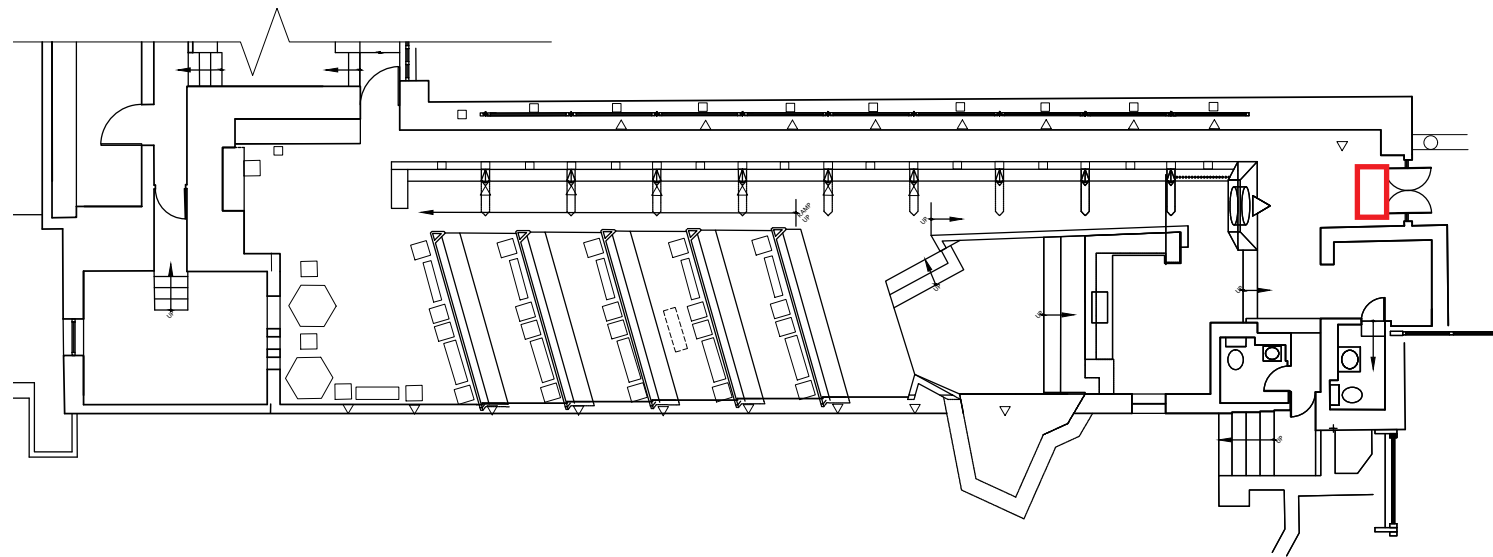
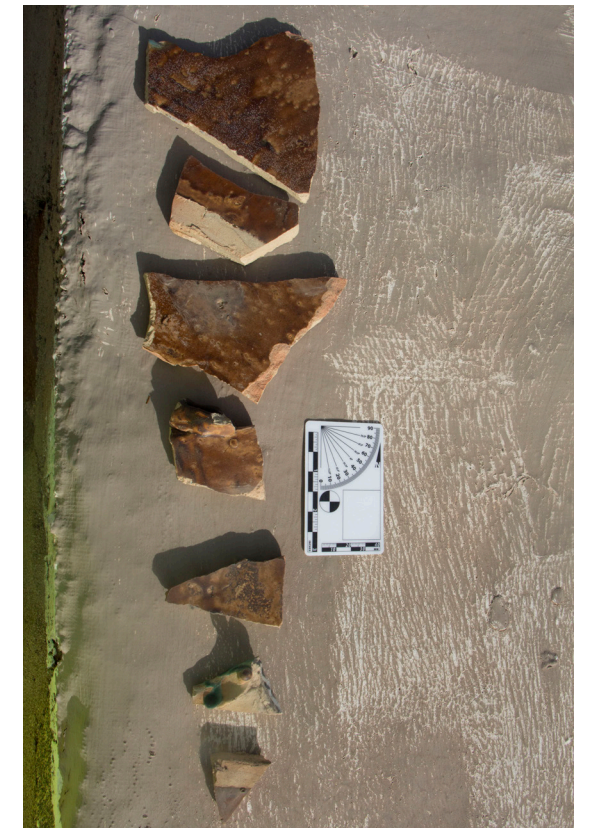
Object Name: Chiwen-motif decorative roof tile
Quantity: 1
Date of original installation: Between 1969 and 2004
Current Location: On the roof above the entrance
Material : Color glazed ceramic
Condition: The upper part is broken. Several separate fragments are piled on the top. Discoloration of the glaze can be observed at several spots.

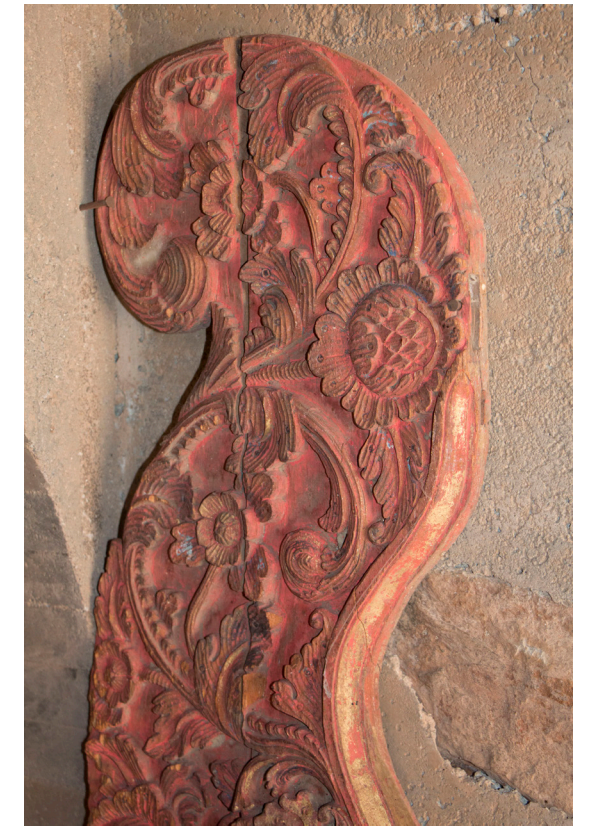
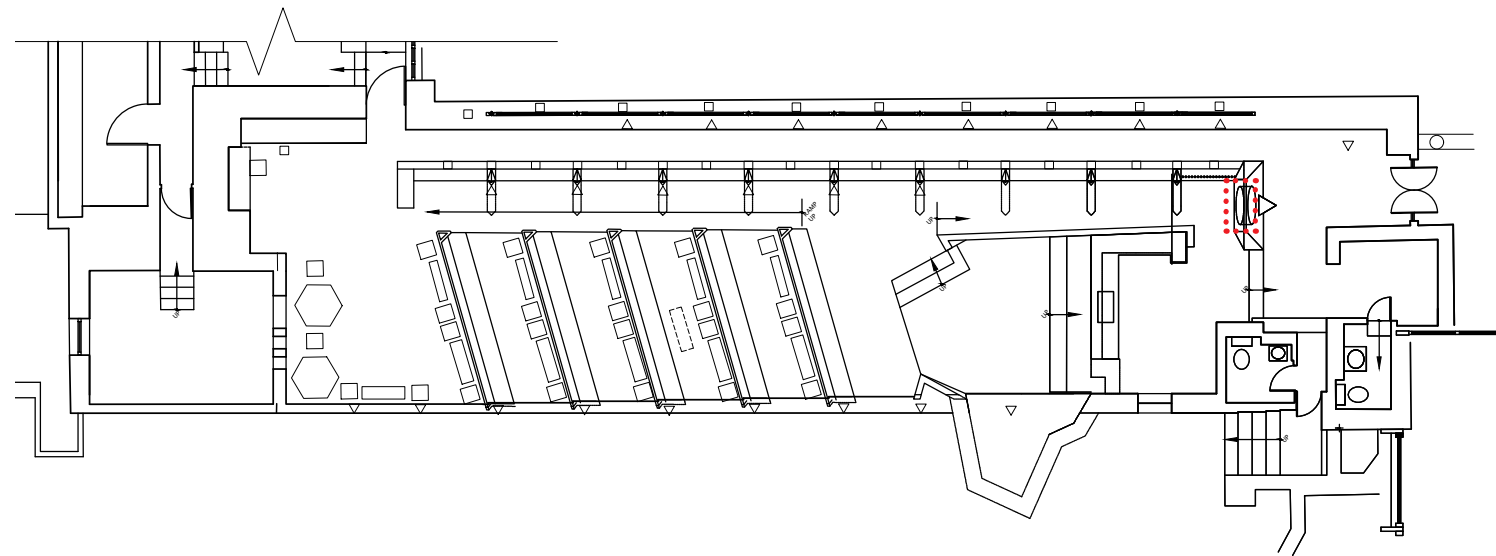
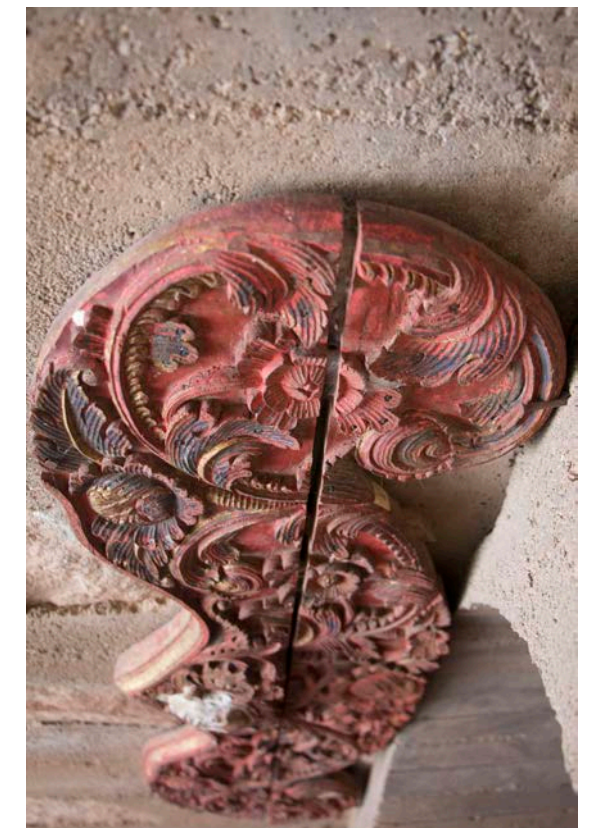
Object Name: Buddha-motif carved wood plaque
Quantity: 1
Date of original installation: 1951-1952
Current Location: Above the buddha head
Material : Wood with finishes
Condition: A deep vertical crack in the center. Discoloring of the paint.

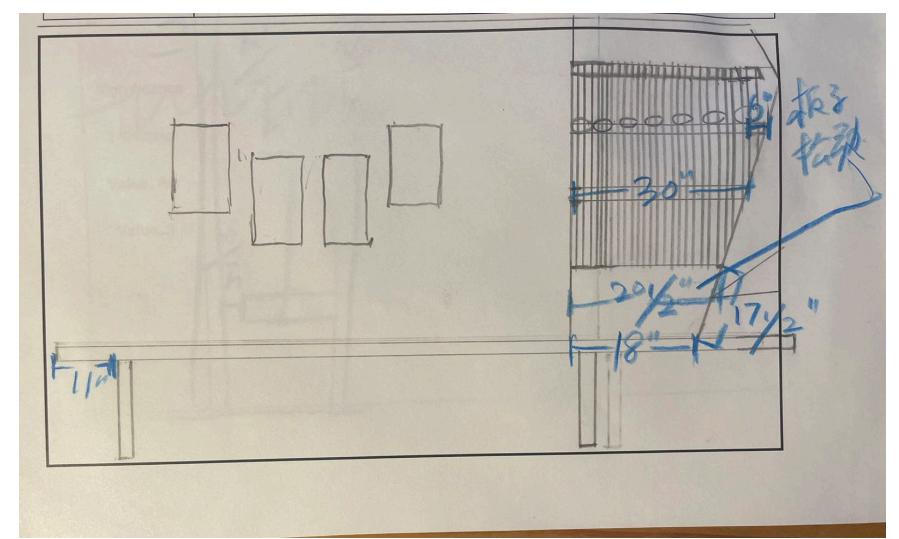
Object Name: Operable Panel
 Quantity: 9
 Date of original installation: 1960s
 Current Location: Along the west wall
 Material : Plywood with finishes
 Condition: Generally good. Peeling paint can be observed at some spots.

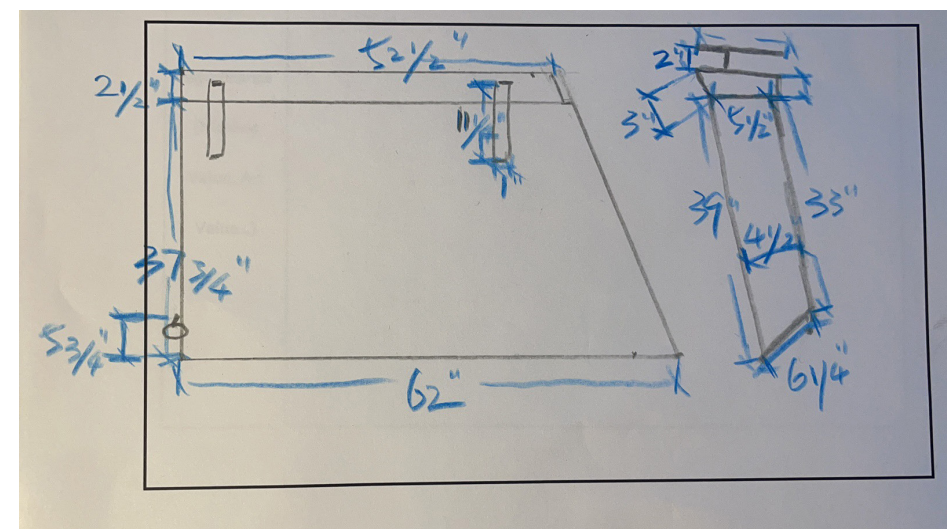
Object Name: Operable Panel
 Object Number: 12
 Quantity: 9
 Date of original installation: 1960s
 Current Location: Between decorative piers
 Material : Plywood with finishes
 Condition: Generally good. Some have a cracking near the hinge

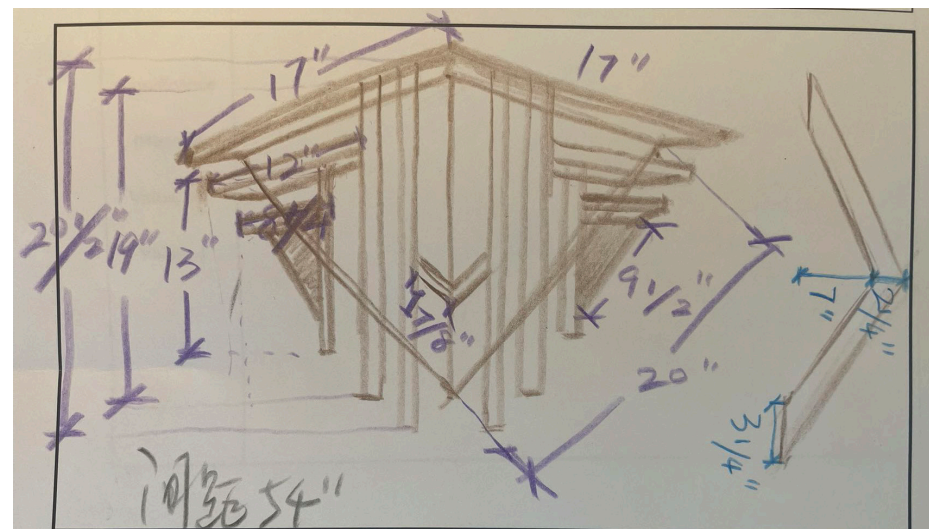
Object Name: Benches
Quantity: 5
Date of original installation: 1964
Current Location: Center of the theater, facing the screen at an angle
Material : Concrete back and pillar, wood seat, fabric upholstery
Condition: Generally good. Upholstery is worn.

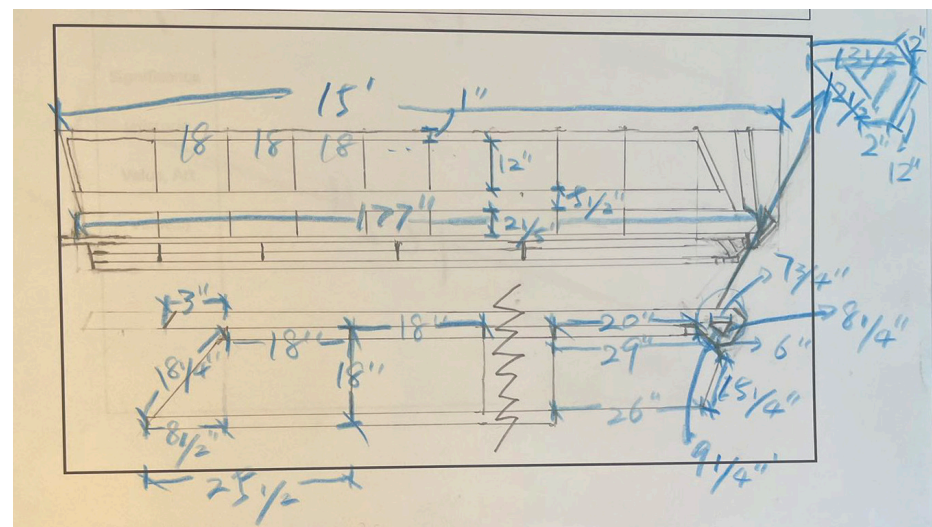
Object Name: Freestanding chairs
 Quantity: 24
 Date of original installation: 1964
 Current Location: Behind each row of benches
 Material : Metal frame and fabric upholstery
 Condition: Generally good. Discoloring of the Red paint on the metal frame is a common problem.
