[First Church of Christ, Scientist]  
**The Rotunda**

Preservation Plan  
HSPV - 701 • Studio • 2011

[The First Church of Christ, Scientist]  
**The Rotunda**

HSPV - 701 • Studio • 2011

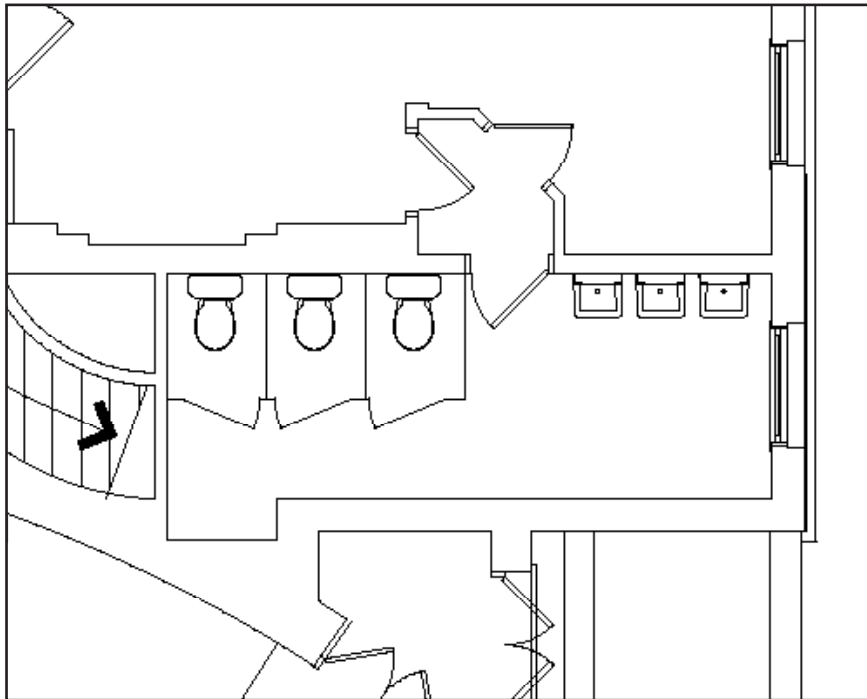
(fig. 9) The existing rest room at the NE corner of the Rotunda is currently non-functional.

(fig. 10) The proposed rest room is accessible to the main entrance as well as the sanctuary, and adheres to mandatory clearances as determined by ADA.

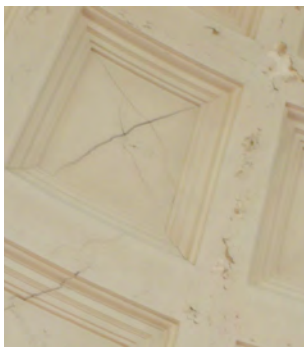
Cracking: splitting or separation of the plaster through one or more layers. Percentage of wall unit affected is expressed using the 1-5 scoring scale.

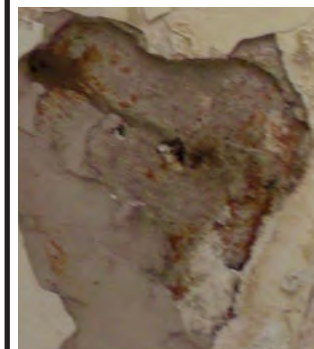
Delamination: separation of one or more of the plaster layers from its support (i.e.: either more plaster, or metal lath). Percentage of wall unit affected is expressed using the 1-5 scoring scale.

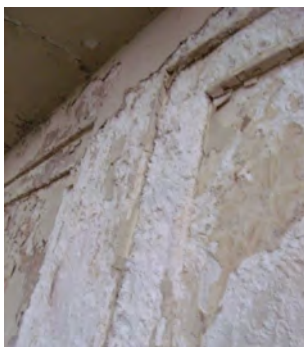
Deformation: physical disruption of the plaster, such as may be caused by the presence of soluble salts which expand in contact with moisture causing dimensional change at the surface. Percentage of wall affected is expressed using 1-5 scoring scale.

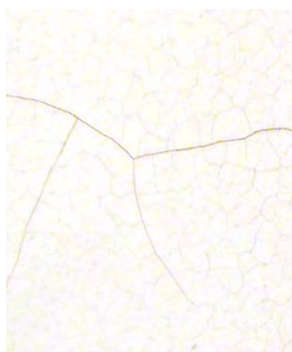
Cracking: refers to a loss of cohesion within the paint film. Percentage of wall unit affected is expressed using the 1-5 scoring scale.

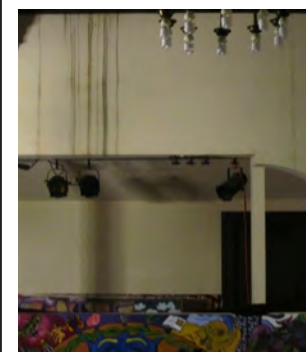
Staining: refers to discoloration of interior surfaces due to water borne contaminants such as dirt. Percentage of wall unit affected is expressed using the 1-5 scoring scale.
