GERMANTOWN Town Hall

Preservation Plan

HSPV 701: Preservation Studio | Fall 2011

Graduate Program in Historic Preservation | University of Pennsylvania

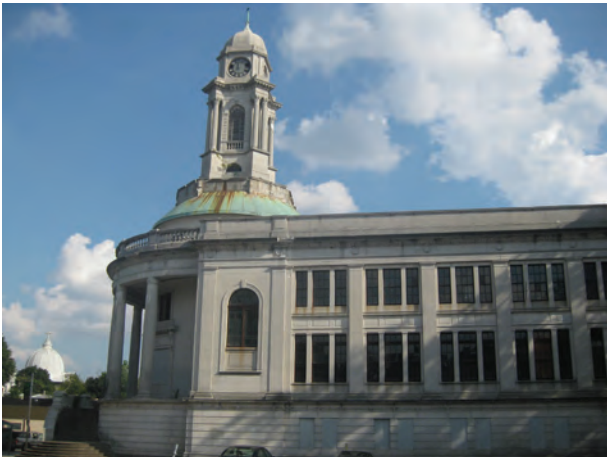
Figure 38. Image of northwest elevation, Source: K.McNabb, 2011

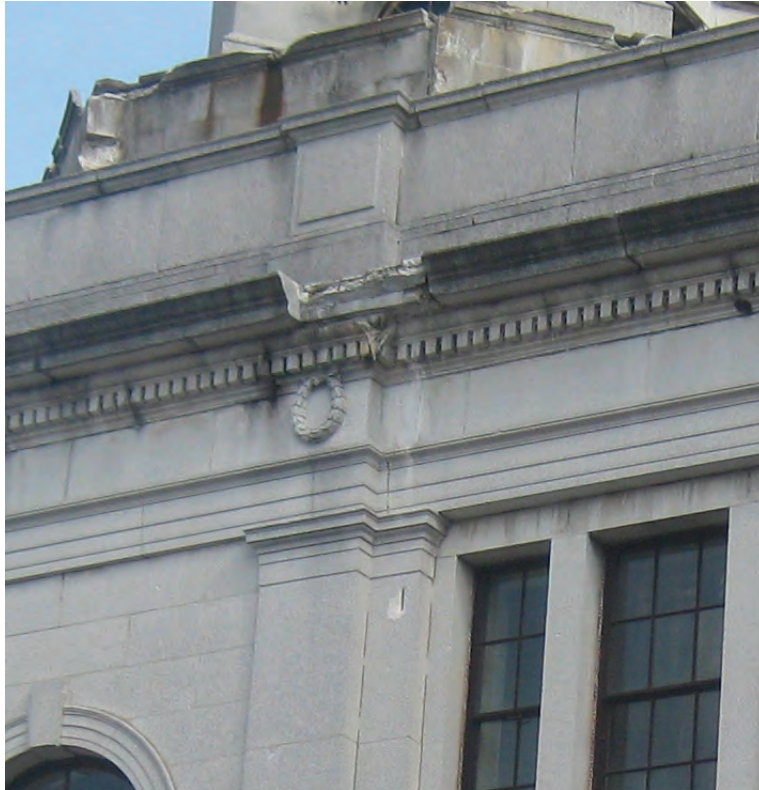
office block.⁴ At this location, a cast stone unit appears to have been solubilized by the entrapment of water in the interior of this element.

Figure 39. Detail of west elevation, Source: K.McNabb, 2011

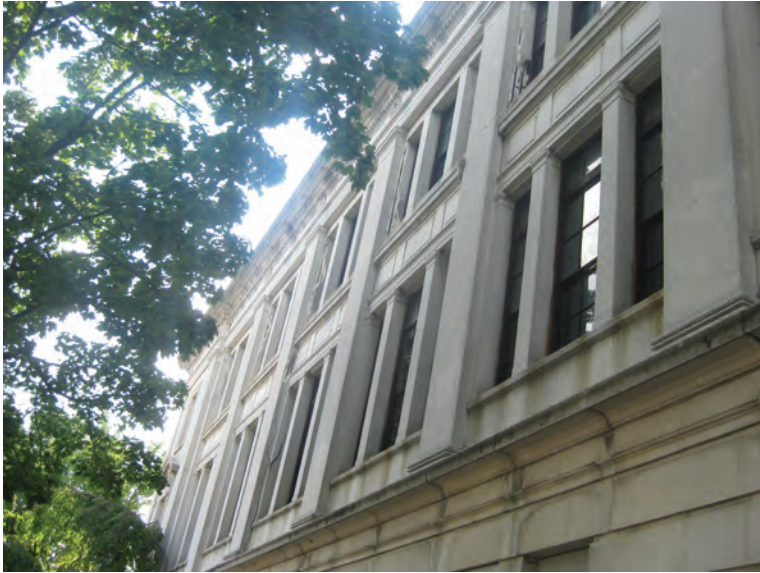
Figure 40. Detail of northeast elevation, Source: K.McNabb

the finished surface of the 4 cast stone elements lining this window has detached leaving the coarse core of the cast stone exposed.⁷

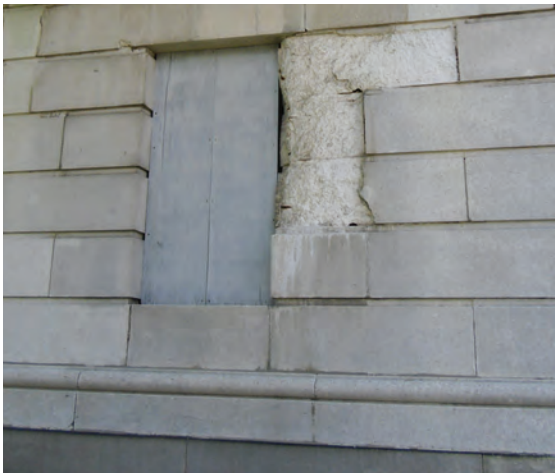
Figure 41. Disaggregation at northeast elevation, Source: L. Allen

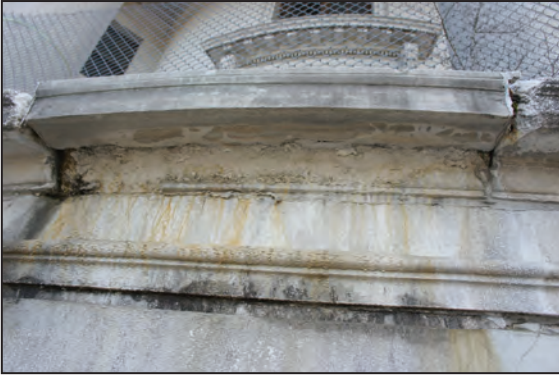
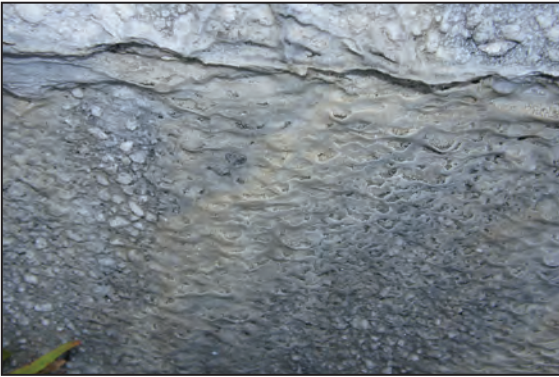
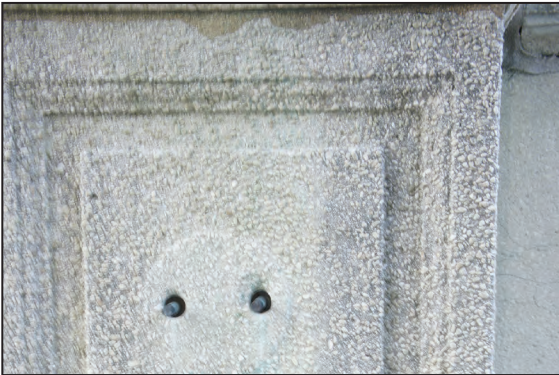
The northwest facade of the building receives significantly less sunlight than the northeast, resulting in a decrease in the number of conditions. Rapid freeze-thaw cycles on the northeast elevation, however, intensify complications that exist on that section. Key issues affecting the north façade include: delamination, leaching deposits, exposed rebar, efflorescence, mortar failure, biological growth, crazing/cracking, and surface staining.

Figure 49. Details of disaggregation (top), leaching (middle), and staining (bottom), Source: M.Rhodes

After a preliminary assessment of conditions located on Germantown Town Hall, a few options are available. With all historic materials, the most gentle methods should be utilized to clean the precast stone.

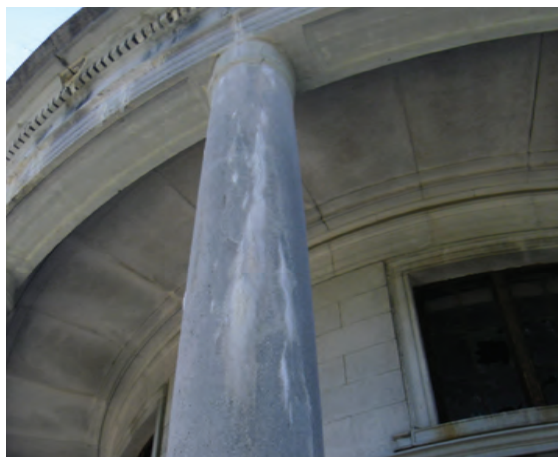
Figure 50. Image of efflorescence, Source: M.Rhodes

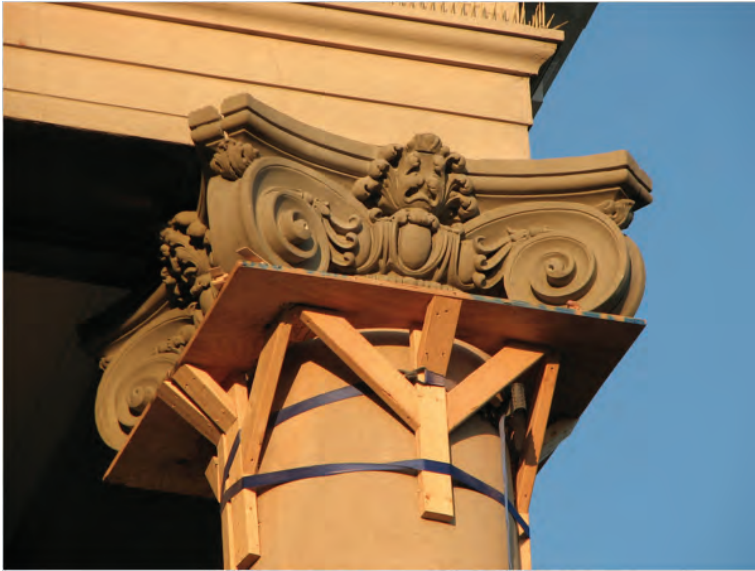
Figure 51. Image of glass fiber column capital, Source: Keystone Waterproofing inc
