The historic fabric of Historic RittenhouseTown is in serious need of repair and conservation. From a site that once comprised approximately fifty buildings, only six remain, each of which is deteriorating. Team members David Artigas and Sarah Vukovich conducted an assessment of the current condition of the buildings at HRT. An analysis of the possible decay mechanisms that are affecting the buildings was completed. From these investigations, a conservation booklet was created for the managers of Historic RittenhouseTown, Inc. to help determine what needs to be fixed, how it can be fixed, and when a specialist needs to be hired to address a condition. It is hoped that the recommendations in this conservation booklet will lead to the preservation of the historic fabric of Historic RittenhouseTown, further improving the visitor experience.

Too much moisture causes a host of problems in buildings. It can cause fungal growth, which is damaging to building materials and is a health risk. It causes wood to rot. And, it causes finishes, like plaster and paint, to deteriorate.

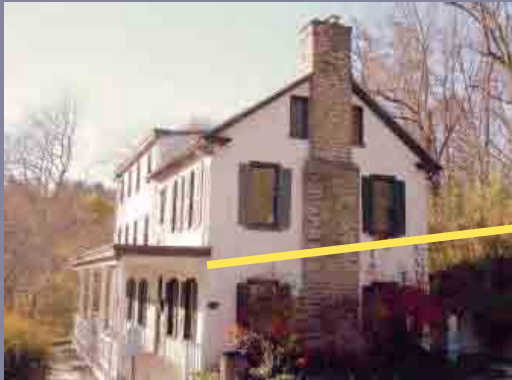
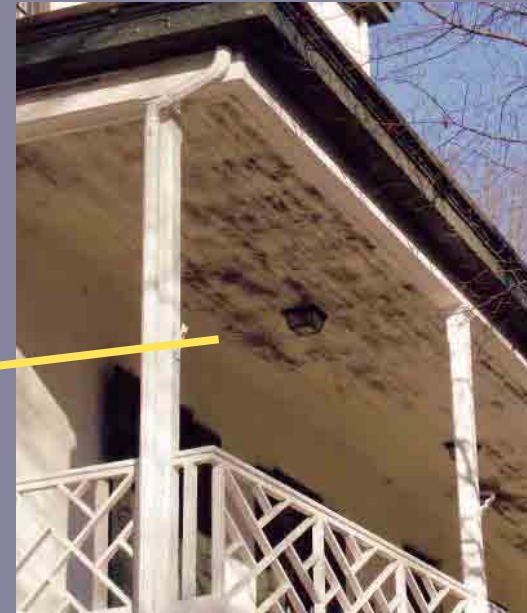
Identification of Problem: **MILDEW**

Possible Source of Problem: Rain water and water vapor

Investigation of Cause: When it is raining, look out second floor window, to the roof of the pent eave. Is the water leaking through the roof? Check the guttering system on the roof and the pent eave for leaks and blockages. To differentiate between dirt and mildew, place a drop of bleach on the affected surface, if it turns white, it is mildew.

Recommendations: The National Park Service recommends a solution for removing mildew which consists of one cup non-ammoniated detergent, one quart household bleach, and one gallon water (please refer to *Preservation Brief 10* in Appendix). The solution should be scrubbed onto the surface with a medium soft brush. Should stubborn spots persist, another quart of bleach may be added to the mixture. After cleaning, the area should be rinsed thoroughly with a hose and nozzle and allowed to dry thoroughly. It is suggested that this maintenance be done on a warm, sunny day. For repainting, specially formulated "mildew resistant" primer and finish coats should be used.

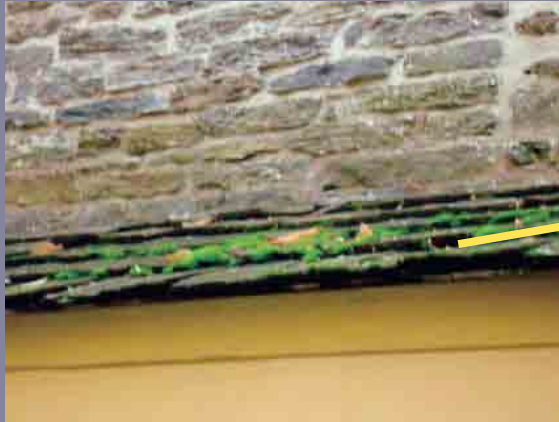
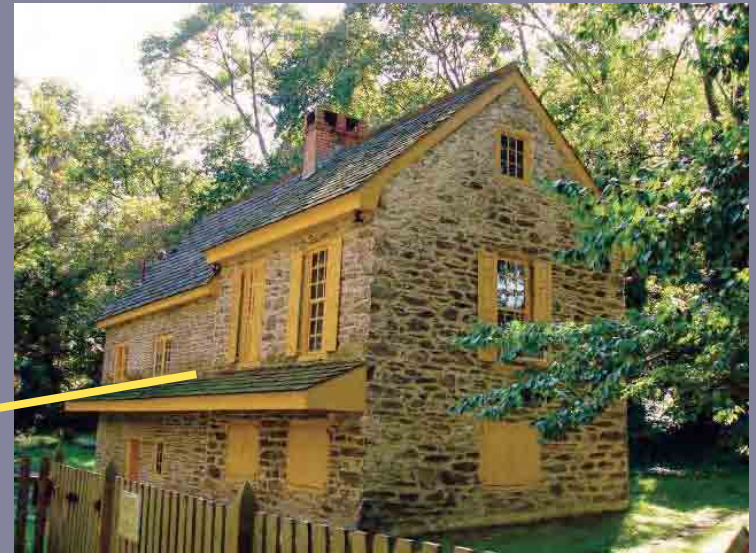
Identification of Problem: MOSS

Possible Source of Problem: Wet material, lack of sunlight for drying

Investigation of Cause: Monitor relative humidity in attic. Observe paths of water when it rains.

Recommendations: Remove with a medium soft brush, being careful not to damage the building. Power washing is common, but should not be used because it saturates the material, causing moss to grow back. A water repellent stain should be periodically applied to wood surfaces to reduce the amount of moisture the wood absorbs. Do not put insulation directly on the under side of the wood materials, because that will slow drying of the wood elements. A biocide should not be used, as it may go into solution when in the presence of water and runoff the building; harming the surrounding landscape. Gutters and downspouts should be installed to collect and direct water away from the building. When the materials are next replaced, it is suggested that strips of zinc be installed beneath the top course of shingles; this will impede moss growth.

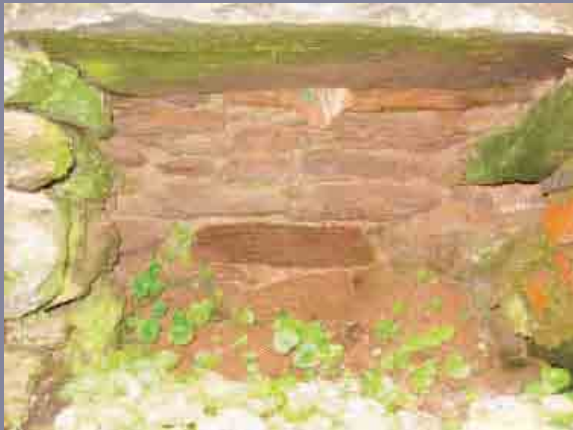
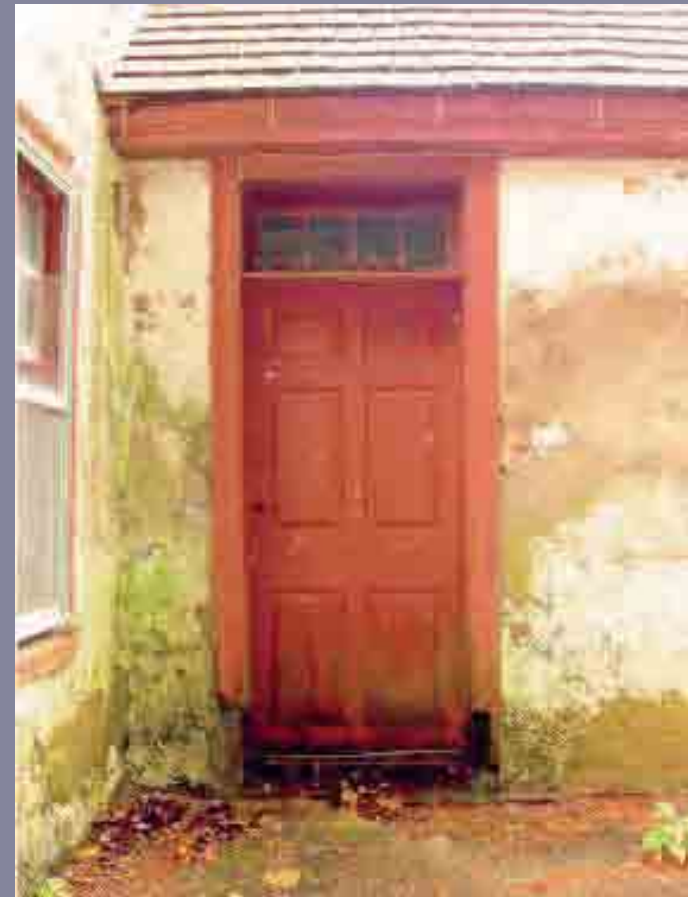
Identification of Problem: **BIOGROWTH ON MASONRY**

Possible Source of Problem: Wet material, lack of sunlight for drying

Investigation of Cause: Observe paths of water when it rains.

Recommendations: Install gutters and downspouts to collect and direct water away from the building. A specialist should be hired to improve the drainage around the building, and to re-grade the surrounding area to direct surface runoff away from the building. The affected surfaces should be gently cleaned with a mixture of bleach, detergent and water (please refer *Preservation Brief 10* in Appendix for appropriate solution). Power washing is not suggested, as it will cause the masonry to become wetter. A fungicide may be used, but may not be very effective if the mold penetrates deeply into the stone. If possible, a specialist should be hired to damp proof the foundation to reduce the amount of ground water that is absorbed by the building.

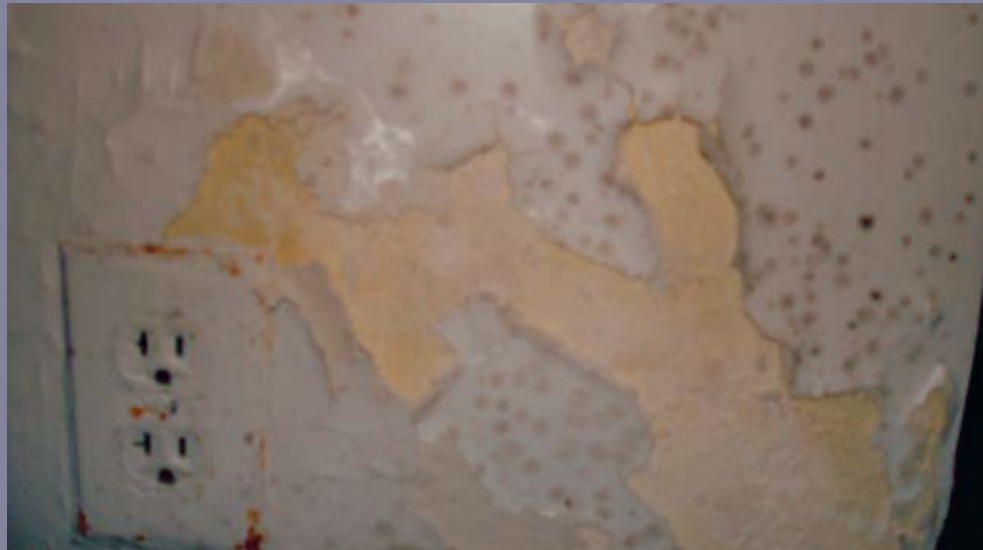
Identification of Problem: INDOOR MILDEW

Possible Source of Problem: Wet material. Indoor relative humidity above 70% RH

Investigation of Cause: Monitor indoor relative humidity. Check for leaks in the roof, walls, and plumbing. Place a drop of bleach on the substance; if it turns white, it's mildew.

Recommendations: Gently brush the affected area with a soft brush and a bleach solution (please refer to *Preservation Brief 10* in Appendix). Repair cracks and open seams in the roof and walls. Repair plumbing leaks. If possible, a specialist should be hired to damp proof the foundation to reduce the amount of ground water that is absorbed by the building. Dehumidification and ventilation should be installed to reduce the indoor relative humidity. Heating the space will reduce the indoor relative humidity. The indoor relative humidity should be monitored to make sure it stays below 70% RH.

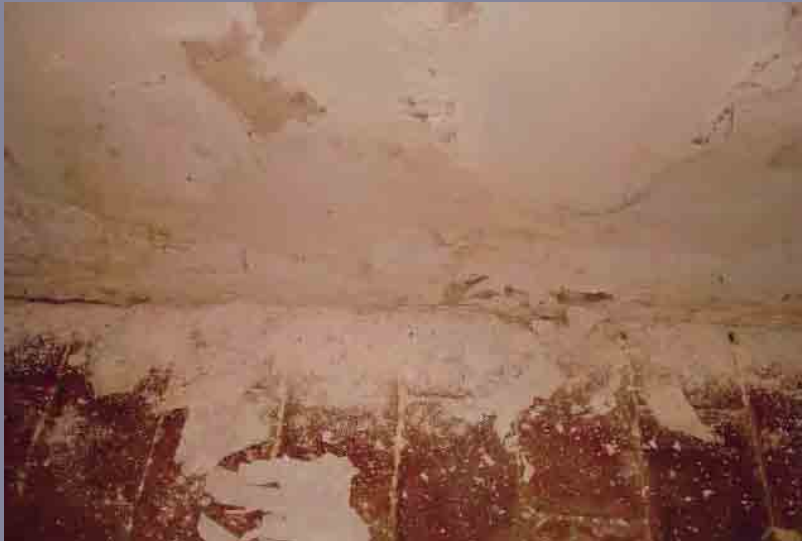
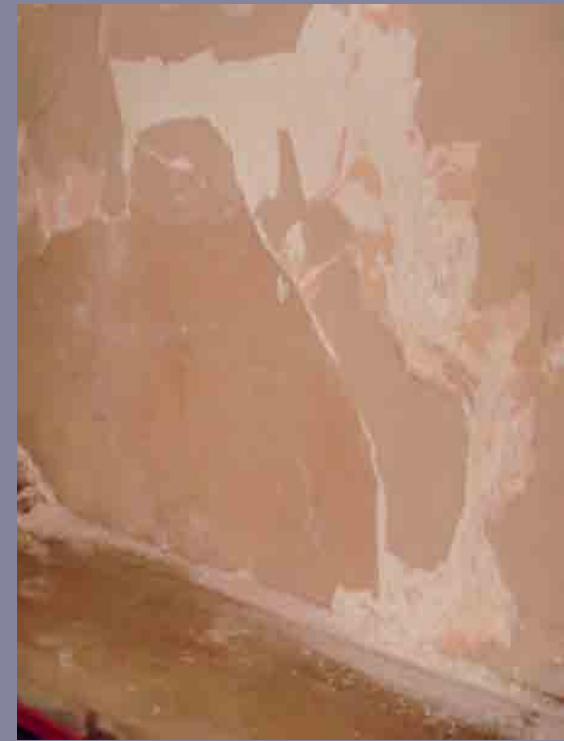
Identification of Problem:
**INTERIOR DETERIORATION OF PLASTER AND
PAINT**

Possible Source of Problem: Wet material, high indoor relative humidity

Investigation of Cause: Monitor indoor relative humidity. Soil boring samples should be done to check the depth of ground water. Check for leaks in the roof, walls, and plumbing.

Recommendations: Repair cracks and open seams in the roof and walls. Repair plumbing leaks. If possible, a specialist should be hired to damp proof the foundation to reduce the amount of ground water that is absorbed by the building. A specialist should be hired to improve the drainage around the building, and to re-grade the surrounding area to direct surface runoff away from the building. Dehumidification and ventilation should be installed to reduce the indoor relative humidity. Heating the space will reduce the indoor relative humidity. Should the materials need to be replaced, they should be replaced in-kind.

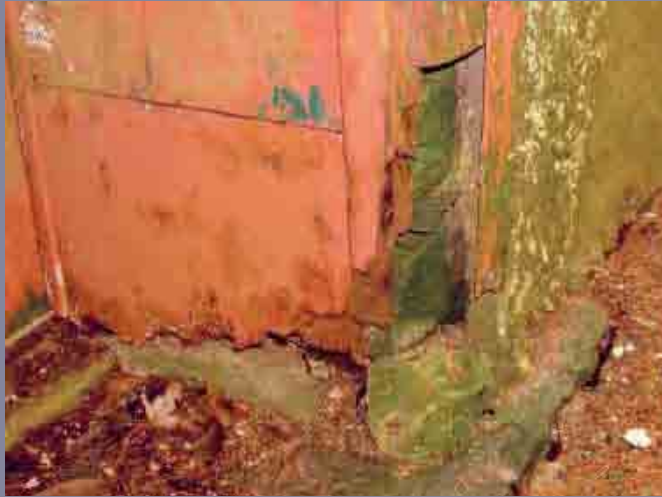
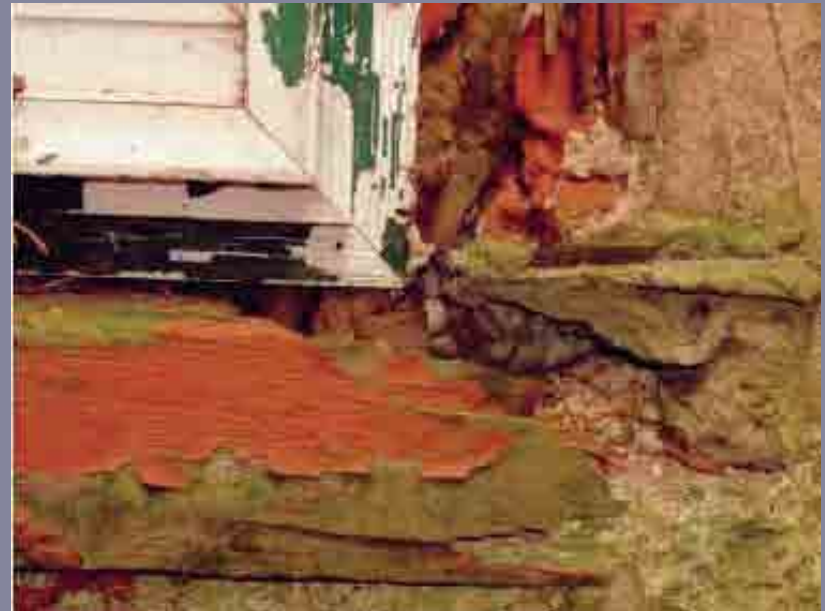
Identification of Problem: ROTTED WOOD

Possible Source of Problem: Wet material.

Investigation of Cause: Monitor indoor relative humidity. Observe paths of water when it rains. Look for leaks in the roof, walls, and plumbing.

Recommendations: Wood pocketed in masonry should have an air gap around the end to allow it to breathe (Wood elements that are mortared into the wall pocket will deteriorate more rapidly due to the inability for moisture to leave the wood materials.). Repair cracks and open seams in the roof and walls as well as leaks in the plumbing. Dehumidification and ventilation should be installed to reduce the indoor relative humidity. Heating the space will reduce the amount of moisture in the wood. A specialist should be hired to improve the drainage around the building, and to re-grade the surrounding area to direct surface runoff away from the building. If possible, a specialist should be hired to damp proof the foundation to reduce the amount of ground water that is absorbed by the building. Deteriorated materials should be replaced in-kind.

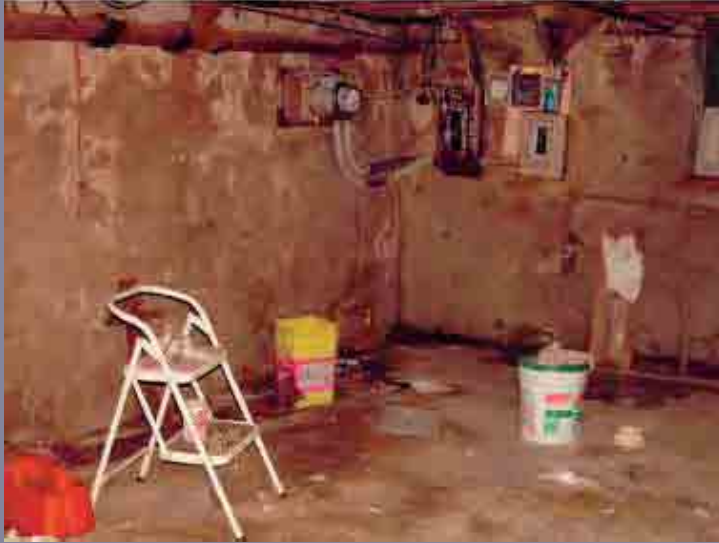
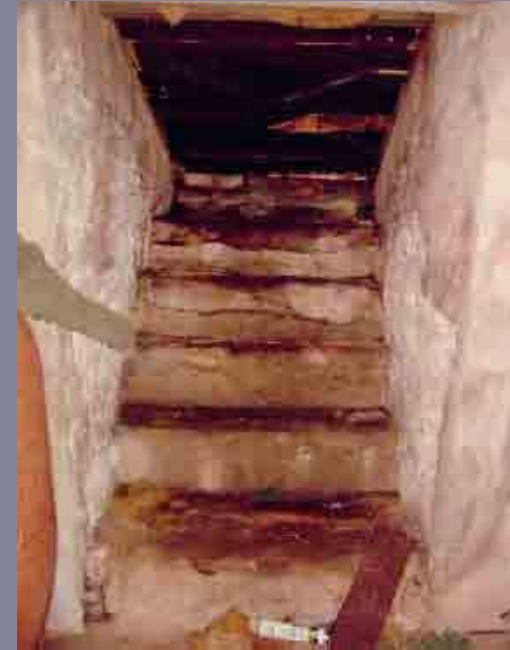
Identification of Problem: DAMP BASEMENT

Possible Source of Problem: Ground water getting in through walls

Investigation of Cause: Check for leaks in the roof, walls, and plumbing.

Recommendations: Repair cracks and open seams in the roof and walls. Repair plumbing leaks. Dehumidification and ventilation should be installed to reduce the indoor relative humidity. Heating the space also will reduce the amount of moisture. Also, materials with low permeability, such as cement, should not be applied to the indoor walls, as they hold moisture and make the space wet. A specialist should be hired to improve the drainage around the building, and to re-grade the surrounding area to direct surface runoff away from the building. If possible, a specialist should be hired to damp proof the foundation to reduce the amount of ground water that is absorbed by the building.

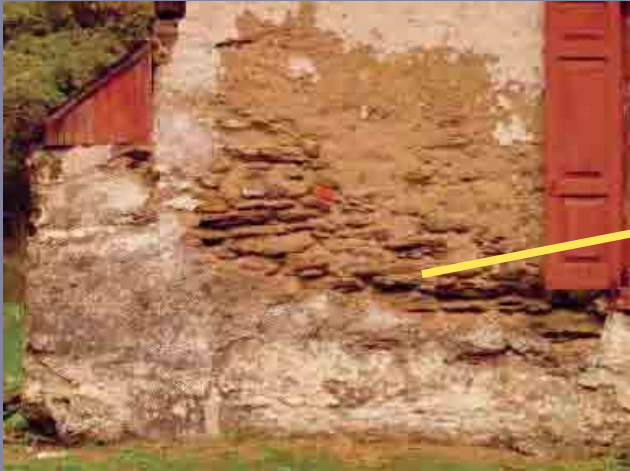
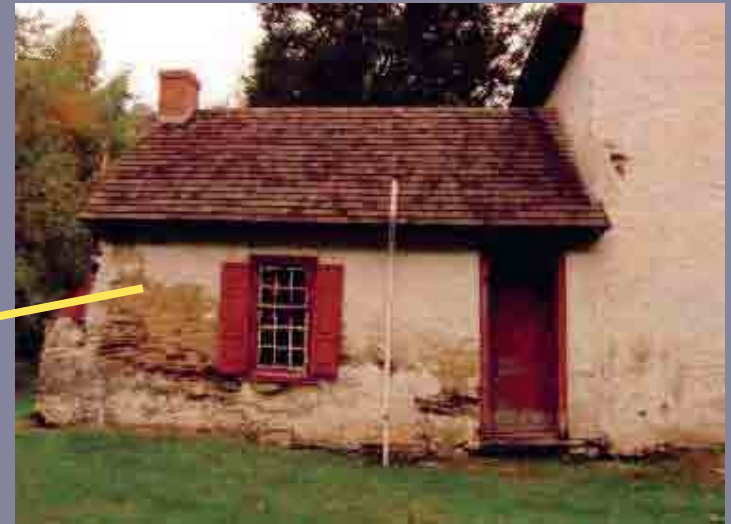
Identification of Problem: SPALLING SURFACES

Possible Source of Problem: Water trapped in material and freeze-thaw cycling.

Investigation of Cause: Observe paths of water when it rains. Look for leaks in the roof, walls, and plumbing.

Recommendations: Do not apply materials with low permeability, such as cement, to the walls of the building. The encapsulation of surfaces will cause the building materials to hold water and deteriorate. Repair cracks and open seams in the roof and walls. Repair plumbing leaks. Install gutters and downspouts to collect and direct water away from the building. A specialist should be hired to improve the drainage around the building, and to re-grade the surrounding area to direct surface runoff away from the building. If possible, a specialist should be hired to damp proof the foundation to reduce the amount of ground water that is absorbed by the building.

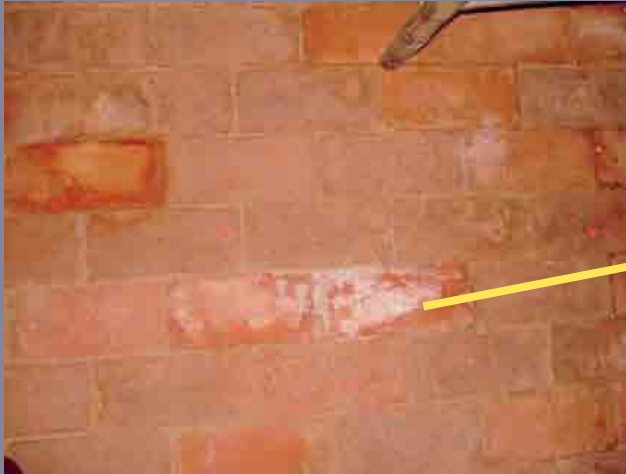
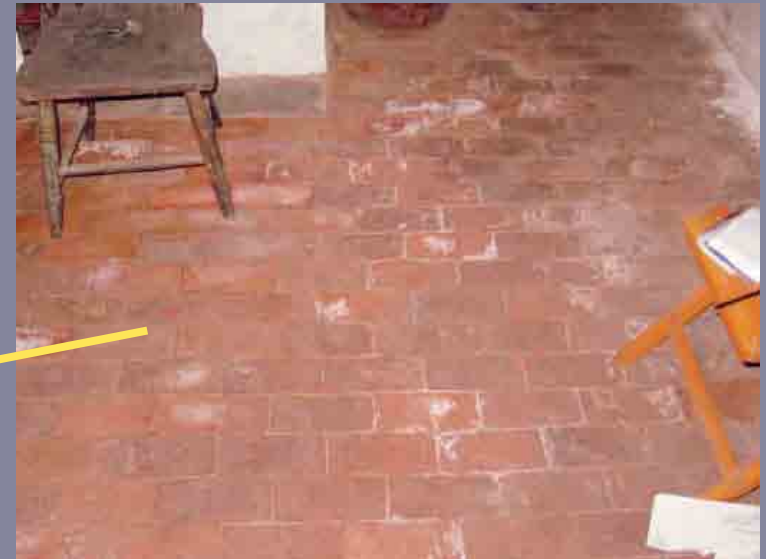
Identification of Problem:
EFFLORESCENCE (SALTS ON SURFACES)

Possible Source of Problem: Wet Material

Investigation of Cause: Observe paths of water when it rains. Look for leaks in the roof, walls, and plumbing. For indoor location, monitor indoor relative humidity.

Recommendations: Salts can be gently scraped from the surface. Power washing should not be considered for treatment as it makes the material wetter. This will cause the salts to come back. Materials should be kept dry. Install gutters and downspouts to collect and direct water away from the building. Repair cracks and open seams in the roof and walls. Repair plumbing leaks. If possible, a specialist should be hired to damp proof the foundation to reduce the amount of ground water that is absorbed by the building. Dehumidification and ventilation should be installed to reduce the indoor relative humidity, if the condition is indoors.

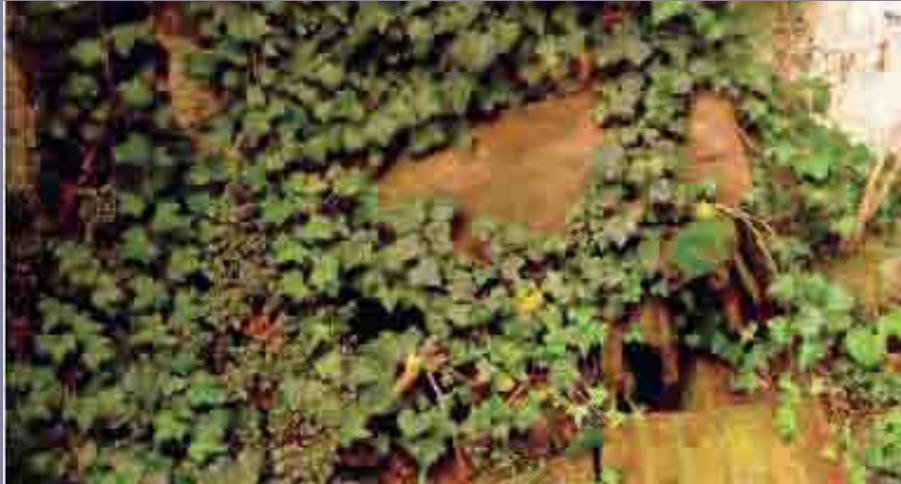
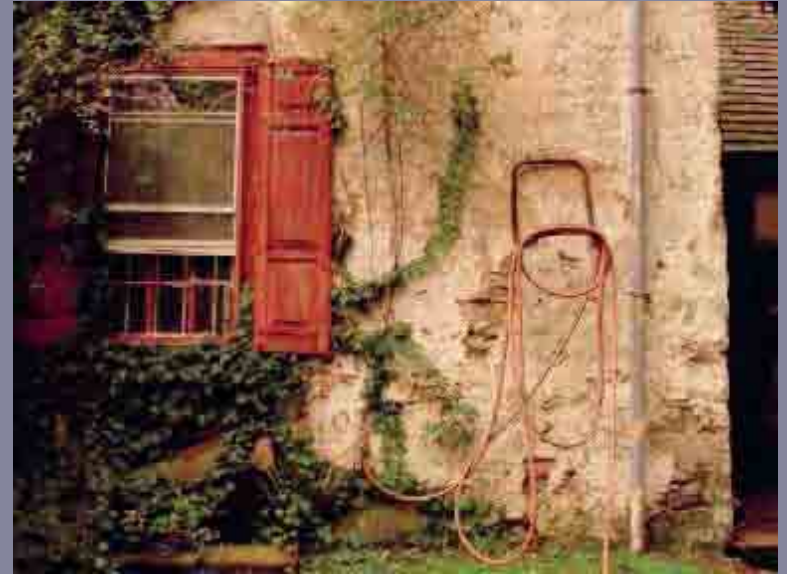
Identification of Problem:
VEGETATION GROWING ON BUILDINGS

Possible Source of Problem: Vegetation growing too close to building or spores trapped within a moist and fertile area of the building (often gutters).

Investigation of Cause: Look for vegetation growing on buildings

Recommendations: Climbing and trailing plants, like ivy, are particularly damaging to masonry surfaces (especially brick). The plant will grow small roots which attach to the wall surfaces, affecting brick surfaces, mortar joints and delicate stone surfaces. Vegetation should be removed, taking care not to damage the building. After removal, all cracks should be sensitively repaired, in-kind. A monthly survey of the buildings should be done to look for vegetation that may be growing too close to, or on the buildings.

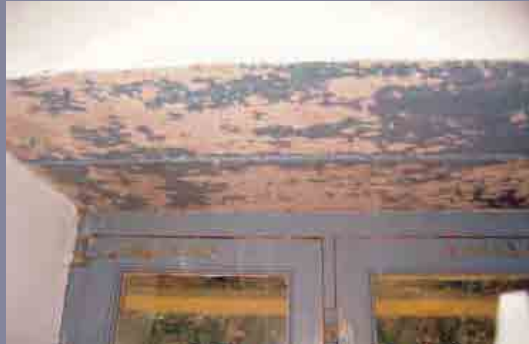
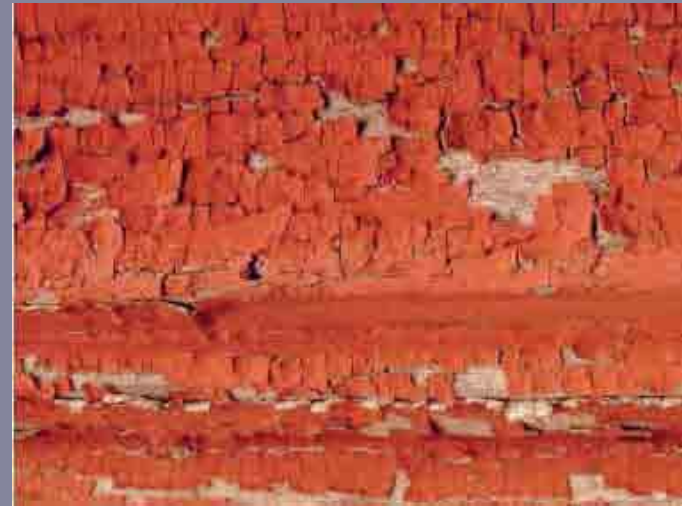
Identification of Problem:
DETERIORATING PAINT SURFACES

Possible Source of Problem: UV degradation, improper surface preparation, saturated substrate, and the absorption and desorption of moisture through the paint film.

Investigation of Cause: Determine moisture content of material using a hygrometer. Observe paths of water when it rains. Look for changes in the painted surface textures: bubbling, cracking, alligatoring, checking, chalking, staining, wrinkling, peeling or complete loss of the painted surface.

Recommendations: Paint is often a materials first line of defense against the elements, without a painted surface, they will often deteriorate rapidly. It is strongly suggested that painted surfaces be retained on-site. Affected areas should be repainted using in-kind materials. Materials must be kept dry; installation of gutters and downspouts will help collect and direct water away from the building. Cracks and open seams should be repaired in the roof and walls. The deteriorated paint surfaces should be gently removed until all flaking paint is removed and the substrate is solid. Should the bare wood appear to be severely cracked or alligatored, this may indicate that the material has reached the end of its service life and needs to be replaced in-kind. A primer should be applied to bare wood and allowed to dry for 48 hours before painting can start. If the paint type is unknown, it is suggested that a paint analysis be done to verify what types of paint are appropriate for repainting. Please refer to Preservation Briefs 10 and 28 in the Appendix.

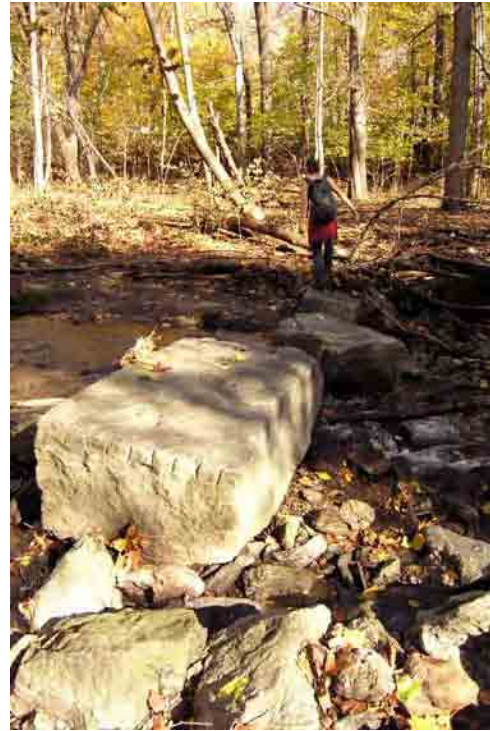
Figure 2. A large stone near the site of the former mill pond. Landscape features such as these may be used to enrich current interpretation of the site.

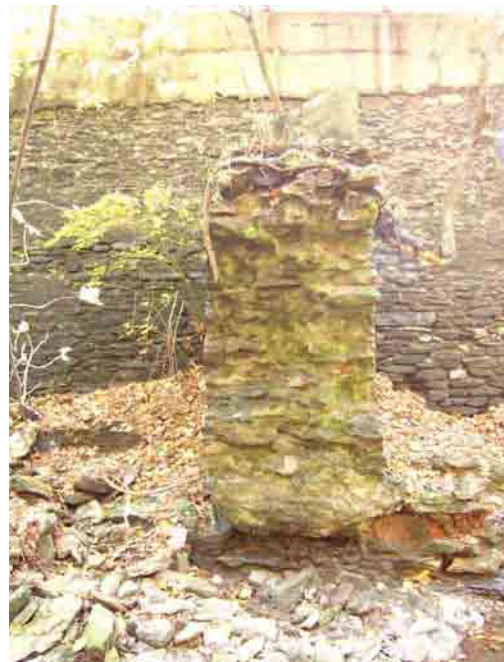
Figure 2. Remnants of the Amindown Mill, which are being eroded by the Monoshone Creek. Measures to slow this erosion may be taken in order to maintain this landscape feature.

- Continue study of historic boundaries.
- Include Bluebell Hill in programming.
- Develop trails throughout Historic RittenhouseTown.
- Take measures to slow the loss of historic landscape features with the help of a conservation professional (figure 2).

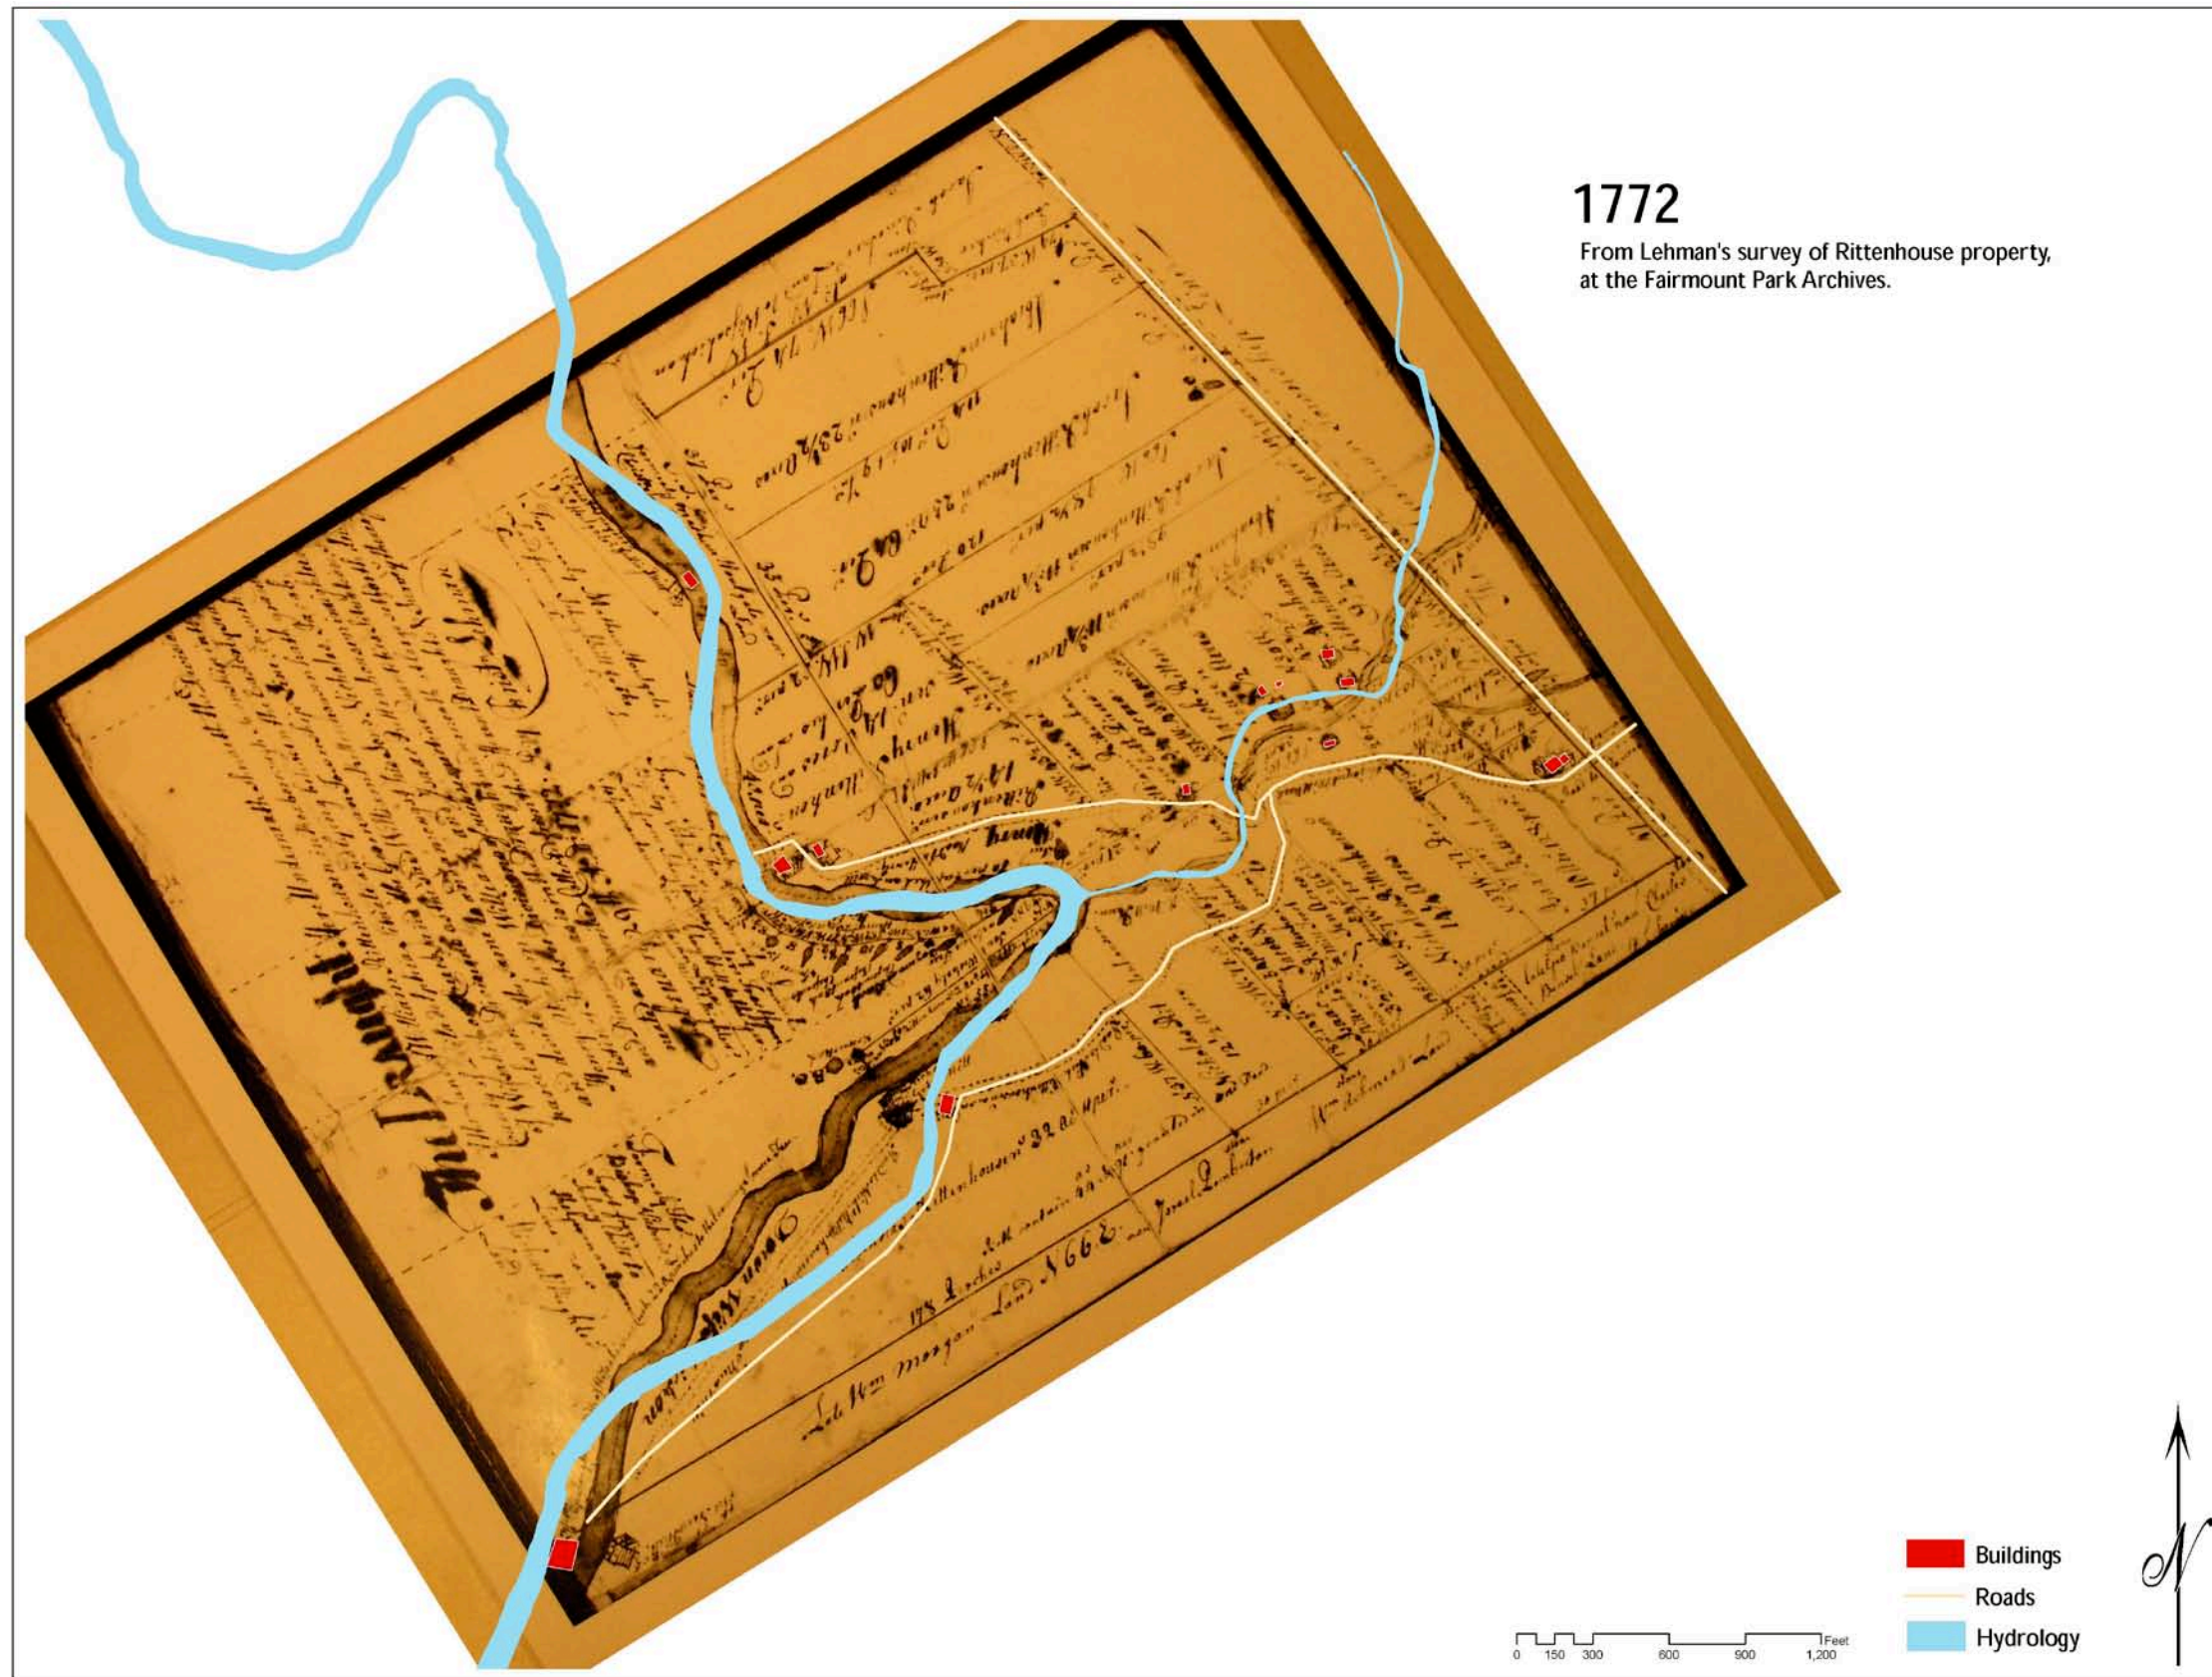
Figure 4. A survey by Christian Lehman in 1772, imported into ArcView and georeferenced in relation to current hydrology (in blue) and Wissahickon Avenue, formerly Township Line Road (upper right). Roads and buildings from 1772 have been traced into ArcView based on this map. Buildings and roads have been traced directly over their appearance on the map, excepting cases in which there would be a significant difference in their placement in relation to the creek. In these cases, their placement has been moved relative to the original map, but their relation to the creek has been maintained.

In researching this topic, historic maps from 1772 and 1875 were imported into ArcView and georeferenced in relation to current creek beds and historic roads, namely Wissahickon Avenue, which was once Township Line Road and appears in the earliest maps used here (figures 4-7). It should be noted that the two maps used are only a sampling of those available, chosen for the time periods they represented and the detail of illustration of property boundaries. This process may be repeated for other historic surveys in order to establish a more accurate sense of the site's boundaries. From these two maps, boundaries of historic Rittenhouse property were traced and set onto a map of current buildings, roads and topography surrounding the site. Suggested boundaries of landscape interpretation and management were

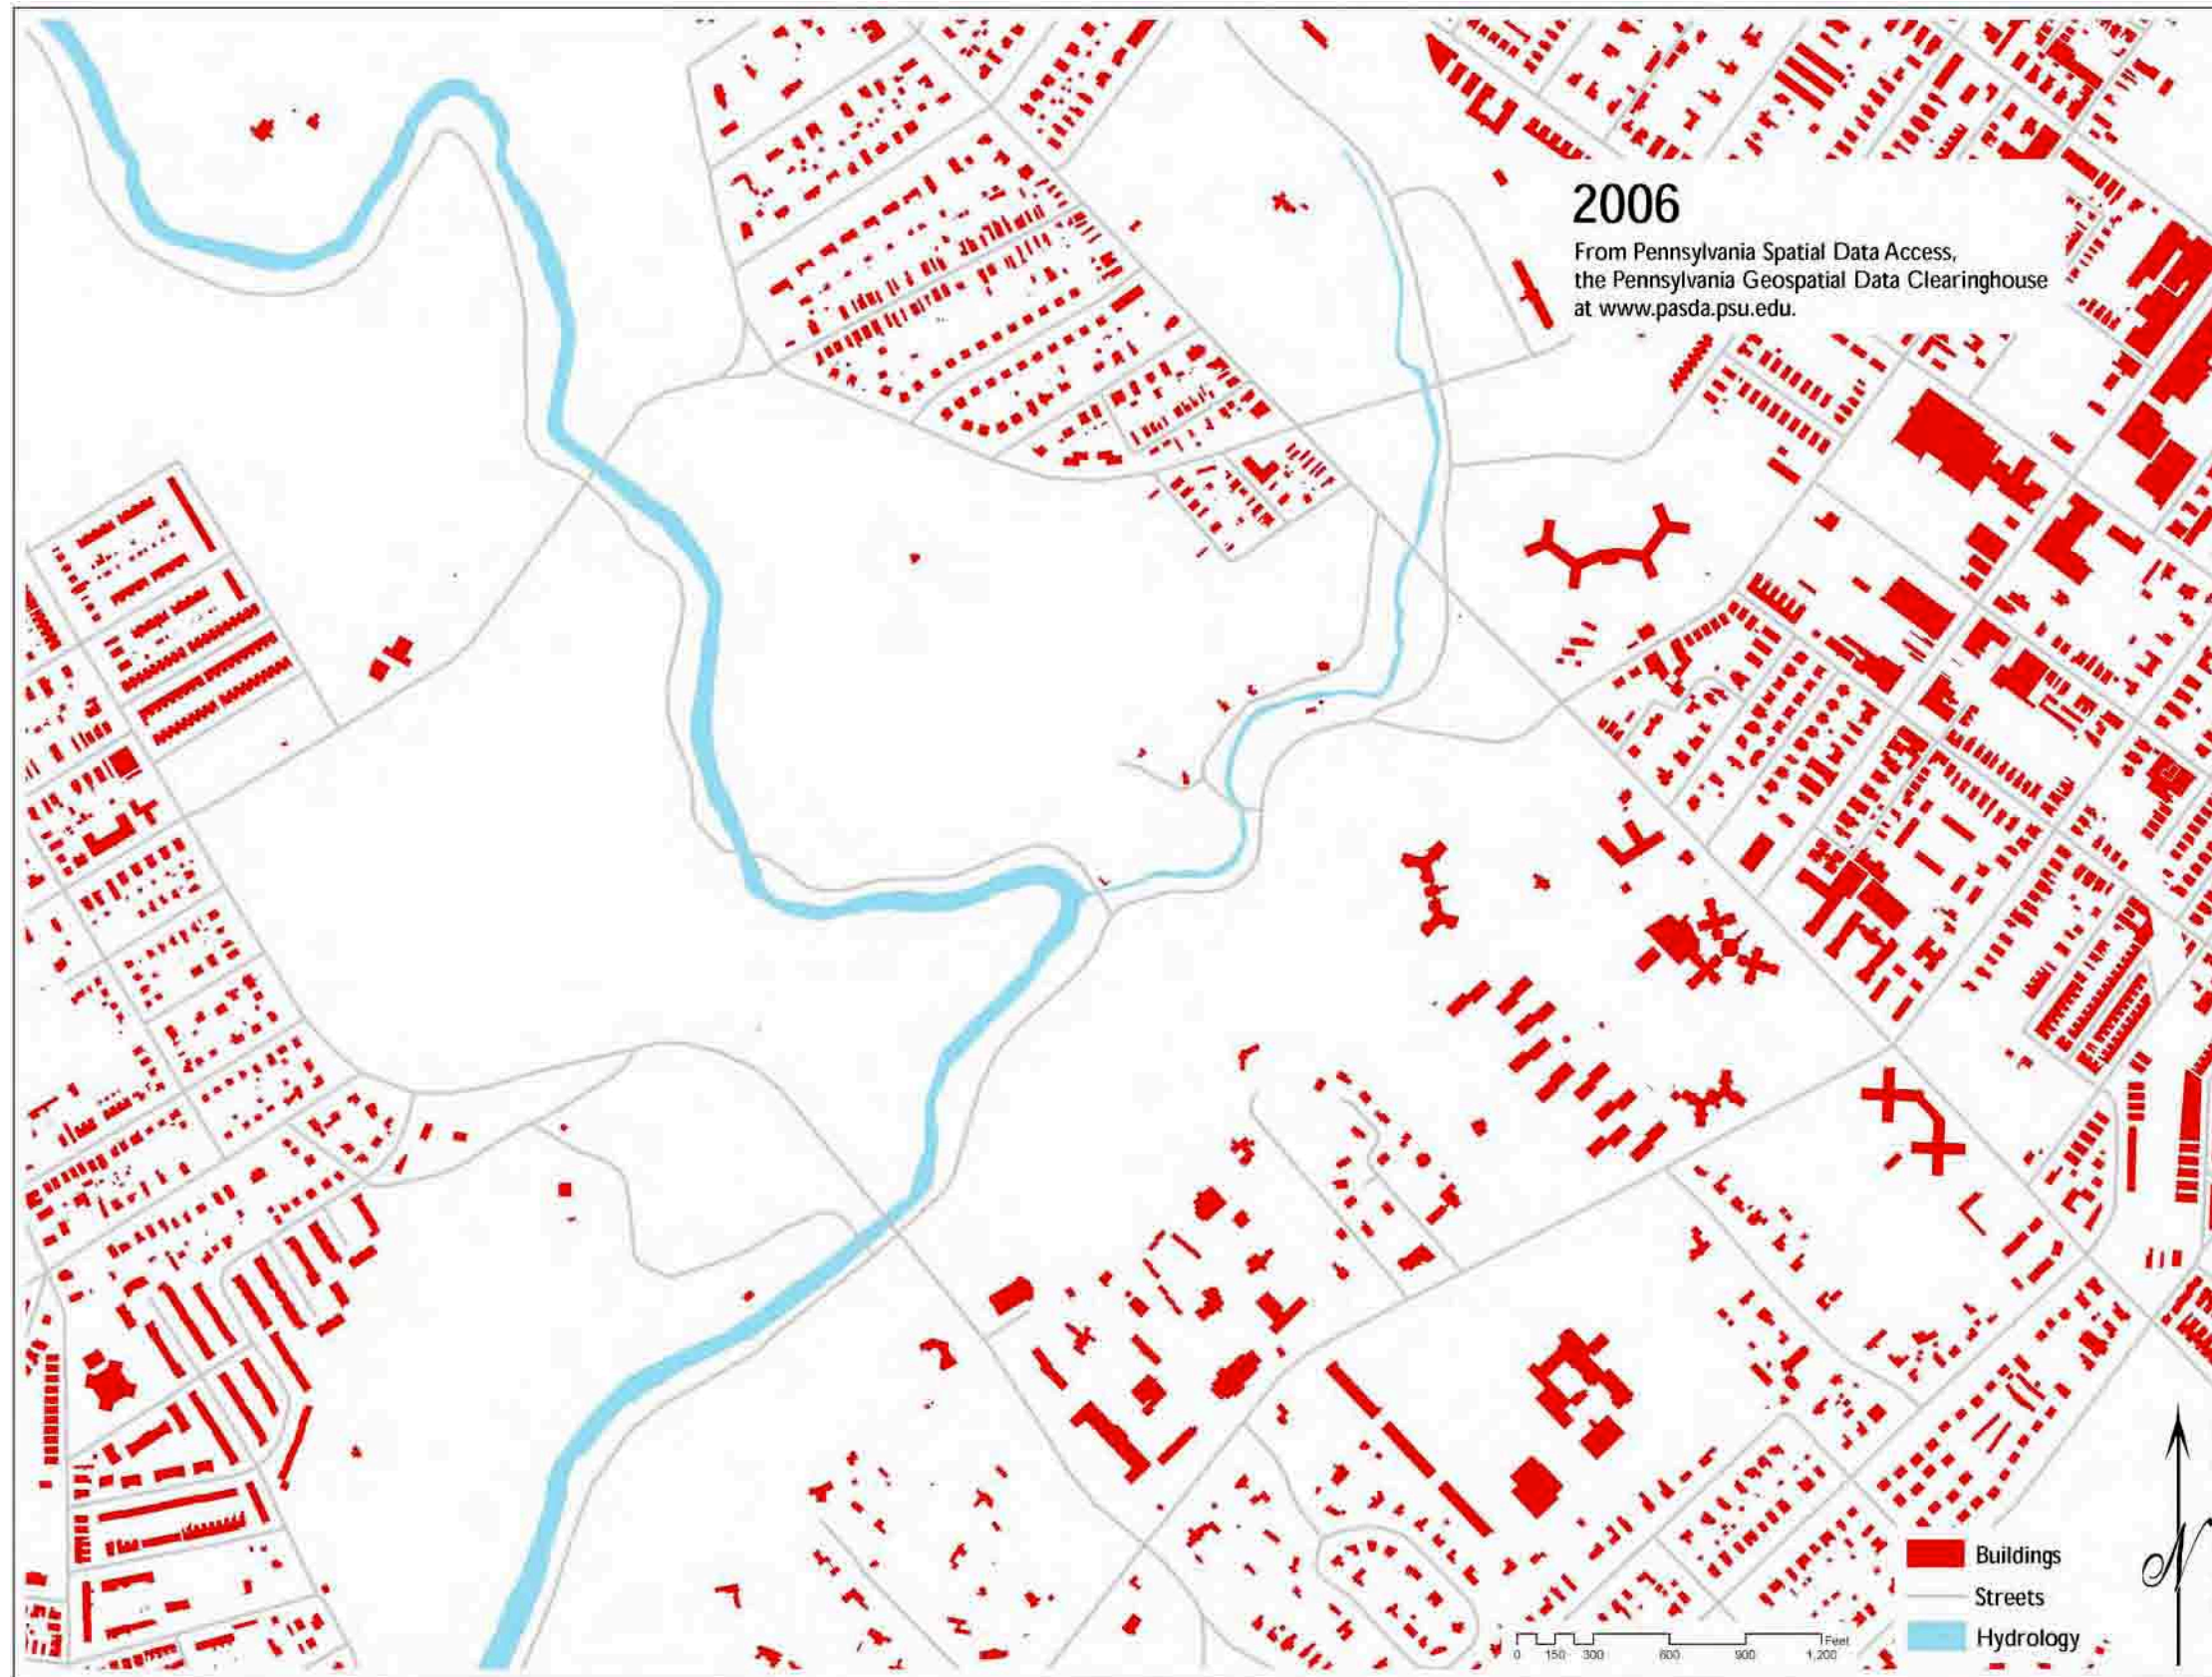
Figure 8. Current location of creeks, buildings and roads based on shape files from the Pennsylvania Geospatial Data Clearinghouse.
