The historic fabric of Historic RittenhouseTown is in serious need of repair and conservation. From a site that once comprised approximately fifty buildings, only six remain, each of which is deteriorating. Team members David Artigas and Sarah Vukovich conducted an assessment of the current condition of the buildings at HRT. An analysis of the possible decay mechanisms that are affecting the buildings was completed. From these investigations, a conservation booklet was created for the managers of Historic RittenhouseTown, Inc. to help determine what needs to be fixed, how it can be fixed, and when a specialist needs to be hired to address a condition. It is hoped that the recommendations in this conservation booklet will lead to the preservation of the historic fabric of Historic RittenhouseTown, further improving the visitor experience.

Too much moisture causes a host of problems in buildings. It can cause fungal growth, which is damaging to building materials and is a health risk. It causes wood to rot. And, it causes finishes, like plaster and paint, to deteriorate.

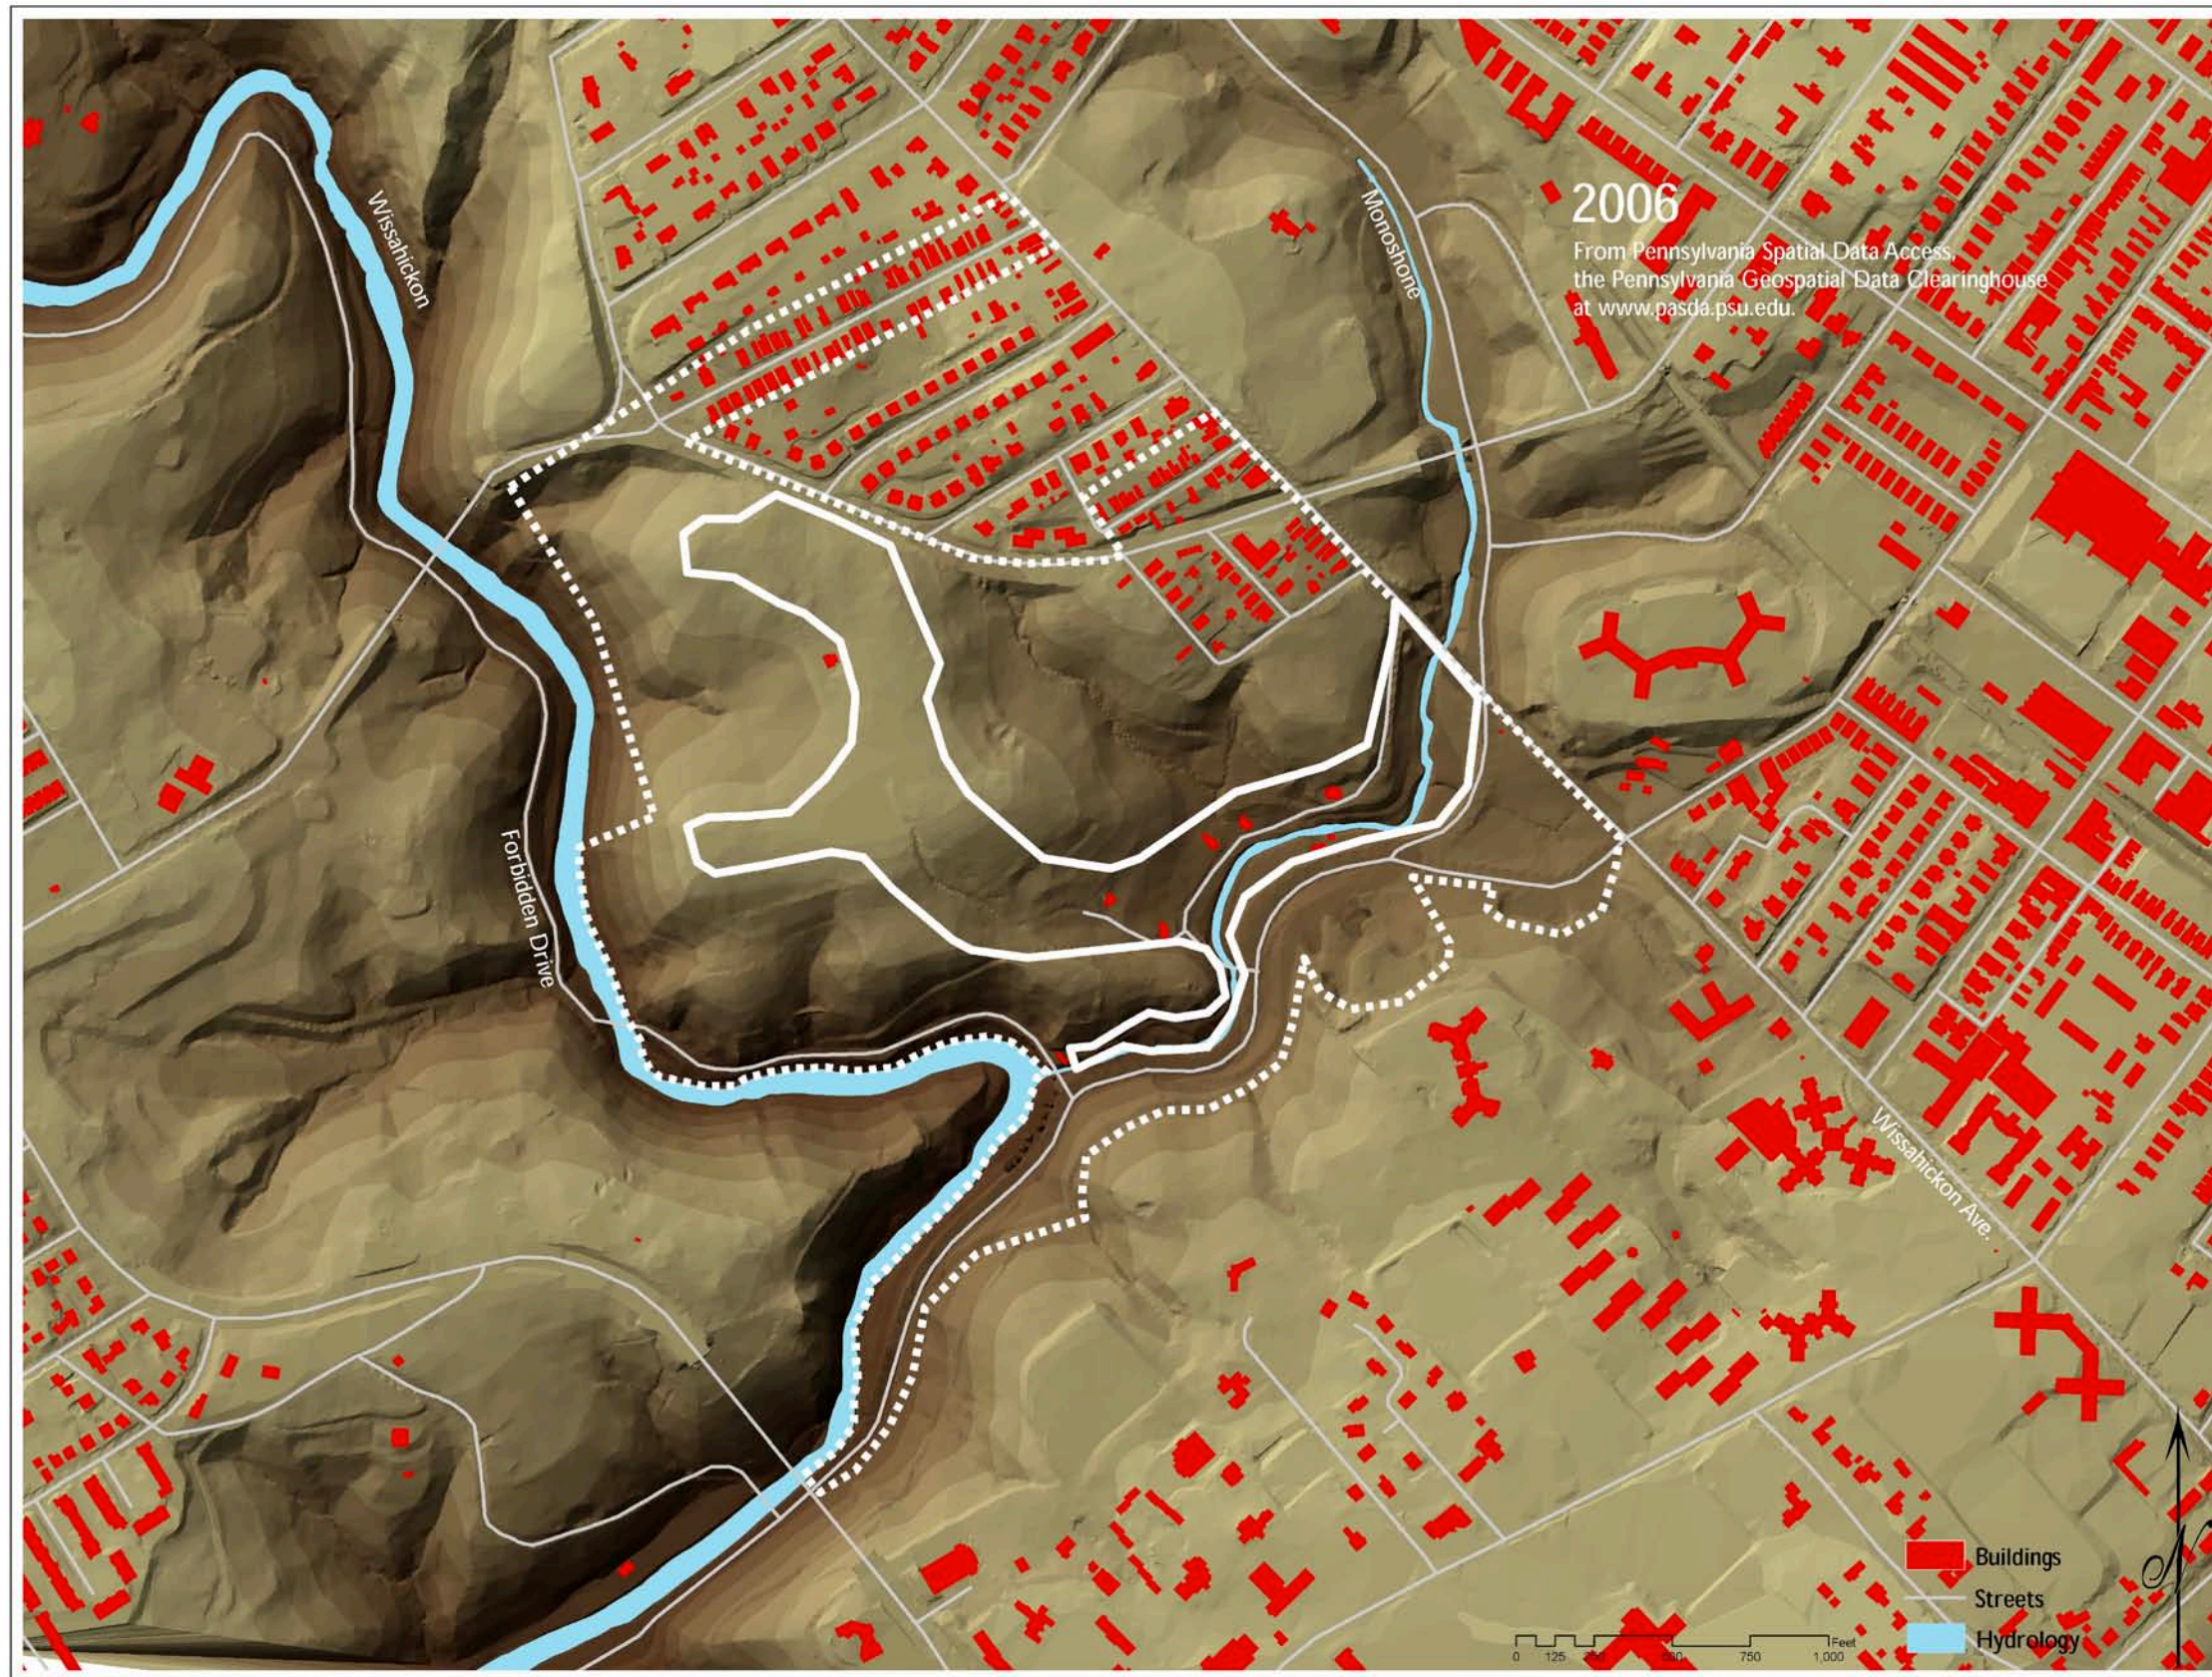
Figure 13. The relation of proposed interpretive and management boundaries to the current topography of the site. The dotted white line indicates suggested interpretive boundaries and the solid white line surrounds the suggested management boundaries. The quarries can be seen here to the south of the historic core, and the high, flat land to the north and west of the core is better illustrated.

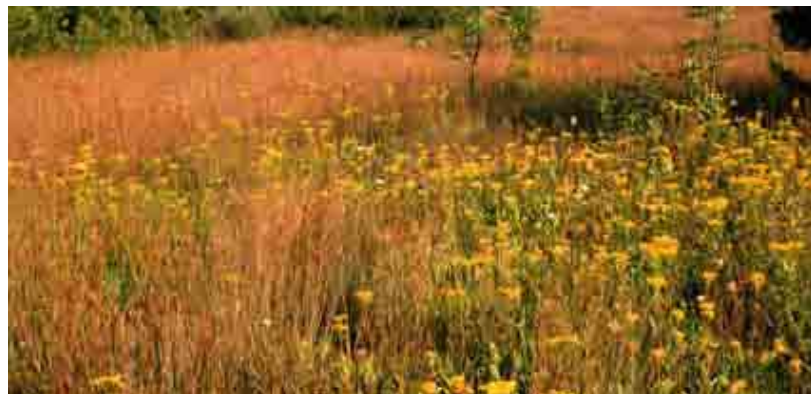
Bluestem Meadow

Plants- Decide which plants should be put in the meadow within the study area. Suggested grasses for the meadow are Andropogon Virginicus or Little Bluestem, Elymus or Virginia Rye Grass. For the wildflowers it is suggested to plant Rudbeckia hirta or Black-Eyed Susan, Aster laevis or Showy Astor, Vernonia angustifolia or Ironweed, and Eupatorium fistulosum or Joe Pye Weed.

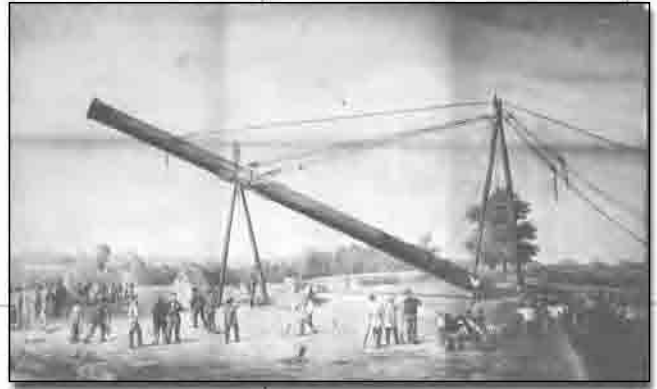
1 GERMANTOWN WATER WORKS & TULPEHOCKEN TRAIN STATION

TULPEHOCKEN STREET, NAMED IN HONOR OF A LENAPE INDIAN CHIEF, WAS THE SITE OF THE GERMANTOWN WATER WORKS ESTABLISHED IN 1851 (PUMP & PIPE PICTURED ABOVE). THE TULPEHOCKEN TRAIN STATION WAS BUILT CA. 1880 BY ARCHITECT W. B. POWELL. AS AN EXPANSION OF THE PENNSYLVANIA RAILROAD, THIS COMMUTER TRAIN WOULD SERVE THE FIRST SUBURB IN AMERICA, RUNNING BETWEEN CENTER CITY AND GERMANTOWN.

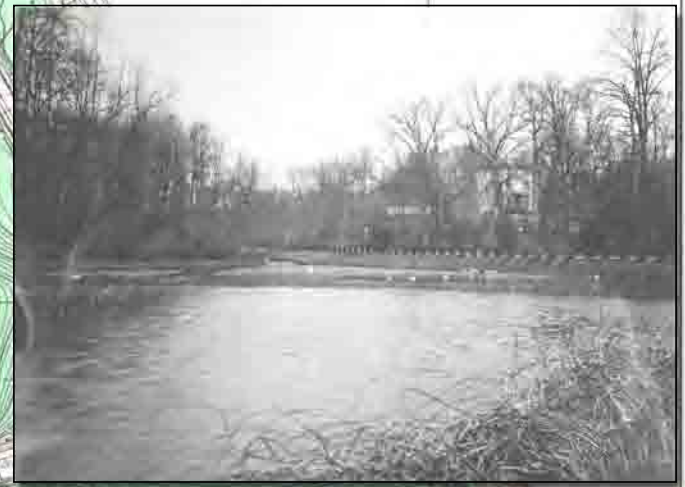
3 LINCOLN LAKE

NOW A RECESSED FEATURE IN THE LANDSCAPE, THIS LAKE ONCE PROVIDED 14,000 GALLONS OF FRESH WATER TO GERMANTOWN RESIDENTS. UPON THE INCORPORATION OF THE WATER WORKS INTO THE CITY OF PHILADELPHIA, THE OBSOLETE RESERVOIR BECAME A LAKE FOR RECREATION AND ENJOYMENT. THE DAMNS ALONG THE MONOSHONE CREEK ONCE PROVIDED POWER FOR THE MILLS IN THE VALLEY, FORMING POOLS WHICH WOULD ACCUMULATE WATER SENDING FORCE WHEN OPENED. GRADUALLY THESE FEATURES WERE TRANSFORMED INTO POOLS AND PLEASURE GARDENS UPON THE EXPANSION OF FAIRMOUNT PARK.
