GRADUATE PROGRAM IN HISTORIC PRESERVATION UNIVERSITY OF PENNSYLVANIA FALL 2008 STUDIO

THE HISTORIC ELKINS ESTATE OF CHELTENHAM TOWNSHIP:

An Integrated Approach to Preservation

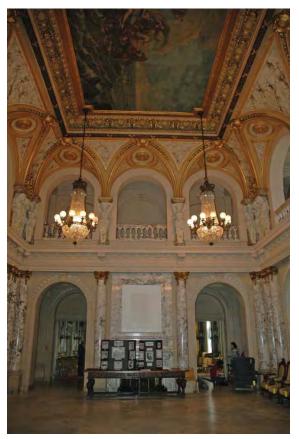
Figure T1. Main entrance hall (Room 100).

Italianate in style and the larger of the two main houses, the Trumbauer-designed sections of Elstowe Manor are ornately detailed with rich finishes of marble, woods, plaster, gilding and other decorative paints (Figure T1). As outlined in the general plan view (refer to Figure 1), the manor house has undergone two major periods of adaptation. Specifically, the additions of the western wing and the southern chapel by the Dominican Sisters lend new periods of significance and tolerance levels to the building. The earlier chapel addition dates to c. 1940 and encompasses three levels of offices and sanctuary space. The western wing—with a later construction date of c. 1960-contains standard dorm-style accommodations on two levels (Figure T2). The wing is accessible through the historic manor on the first floor only (Figure T3). Though these wings represent the various owners and impact the overall character of the historic structure, the original Elkins rooms retain their historic aesthetic and intent.

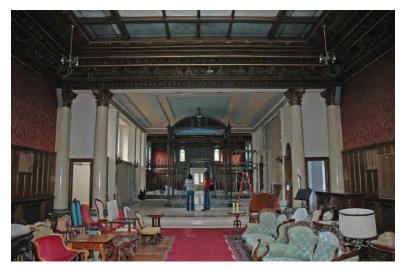
Figure T4. Former gallery and chapel addition (Rooms 2000 and 2001).

Because the Sisters reuse programs largely incorporated existing Trumbauer fabric, most alterations in Elstowe Manor have remained relatively minor and have allowed much of the original structure and finishes to survive. The chapel addition provides the only major structural alteration to the historic building (refer to Figure T4); the southern exterior wall was removed to connect the new sanctuary space to the former Elkins art gallery (rooms 2000 and 2001). The

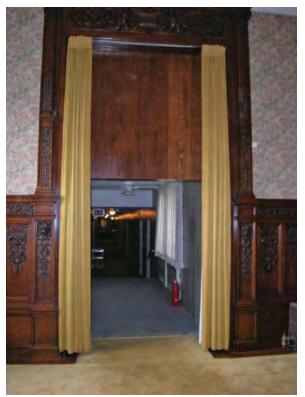
Figure T7. Entrance to western wing addition from billiard room (Room 103).

1960's housing wing required a minor structural change to a western-facing doorway to permit circulation from the historic building to the new spaces (room 103; Figure T7). Other envelope and finish alterations occur in the basement rooms. These spaces were updated when they acquired new uses. Rooms that retained their old functions, such as the kitchen service areas (rooms 8 and 29-31), were left wholly intact but with possible changes to appliances and moveable components (Figure T8). Significant extant fabric includes counters, wood cabinets, windows and tiles.

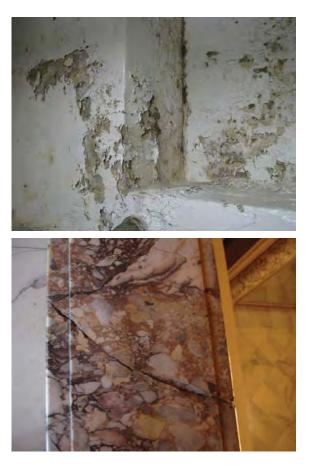
Figure T10 (top). Water damage to basement wall (Room 1).

Current conditions attest to the extraordinary stewardship of the site's former owners. Only minor water damage appears in the basement (rooms 1 and 8; Figure T10). Very little damage has been recorded on the first floor and is generally limited to peeling paint. All aspects of structure, envelope and finishes have been best preserved in these spaces with many original finishes and immoveable furnishings (such as chandeliers and statuary) still intact.

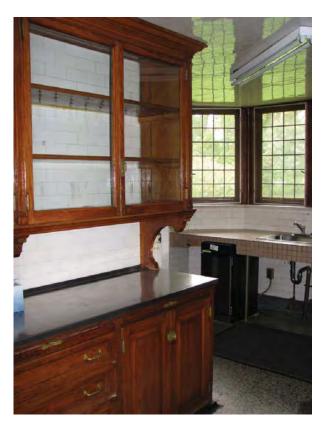
Image3. Kitchen 112 with Dominican and Trumbauer fixtures

The first floor of Chelten House does not possess any additions dating to the Dominican Sisters' period of occupation. Instead, the building retains its Elkins period form. There are, however, some rooms with alterations to appliances, building fabric and function. These rooms are therefore representative of both the Elkins' and the Dominican Sisters' periods of significance. In rooms 106, 110, 111, 112, 116, and 118, for instance, the Dominican Sisters altered appliances and fixtures, such as sinks and toilets (see image 3). They converted room 103, the library, into a chapel by changing wall finishes and lighting, as well as adding speakers and an altar. The forms of these spaces still mirror Trumbauer's original design. In rooms 119 and 120, however, the degree of intervention is high enough that they best represent the Dominican Sisters' period of significance. The

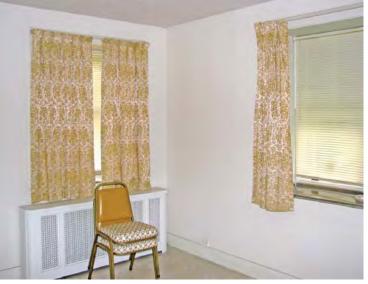
Image 4. Dominican Period Room 119

Sisters converted one closet, room 120, into a bathroom and added a water fountain in another, room 121. None of the wall finishes or fixtures in room 119 date to the Trumbauer period (see image 4).

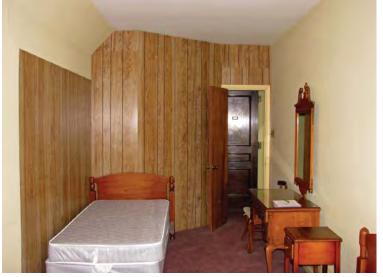
Image 8. Partition Wall in Room 314

er stalls and a toilet partition. Trumbauer designed bathroom 312 to serve as a hall bathroom, however the stalls and fixtures currently in the space appear to be from the Dominican Convent era. The open space and hall of the third floor (rooms 307 and 316) received emergency light-ing, exits signs and varying amounts of faux wood paneling.

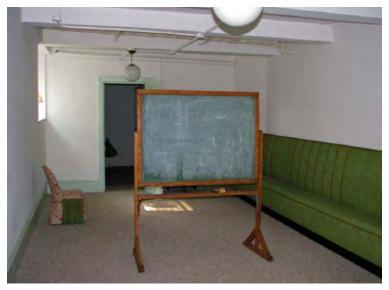
Image 9. Dominican Basement Finishes

The finished portion of the basement under the west service wing reflects the aesthetics and usage of the Dominican Convent. It served as a social space and fallout shelter. This required the introduction of new lighting, carpeting and wall finishes (see image 9). The Sisters did not use the portion of the basement under the main house. As such, it remains unaltered from Trumbauer's original design, with minor changes to the building's utilities.

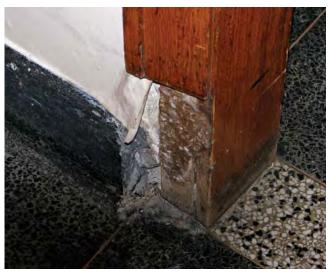
Image 10. Kitchen Doorframe Loss

The first floor is in good condition and most rooms do not display anything that goes beyond aesthetic concerns. Rooms 101, 110, and 111 show some signs of deterioration that must be addressed. Cracks run through the walls of the vestibule (room 101), and show signs of repeated patching. Rooms 110 and 111, in the kitchen area, need repairs to their doorframes, tiles, and holes in the interior walls (see image 10). No rooms on this floor possess severe conservation issues.

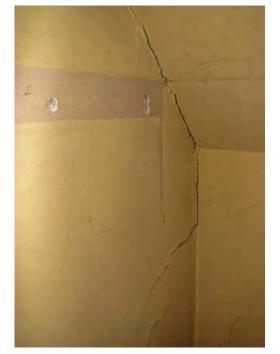
Image 13. Room 309 Cracking

While many rooms show minor signs of finish cracking and old water stains around fixtures, only three rooms possess any significant conservation issues on the third floor. Sitting room 309 shows structural cracks in the corners of the exterior walls (see image 13). Bathroom 312 needs repairs to flaking paint and leaks from fixtures that are deteriorating the walls. Bedroom 315 show structural cracks along the top of the baseboards, in addition to other cracking and water damage. No rooms here possess severe conservation issues.

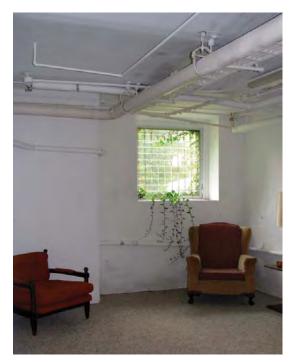
Image 14. Basement Window Plant Growth

The finished portion of the basement displays severe conservation issues, including plant growth through windows (see image 14), salt efflorescence through the exterior walls, loss of material in the foundation walls (see image 15), water damage and staining. The conditions of the basement under the main portion of Chelten House appeared to be good, although the spaces are unfinished and were not completely examined.

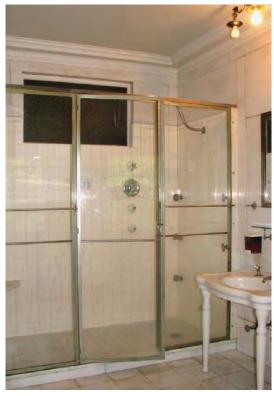
Image 17. Bathroom 210 with Original Fixtures

Few second floor spaces experienced alterations; this report considers all bedrooms low tolerance areas, along with hallway 208, which connects them, and bathroom 210, which contains original bathroom fixtures (see image 17). The gallery and stairwell are vital to the experience of the building and the views from both the first and second floor. They also contain exceptional woodcarving, colonnades, lead casement windows and stained glass. As a result, these are areas of very low tolerance. Again, areas with moderate tolerance levels are those altered by the Dominican Convent. These are bathrooms 204, 206, 211 and 215, and hallways 213 and 217. There is a single high tolerance space, bathroom 221, which is an addition from the Convent's occupation.

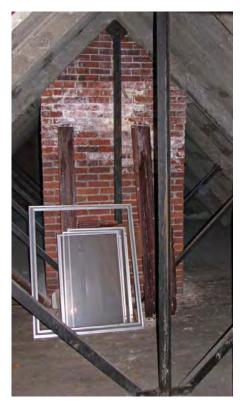
Image 18. Third Floor Attic

The third floor contains two very low tolerance areas. Unfinished attic space 301 exposes Trumbauer's roof and wall structural systems (see image 18). Bedchamber 313 retains its original walk-in linen closet and all of its original architectural details. Most of the other areas are low tolerance, such as the stairwells (rooms 302 and 306), the hallways (rooms 303 and 316), the social spaces (rooms 307 and 309) and nearly all bedchambers (rooms 305, 308, and 311). As with the first and second floors, the bathrooms (rooms 304 and 312) are moderate tolerance spaces that were previously altered by the Convent. Bedchambers 314 and 315 are moderate

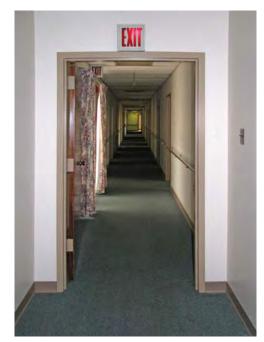
Image 8. Assissted Living Center

The powerhouse holds particular importance for both periods of significance at the Elkins Estate. During the occupation of the Elkins family, this served as the agricultural heart and power center for the estate. Later the Dominican Convent retrofitted the spaces and added additions to the north that more than doubled the size of the original building. The powerhouse then became a modernized assisted living center, with new interiors and utilities (see image 8).

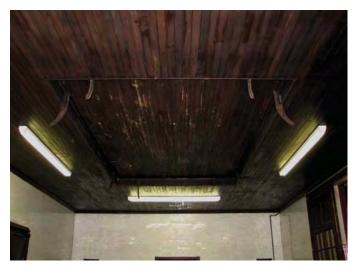
Image 9. Carriage Elevator

In addition to the Tudor exterior finishes, the stables retain a few key Elkins period elements, such as the carriage elevator (see image 9) and the stable room. Spaces surrounding the entry courtyard generally retain some degree of wood paneling, original doors, wall tiling, patterned concrete floors and stained wood and beam ceilings. Otherwise, the Convent altered much of the space by converting it to apartments, and changed the use with the addition of a laundry and storage for maintenance/grounds-keeping. The addition of utilities and fluorescent lighting accompanied these alterations.

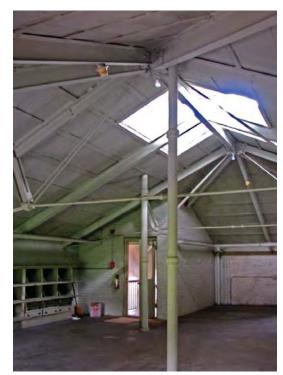
Image 12. Elkins Powerhouse Attic

The powerhouse is possibly the most altered structure on the property. The Convent removed much of the interior in order to accommodate its reuse as an assisted living center. Of particular note is a chapel, inserted in the southernmost wing of the original building, that demonstrates the influence and importance of religion to the site during the Dominican Sisters' period of occupation (see image 11). New additions to the north completely changed the compound's form. Other than the exterior of the original powerhouse, the only remaining Elkins period elements appear in the extant

fireplaces, boiler room, and the sky lit attic space (see image 12).

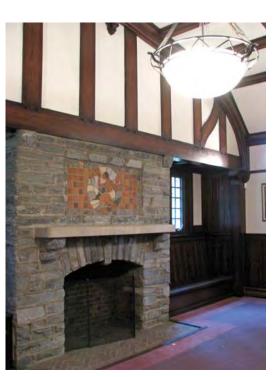
Image 17. Squash Court Original Finishes

The squash court is already a highly altered space. As such, its tolerance to interior change is moderate. The structure could also tolerate reinstitution of its original form in the spaces containing decorative finishes. The characteristic Elkins features, such as the fireplaces with mosaic tiles, the wood benches with ornate joinery and the wood ceiling beams, constitute areas with very low tolerances to change (see image 17). The only acceptable change in these areas would be to reopen the space and remove the modern-day partition walls.

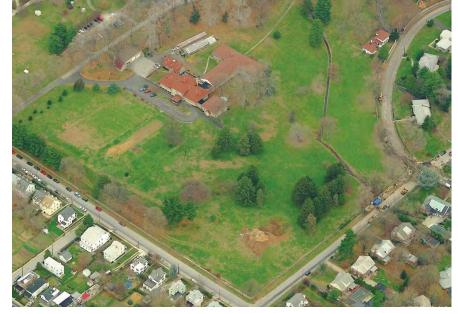
Figure 1. A view of the southern parcel of the Elkins Estate. Provided by Food for Life, Inc.

Currently, there is a great deal of pressure to develop the Southern Parcel of the Elkins Estate (see figure 1). This parcel comprises the southernmost part of the site and is currently undeveloped. However, several developers have shown an interest in building townhouses or condominiums on this part of the property. We feel that an acceptable alternative would be to put residential development across the street on a lot that is part of the future sale of the Tyler School of Art property. We suggest that the future owner of the Elkins Estate purchase this property as well and delegate any new parking and development to the Tyler property. This

We strongly recommend that the southern parcel **not** be sold off for development purposes in fear of the negative effects development would have on the site. The southern parcel is crucial for supporting high-impact public and private recreational uses such as music concerts and theater events. Having a piece of land that is separate from the main buildings is important to any retreat or hotel and provides a private area for holding noise-producing events.

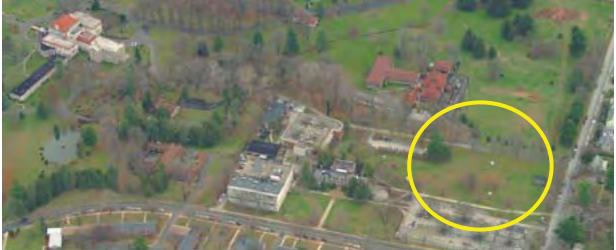
Figure 2. Possible parking area on Tyler School property located within yellow circle

Additional open space would also prove useful for holding other events at the property. Wedding receptions could take place under tents in the southern parcel. The parcel also provides desirable open space in the otherwise dense residential area and greatly contributes to the parklike quality of the Estate. Acquiring the Tyler property is an important condition of this option, which prioritizes preservation of the historic and architectural integrity of the Elkins Estate. If the Estate's owners purchase the Tyler property, they could delegate parking to the location represented by the yellow circle in Figure 2. This separate parking area would allow the Elkins Estate to remain uncluttered by automobiles. It would eliminate the visual interference created by cars, trucks, and buses that might otherwise be permitted to park along the interior roadways of the site. A concentrated parking area would also increase pedestrian safety by restricting vehicles to designated locations at the property's periphery.

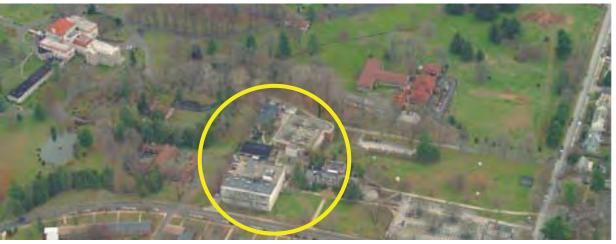
Figure 3. The Tyler Property development scenario: the former Tyler School buildings (within yellow circle) maintain their use as educational buildings and the center Georgian Terrace becomes the visitor's center for the Elkins Estate site.

In terms of development on the Tyler site, the former Tyler School buildings would be best used for educational purposes. Educational buildings and a possible visitor's center could be located within the yellow circle (see figure 3). Classes on religion, yoga, and other spirituallycentered topics could be taught in these buildings. Georgian Terrace, the original Trumbauerdesigned building on the Tyler property, could be used as a community and visitor coordination center for the site. Visitors to the Elkins Estate would park at the former Tyler site and proceed to Georgian Terrace for information. Tours of the site would also leave from Georgian Terrace.

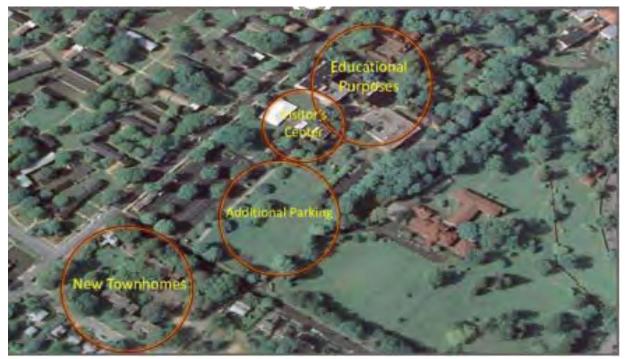
Figure 5. Overview of Option 1 development scenario

To summarize this option for the site, the northwestern buildings would continue to serve an educational function, the central portion of the property would be the visitor and community center, east of the visitor center would be the additional parking lot, and the remaining southern property would accommodate the new townhouse development (see figure 5).

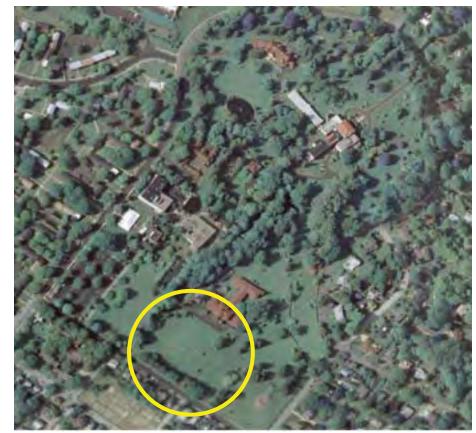
Figure 6. Preferred location of possible development on the Elkins Estate property.

A second and less desirable option is to develop the southern parcel of the historic property. There are two sides to this parcel, the west side, which is located behind the Powerhouse, and the east side (according to the picture shown). If development or parking went on the eastern portion, it would potentially interfere with the historic viewshed of Elstowe Manor, while the powerhouse building would block the view of development on the western portion. This land could be used for one of the following: additional parking or residential development that would not block the historic viewsheds from Elstowe Manor. Only the parcel behind the Powerhouse would be able to tolerate development or parking. The preferred location of this option is located within the yellow circle in figure 6.
