North Brother Island Conservation and Access Study

PennPraxis

March 27, 2017

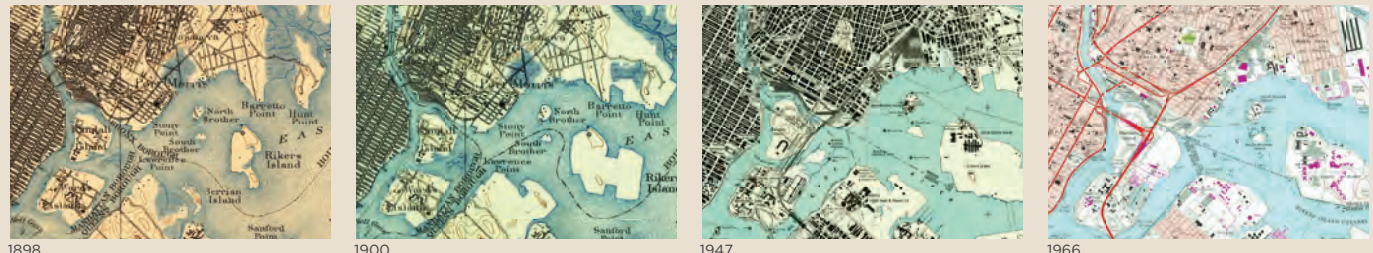
FIGURE 1. Historic development of area around North Brother Island and modern land use categories. Angelina R. Jones. 2016.

- metro stops
- time to barretto point via public transit
- parks + outdoor recreation
- residential
- commercial
- industrial
