Thin Stone Veneer Case Study: Amoco Building and Finlandia Hall

Anyuan Ji

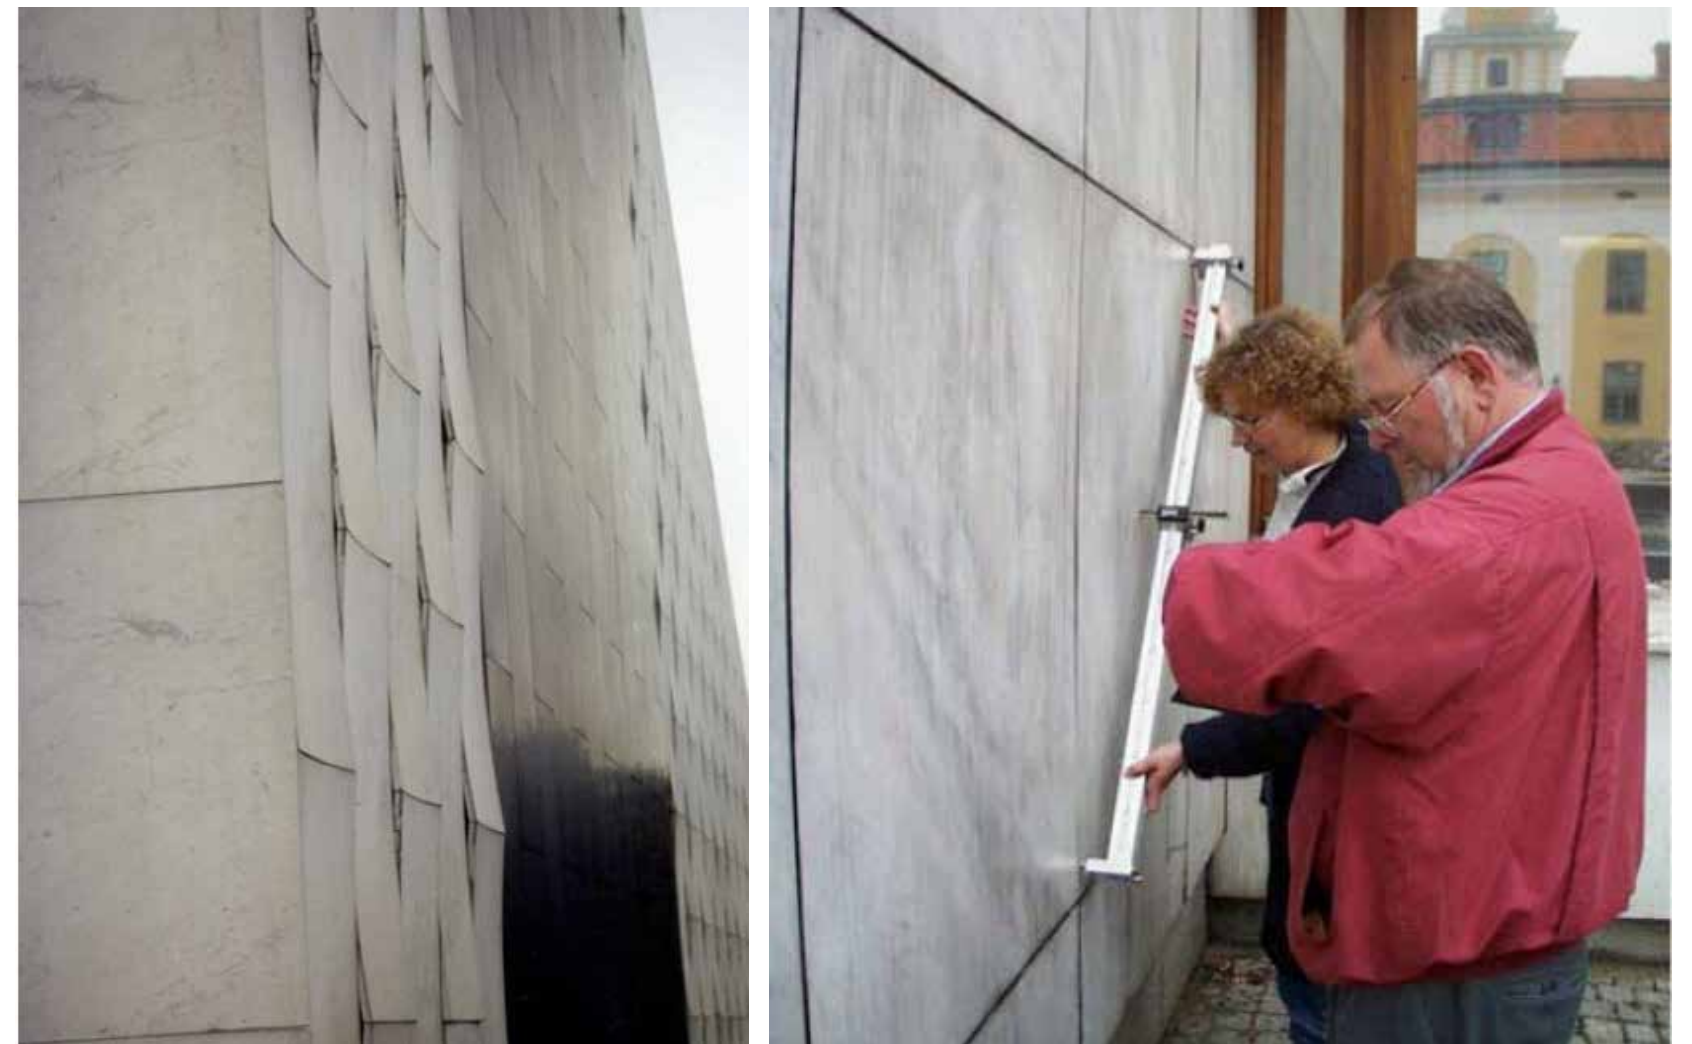
Figure 2(left). Part of the old marble facade at Finlandia Hall in 1999. (Source: Symposium on Dimension Stone Use in Building Construction Tampa, Fla).
Figure 3(right). Measurements of bowing amplitudes with the use of a Bow meter. (Source: Symposium on Dimension Stone Use in Building Construction Tampa, Fla)

Thin Stone Veneer is widely used as an affordable modern building decorative envelop system. However, it brings much economic burden on restoration works. The most severe problem for marble cladding is thermal hysteresis combined with moisture, leading to bowing issues. Deterioration of the marble panels may result in: Bending of panels, Surface deterioration, Cracking and spalling around fixing points, Inferior appearance, and Safety problems. Furthermore, stone weathering is another problem that needs to be carefully considered, which is associated with four factors: Natural defects in the materials, Workmanship, surface finishes, Design, and Environment. In the first research paper, I focused on the problems created by thin stone veneers and solutions for the bowing problem. I expanded on this topic by reviewing the case study and discussing the application, anchoring system, repair, and monitoring methods for this paper. In most cases, the conservator can only regrettably replace the stone veneer periodically. Moreover, other methodologies will only cause more safety issues and damage building authenticity. My case study for thin stone veneer focuses on Finlandia Hall and Amoco Building in Chicago.
