## Historic Structure Report THE JOHN COPE HOUSE

East Bradford Township Chester County, PA

Graduate Program in Historic Preservation Site Analysis-HSPV 601-201 Spring 1998

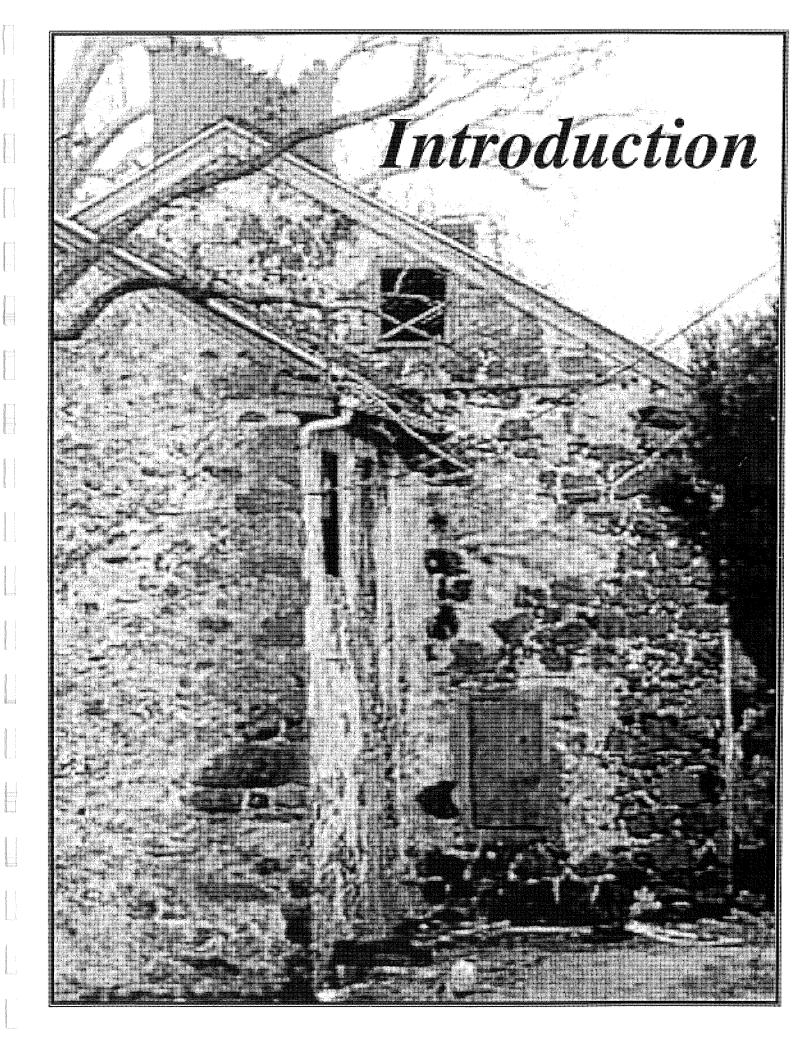
Figure 1.1. Exterior view of Cope House from the South showing Phases II, III, and IV.

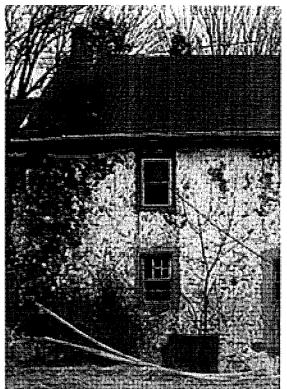
Figure 4.11. Correct condition of Plans II from the North.

Nail analyses from Phase II show all the nails to be large and hand wrought. This, as well as the molding profiles of the woodwork, point to Phase II being the oldest extant phase of construction.

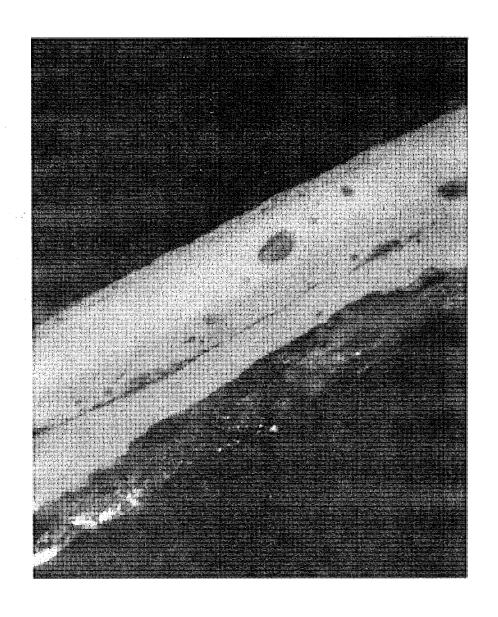
Sample No. 001.2		
Location: window sill closest to door		
Magnification: 100x Photo Magnification: 225x		
Light: Reflected Light Source: Quartz halogen		
Film: Kodak Royal Gold 100

Layers	Observations	Thickness (µm)
1	very thin green	. 1
2 ·	thick white with golden brown particles	15
3	very pale green	7
4	very pale green	8
substrate	wood

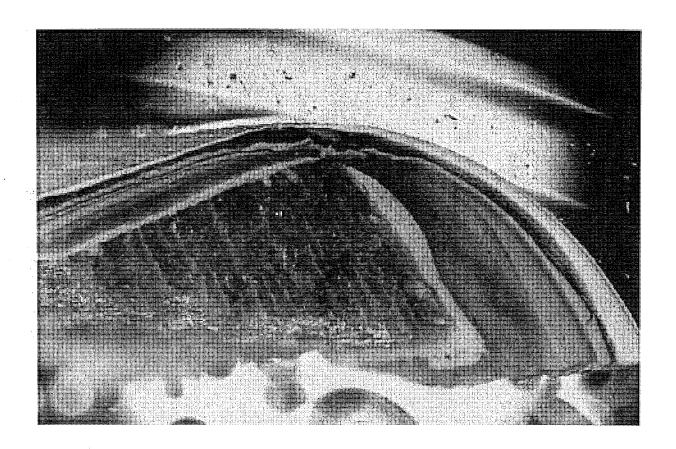
Sample No. 002.1		
Location: door frame E wall		
Magnification:50x	Photo Magnification:112.5x	
Light: Reflected	Light Source: Quartz halogen	
Film: Kodak Royal Gold 100

Layers	Observations	Thickness (µm)
1	opaque white	2
2	thin, red-brown, resinous coating	3
3	uneven pale yellow	5
4	thin uneven, red-brown, resinous similar to 2	1
5	uneven pale yellow, similar to 3	3
6	thin light blue	3
7	even light gray, low pigment, refractive quartz-like aggregate	3
8	thicker darker gray, similar in material to 7,	10
9	white primer	5
substrate	wood

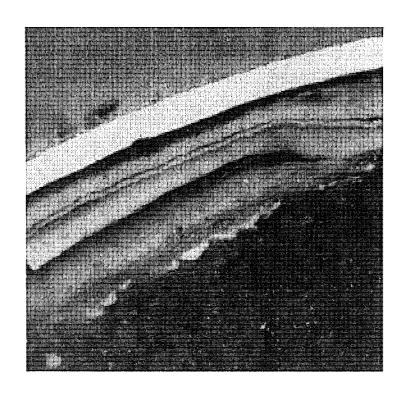
Sample No. 002.2		
Location: window sill S wall		
Magnification:100x	Photo Magnification:225x	
Light: Reflected	Light Source: Quartz halogen	
Film: Kodak Royal Gold 100	3

Layers	Observations	Thickness (µm)
1	thin, gray brown	1
2	thin, opaque white paint	10
3	thicker white primer filling cracks in lower layer	3
4	thin, red-brown, resinous coating	1
5	thick, uneven yellow	2
6	thin, undulating, resinous, red-brown	1
7	thin yellow	2
8	dark gray with refractive quartz-like aggregate	4
9	light blue, similar in material to 8	1
10	light brown, similar in material to 8 but with white aggregate	10
11	dark brown, similar to 4	3
12	thin, white-yellow, possibly second coat of primer	1
13	thin, white-yellow	2
substrate	wood

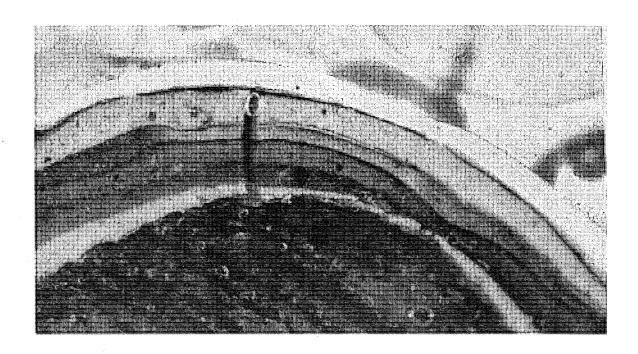
Sample No. 002.3		
Location: window frame, S window		
Magnification:100x Photo Magnification:225x		
Light: Reflected Light Source: Quartz halogen		
Film: Kodak Royal Gold 100

Layers	Observations	Thickness (µm)
1	similar white material with possibly 3 successive coats,1a white,1b gray-	5
	brown, 1c light blue	
2	thin, even, opaque white paint	1
3	thin, red-brown resinous coating	1
4	thin, uneven peach	5
5	similar to 3	
6	thin, undulating mustard	1
7	blue-gray, darker near the top with refractive aggregate	2.5
8	light gray-brown, darker near the top, similar in material to 9	4
9	darker brown, similar to 8	4
10	white primer	2
substratė	wood

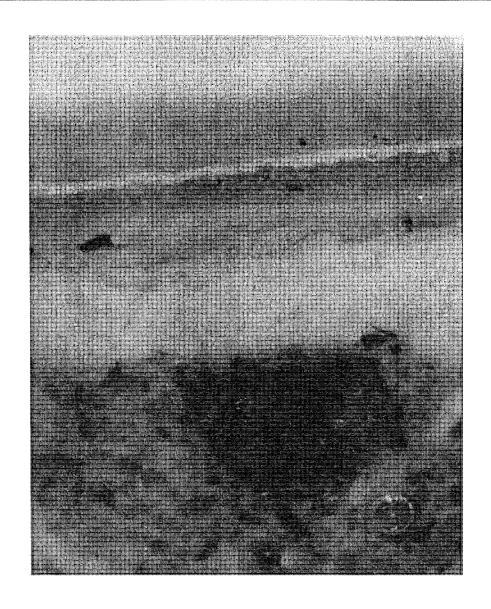
Sample No. 101.1		
Location: collected from floor		
Magnification:50x	Photo Magnification:112.5x	
Light: Reflected	Light Source: Quartz halogen	
Film: Kodak Royal Gold 100

Layers	Observations	Thickness (µm)
1	very pale, chalky, bluish white	5
2	olive green, olive colored particles visible	16
3	opaque white	. 5
4	pale pink	4
-5	pale gray	7
substrate	finish plaster	55
substrate	scratch coat plaster

Room 101: The plaster sample found in this room shows a disturbed paint history, possibly from the water damage which has destroyed the east side of the room. The cross section shows five successive layers of possibly distemper paints all in a whitish color and a final coating in light blue (101.1).

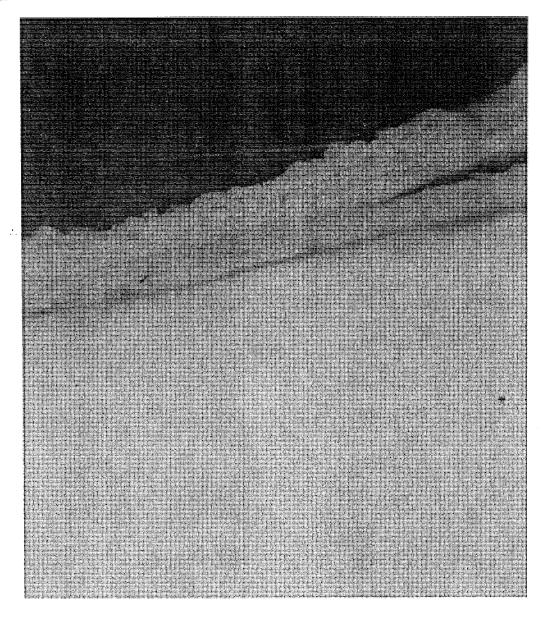
Sample No. 102.2		
Location :window area		
Magnification:100x	Photo Magnification:225x	
Light: Reflected	Light Source: Quartz halogen	
Film: Kodak Royal Gold 100

Layers	Observations	Thickness (µm)
1	thin, spongy white	2
2	spongy pare green	8
3	chalky pink	. 8 .
substrate	white finish plaster

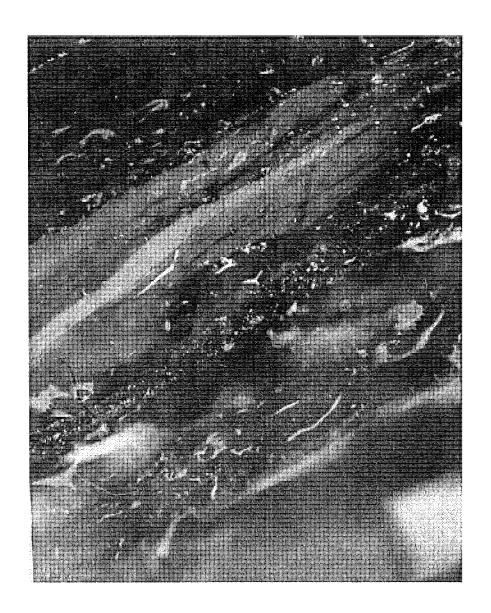
Sample No. 103.1		
Location: chair rail		
Magnification:100x	Photo Magnification:225x	
Light: Reflected	Light Source: Quartz halogen	
Film: Kodak Royal Gold 100

Layers	Observations	Thickness (µm)
1	white	3
2	pale gray	5
3	pale green	5
4	graining	. 5
substrate	wood

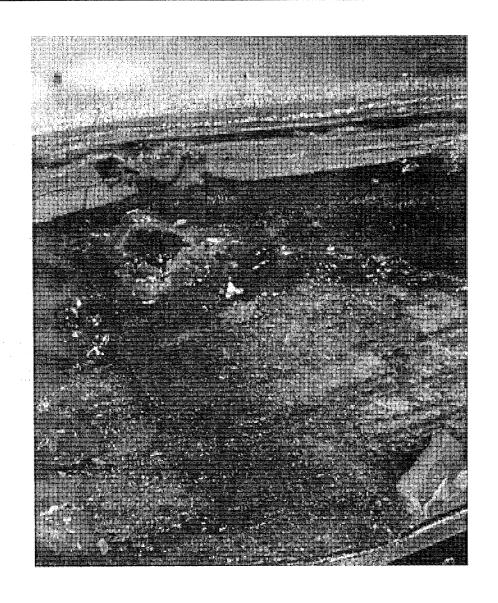
Sample No.103.4		
Location: E partition wall		
Magnification:50x	Photo Magnification:112.5x	
Light: Reflected	Light Source: Quartz halogen	
Film: Kodak Royal Gold 100

Layers	Observations	Thickness (µm)
1	blue chalky	7
2	cracked white	9
3	graining or Layer of oil	10
substrate	wood

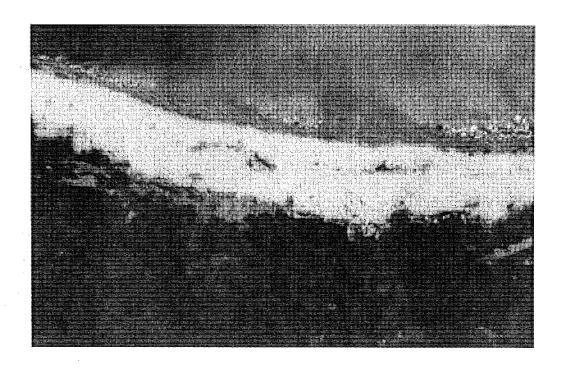
Sample No. 103.5		
Location: SW window sill		
Magnification:50x	Photo Magnification:112.5x	
Light: Reflected	Light Source: Quartz halogen	
Film: Kodak Royal Gold 100

Layers	Observations	Thickness (µm)
1	white	7
2	white	15
substrate	wood

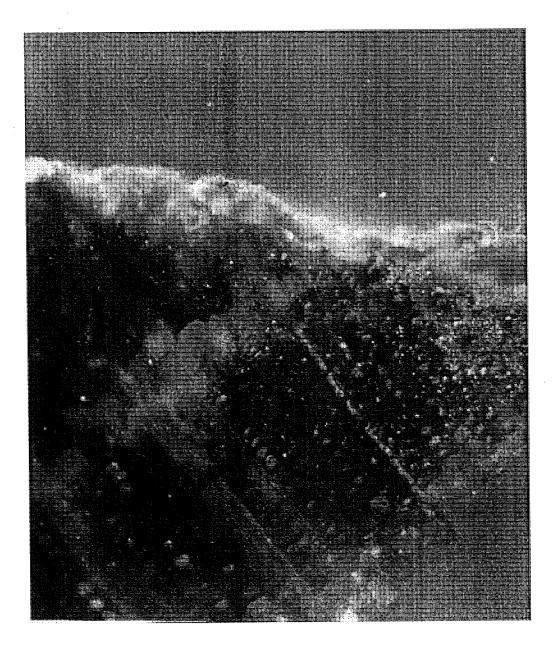
Sample No. 103.8		
Location: interior of cabinet		
Magnification:100x	Photo Magnification:225x	
Light: Reflected	Light Source: Quartz halogen	
Film: Kodak Royal Gold 100

Layers	Observations	Thickness (µm)
1	slightly visible layer	5
substrate	wood

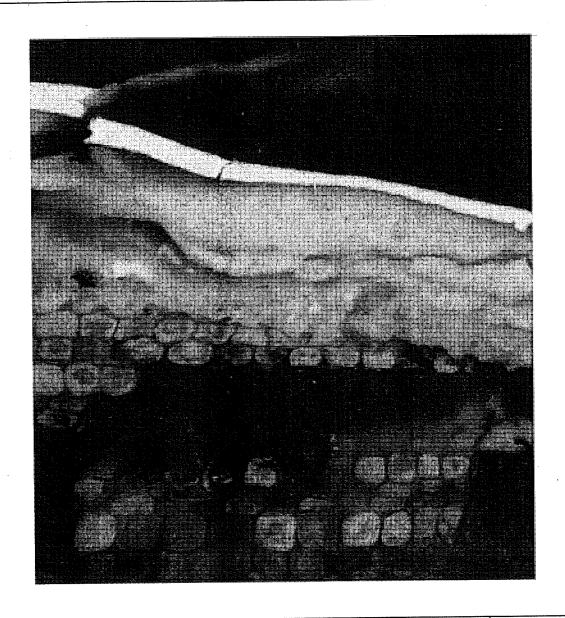
Sample No. 104.2	
Location: wainscoting above first floor stairs	
Magnification:100x	Photo Magnification:225x
Light: Reflected	Light Source: Quartz halogen
Film: Kodak Royal Gold 100

Layers	Observations	Thickness (µm)
1	black (barely visible in photograph)	5
2	opaque white	4
3	chalky pale pink, dark visible particles	14
4	pale golden creme, clear particles	5
5	uneven pale golden creme, clear, white, orange particles	10
substrate	wood

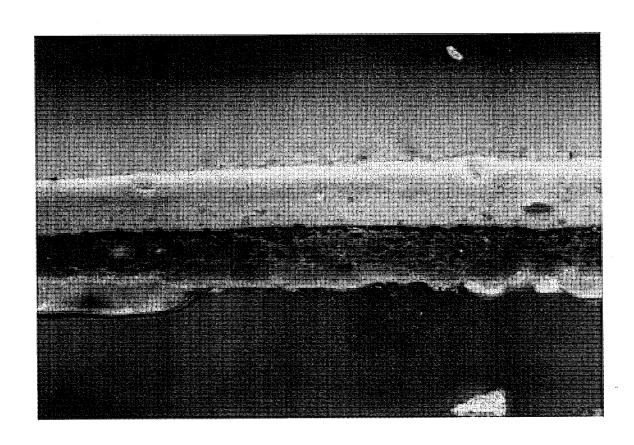
Sample No. 106.1		
Location: N wall interior wa	l of cabinet	
Magnification:100x	Photo Magnification:225x	
Light: Reflected	Light Source: Quartz halogen	
Film: Kodak Royal Gold 100

Layers	Observations	Thickness (µm)
1	white	3
2	white	2
3	beige	6
4	white	2
5	red	1
6	green	8
substrate	missing

The shelf (106.4) and the bottom rail (106.5) of the cabinet on the north wall both show successive layers of white paint. There is an extra black layer as the second layer found in the shelf which is not found in the cross section of the bottom rail. The interior of the cabinet shows a characteristic series of layers of thick green porous layer, followed by a thin bright red layer, and two or three layers of porous off-white finishes. This is seen repeated twice in 106.2 and only once in 106.1.

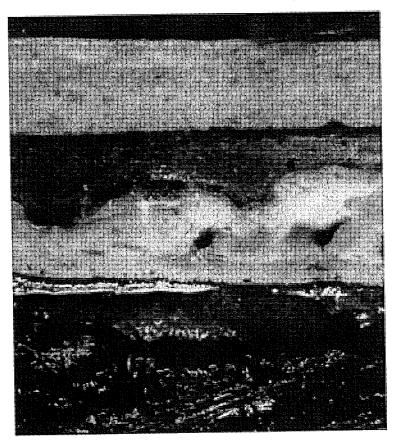
Sample No. 106.2	
Location: cabinet	
Magnification:100x	Photo Magnification:225x
Light: Reflected	Light Source: Quartz halogen
Film: Kodak Royal Gold 100

Layers	Observations	Thickness (µm)
Layers 1	white	3.5
2	off-white	3
2		4
3	white	3
4	off-white	1.5
5	red	5
6	green	
7	white	3
8	off-white	3.5
9	red	1.5
10	green	5.5
11	white	10
12	off-white	3
13	red	1
14	green	7
substrate	wood

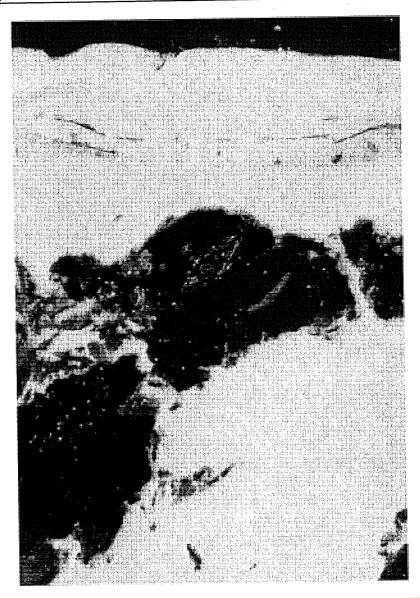
Sample No. 106.10	·
Location: southeast window frame	
Magnification:100x	Photo Magnification:225x
Light: Reflected	Light Source: Quartz halogen
Film: Kodak Royal Gold 100

Layers	Observations	Thickness (µm)
Layers	white	8
2	off-white	3
2	off-white	3
1	off-white	2
5	off-white	1.5
	off-white	8
substrate	wood

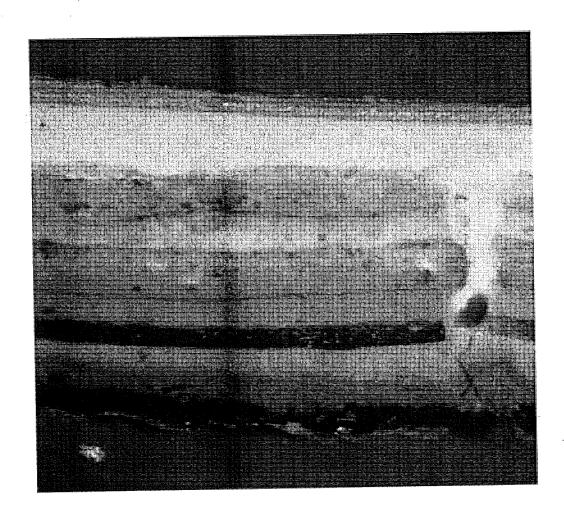
Layers	Observations	Thickness (μm)
	off-white	23.5
1-9		3.5
10	yellow	2.5
11	translucent yellow	2.3
12	off-white	
13	light green	1.5
14	beige	3
substrate	wood

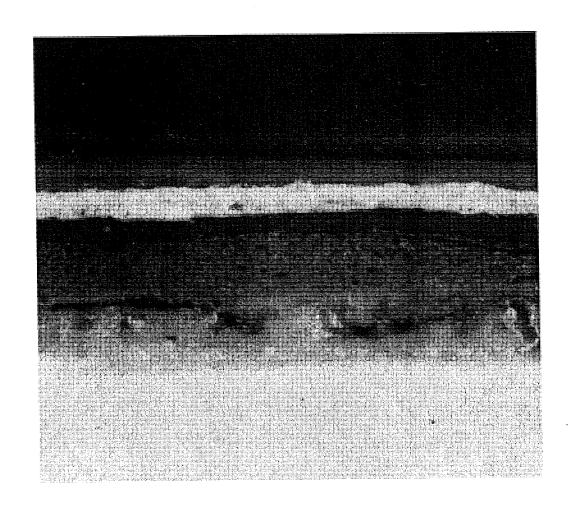
Sample No. 106.13	
Location: S wall below chair rail	
Magnification:100x	Photo Magnification:225x
Light: Reflected	Light Source: Quartz halogen
Film: Kodak Royal Gold 100

Layers	Observations	Thickness (µm)
1	white	4
1 2	red	3
3	green	10
4	14 layers of off-white, difficult to distinguish between the layers	11
substrate	scratch coat plaster	
substrate	rough coat plaster

The south wall plaster samples show the green, red, white layer structure. This is found in samples 106.15 and 106.17-2 from below the chair rail on the south wall. Sample 106.17, also from below the chair rail, shows only a thin red layer followed by the white layers. The plaster sample 106.16, taken from the south wall between the windows, shows a different treatment. Here, the finish coat has a thick mustard colored layer, followed by a thin canary yellow layer, and then finished with a white. The west wall plaster sample taken from above the baseboard (106.18) shows several successive layers of white, followed by the thick green, thin red and white finish combination. The north wall sample (106.9) shows numerous layers of white, possibly limewash finishes, with two interspersed dark layers which are most likely dirt. These are followed by yellow, beige, and white porous layers.

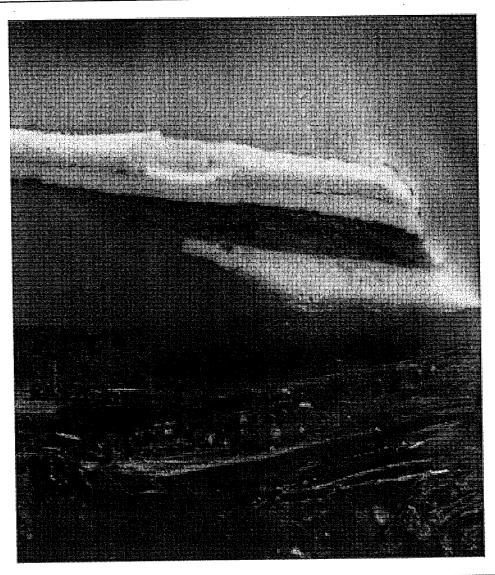
Sample No.106.19			
Location: west door, middle panel			
Magnification:100x	Photo Magnification:225x	-	
Light: Reflected	Light Source: Quartz halogen		
Film: Kodak Royal Gold 100

Layers	Observations	Thickness (µm)
1	white	4
2	off-white	3
3	red	1
4	green	5
5	off-white	3
6	off-white	3
7	of-white	2
substrate

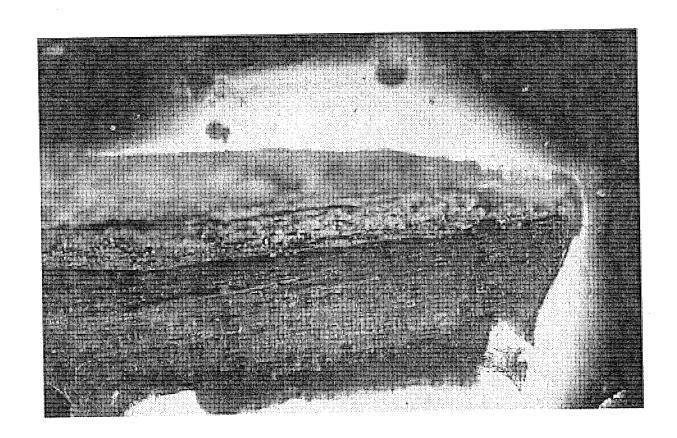
Sample No.201.1	·
Location: NW window sill	
Magnification:50x	Photo Magnification:112.5x
Light: Reflected	Light Source: Quartz halogen
Film: Kodak Royal Gold 100

Layers	Observations	Thickness (µm)
1	thick, white layer with medium sized, brown colored aggregate	30
substrate	wood

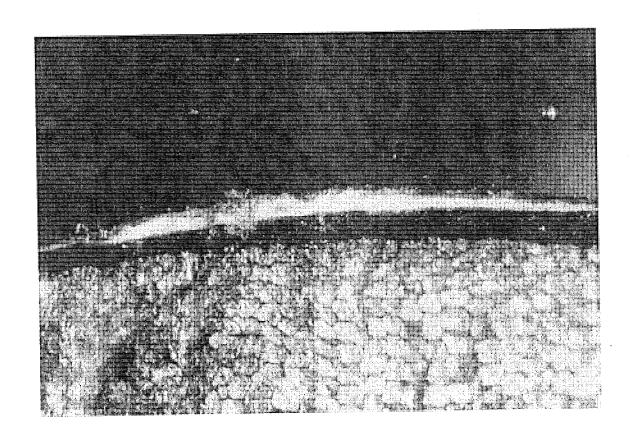
Sample No.203.2	
Location: top of banister	-
Magnification:100x	Photo Magnification:225x
Light: Reflected	Light Source: Quartz halogen
Film: Kodak Royal Gold 100

Layers	Observations	Thickness (µm)
1	wax coating	6
2	black	7
- Laubetrata	1	
substrate	wood

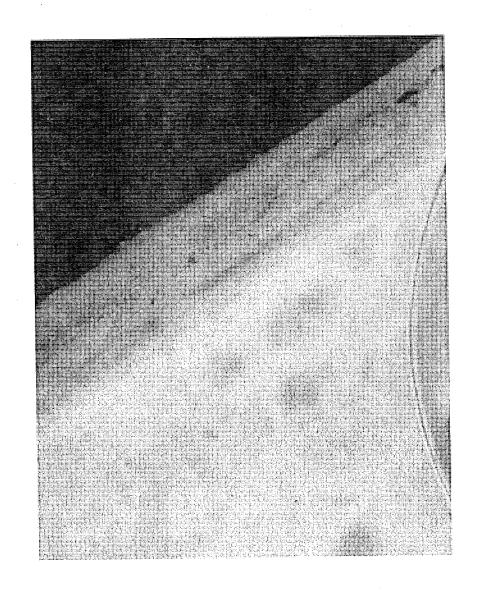
Sample No.206.1	
Location: ceiling plaster from cent	er of room
Magnification:100x	Photo Magnification:225x
Light: Reflected	Light Source: Quartz halogen
Film: Kodak Royal Gold 100

Layers	Observations	Thickness (μm)
1	very pale blue	5
2	pale gray	3
-3	white	5
substrate	finish plaster

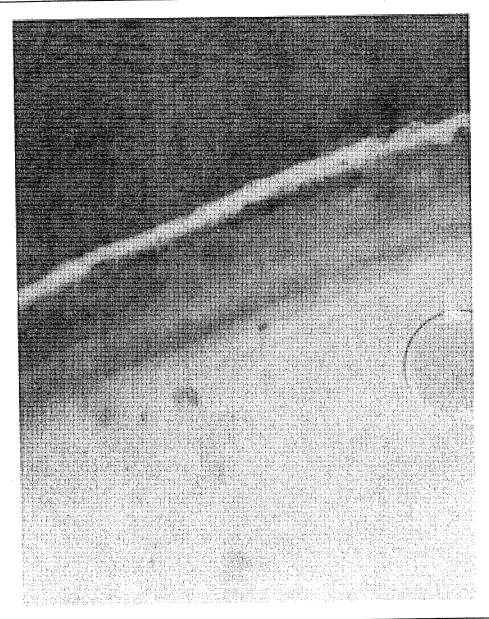
Sample No. 206.2	
Location: ceiling area near partition	1
Magnification:100x	Photo Magnification:225x
Light: Reflected	Light Source: Quartz halogen
Film: Kodak Royal Gold 100

Layers	Observations	Thickness (µm)
1	white	5
2	blue	3
3	blue-gray	9
<u> </u>	white	5
5	gray	4
substrate	finish plaster

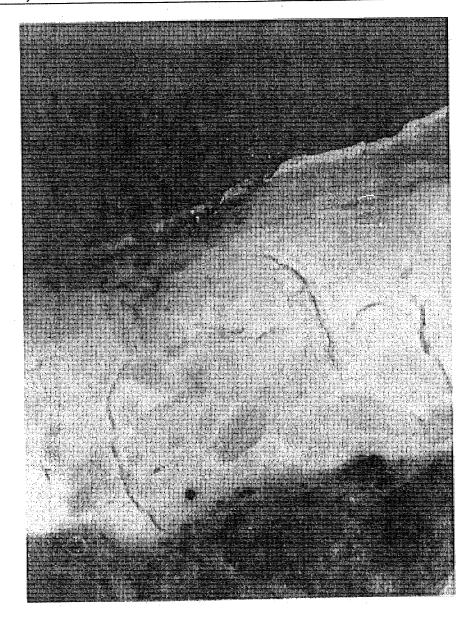
Sample No.207.1	
Location: east wall near stairway	
Magnification:50x	Photo Magnification:112.5x
Light: Reflected	Light Source: Quartz halogen
Film: Kodak Royal Gold 100

Layers	Observations	Thickness (µm)
1	thin white layer with dirt	3
2	vellow	3
3	white finish plaster	150
substrate	scratch coat

Room 207: The plaster samples from this room show successive layers of indeterminate color, and a final yellowish finish (207.1, 207.2). Sample 207.1 shows microcracking throughout the finish coat and discoloration throughout the layers. The cracking and discoloration may have been caused by the fireplace on the other side of the
