# Proposal for the Repair and Restoration of the Robinson Store Mosaic-Clad Concrete Façade

Priyanka Gorasia

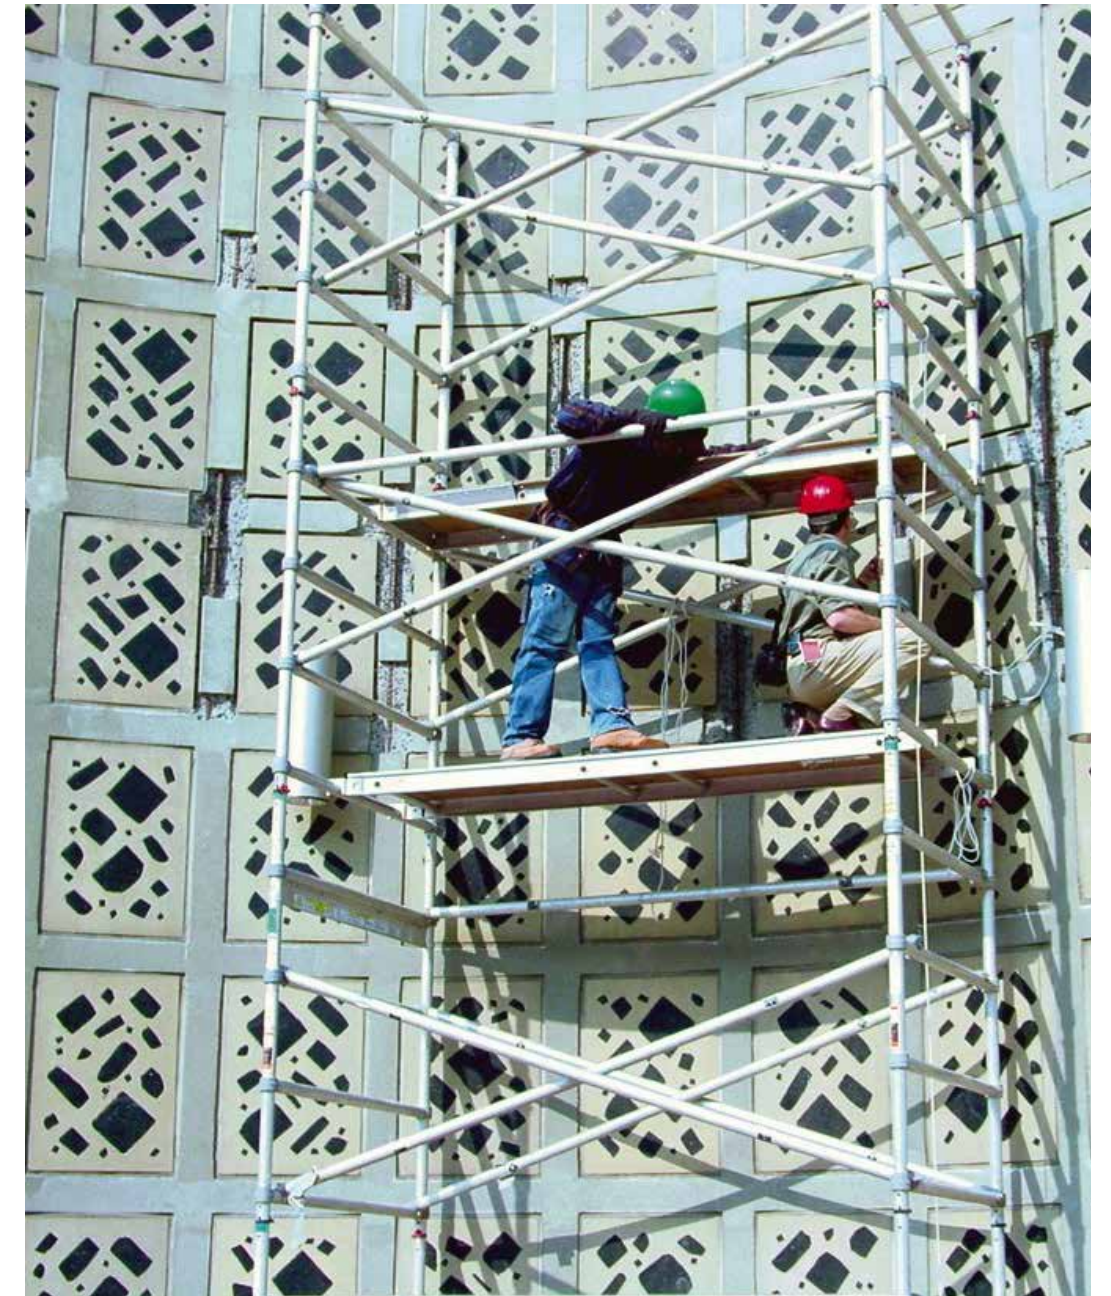
Figure 2. Conservation of dale-de-verre at the New York Hall of Science. (Source: Ennead Architects).

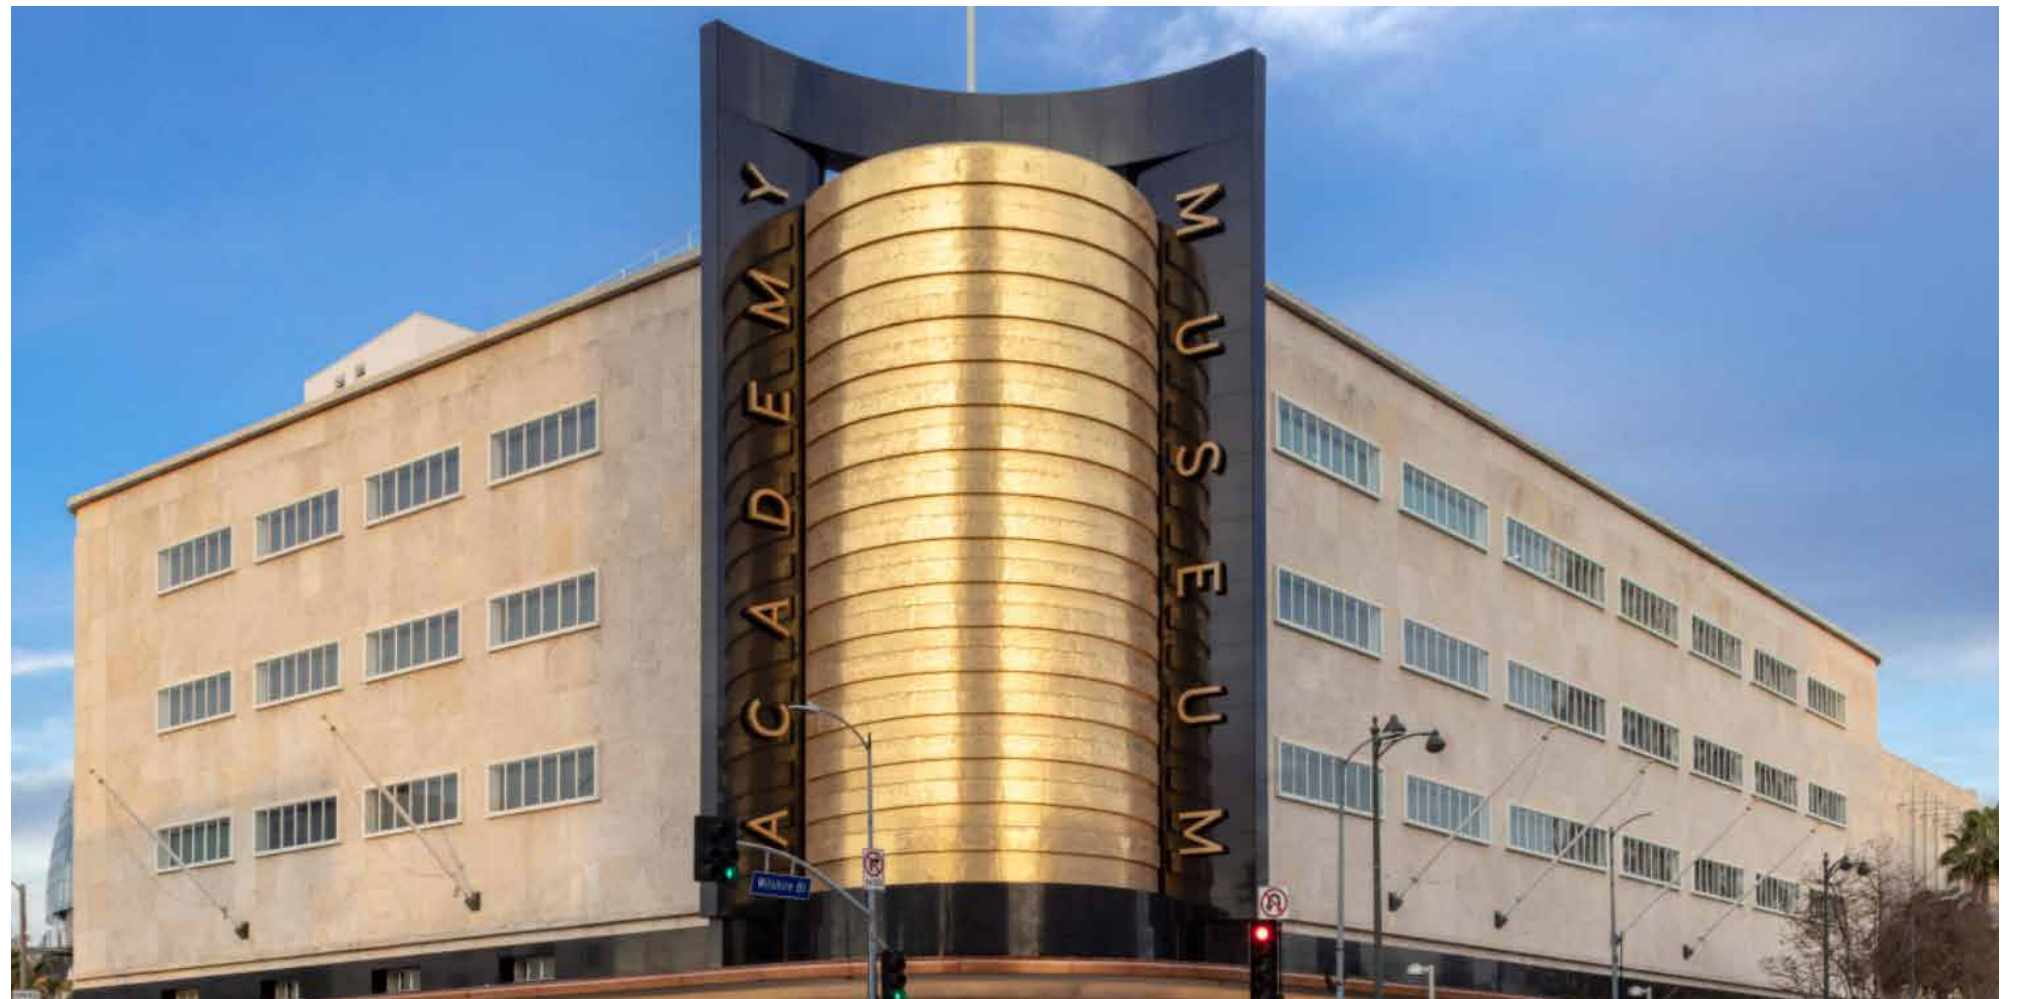
Figure 3. View from Wilshire Boulevard and Fairfax Avenue. Photo by Joshua White/JW Pictures. (Source: Academy Museum Foundation, <https://www.academymuseum.org/en/about/the-building/preservation/mosaic-tiles>).
