## Capstone Studio: Materials + Materialities

Crescent building analysis and Visitor Center design proposals Report  
Talesin West, Scottsdale, AZ

Master of Science in Historic Preservation, University of Pennsylvania

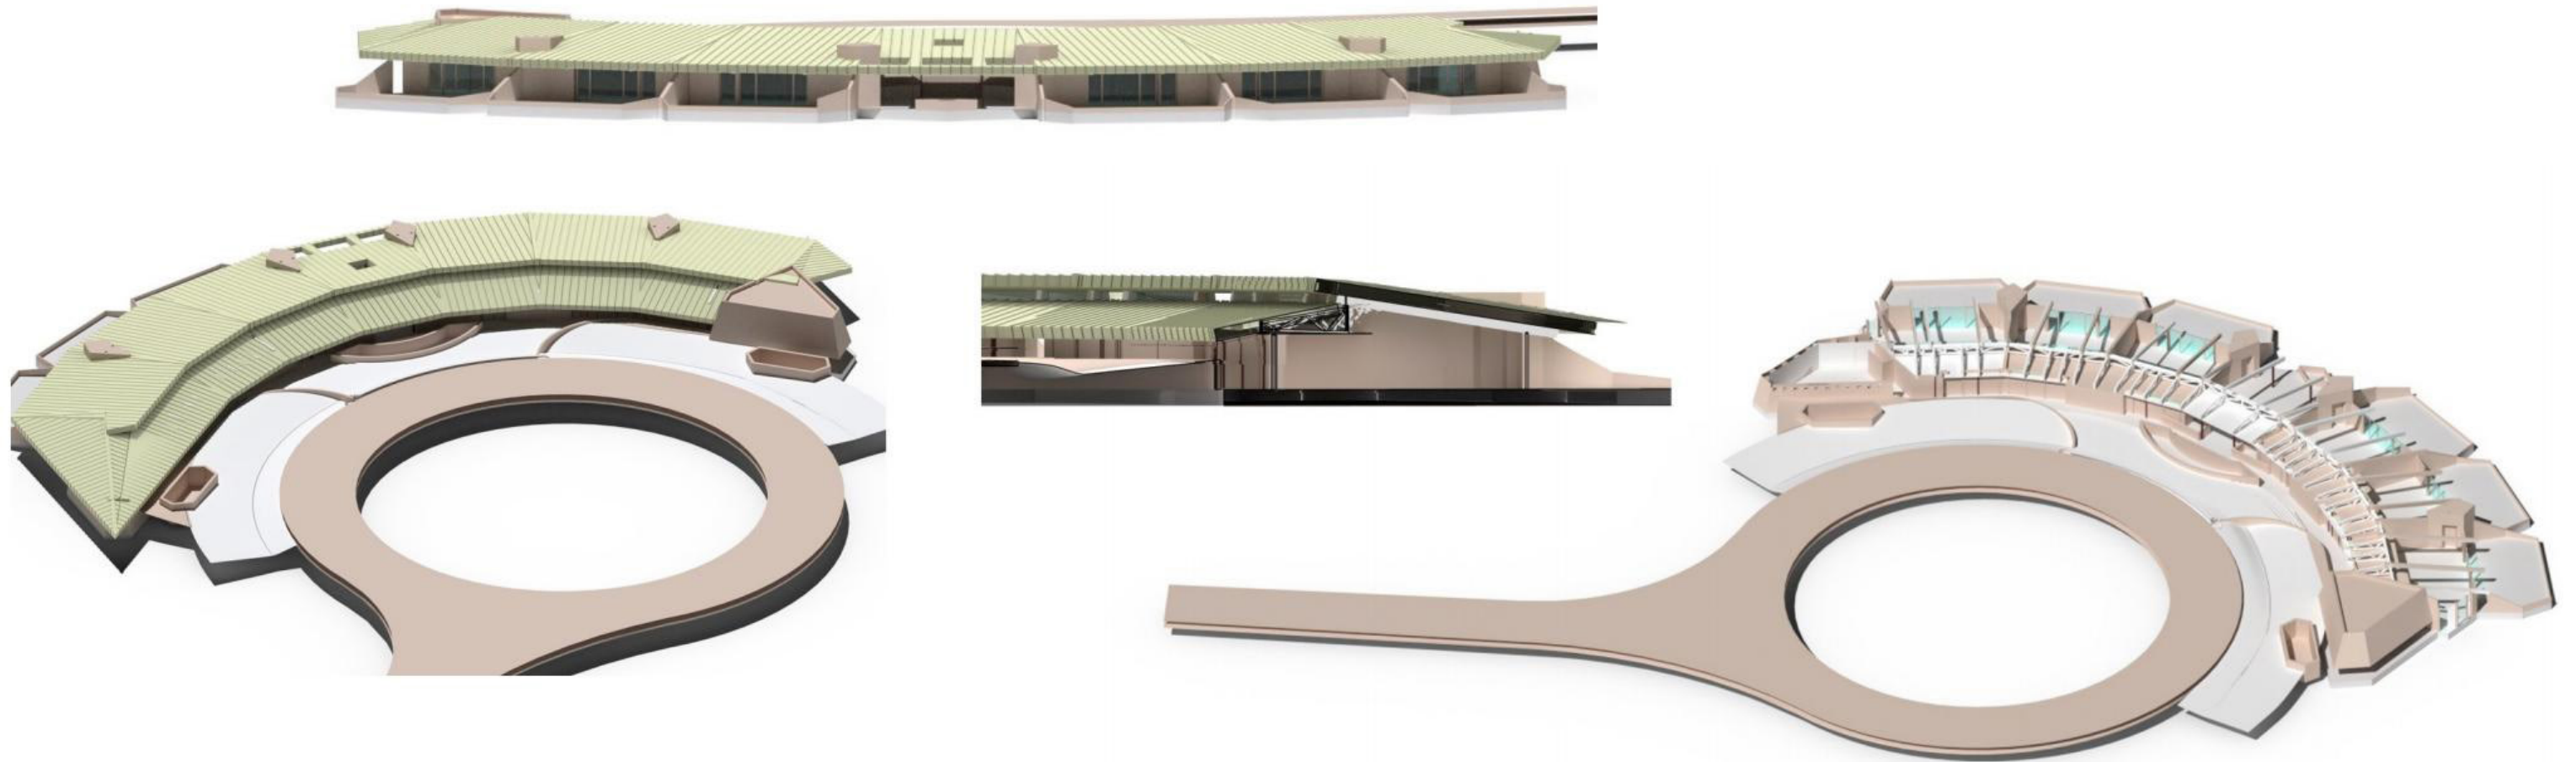
# 3D Model

Reflects as accurately as possible the true material and tectonic conditions of the building.

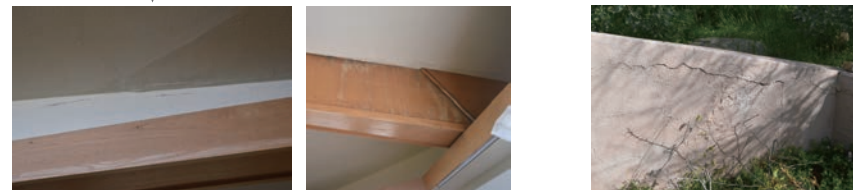
**04** UNIT 1 SECTION (LOOKING WEST)  
 SCALE: NOT TO SCALE  
 DRAWN BY: FLORENCE WANG

Water infiltration is found on the end of the beam and its surroundings near the windows.

Water infiltration is found on the end of the beam and its surroundings near the windows.

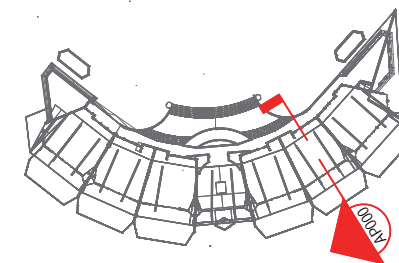
## 06 UNIT 2 SECTION (LOOKING WEST)

The horizontal ablation on the east wall of the room may be man-made.

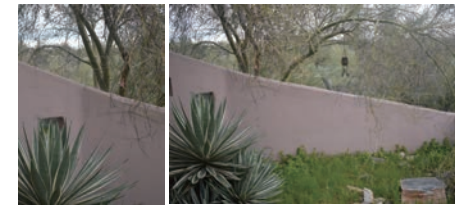
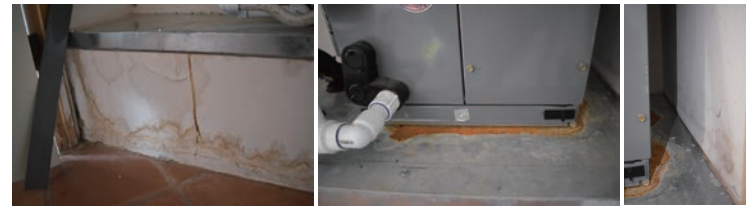
**08** UNIT 4 SECTION (LOOKING WEST)  
 SCALE: NOT TO SCALE  
 DRAWN BY: FLORENCE WANG

Water infiltration occurs at the east-south corner between the ceiling and the walls.

There might be pipe leaking problems around the mechanical room, causing water damage, and causes cracks, staining, flaking, missing materials, corrosion, and mold.

Water infiltration occurs at the east-south corner between the ceiling and the walls.

There might be pipe leaking problems around the mechanical room, causing water damage, and causes cracks, staining, flaking, missing materials, corrosion, and mold.

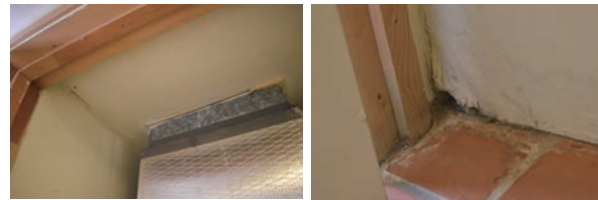
**09** UNIT 5 SECTION (LOOKING EAST)  
 SCALE: NOT TO SCALE  
 DRAWN BY: FLORENCE WANG

Flaking, staining, and water infiltration occur at the southwest corner beneath the ceiling.

Flaking, staining, and water infiltration occur at the southwest corner beneath the ceiling.

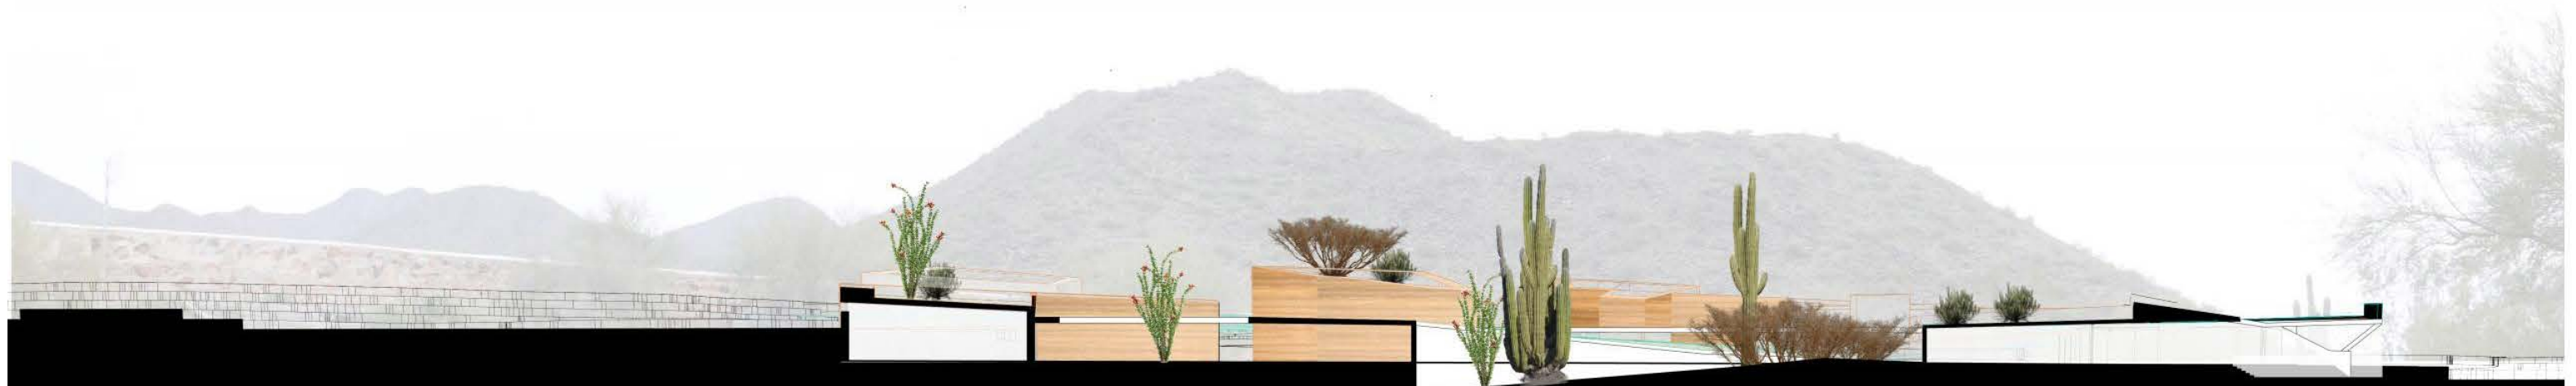
The visitor center will make use of the slope as an opportunity to nest the program into the ground which aids in passive cooling in the extreme heat. The pedestrian path will be at ground level closer to the main campus and become a roof walk towards the south allowing for views of the campus and the city of Scottsdale AZ. Each basin will be fitted with a drainage system to empty runoff water into a rain garden to resolve the movement of water in high amounts during the rainy season and embrace the natural cycles of the desert.

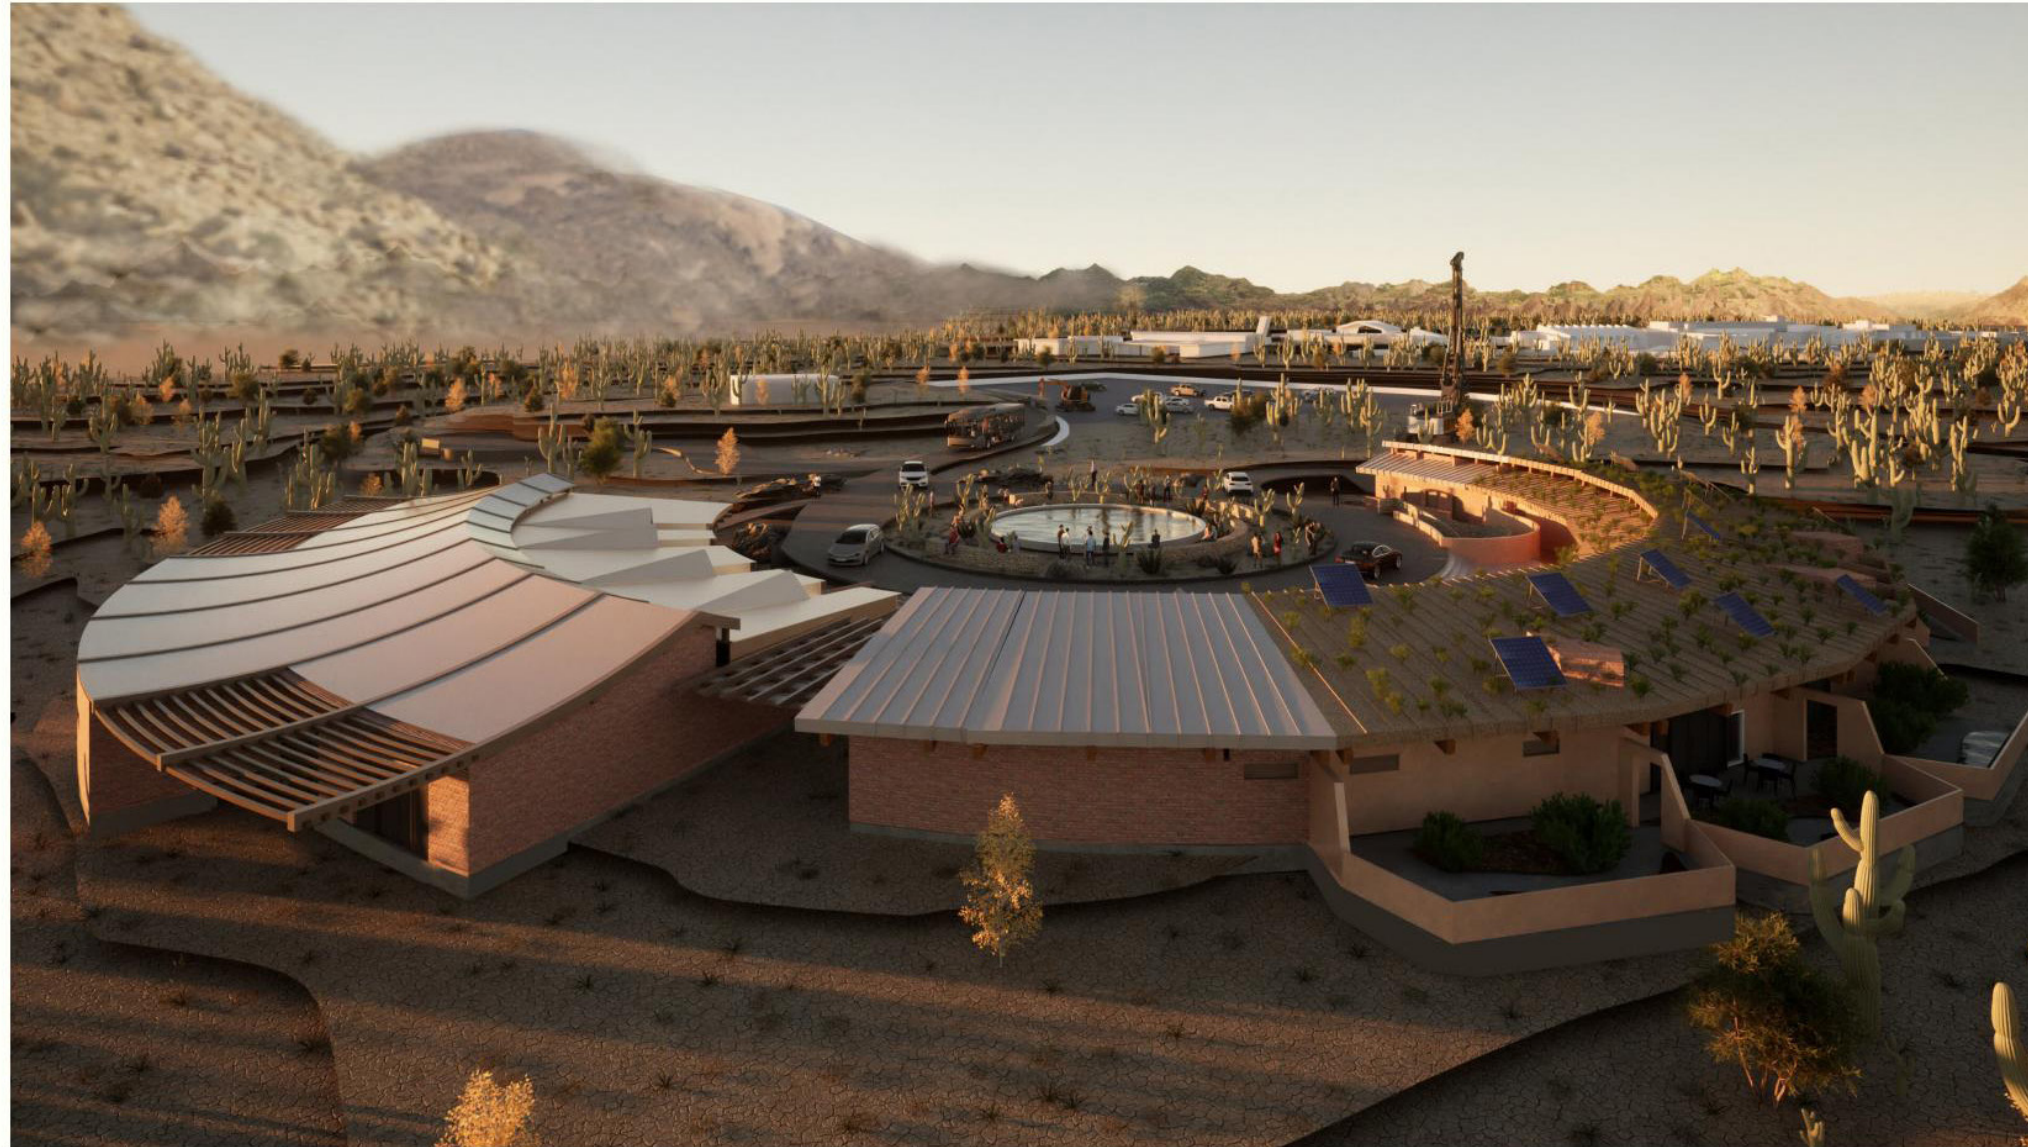
**Top left:** Main view of the two buildings showing harmony in form, scale, proportions. Green roof and solar paneling atop Crescent building.

**Top right:** Aerial view of the two buildings laid in hemicycle layout showing dominance of Crescent building.

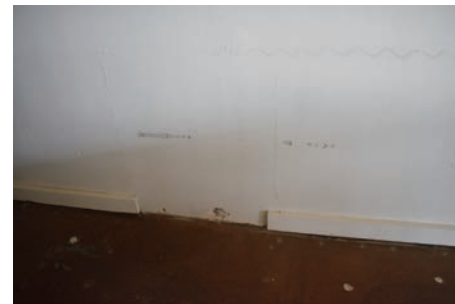
**05** UNIT 2 SECTION (LOOKING EAST)  
 SCALE: NOT TO SCALE  
 DRAWN BY: FLORENCE WANG

The horizontal ablation on the east wall of the room may be man-made.
