Saving the Bar BC Dude Ranch: A New Method for Setting Preservation Priorities

Frank Matero

The George Wright Forum, vol. 33, no. 1, pp. 47–58 (2016).

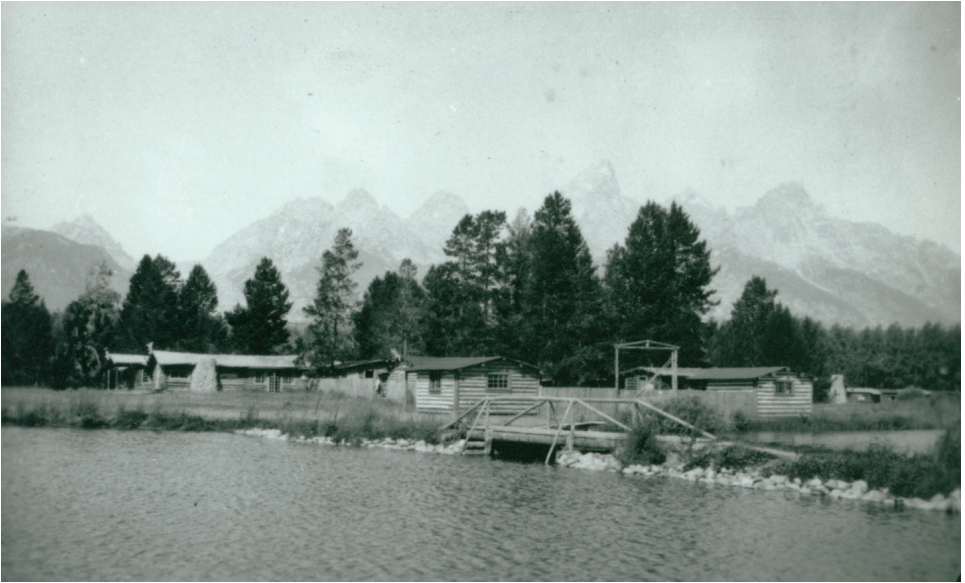
Figure 1. Bar BC Dude Ranch, n.d., before 1945. View toward the Tetons with cabins, landscape and reflecting pool. (Photo by H.R. Crandall, Jackson Hole Historical Society and Museum.)

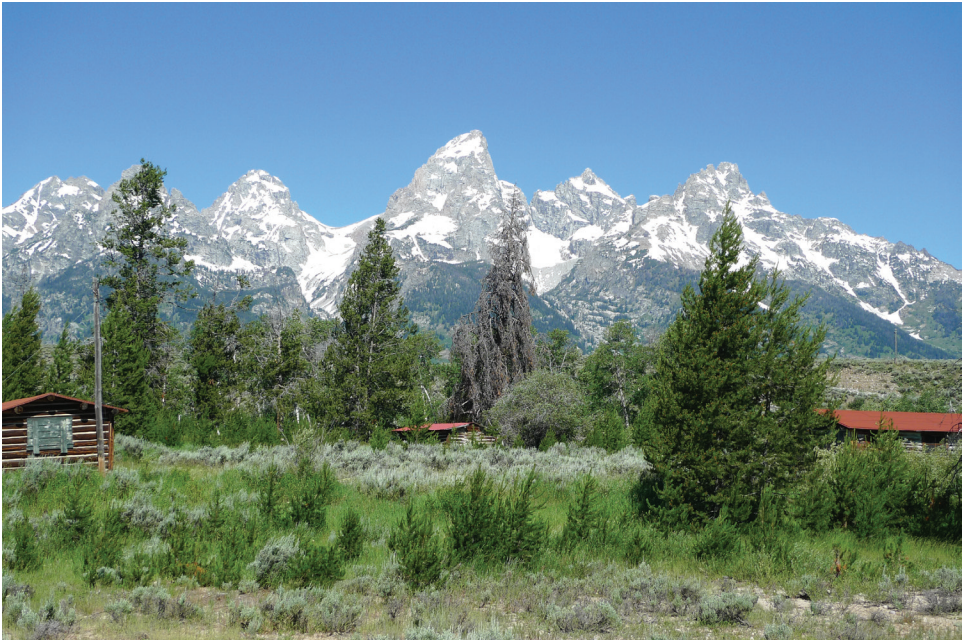
Figure 2. Bar BC Dude Ranch, 2015. Current condition of overgrown landscape and ruined buildings. (Photo courtesy of the Architectural Conservation Laboratory/University of Pennsylvania.)
