HSPV 721 Capstone Studio: Materials + Materialities  
**Desert Masonry at Taliesin West**

Qianhui Ni and Ying Wang  
Adviser: Irene Matteini and Frank Matero  
Spring 2023  
Graduate Program in Historic Preservation  
Stuart Weitzman School of Design, University of Pennsylvania

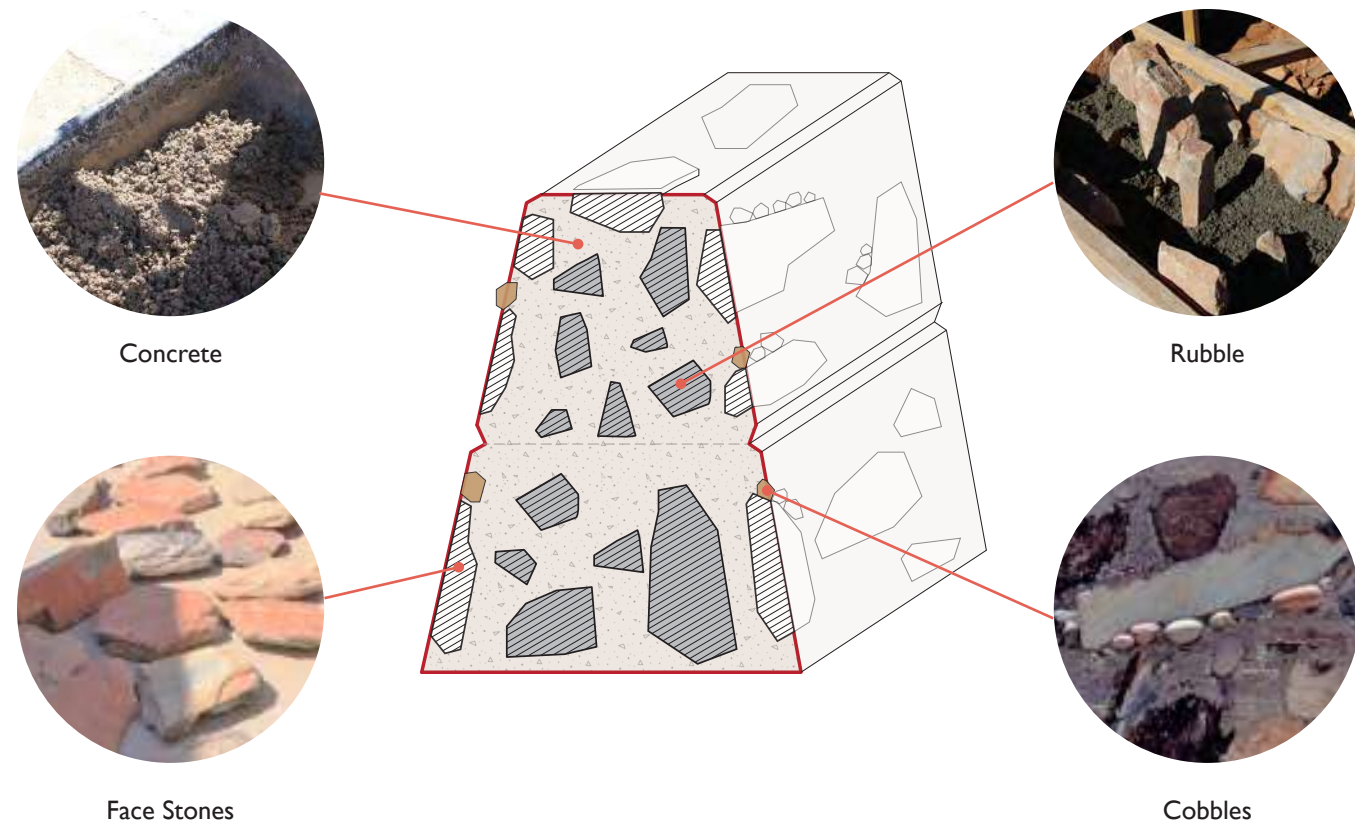
Figure 1.2. Cross-sectional view of a desert masonry wall, showing four different material compositions. (Source: images from franklloydwright.org, "New Desert Masonry Gateway Structure Unveiled at Taliesin West")

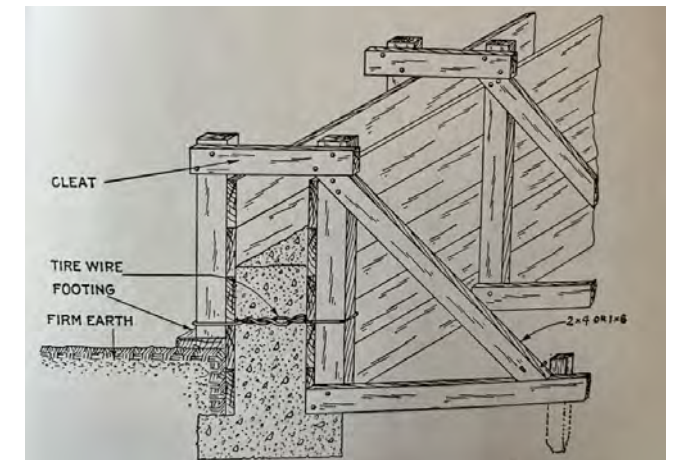
Figure 2.2. Single side foundation form, for foundation built in firm earth. (Source: Concrete Construction, International Textbook Company lcs)

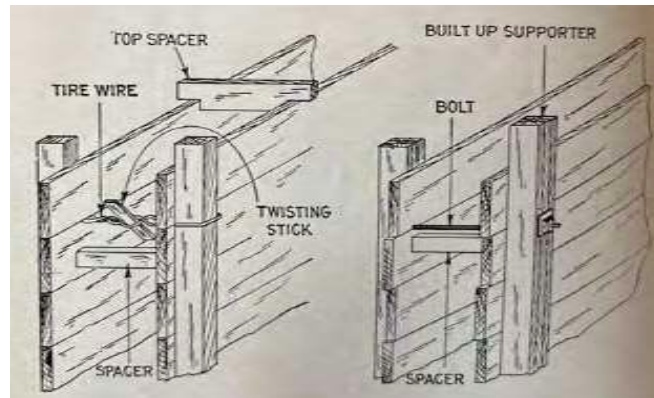
Figure 2.3. Twisted wire and bolt braces as used on concrete forms to insure maintaining the proper distance between the retaining boards. The tie wire braces are tightened by twisting. (Source: Concrete Construction, International Textbook Company Ics)

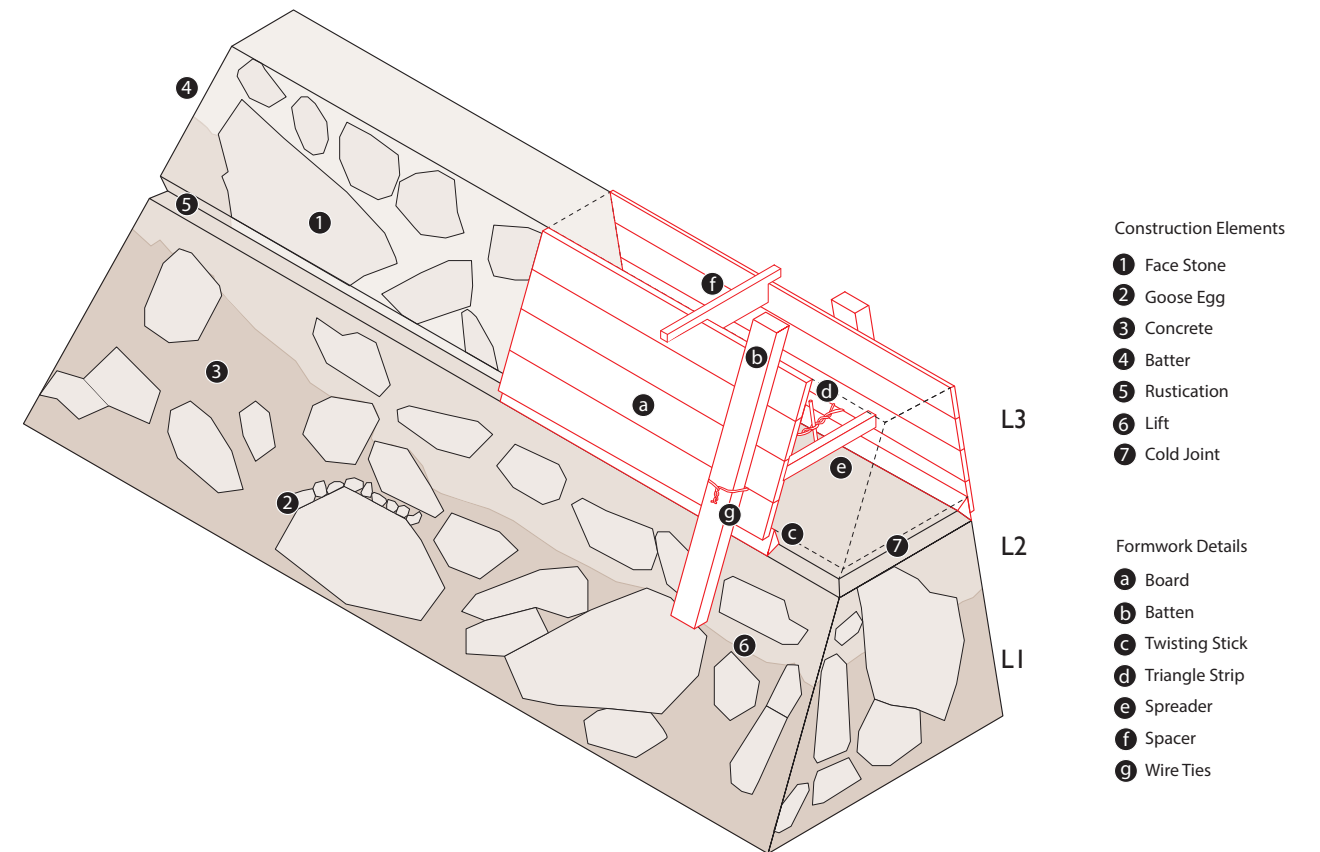
Figure 2.9 identifies the principal construction elements and formwork components of desert masonry. Illustrated is a typical knee wall with rustication. The first group of terms describes the wall's construction elements. Batter means the angle of the masonry, creating a slope. Lift refers to the sequential layers of concrete poured and cured on top of one another. In this diagram, there are three lifts. (L1, L2, L3) Rustication refers to horizontal grooves cast into the masonry. These are triangular in section and used as a method to hide cold joints and sometimes individual lifts. A cold joint is the connection between two separate pours of concrete that have been allowed to harden before

The second group of terms relates to formwork details, including board, batten, twisting stick, triangle strip, spreader, spacer and wire ties. With this type of formwork, spacers are used to ensure maintaining the proper distance between the retaining boards. The tie wire braces are tightened by twisting. All these elements make the form rigid against pressure due to the weight of the raw masonry. Wire ties were used to tie the two sides of the formwork together during the construction, and many of them remain visible on the desert masonry surface today.

Figure 2.9. Construction diagram with formwork details and terminology (Source: created by authors)

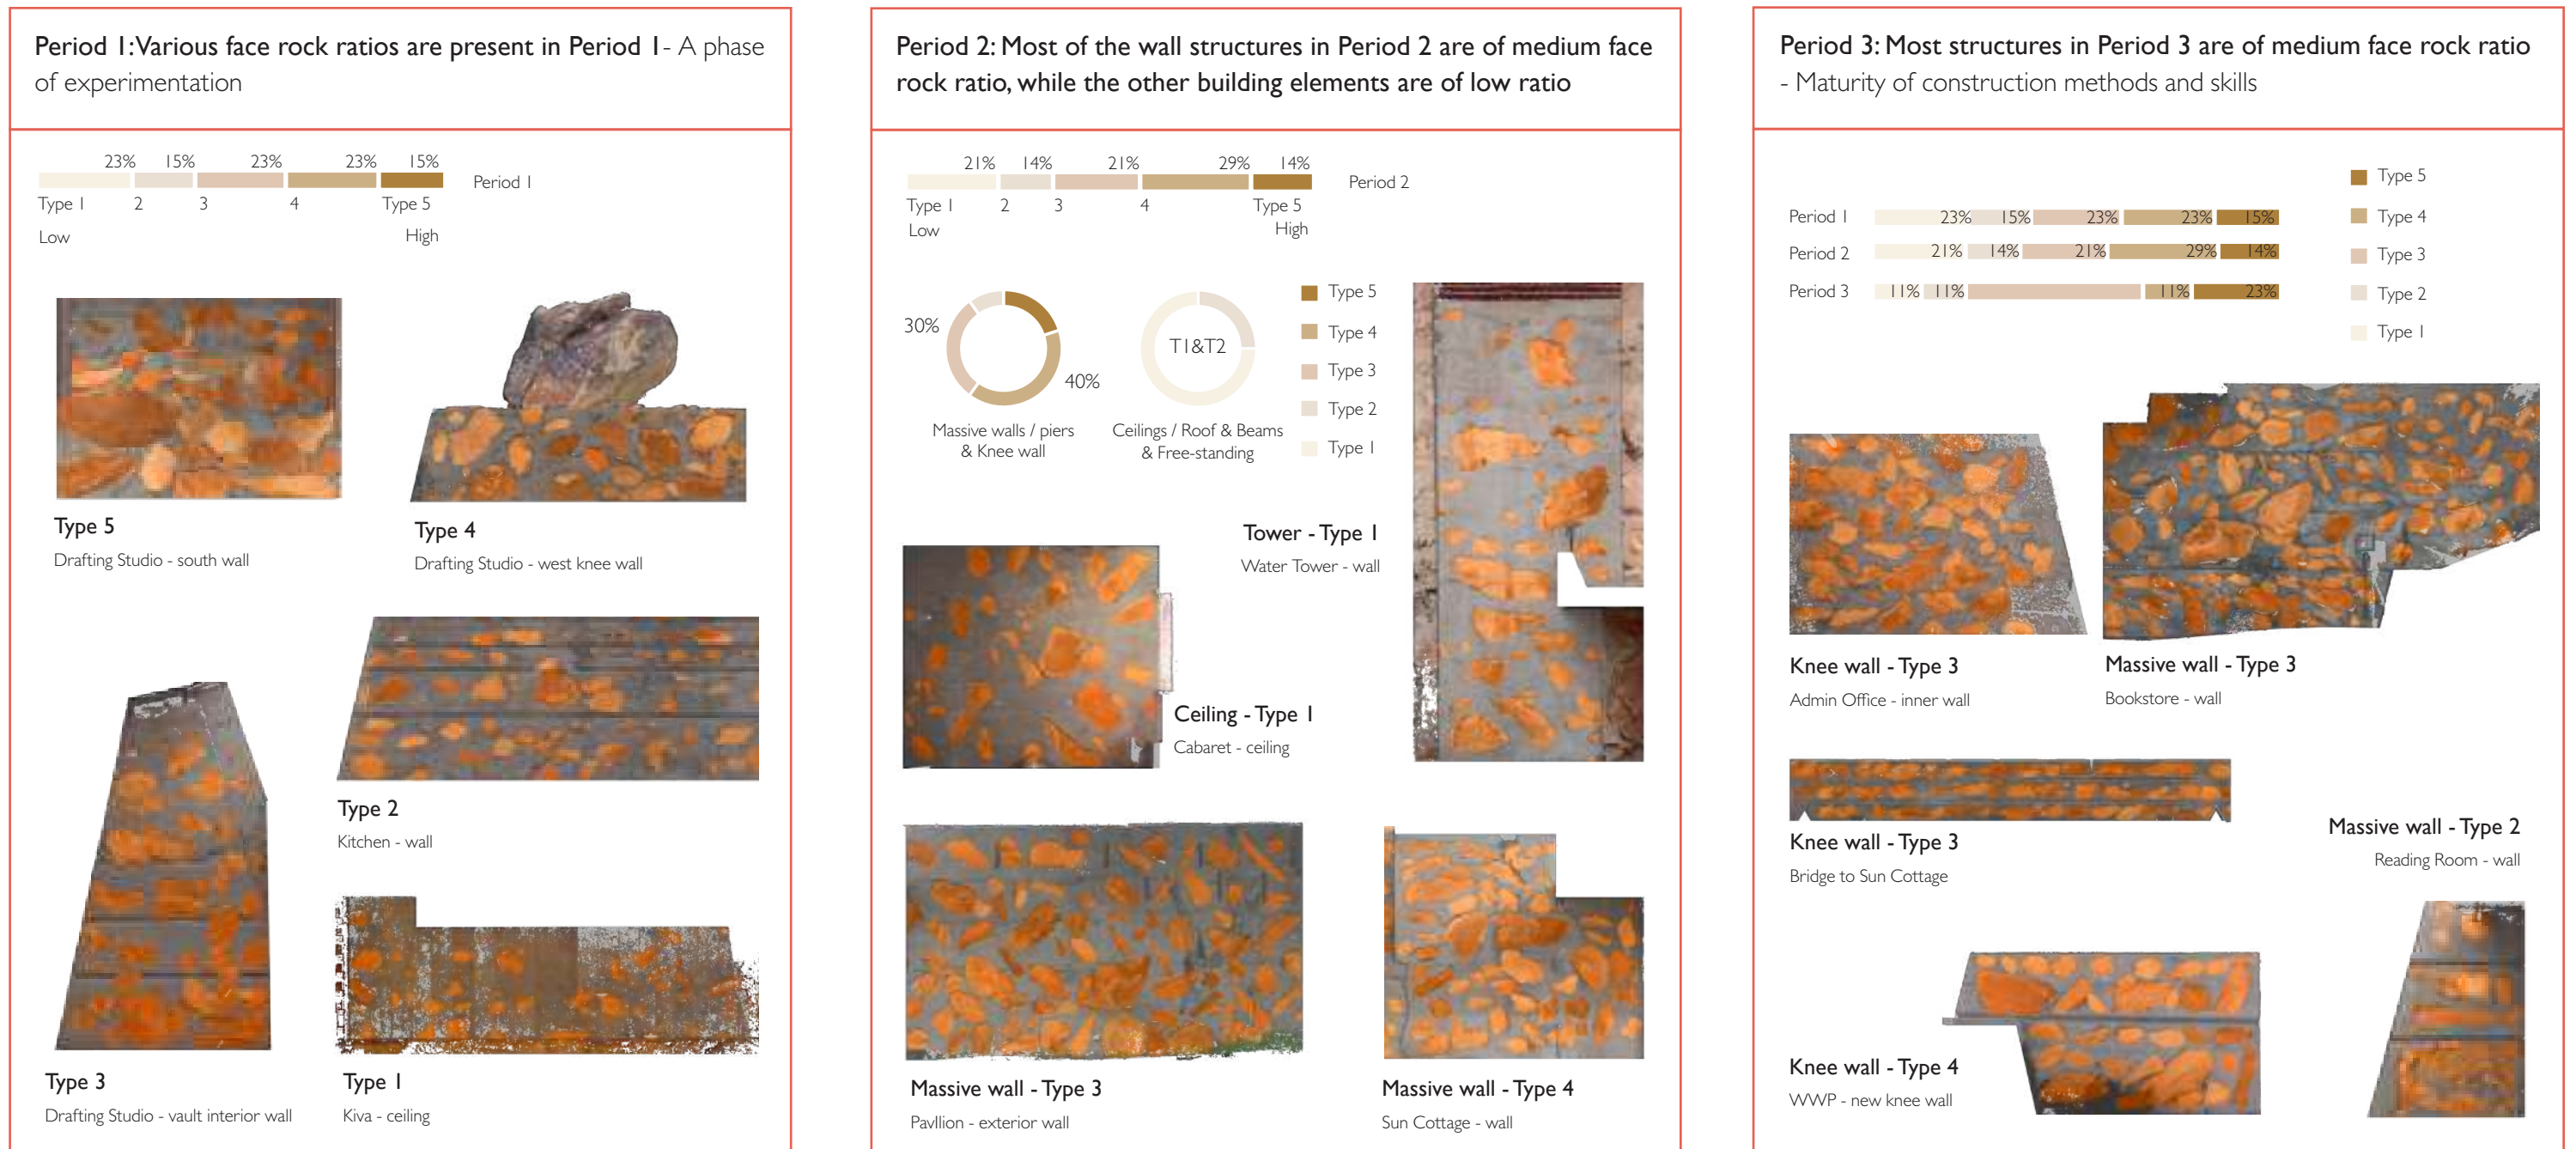
Regarding the surface area ratio of face rock, we found that the ratio varied in Period 1, with an almost equal distribution across different ratios. This pattern continued in Period 2, with wall structures

Figure 3.21. Findings for desert masonry surface area ratio of face rocks in Period 1, 2, and 3. (Source: drawn by authors)

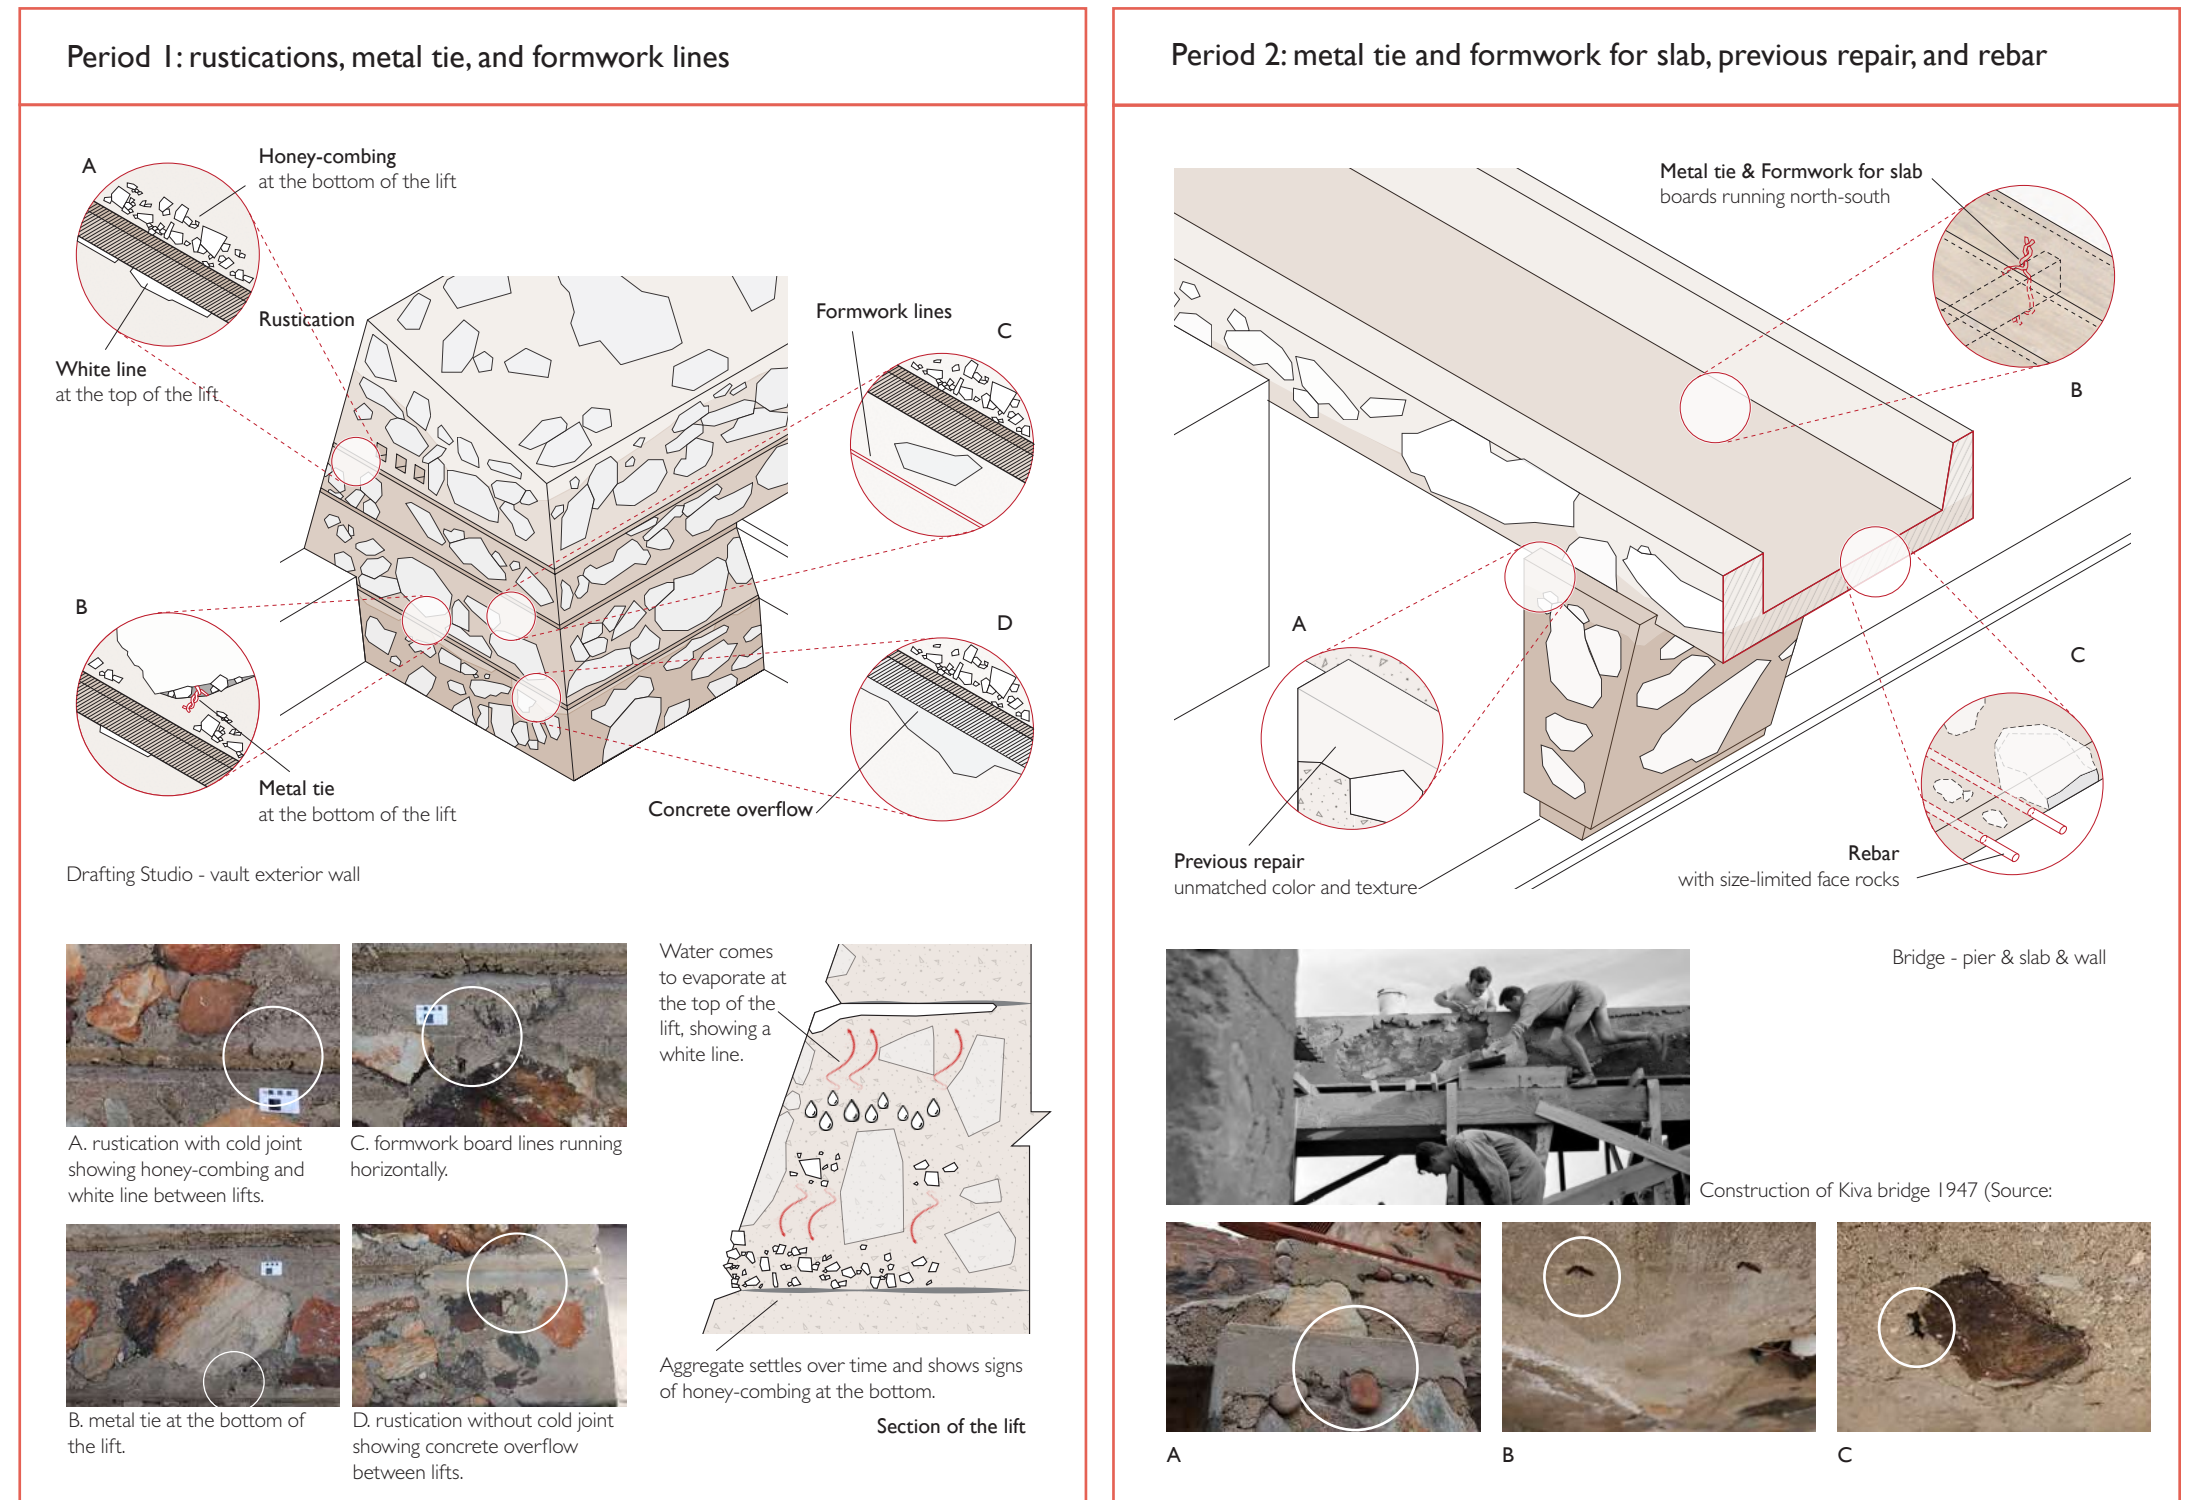
Lastly, we identified some construction details across different periods. During Period I, we found construction remains in the drafting studio vault, including rustications with cold joints (Figure 3.25, Period I-A), metal ties at the bottom of a lift to enhance formwork stability (Period I-B), horizontal formwork lines showing formwork board size (Period I-C), and rustication with concrete overflow (Period I-D). Rustication with cold joints typically exhibits a white line at the top of a lift and honeycombing at the bottom due to aggregate settlement over time, where the water goes up to evaporate and presents a white line, and the aggregate settles and shows signs of honeycombing at the bottom (Figure 3.25, section of the lift). In Period 2, reinforced steel, metal ties, and formwork for slab construction, as well as signs of previous repair, were identified in the Kiva bridge, providing evidence for construction analysis.

Figure 3.25. Findings for desert masonry construction details in period 1 and 2. (Source: drawn by authors)

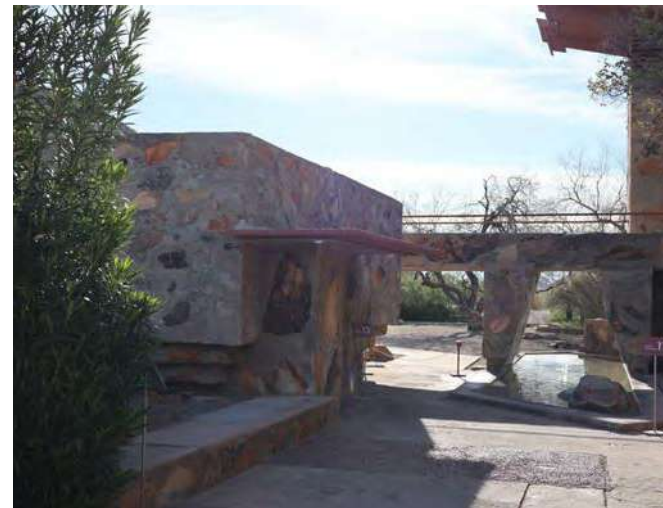
Figure 4.3. Kiva Bridge, 2023 (Source: photographed by the author).

As large reinforced horizontal elements are prone to water infiltration, the masonry roof and bridge are more vulnerable to decay than other areas on site. The primary condition issues are efflorescence, loss, honeycombing, cracks, and previous repair. (Figure 4.6) Efflorescence is clear evidence of water infiltration in desert masonry. It refers to crystalline deposits resulting from the dissolution and evaporation of water from a salt solution, which can then crystallize within and on the surface of a porous material exposed to air. This in turn can lead to loss, honeycombing, and cracking. Sources for salts can be the concrete, stone, or water.

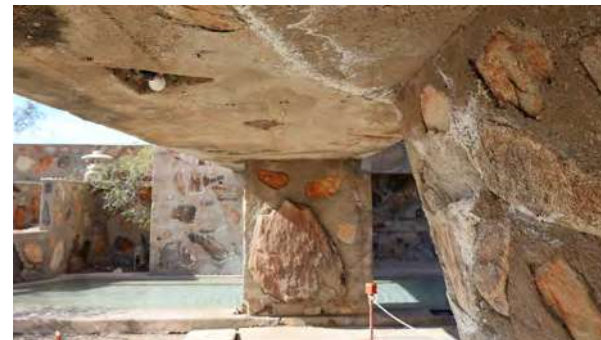
Figure 4.4. Underside of the bridge (Source: photos taken by authors)

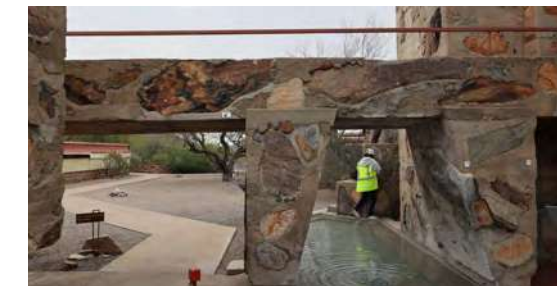
Clearly, water infiltration and related damage have been a chronic problem at the Kiva. Condition mapping of the two bridge elevations shows large areas of previous repair on the lower part of both sides and some areas of loss on the higher part of the elevation. (Figure 4.7-4.10)

Figure 4.7. Bridge west elevation (Source: photos taken by authors)

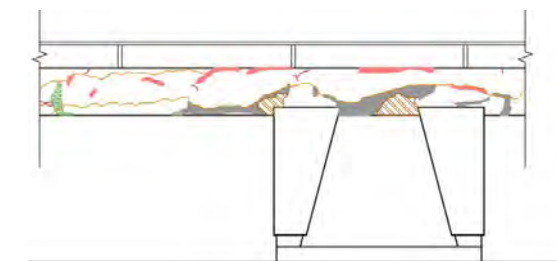
Figure 4.9. Bridge west elevation condition mapping (Source: created by authors)

In general, the desert masonry of Taliesin West is in good to excellent condition with exceptions where rebar was embedded and in association with water infiltration and /or inappropriate repairs. The following treatment program is recommended: (Table 4.1)

- (1) Maintenance and monitoring
- (2) Improve the drainage system & manage mount of moisture sources
- (3) Cleaning and salt removal by poulticing
- (4) Matched mortar repairs
- (5) Grouting for cracks

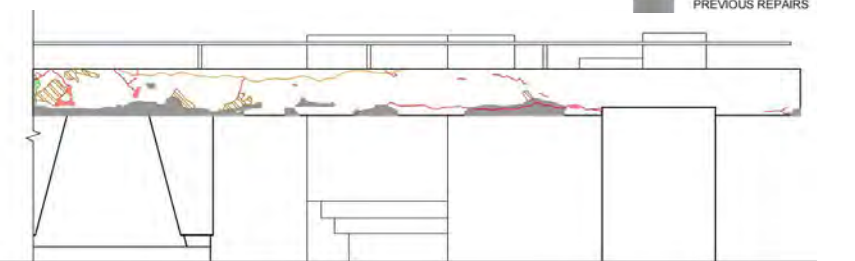
Figure 4.10. Bridge east elevation condition mapping (Source: created by authors)

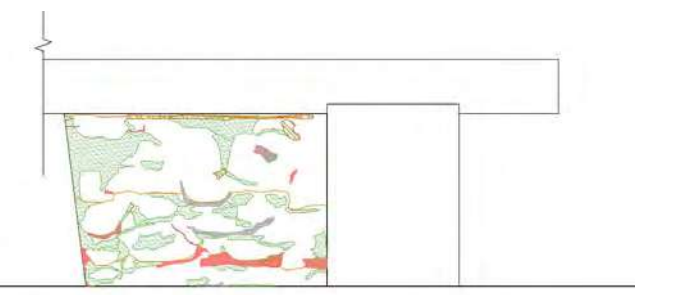
Three walls near the crossing of the Kiva and the bridge are probably in the worst condition among all the desert masonry. The two mappings on the below show a large area of efflorescence and loss. (Figure 4.14-4.16)

Figure 4.16. Kiva east addition west elevation condition mapping (Source: created by authors)

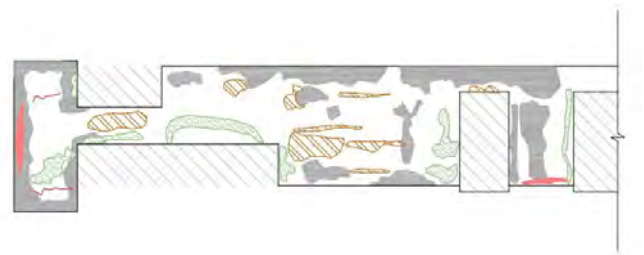
Figure 4.17. Bridge slab underside condition mapping (Source: created by authors)

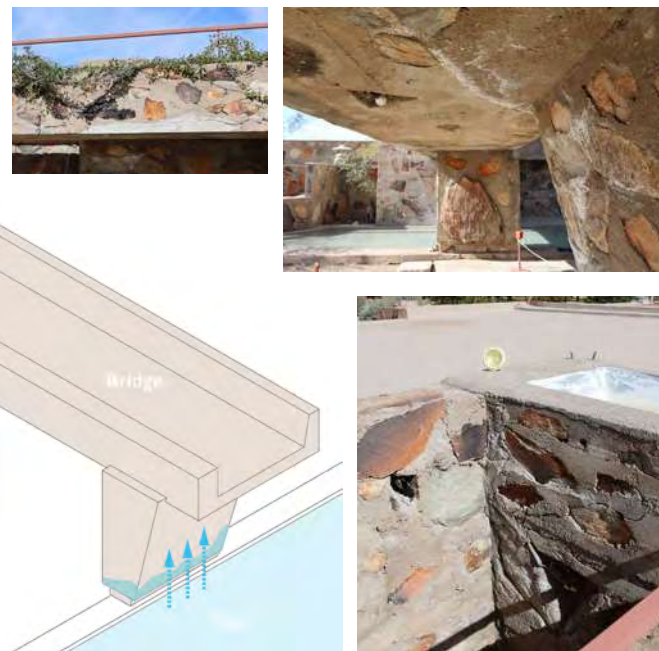
Figure 4.29 shows the sources of water and how water enters the desert masonry of the Kiva walls, roof, and the bridge (Figure 4.29). The fountain and pool under the bridge constantly create high levels of humidity and aerosol which can penetrate the surface of the masonry. The Kiva's roof drainage system is also another source of water infiltration into the ceiling and walls below. Both sources deliver and activate residual salts in the masonry leading to efflorescence, rebar corrosion, and stone and concrete damage.

Figure 4.29. Diagram of water infiltration in the Kiva-Bridge area (Source: created by authors)

There are two main sources of moisture in the Kiva-Bridge area. One is from the Kiva roof and

the other is from the pool. It is recommended that drainage from the Kiva roof be redirected away from the bridge by downspouts or scuppers and moved away from the base of the building. Back-splash and aerosol from the pool will be more difficult to control however a water repellent applied to the adjacent pier and wall may prove effective. A green roof could also offer an alternative to water collection and removal and provide a positive new design element to the Kiva roof as a garden. (Figure 4.32-4.33)

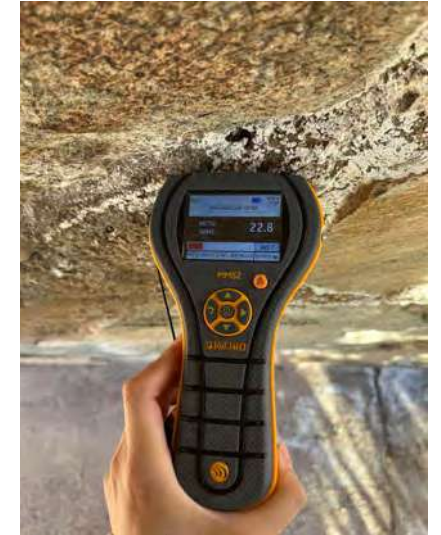
Figure 4.32. Moisture meter

Additional moisture monitoring is necessary to map specific locations of wall moisture and its movement over time. Infrared thermography could prove useful as a nondestructive and versatile method of moisture mapping. We recommend performing corrosion testing to understand the level of corrosion that is occurring at the embedded steel reinforcement. Petrographic analysis of the concrete could identify the source of salts as well as provide base information on concrete performance. For crack monitoring, we recommend using simple crack gauges to monitor crack movement.

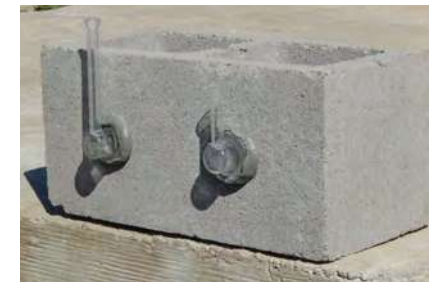
Figure 4.33. RILEM tubes
