POWDERHAM PRAXIS, 2017-2018

University of Pennsylvania Graduate Program in Historic Preservation
Cornerstone Praxis, University of Plymouth
Powderham Castle

1: INTRODUCTION

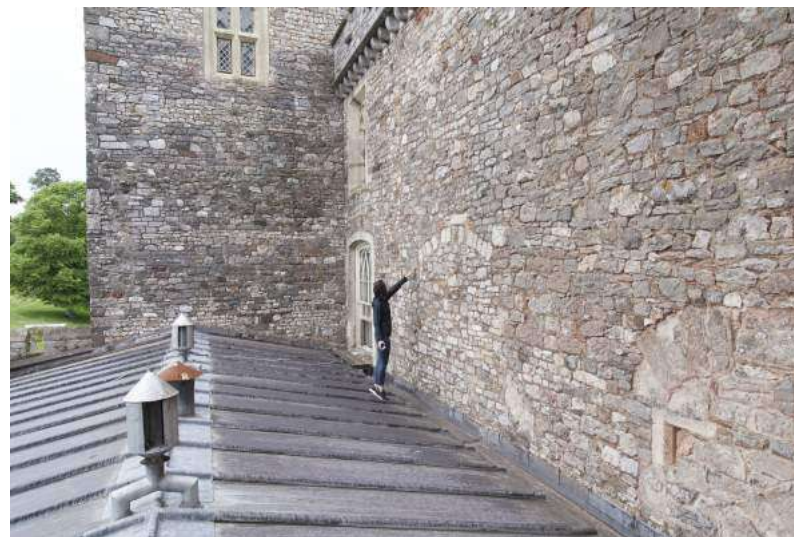
Liz Trumbull studies remnants of past window campaigns embedded in the exterior masonry above the State Dining Room. (Starr Herr-Cardillo, 2018)

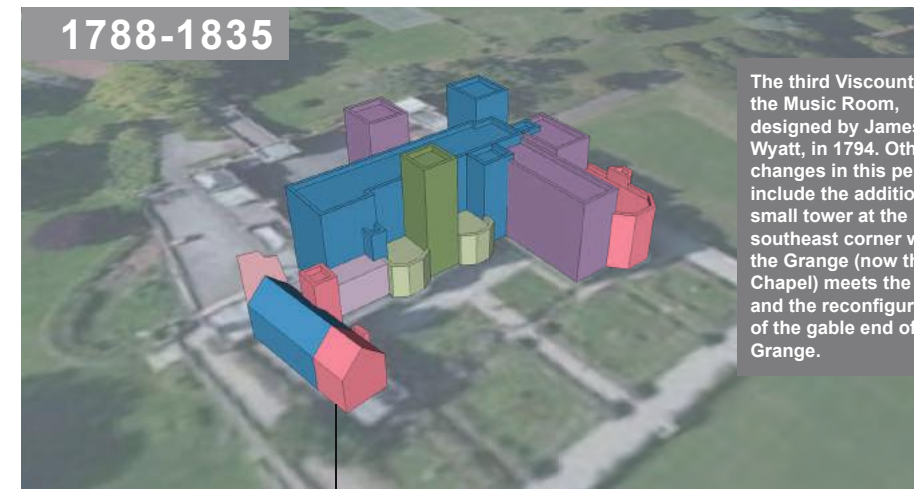
1788-1835

The third Viscount added the Music Room, designed by James Wyatt, in 1794. Other changes in this period include the addition of a small tower at the southeast corner where the Grange (now the Chapel) meets the castle, and the reconfiguration of the gable end of the Grange.

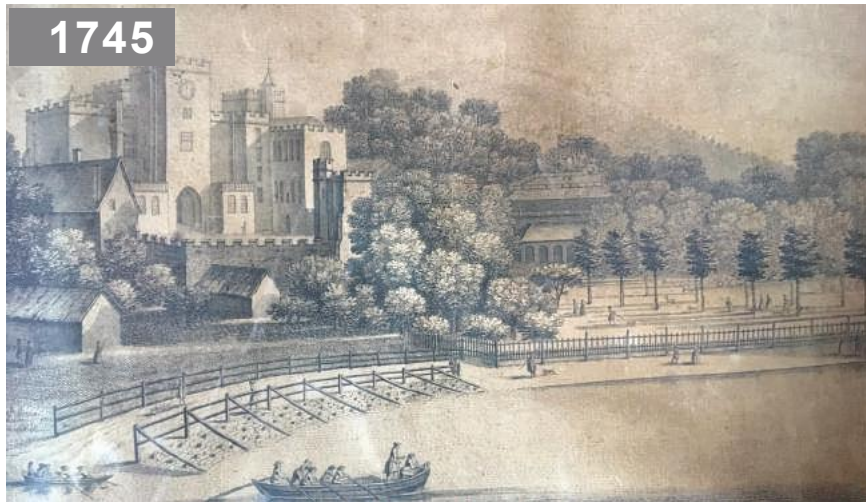
The Bucks' other known engraving, made eleven years later, shows the southeast face of the castle on the Exe. No major changes are apparent, but the configuration of windows on the East tower seems to have changed, showing what appears to be a round clock nearest the top of the tower, with two rectangular windows below. The arched entry at the base of the tower appears to be open. The walled yard is still in place and an outbuilding is shown in the park, to the northeast of the house. There are new paths throughout the park, as well as an octagonal structure and small boathouse near the river. (Powderham Estate Archives)

In the 1745 Buck engraving, a clock was shown on the tower. In 1766, castle account books recorded payment to a James Dalton for “taking down the East Tower and rebuilding it from brick.” (Chapple, Cash Book: Books of Accounts relative to the New Building at Powderham Castle, January 1766.) An anonymous, undated architectural drawing that appears to date from the 18th century (Fig 3, KK Fig. 8) shows the tower with a grand clock and cupola above. Larger, more refined windows are depicted at the first and second floors, and large, pointed “gothick” windows at the entrance and flanking bays, with crenellations above the bays and below the cupola. This work may have taken some time to complete; a 1774 view shows the East Tower with no flanking bays, though this may not be accurate. Nineteenth century historian Lieutenant Colonel Harding dated the bay-windowed rooms to the 1780s (Harding, pp. 181) and Swete’s 1798 depiction of the castle again shows them in place. By that time, the gatehouse and wall around the east front had been removed, and the meadows were drained to create the parkland between the castle and the estuary (Emery, pp. 619.)

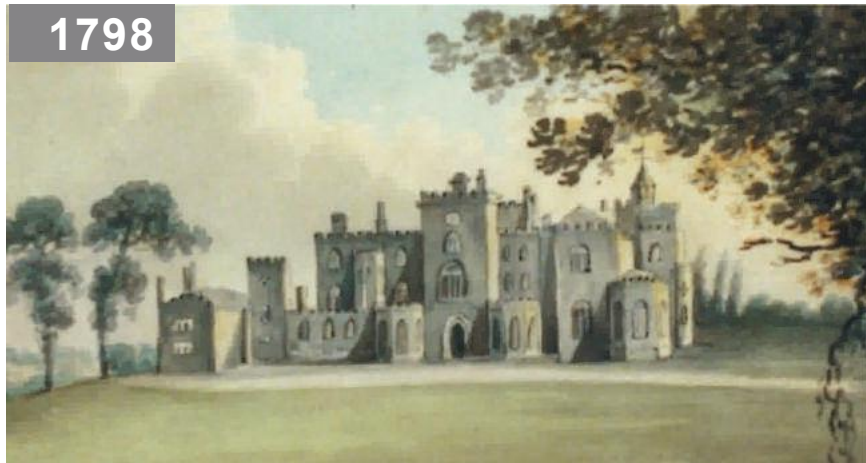
This image is one in a series of paintings made by Reverend John Swete between 1798 and 1799, and shows modifications to the east facade that have been made since the Buck views. The east yard is no longer walled, and a path approaches the east side of the house from the north. Many of the windows appear to have been changed into an arched, Gothic style and a small tower has been added between the castle and the Grange (which is the location of the current Chapel). The gabled end of the Grange has been reconfigured with a stepped parapet. The Music Room has been added to the northeast corner and a slim, attached tower sporting quatrefoils above arched windows projects slightly from the north side of the music room. (Powderham Estate Archives)

The bays flanking the east tower appear to have been altered by 1798 in a depiction of the east facade by Reverend John Swete. They were likely reconfigured at the same time or shortly after the east tower was rebuilt.

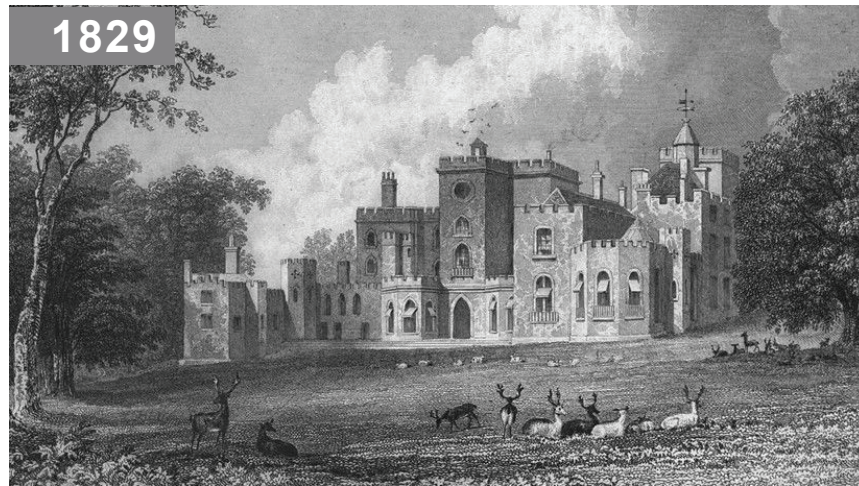
This engraving by W. H. Bartlett shows a stepped terrace spanning the east. Awnings have been added to many of the larger arched windows, small railings or balconettes have also been added to some of the full-length windows. (Powderham Estate Archives)

Nineteenth century views show few major changes. Between 1798 and the 1829 engraving by W. H. Bartlett and an unsigned sketch dated 1830, awnings were installed to shade the large ground floor windows as well as iron railings in front of the windows, vestiges of which can still be seen today. A major focus of Fowler’s work in the 1830s and 40s was creation of a new entrance courtyard on the west side of the castle—perhaps in response to the construction of the railroad along the banks of the River Exe—which diminished the importance of this elevation. An 1874 photograph shows a large, three-part window with sculpted arch at the first floor level of the tower; this is more elaborate than the window shown in the mid-18th century drawings, but very similar to what was depicted in the 1798 Swete drawing. This was changed to a projecting bay by 1895, marking the last major change on the tower. Sometime after 1962, the parapets above the White Drawing Room and the Family Dining Room were closed in.

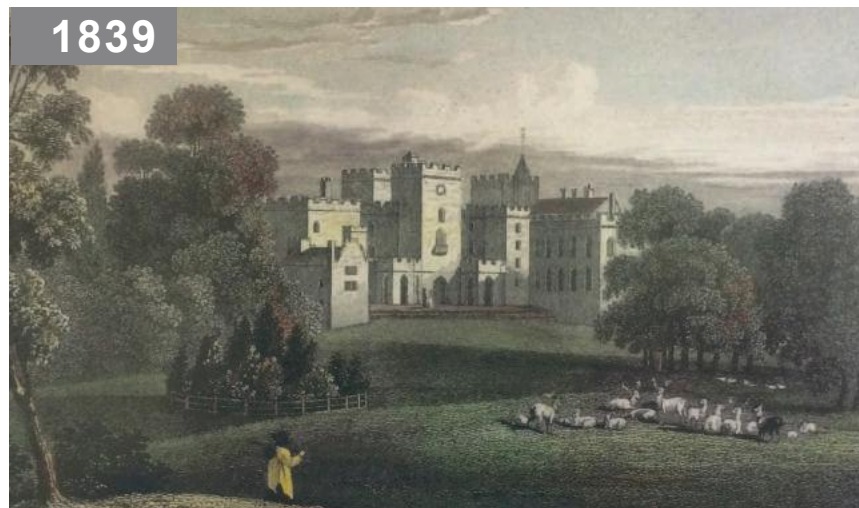
1839

This view from the southeast again clearly shows the stepped terrace and the east façade relative to the surrounding landscape. The openings in the one-story wings flanking the east tower appear to be full-length and open onto the terrace. (Powderham Estate Archives)

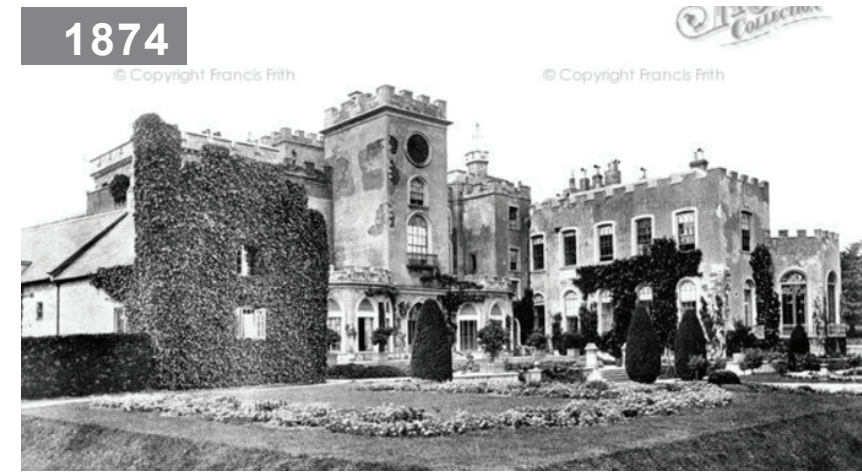
1874

This photograph, taken from the southeast corner of the garden, shows a new, formal garden space off the east terrace. Some wear and patching are visible in the surface render on the tower and sections of dark brick are revealed in some of the patches. The overall window style and configuration appear to match earlier depictions of the central (East) tower, indicating that there was a later campaign that changed a number of the windows after Fowler's remodeling. (Francis Frith Collection)

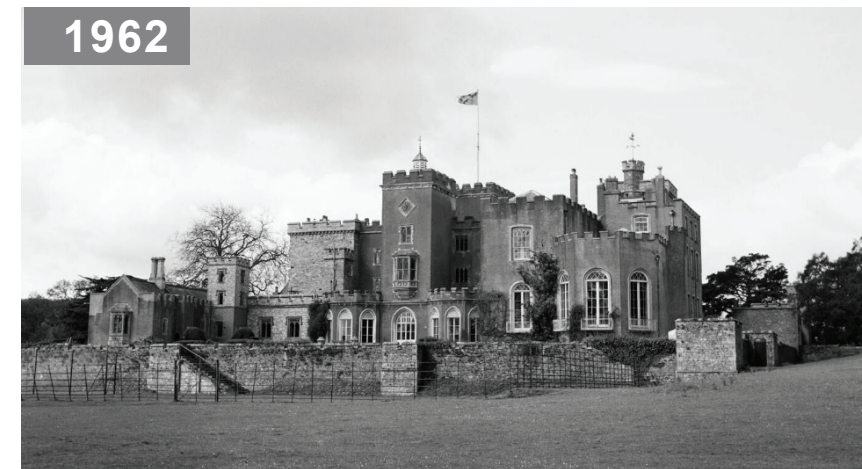
1962

This view shows the terrace wall surrounding the garden east of the castle. The windows and clock on the East Tower and gable end of the chapel have been replaced with Gothic style windows and two oriels. The render on the East Tower's exterior also seems to have been repaired or replaced. (Historic England Archives)

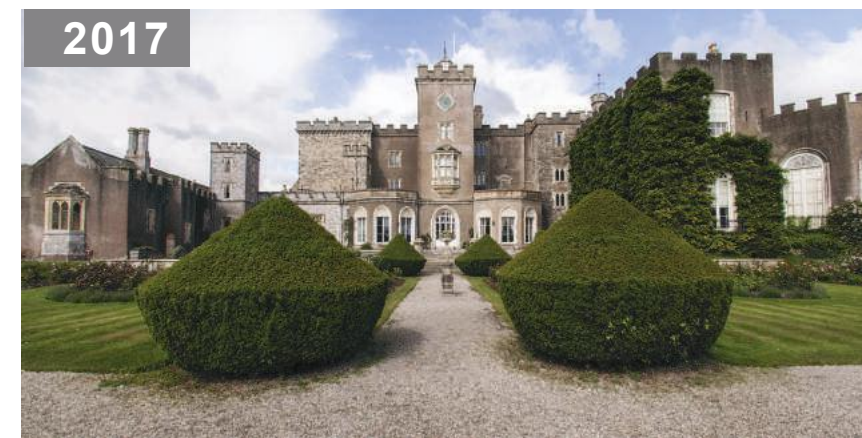
2017

Little has changed since the 1962 depiction, though the crenelated parapets of the one-story bays have been filled in. (Photo: Starr Herr-Cardillo)

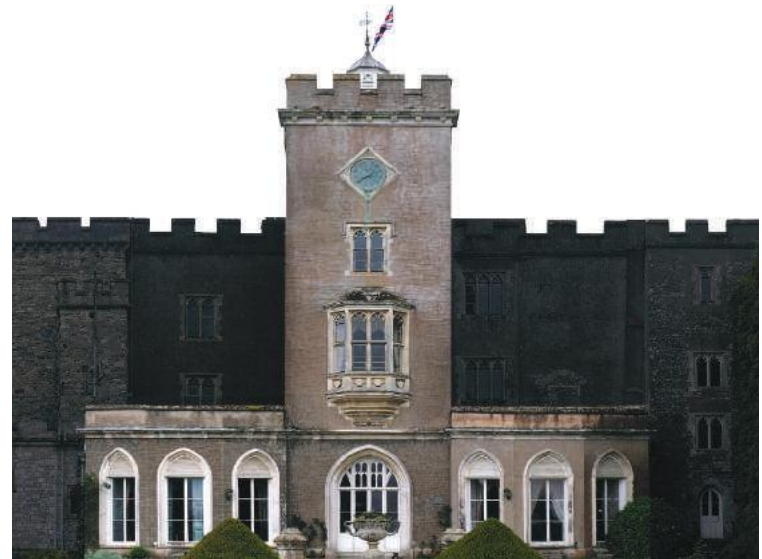
Figure 1: Orthorectified photograph of the East Tower. (Evelyn Pae, 2018)

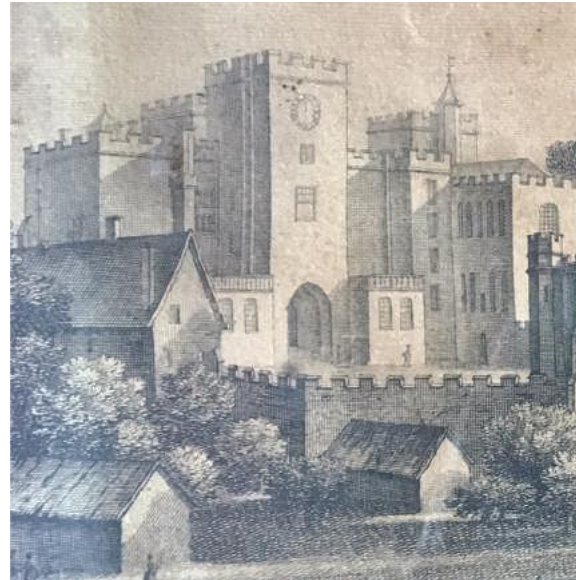
Figure 2: 1745 Engraving by Samuel and Nathaniel Buck showing an open entrance to the East Tower (Powderham Estate Archives)

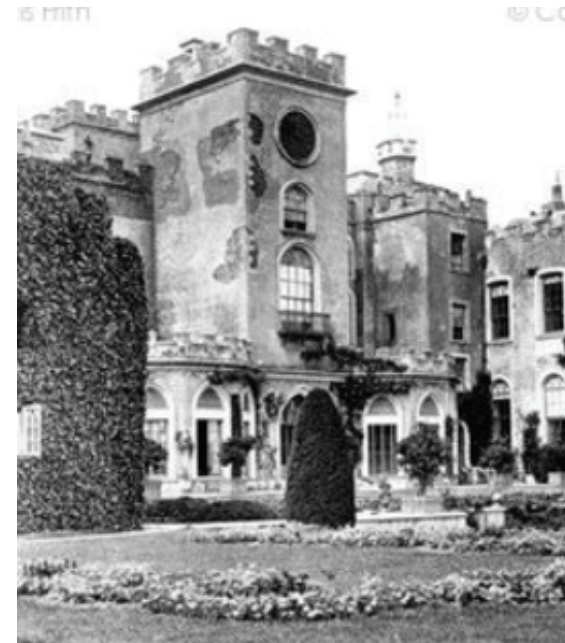
Figure 4: In this circa 1874 photograph of the East Tower, loss in the surface render on the tower reveals dark brick. The window style and configuration appears to match earlier depictions, indicating that there was a post-1874 renovation. (Francis Frith Collection)

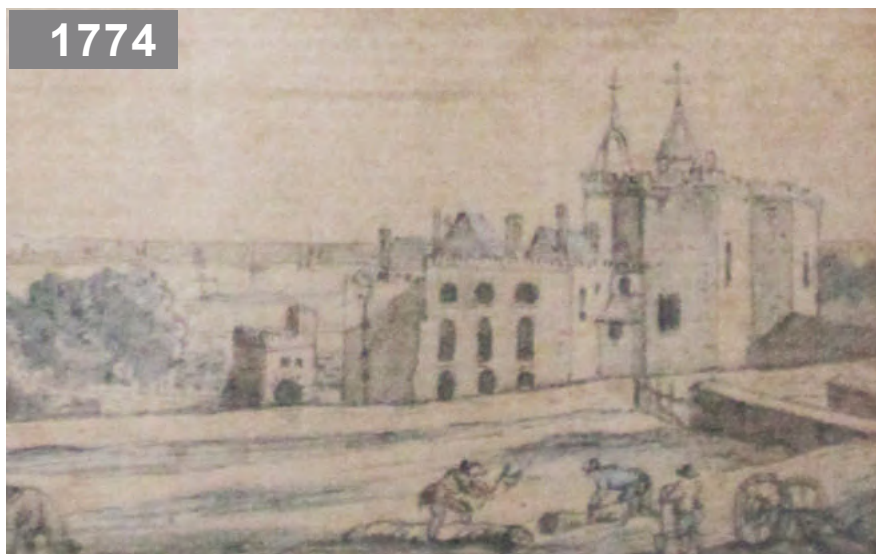
1774
This view of the north façade is one of two sketches framed and hung in the castle with the caption "Powderham Castle 1774." It shows clearly that the east gatehouse is still in place and provides a clear view of the North Block (or 30's Block), which appears to be three stories tall with three bays of windows and a crenelated parapet. It is unclear whether or not the door and staircase remain. A privy with a shed roof is located between the North Tower and the 30's Block. A gable-roofed out building is visible to the northwest of the castle. (Powderham Estate Archives)

The Hall (0006) was likely built as the lowest level of the Northeast Tower. Images indicate that, by 1774, a ground level privy had been added between this and the North Tower (Fig1), likely accessed from the Northeast Tower and later removed by Charles Fowler (Figs. 2 and 3). Fowler reworked the stair in this area. (Fowler, p. 6) In 1954, in response to opening the Castle to the public, a new at-grade entrance to the private quarters replaced two low windows on the west wall. Doors modified in this period have flat, gothic arches, with the Courtenay family crest carved on the exterior lintel.

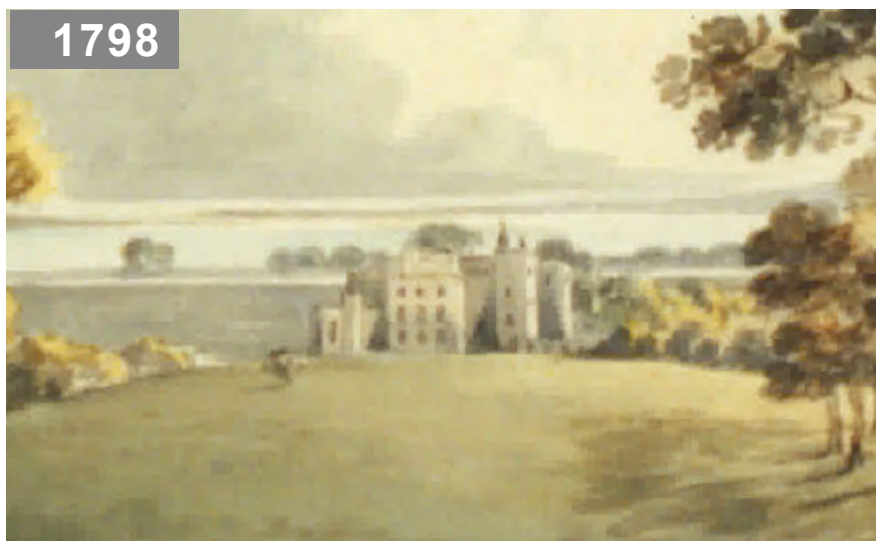
1798
This view is part of a series made by Reverend John Swete and shows the addition of the Music Room, which projects east from the northeastern corner of the castle. The privy between the 30s block and the tower appears to have been removed. (Powderham Estate Archives)

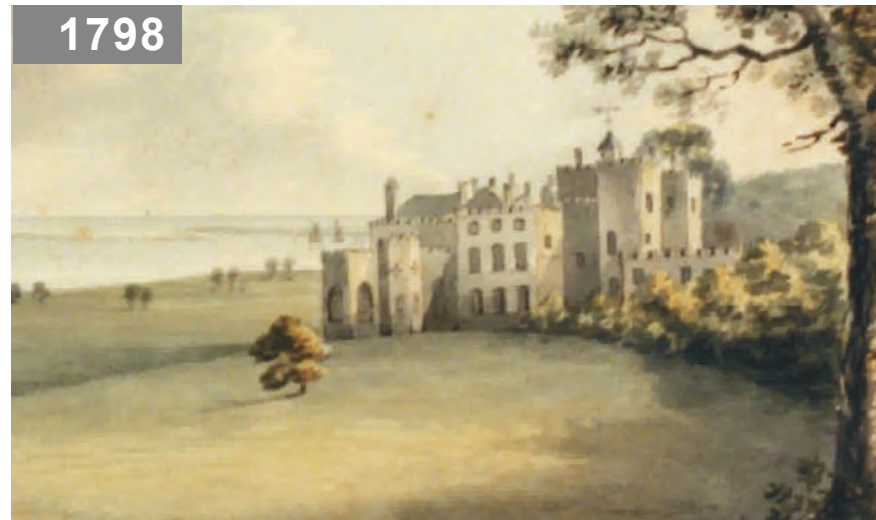
1798
Another view by Rev. John Swete provides a closer look. Large, arched windows along the north wall of the Music Room are clearly visible, flanking the three-sided attached tower, which also appears to have three small arched windows and decorative quatrefoils. There is no visible entrance on the north facade and there no longer appear to be formal gardens to the north of the castle, shown in the Whittlesby map from 1732. Powderham Estate Archives)

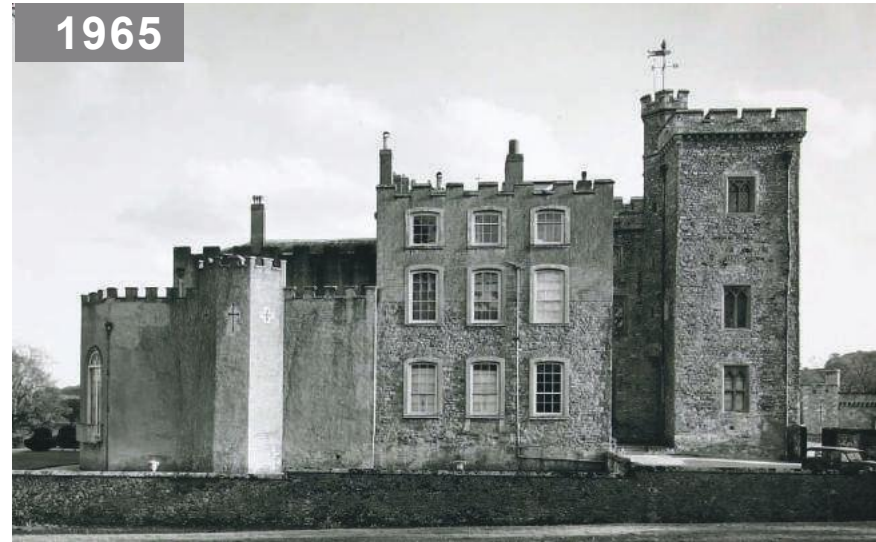
1965
This photograph shows the north wall of the Music Room with no indication of former windows. The crosses on the attached tower appear to have been modified, perhaps from the quatrefoils depicted earlier. A distinct line is visible on the 30's Block where the material transitions from rubble stone to rendered brick. Remnants of an elongated door surround are visible below the middle window in the first row. (Historic England Archives)

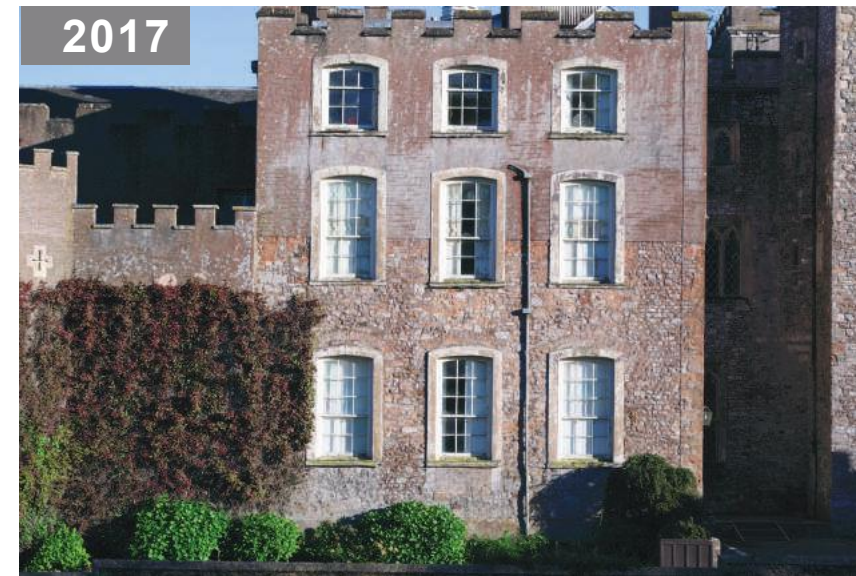
2017
The 30's Block added in the first quarter of the 18th century, retains its Georgian window configuration and window surrounds. The exterior walls of half of the addition are built of stone rubble with a reddish stone mortar and transition to rendered brick. (Photo: Starr Herr-Cardillo)

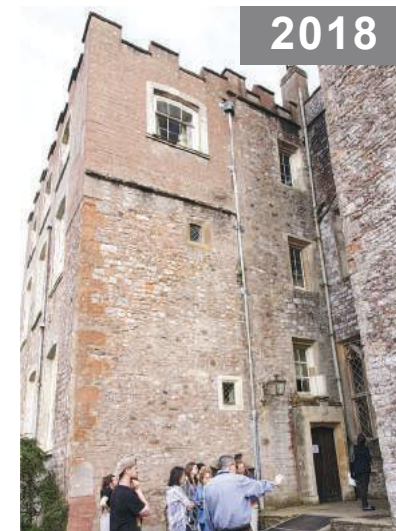
2018
On the west side of the 30's block a light stone belt course is visible at the juncture between the stone masonry and brick portion of the addition. A medieval tower, visible where the masonry extends to the roof to the right of the rain hopper, is embedded in the addition. (Photo: Starr Herr-Cardillo)

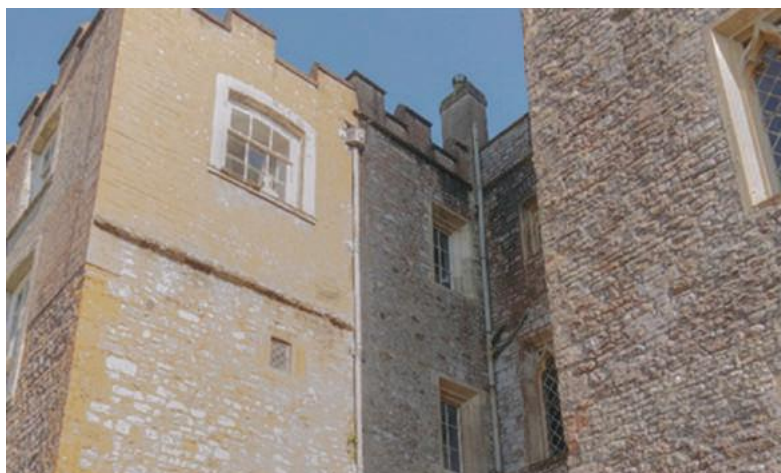
Figure 4: Exterior of the floors above the Hall (right of drainpipe), showing different masonry pattern, lack of string course, and higher crenellations. Also shows change in masonry between upper and lower floors to the right of the drainpipe, marked by string course. (Photo by Katherine Randall.)

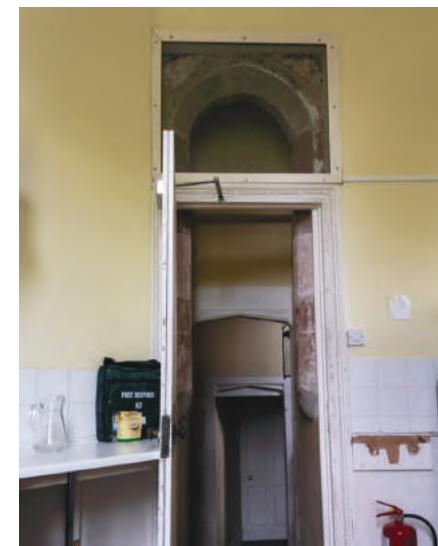
Figure 5: Red sandstone arch in wall between Hall and Kitchen. (Photo by Margaret Back.)

The oldest portion of the North Wing seems to be the Hall (Room 0006), which appears to incorporate one of the six towers said to have protected the medieval fortified manor (Harding, 1863). In plan, these walls are thicker in width than others in the wing. Its location directly north of the Anteroom, which marks the northern end of the medieval core, suggests that the tower likely housed a stair providing access from the Great Hall to the Solar, and indeed stairs fill the upper levels of this space today (Wood) (fig. 3). At all three stories, this section has a different exterior masonry pattern than the rest of the North wing, lacking a prominent string course (fig. 4). The parapet is higher here, extending through the roof. A narrow, red sandstone pointed arch in the wall between the Hall and Kitchen, consistent with the area where the masonry changes on the exterior, (fig. 5) appears to mark an opening in the exterior wall of that tower which may have lit the stair. Although much of the tower stone has been repointed, patched or rendered, red breccia and creamy limestone semi-coursed rubble stones can be seen underneath the drip edge, while the masonry immediately beyond it is render-covered brick. Breccia is a soft, local stone that declined in popularity after the 1500's, when more durable stone deposits became available (Baylock). Harding identifies the creamy limestone as "a white material of rather soft character, locally called 'Exmouth stone.'" (Harding, 1867).

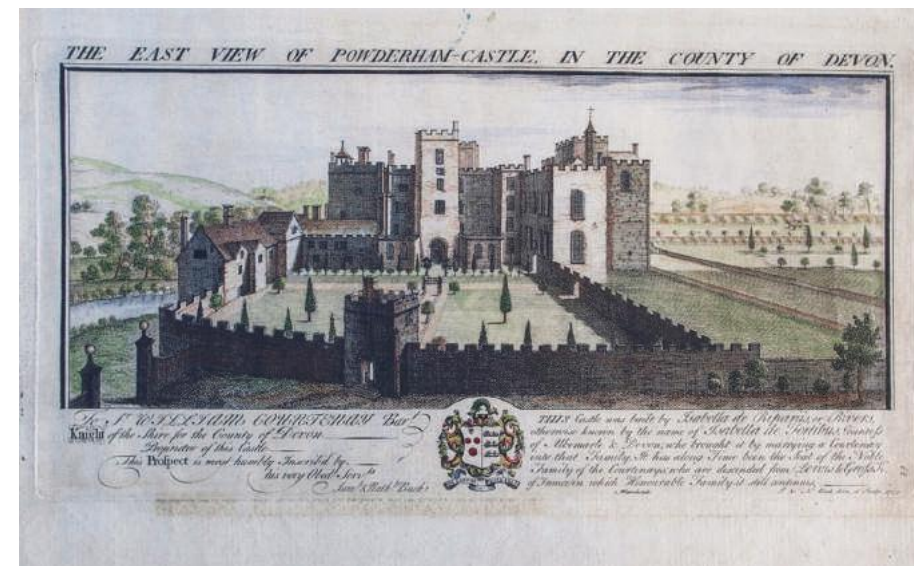
Figure 6: North Wing Visible to the far right of the castle with all three floors constructed. (S. & N. Buck, 1734.)

The area appears to have been expanded in the early 18th century, with the re-occupation of the Castle by Sir William Courtney, the 2nd Baronet, who inherited the property from his grandfather in 1702. The first documentary evidence for the North Wing is a 1734 engraving, which shows the entire three-story wing in place (fig. 6), as well as a stair extending from what appears to be the central ground floor opening in the north elevation; ghost marks remain visible below the sill of the center opening (fig. 7). This may have led to a large formal garden on the north side of the complex, visible in "A Map of Powderham Castle with Marsh," created in 1732 by Robert Whittlesey (fig. 8).

By the time the 1734 print was made (see fig. 6), the wing had risen to its current three stories and no doors are shown at the ground floor level. Two rows of three 9-over-6 double-hung Georgian sash windows lit the lower two stories with a third story of three 3-over-6 double-hung windows with flat-arched Georgian sashes.

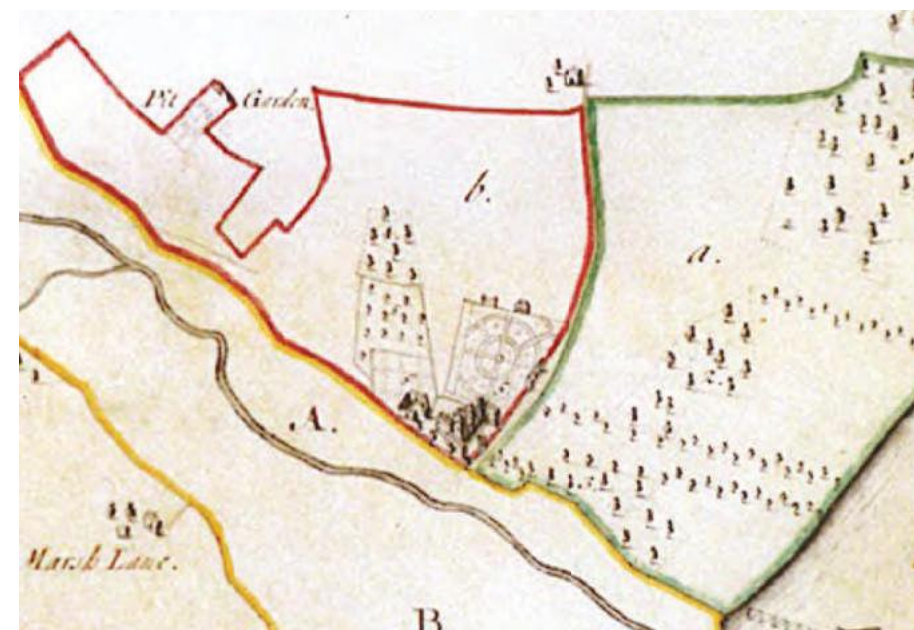
Figure 8: The stair shown in the Buck engraving likely gave access to a large formal garden just to the north of the castle. (Robert Whittlesey, "A Map of Powderham Castle with Marsh", 1732.)

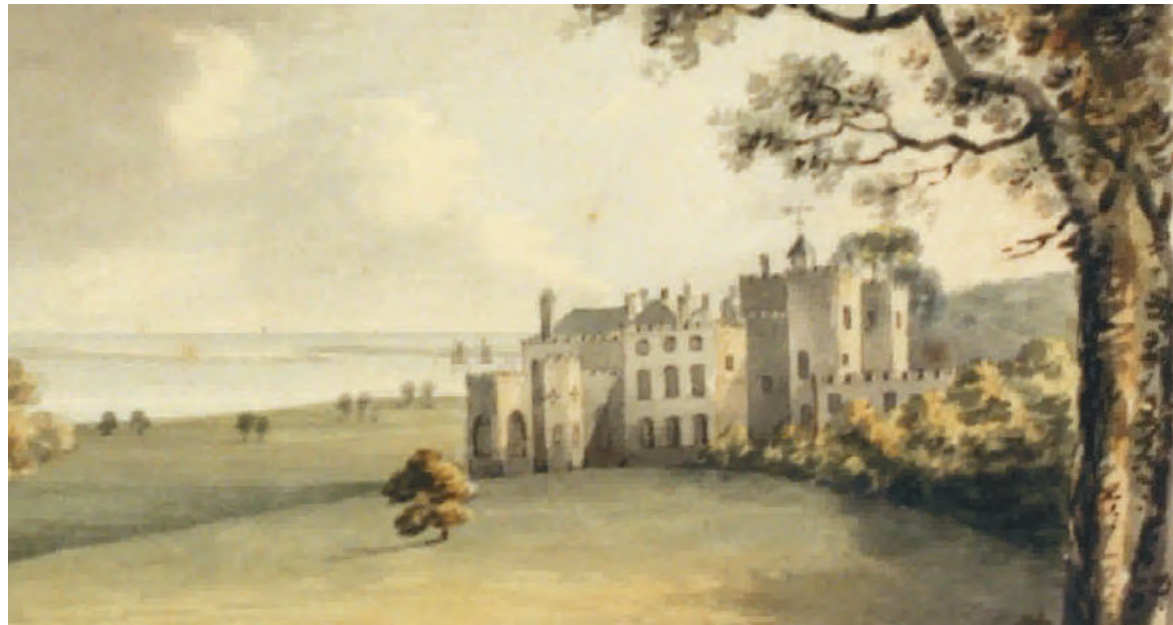
Figure 9: The central window and upper floor openings have not changed significantly since 1798. (Swete, 1798.)

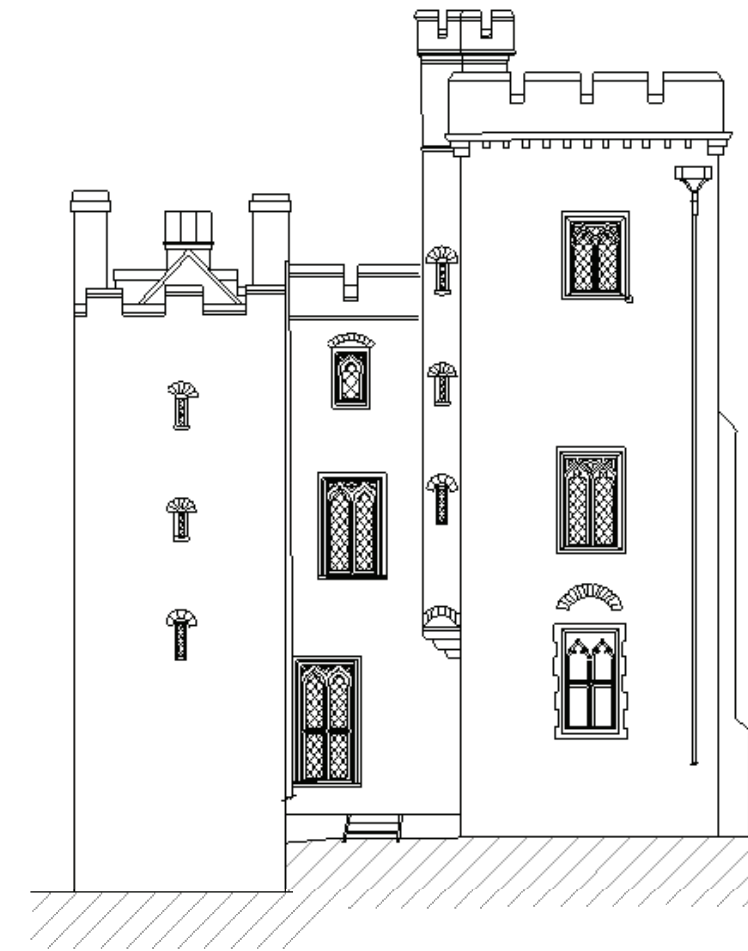
Figure 10: Possible appearance of medieval northeast tower. (Source: Allison King.)

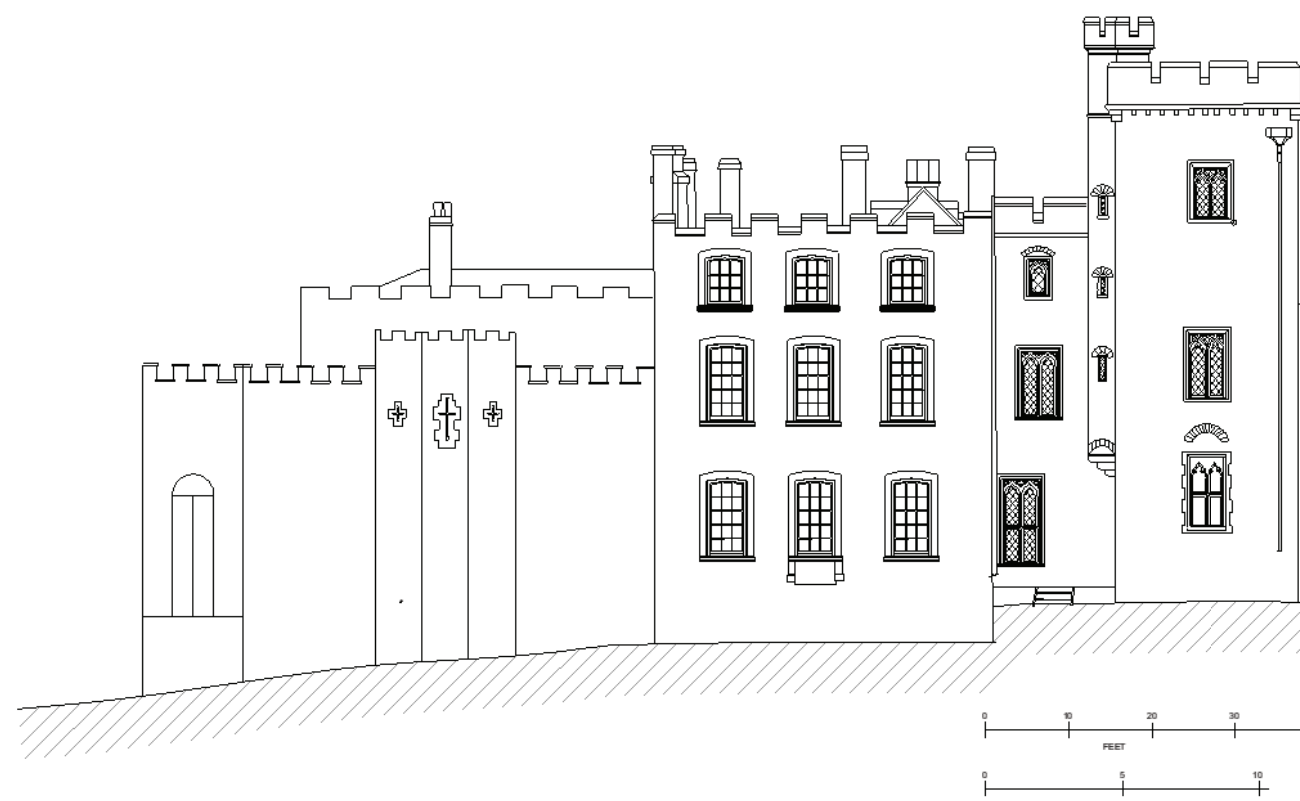
Figure 12: The central window and upper floor openings as they appear today. (Source: Starr Herr-Cardillo.)

Both teams working on different levels of the North Wing have conjectured that it may have been built in two phases in the first half of the eighteenth century—initially a one-story high structure, which was later expanded upward (figs. 10 through 12). On both the north and west elevations, there is a clear change in masonry halfway up the first-floor windows (see fig. 4), marked by a string course which looks like those found beneath parapets in other parts of the castle, including the Northeast Tower. This may have been built from recycled stone. A conjectural rendering of that lower façade is shown in figure 11. This initial construction may date from soon after the family returned to the Castle (Nicholas Pearson Partnership LLP). Receipts show that John Moyle, a “master builder and bricklayer from Exeter, (The Buildings of England) was paid \$1,500 for work on Powderham from 1710-1727, though this could relate to work in many areas, even beyond the castle proper (“Powderham Parkland Tree Management Plan”). The downspouts on the second level carry a date of 1720, possibly marking a construction campaign, but they could have been moved from another location at a later date. Alternatively, the lower level of the wing may have been constructed of reused stone, then brick added above.

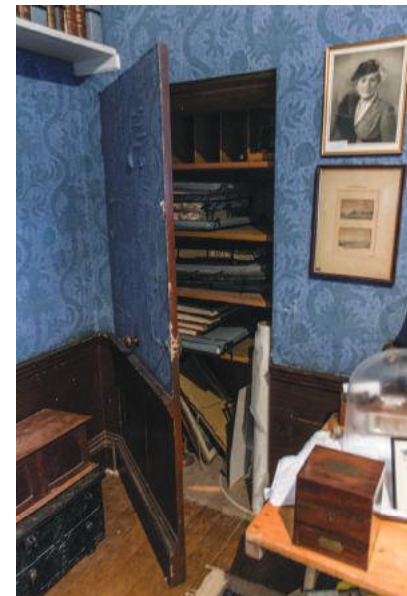
Figures 1-2: The removed exterior door, now a document closet, in Lord Courtenay's Study (Plan: Powderham Archives; Photo by Anthony Hita)

Fowler directed many changes to the North Tower exterior: adding iron straps; repairing decayed stonework; rebuilding crenellations; and removing the conical top of the spiral staircase, replacing it with an octagonal, crenelated Gothick cap. Fowler closed an exterior doorway on the ground floor, creating a closet (Figures 1-2) He also closed a window opening on the west elevation of the third floor to create a fireplace, and made a new window on the north side in its place (Fowler 1840, 19)(Figures 3-4). Additional repairs occurred after this period, indicated by modern, machine-made brick and plastering, but these only account for a very small portion of the total fabric of the tower.

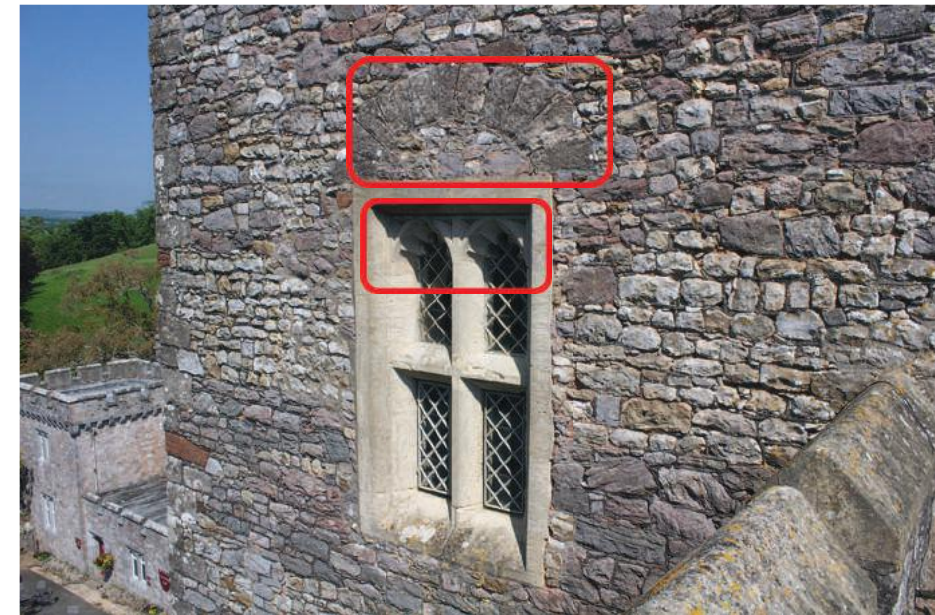
Figure 3: The exterior of the North Tower's third level southern wall showing a medieval arch above the window that Harding claims was uncovered and restored during Fowler's renovations. The trefoil caps appear to be a separate stone from the Fowler-added framing. A similar situation appears in-situ on the exterior west wall of the Stair Hall (Photo by Anthony Hita)

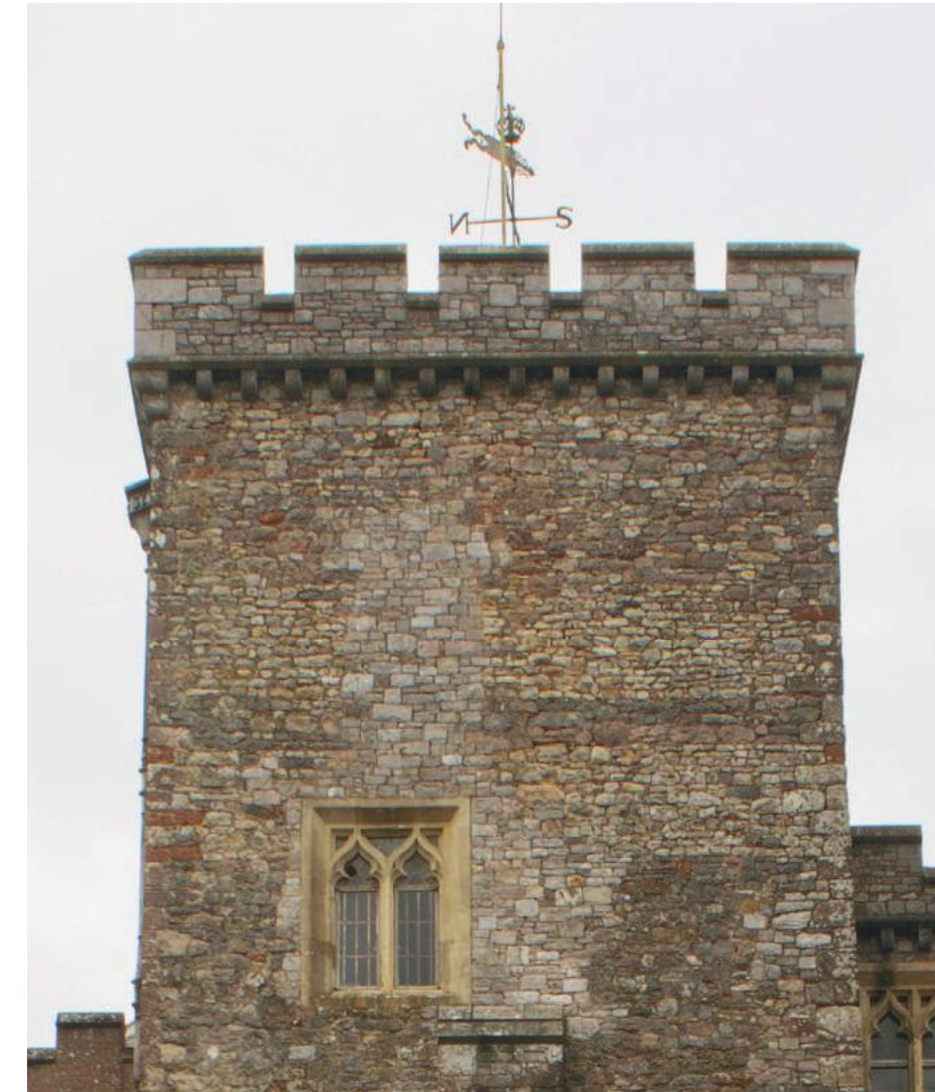
Figure 4: Evidence of a removed opening on the west side of the North Tower's third floor. Fowler placed a fireplace here, moving the window to the north side instead. (Photo by Rebekah Yousaf)

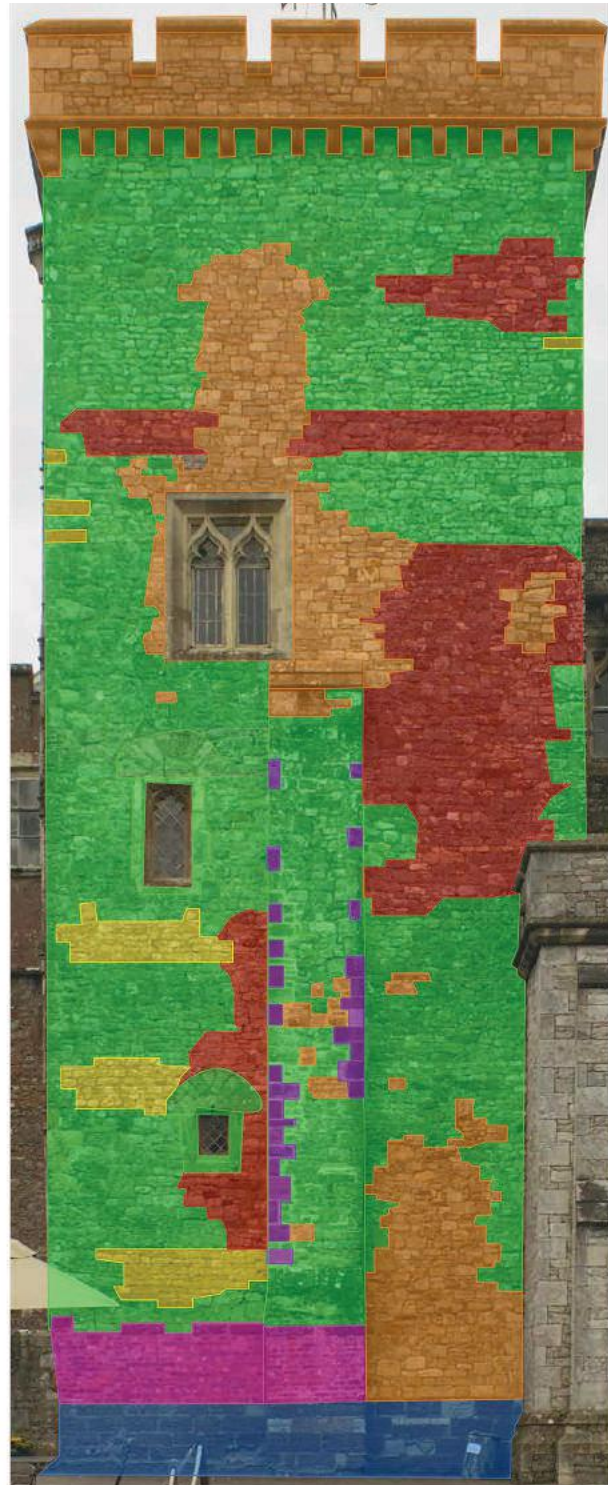
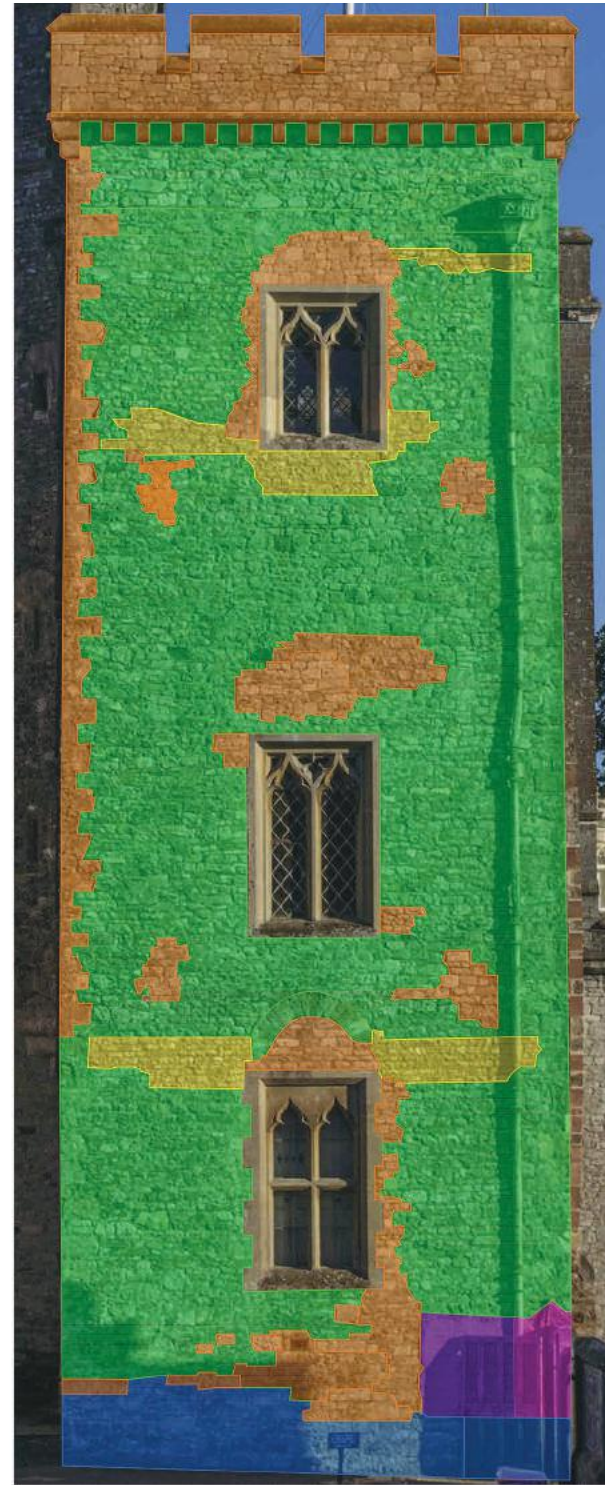
NORTH TOWER STONE STRATIGRAPHY

Northern Elevation

Western Elevation

PHASE 3: TAN TO DARK GREY ROUGH STONE
UNCLEAR DATE, BUT POSSIBLY SECOND PHASE MEDIEVAL USED FOR FINISHING AND REPAIRS

PHASE 6: DRESSED GREY STONE BLOCKS, AND DARKER GREY DRESSED DECORATIVE FEATURES. RED MORTAR, WITH SOME DARKER COLORS. HORSE HAIR PLASTER.
1837-1840, FOWLER MENTIONS REPAIRING DETERIORATED STONE, ADDING OR MODIFYING OPENINGS, AND MODIFYING THE TURRET AND CRENELATIONS (FOWLER 1840, 19)

PHASE 7: MODERN MACHINE MADE RED CLAY TILES AND PLASTER SCORED TO RESEMBLE STONE. TAN MORTAR AND MODERN CEMENTS.
CA. 1950-PRESENT: SPOTS OF REPAIR TO OLDER FABRIC AND WORK MEANT TO DISGUISE OLDER MATERIAL WITH MODERN SCORED PLASTERING

At least seven phases of repair are visible in the exterior stonework of the North Tower. The majority of the tower walls consist of rough, undressed field stone mostly grey to tan in color, which are likely the oldest material (Harding 1867, 174). Charles Fowler's reports in the 1830's suggest that, like much of the rest of the castle, these were in a semi-ruinous at the time, and that the ground level originally had a raised earth parapet covering the foundations. Sometime prior to Fowler's engagement, workers had uncovered the foundations, which allowed him to observe that the tower base rests upon a well-packed base of gravel (Fowler 1840, 2). Observations underneath the floor of the ground floor revealed evidence of this base, as well as what appears to be either well-compacted earth, possibly rammed earth, surrounded by an exterior course of red and grey cut stones.

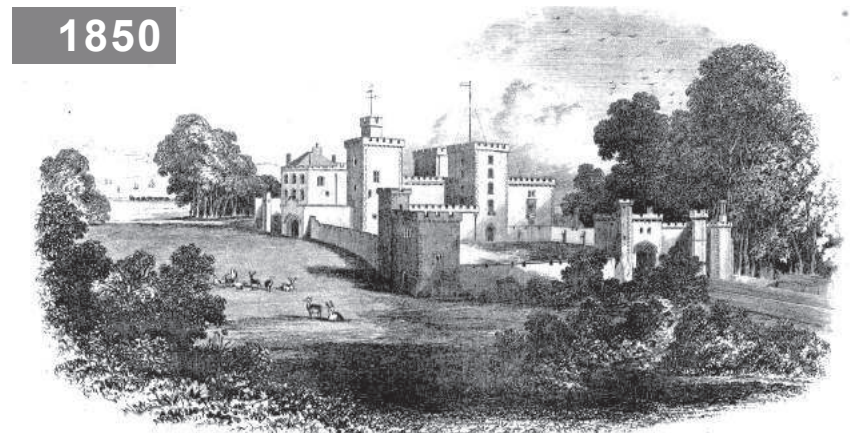
This engraving, labeled "Powderham Castle (S. Devon Railway)" depicts the castle from the northwest. It shows the west entrance, reconfigured post-Fowler, with a walled yard accessed by a gatehouse and with two towers at the northwest corner. The central tower on the west façade maintains a window configuration and style similar to that of the east tower before its late 19th or early 20th century modifications, with a series of arched windows above an arched doorway. (Powderham Estate Archives)

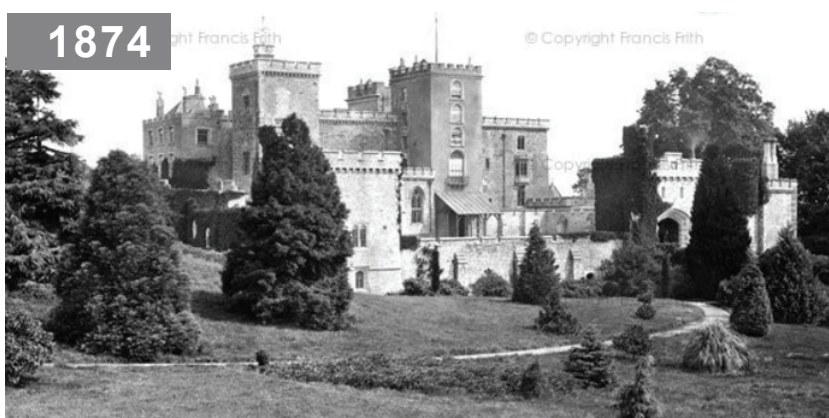
This photograph gives a clearer view of the tower's window configuration. To the south of the West Tower, windows on the upper stories appear to be of a different style, one with a projecting bay. A temporary porch projects over the entrance on the West Tower, and a path from the north curves in towards the walled court. (Francis Frith Collection)

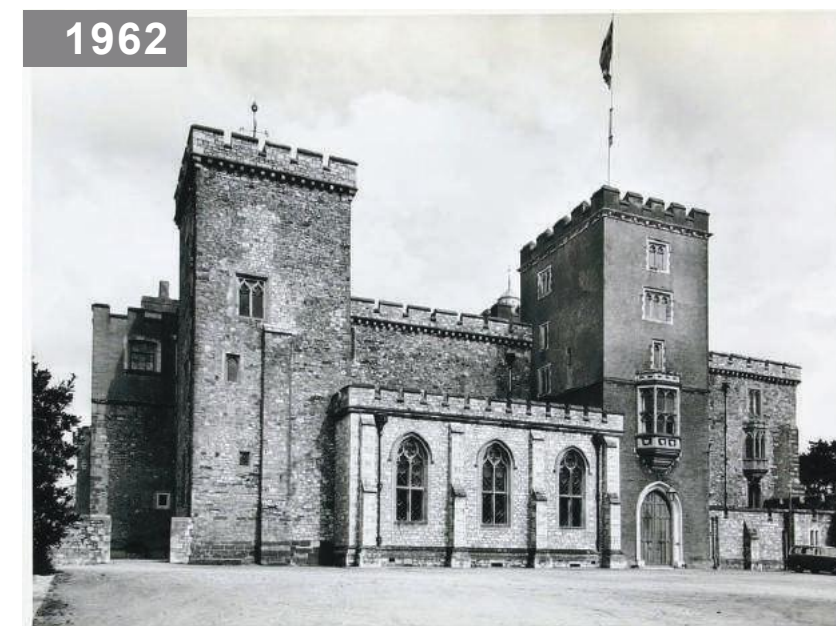
This view shows the west side of the 30's block and of the North Tower with a clear view of Fowler's State Dining Room addition. The temporary porch has been removed. (Historic England Archives)

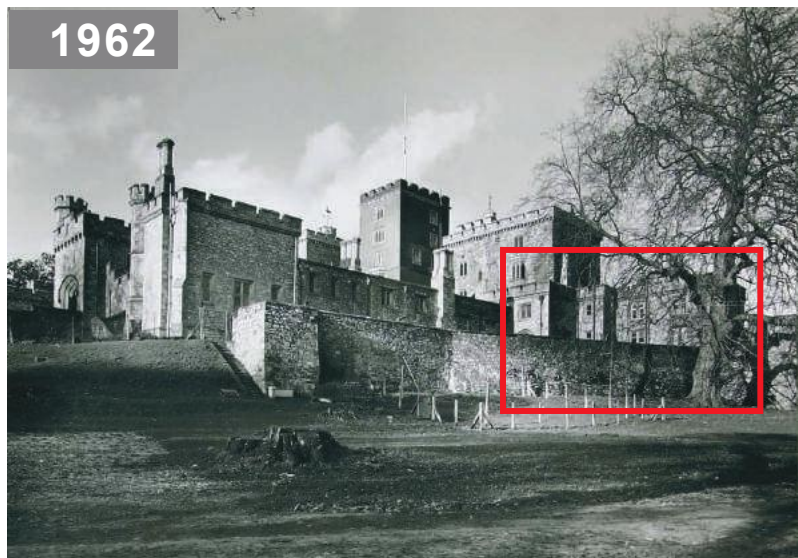
1962
This photograph shows the south side of the west court. Additions to the south end of the castle were made by Charles Fowler; the spaces now function as offices. (Historic England Archives)

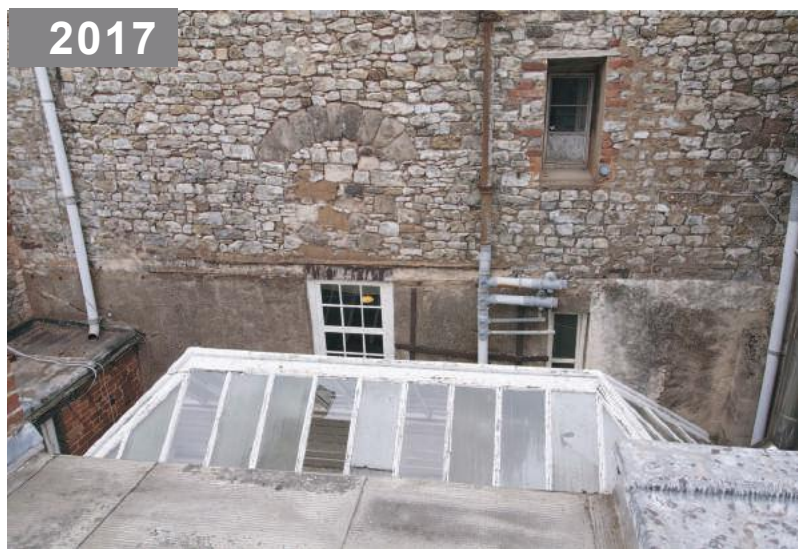
2017
At some point following Fowler's work, the open space between the Kitchen and the southern buildings was enclosed. This likely coincided with the demolition of the back portion of the Grange, labeled on Fowler-era plans as the "Steward's Room." It was replaced by a rectangular addition that now houses the offices. A large skylight was inserted and the room is now called the Scullery. (Photo: Starr Herr-Cardillo)
