POWDERHAM PRAXIS, 2017-2018

University of Pennsylvania Graduate Program in Historic Preservation
Cornerstone Praxis, University of Plymouth
Powderham Castle

1: INTRODUCTION

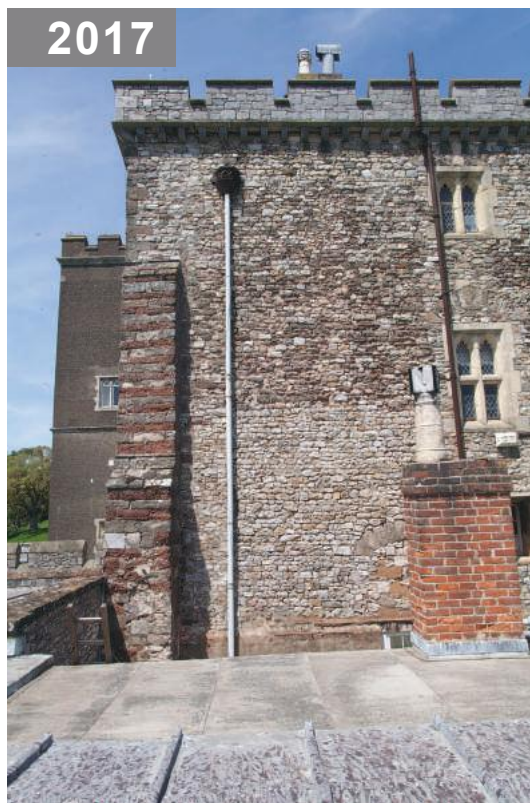
2017
This buttress, made of alternating bands of red breccia and light sandstone, was pointed out by Charles Fowler in his Account of Works as a "very important support" for the castle. He repaired and re-stabilized the buttress while working on the office buildings to the southwest. (Fowler, 5-6) (Photo: Starr Herr-Cardillo)

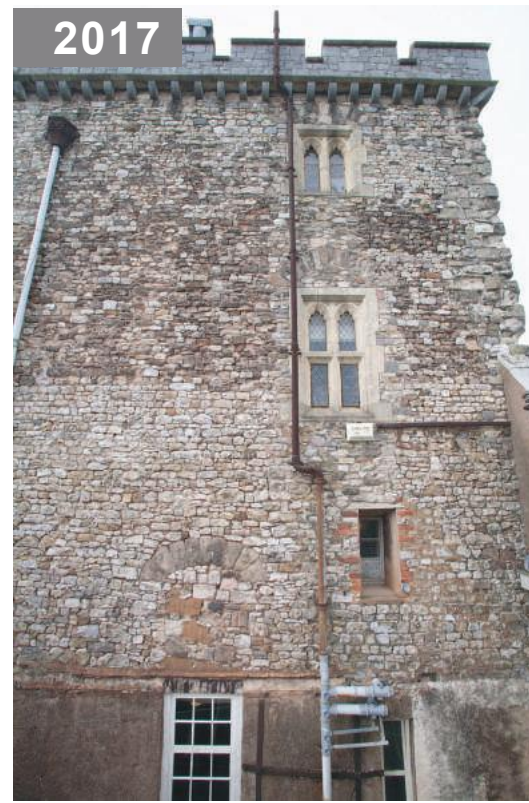
2017
A distinct change in stone rubble is visible on the south wall of the former medieval hall approximately 1/3 up the wall. A red sandstone arch indicates the presence of a medieval opening above a window in the Victorian Kitchen. Various arch campaigns are visible above the second and third story windows. The incongruous battlement, made of grey chert stone, was added by Fowler. (Photo: Starr Herr-Cardillo)

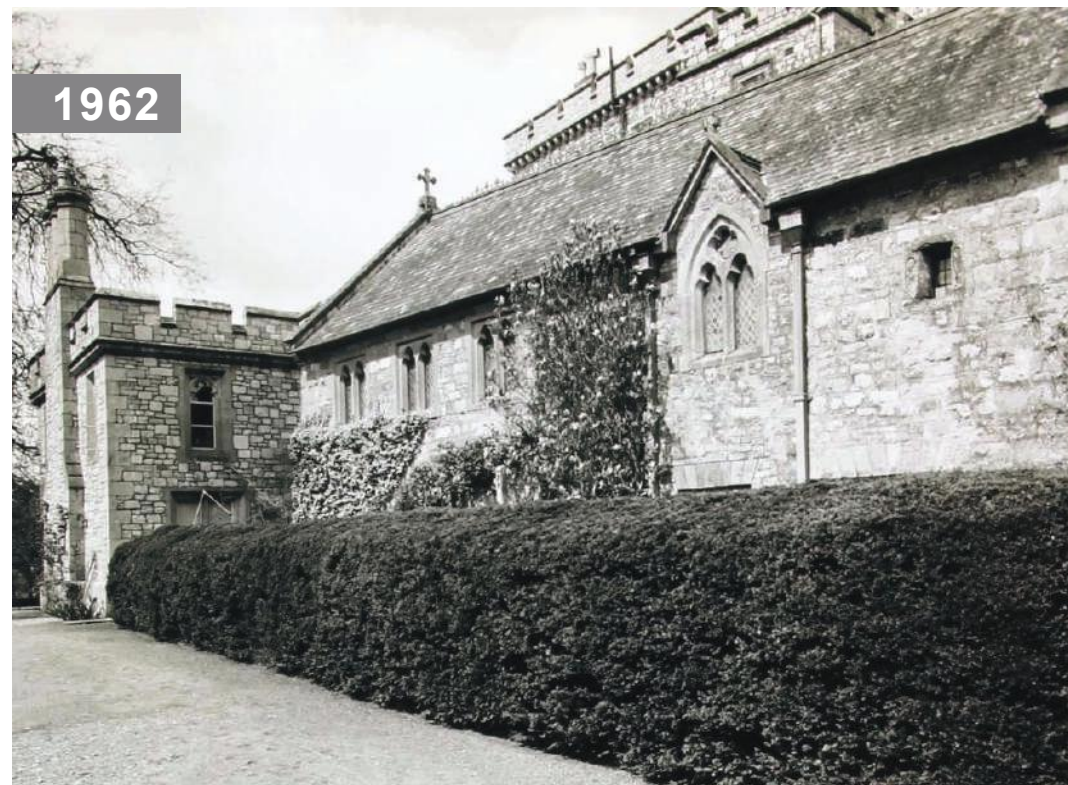
1962
The south wall of the Chapel (formerly the Grange) is constructed of the same irregular stone rubble as the medieval portion of the castle including the red sandstone quoining seen on other medieval portions of the castle. Lieutenant Colonel Harding suspected that the Grange and the original Chapel (in the location of the First and Second Libraries) were both built in the 1450s. (Harding, 176-177) A small and likely very early window framed in red breccia is visible on the right. The Grange was refitted into a family Chapel in 1861. (Historic England Archives)

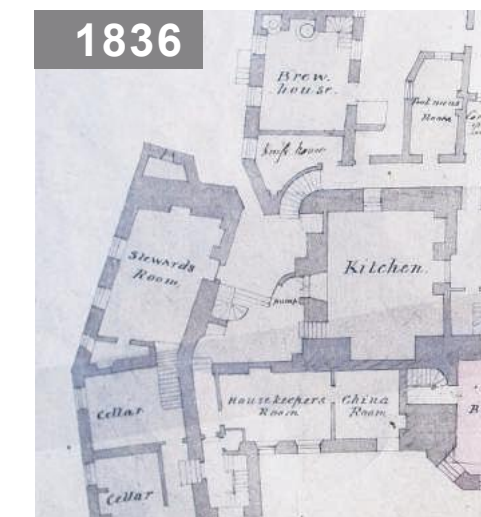
1836
Fowler's plan from 1836 shows the southern end of the castle prior to renovations. The Steward's room is connected to the Grange and extends northwest at an angle. (Powderham Castle Archives)

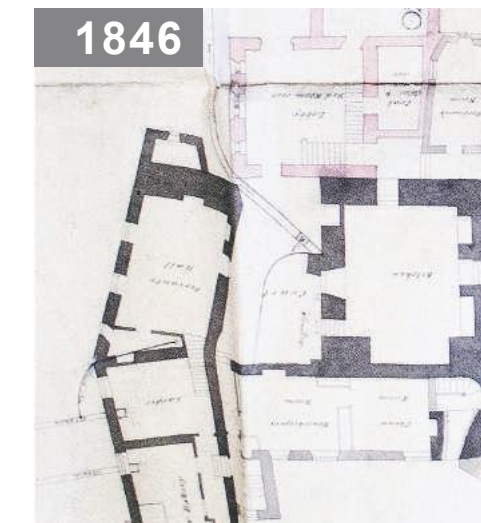
1846
Fowler's plan ten years later, shows changes that he has made. A key notes that the dark grey portions are the oldest sections of the castle, the lighter grey are a later campaign, and the pink denote portions built by Fowler. (Devon Heritage Centre)

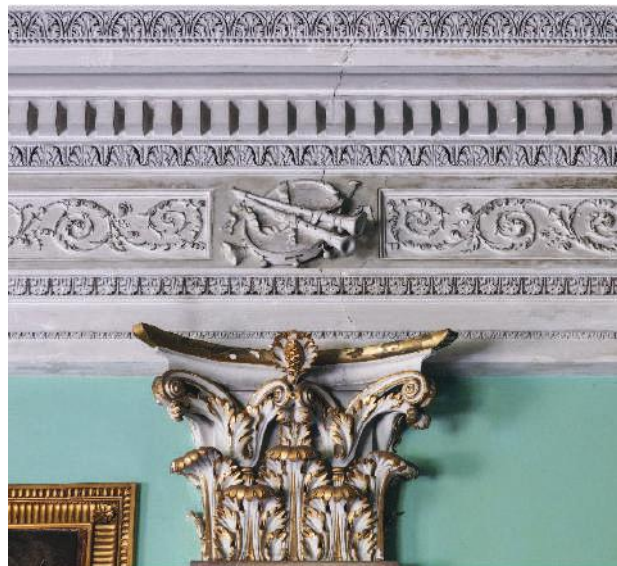
Figure 3: Detail of capital and frieze that bear a striking similarity to Plate 6 in *The Works in Architecture* by Robert Adams, 1775. Adams notes that the design was copied widely. (Photo: Margaret Back)

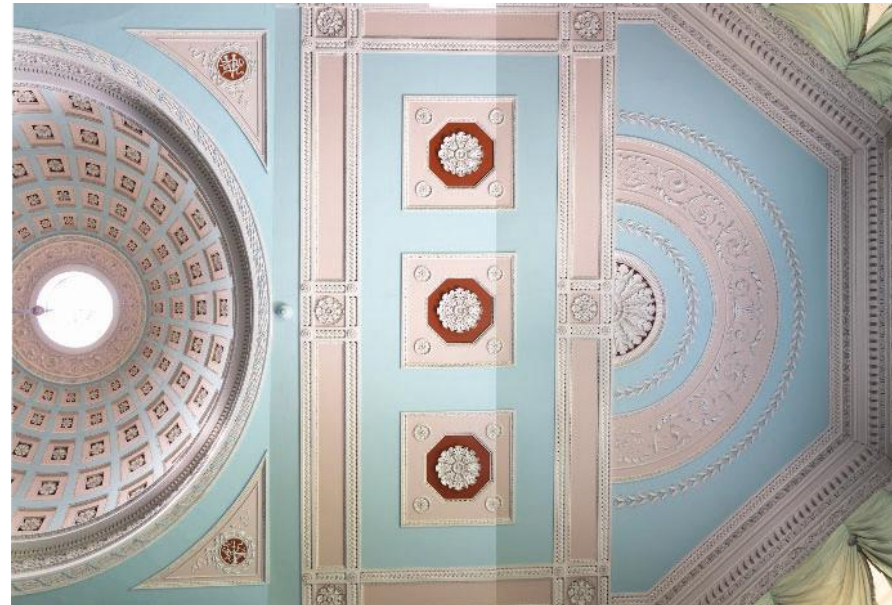
Figure 4: Rectified photograph of the ceiling and coffered dome of the Music Room. (Photo: Margaret Back)

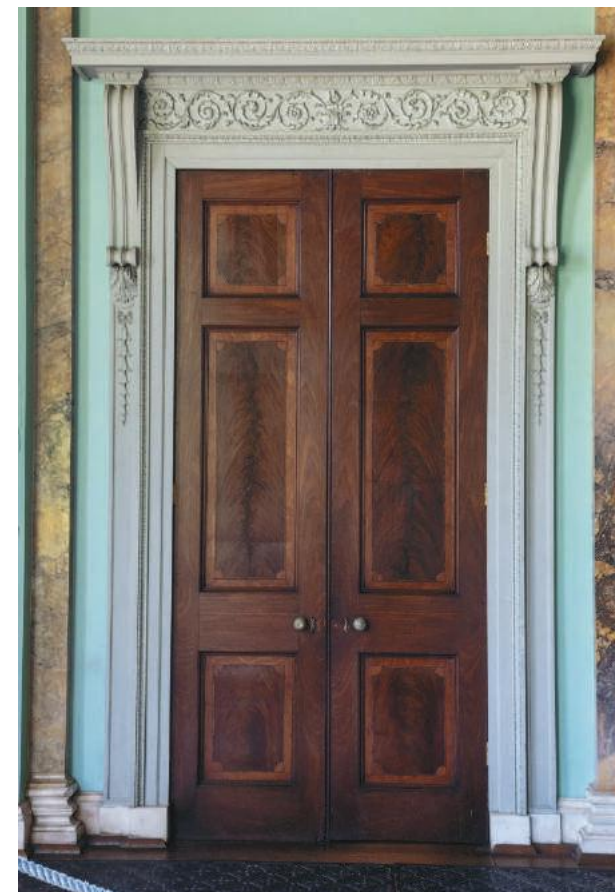
Figure 7: The easternmost door was likely a blind door, added to provide symmetry when Wyatt designed the room. It was later made functional by Charles Fowler. (Photo: Margaret Back)

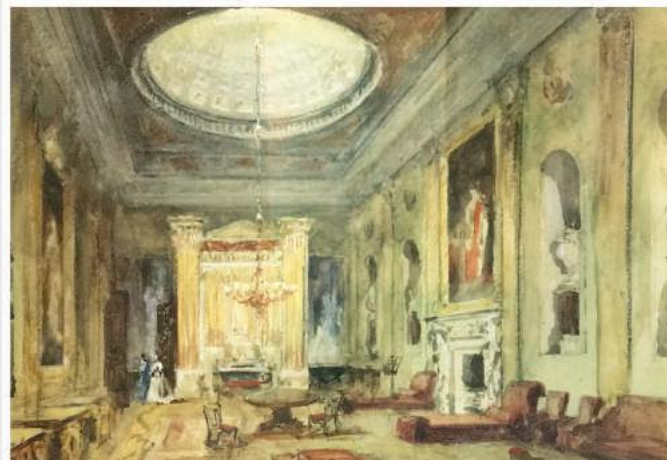
Figure 8: Undated water color facing west in the Music Room, likely mid-nineteenth century. (Powderham Castle Archives)

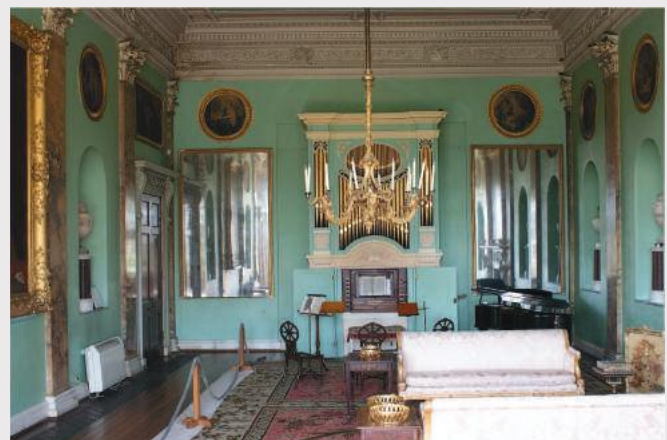
Figure 9: The Music Room today features a Brice Seede organ, which appears to be a slightly more narrow organ than the one depicted in the painting. (Photo: Margaret Back)

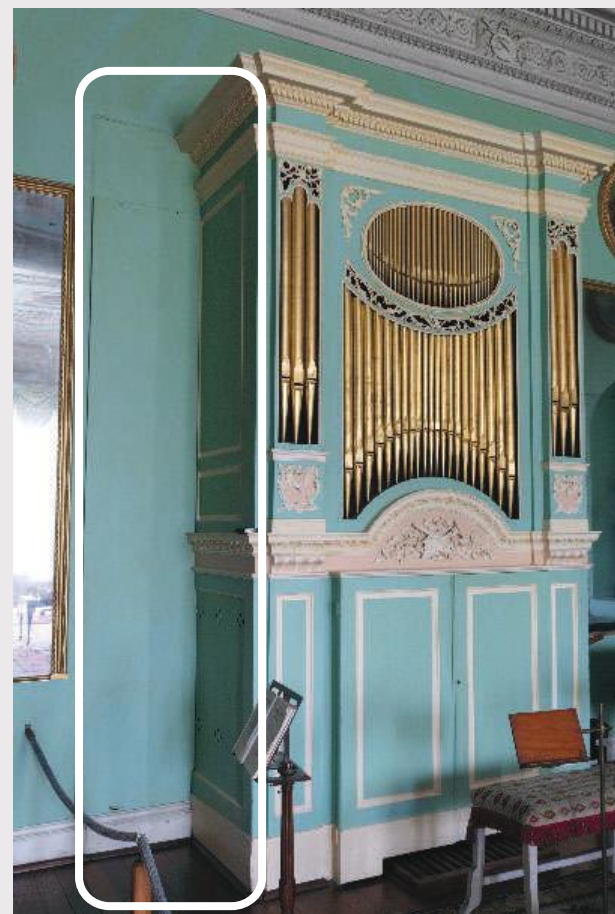
Figure 10: Closer inspection of the wall on either side of the Brice Seede organ reveals that an open space has been infilled by canvas panels. (Photo: Margaret Back)

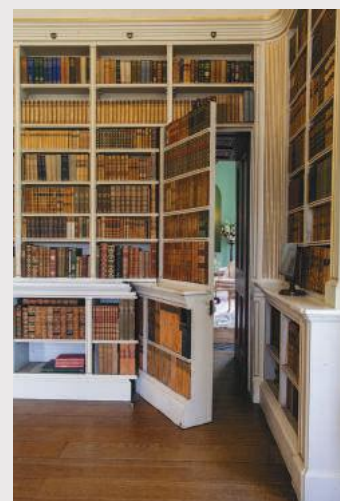
Figure 13: View of the jib door from the Second Library. (Photo: Starr Herr-Cardillo)

Though Fowler's floor plan post alterations doesn't show a new opening on the east end of the south wall, he describes adding a jib door in his Account of Works at Powderham Castle from 1835 to 1840 Inclusive that leads into the Second Library.

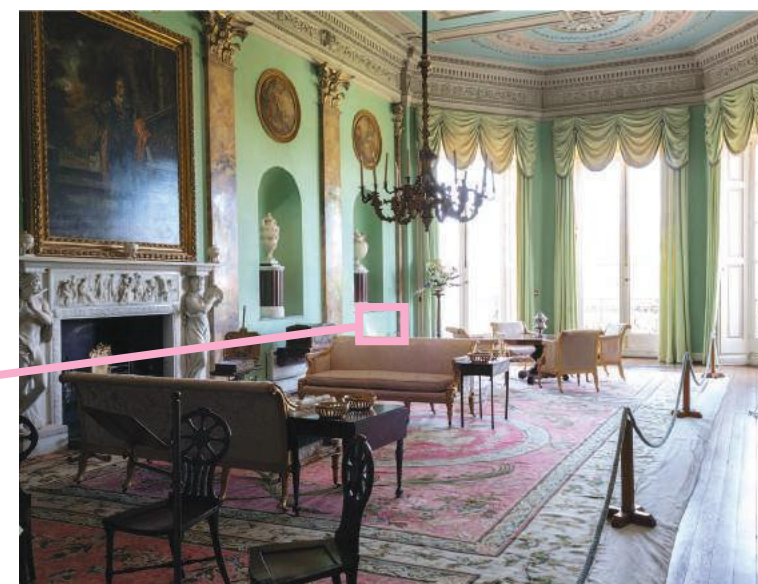
Figure 14: The first paint sample was taken from a pre-existing chip in the plasterwork of the room on the eastern end north wall. The paint appears to have five distinct layers, although some of these likely include the substrate and primer. What is clear is the darker hues of paint on the oldest layers, those closest to the wood. These colors suggest that the Music Room perhaps was once a darker shade of green or turquoise than the shade of green/blue we see today. More extensive testing is needed to support this theory. Pale blues and greens are particularly subject to fading, therefore paint analysis prior to any future restoration is critical.

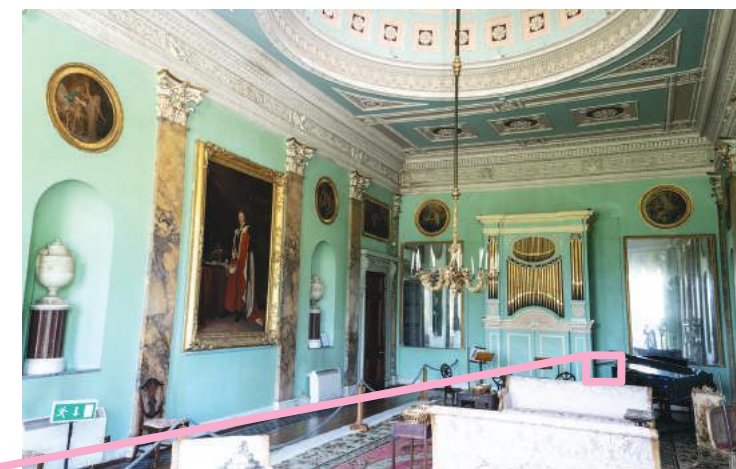
Figure 16: The second paint sample was taken from a pre-existing chip in the paint on the right side of the Seede organ box, against the west wall of the Music Room. This sample appears to show more layers than the paint sample of the north wall of the Music Room. The colors also appear more vivid, as they were likely less exposed to the sun and fading as the north wall. The presence of more paint layers supports the idea that this organ was not moved to the Music Room in 1796, but likely years later. The organ, if located elsewhere previously, would likely have more and different paint layers. More analysis of these paint layers is needed.

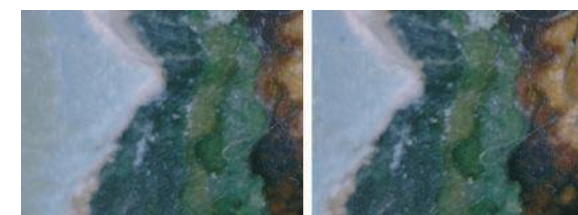
Figure 17: The samples can be read right to left in terms of age: the oldest layers are those furthest to the right, and the current shade of green/blue is the paint layer furthest to the left.

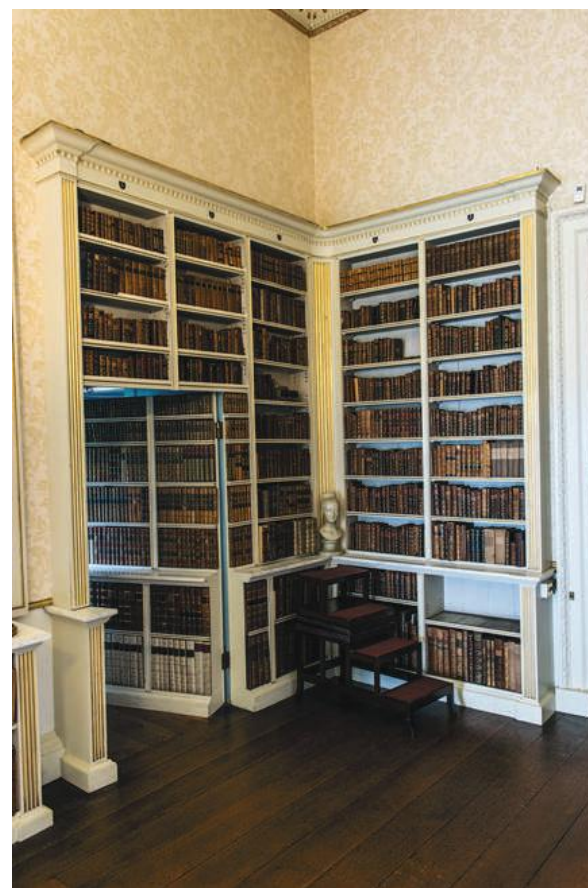
Figure 3: One of the hidden bookcase doors. (Photo: Dorcas Corchado)

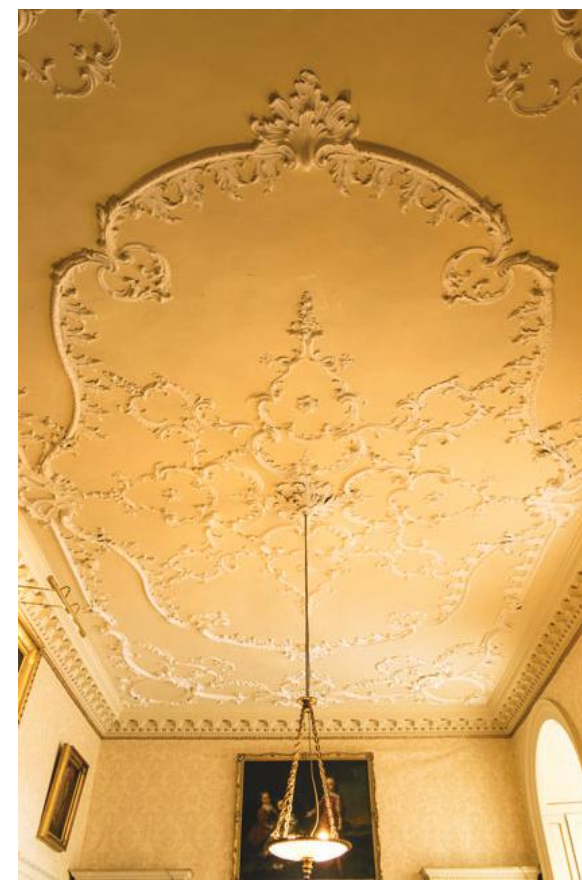
Figure 4: The fine rococo style ceiling found in the First Library. The ceiling experienced water damage and portions were replaced in the early 2000s. (Photo: Dorcas Corchado)

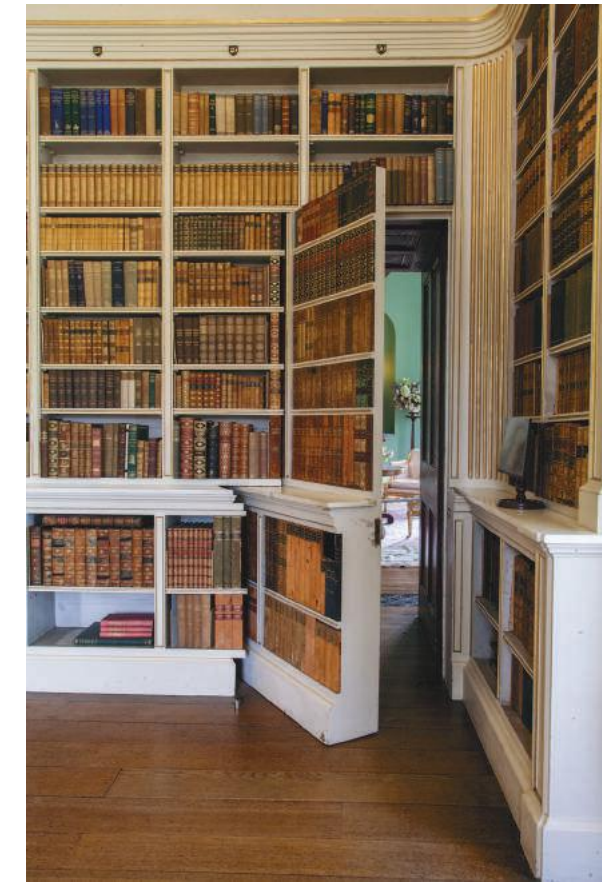
Figure 10: A jib door in the northeast corner bookcase, added by Charles Fowler, leads into the Music Room to the north. (Photo: Starr Herr-Cardillo)

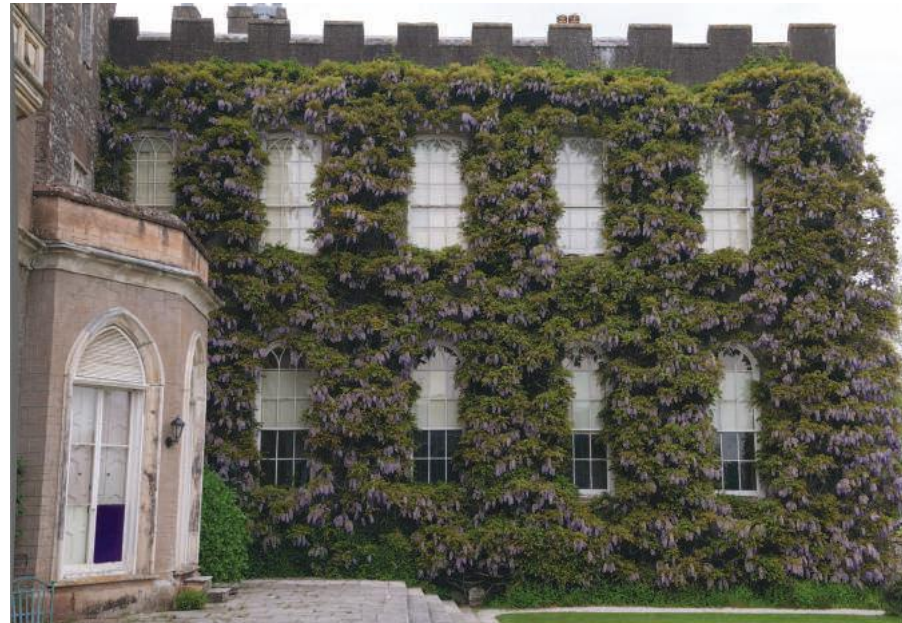
Figure 9: The south wall of the Libraries is covered with massive wisteria vines and render, making examination of the masonry walls impossible. (Photo: Dorcas Corchado)

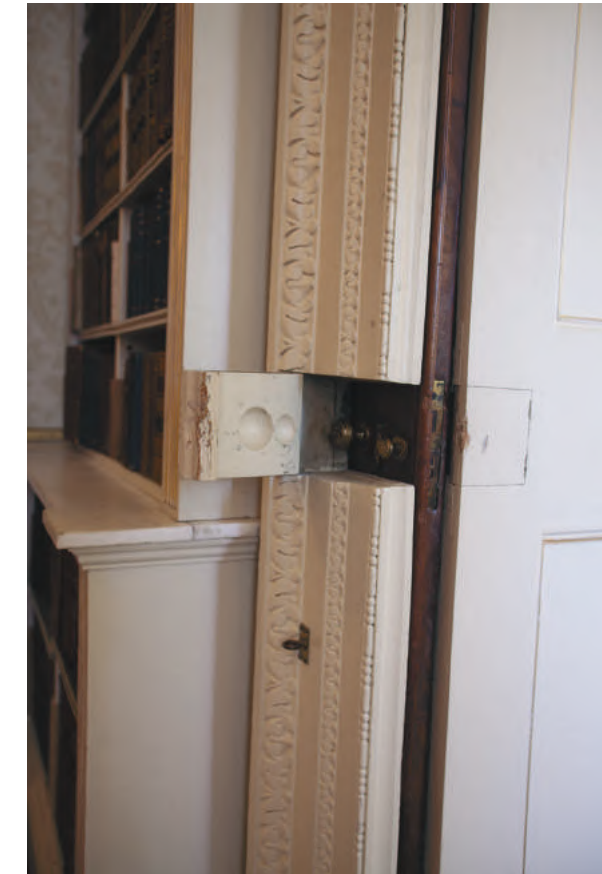
Figure 11: The Second Library is separated from the First Library by pocket doors installed by Charles Fowler. (Photo: Starr Herr-Cardillo)

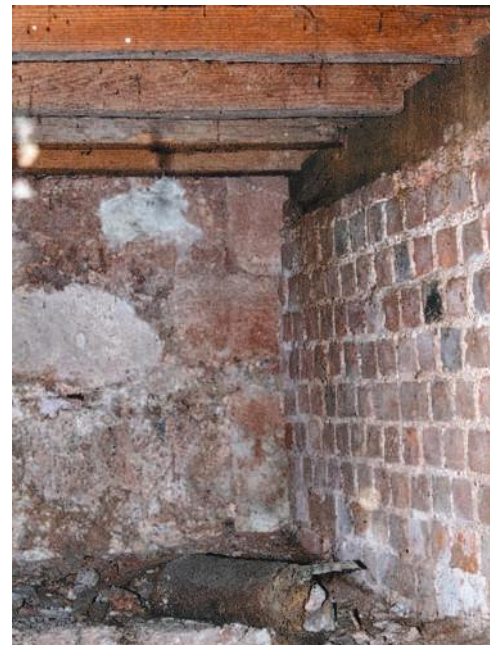
Figure 13: Image of the stone foundations found below the Second Library with indications of quoins. (Caroline Dickensheets)

During the floorboard investigations, we identified a stone wall that appeared to have quoins at the corner. Quoins would suggest that it was an exterior wall and marked the exterior wall of the castle with the chapel as a separate structure. [Fig. 2] In his article on Powderham, written in 1876, Harding gives the dimensions of the original chapel as “33 feet 4 inches by 19 and 18 feet high.” These dimensions are extraordinarily similar to those of the present day Second Library, suggesting that this room was indeed constructed on the foundations of the medieval chapel.

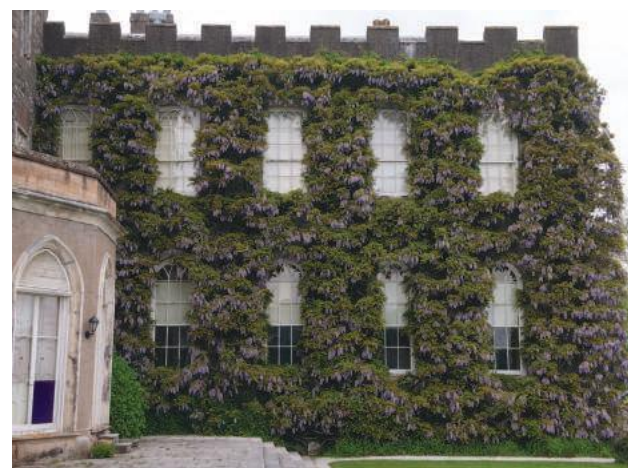
Figure 14: The exterior of the libraries is covered in an old-growth wisteria vine, making examination of the physical fabric a challenge. The walls have also been covered with a render, which obscures physical indications of building campaigns. (Dorcas Corchado)

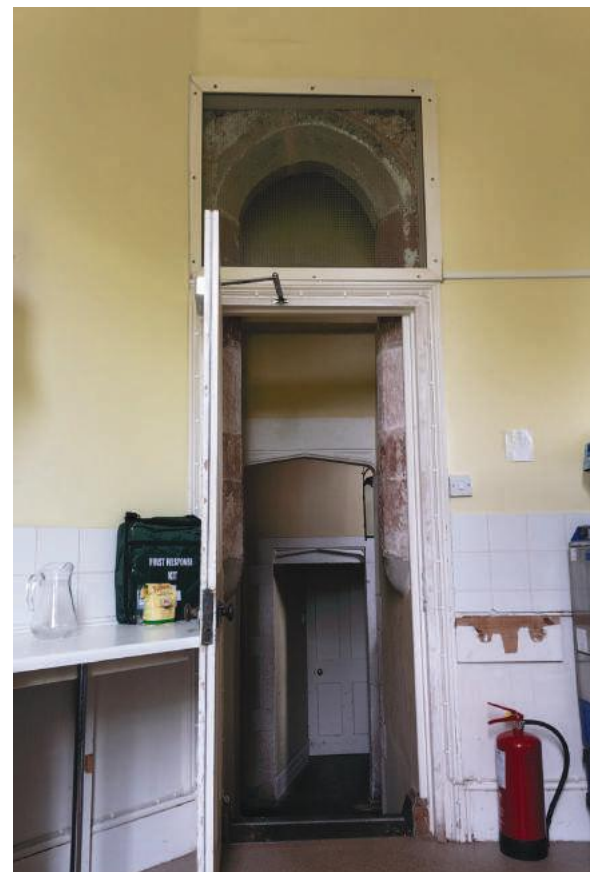
Figure 5: Remnants of a medieval door opening made of red sandstone are visible leading from the prep kitchen to the entryway. (Photo: Margaret Back)

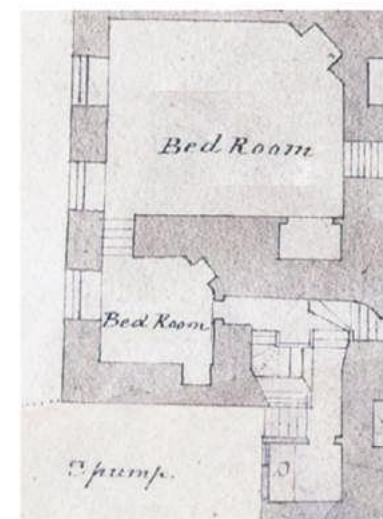
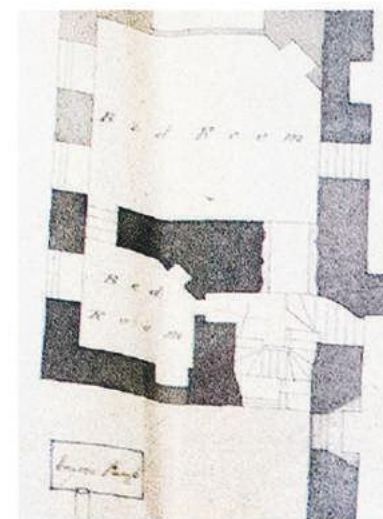
Figures 2 and 3: Fowler's "before" plan left and "after" plan right, showing removal of privy to the west and creation of passage to the east. 1836 and 1846.

Fowler's notes discuss doing foundation work in the area, as well as lowering the floor of the smaller chamber, shown five risers above the level of the bedroom in the pre-construction plans, to align with the larger room. He also discusses a new staircase in the existing stair well, (Fowler, p. 19-20.) and the creation of a passage between the stairhall and the larger chamber. Finally, Fowler may have added the present wood mouldings to the Prep Kitchen and Kitchen. While they appear identical to those in the First Library and Anteroom, the profiles are different enough to suggest different construction dates, and Fowler referenced "reconstructing and making good all the joiners work" (Fowler, 19). The paint on this trim also have fewer layers of paint than on the shutters in the Prep Kitchen, which implies that they were installed after the shutters, which may date from the 18th century.

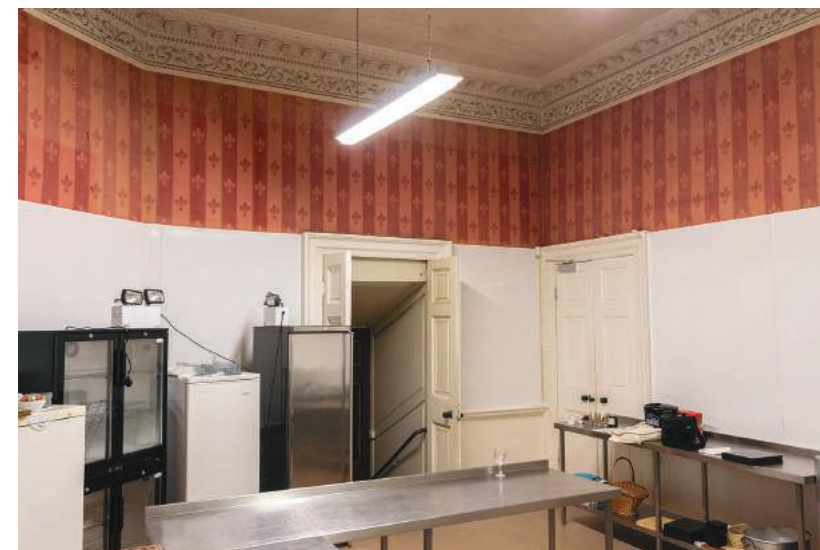
Figure 6: The prep kitchen sports an elaborate cornice. (Photo: Margaret Back)

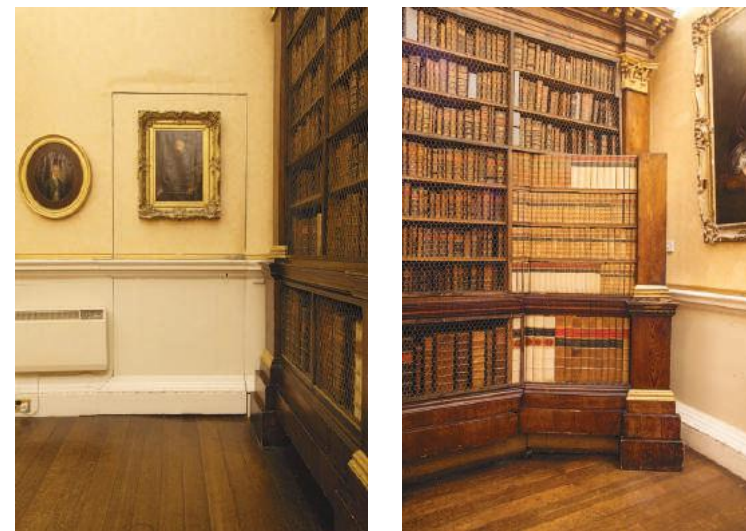
Figures 1 & 2: Jib doors lead to the first floor in the North Tower and to the Prep Kitchen. (Photos: Starr Herr-Cardillo)

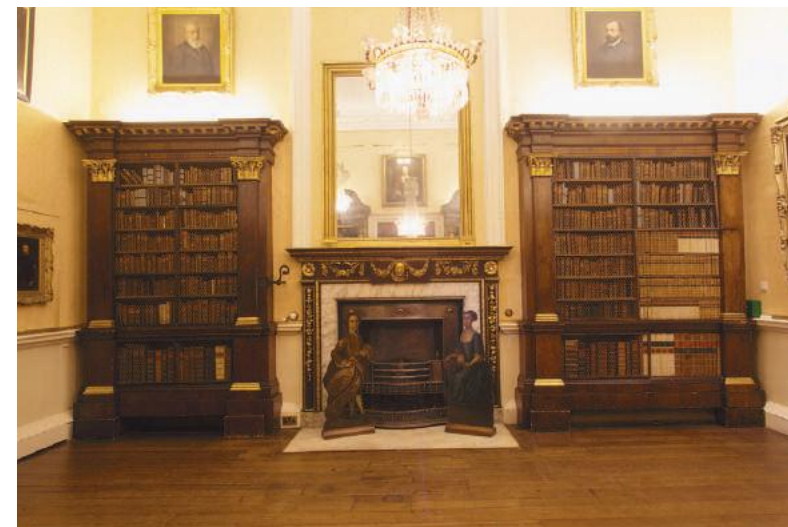
Figure 3: After adding the State Dining Room to the west of the space, a new window was needed to provide natural light. Fowler devised a sliding mirror above the fireplace which, when open, reveals a window. Photo: Zara Bhatti

The room's configuration in the early 19th century is shown in plans drawn by Charles Fowler prior to renovations (Fig.8). A fireplace was centered on the north, in its current location, and a window is shown near the south end of the west wall. When Fowler added the Dining Room to the west, this opening became a doorway. To compensate for the elimination of that source of natural light, Fowler created an ingenious arrangement over the fireplace, opening a new window that could be masked with a mirrored panel that slides into a side pocket. At the same time, privies and stairways between the Northwest and North Towers were removed, and in 1838, the new opening was finished with a neogothic stone surround and leaded glass sash (Fowler, Account of works at Powderham Castle from 1835 to 1840) (Fig.6). The secret door that leading to the north tower was reinstated in 1839, (Guide Book: Powderham Castle, Gardens & Deer Park) (Fig.1).

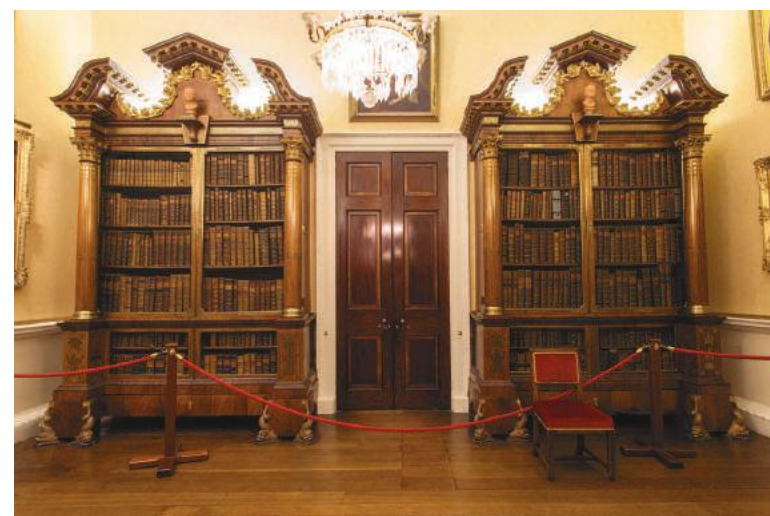
Figure 4: The elaborate bookcases designed by John Channon for the former library at the current location of the State Bedroom, are now located in the Ante Room. (Photo: Starr Her-Cardillo)

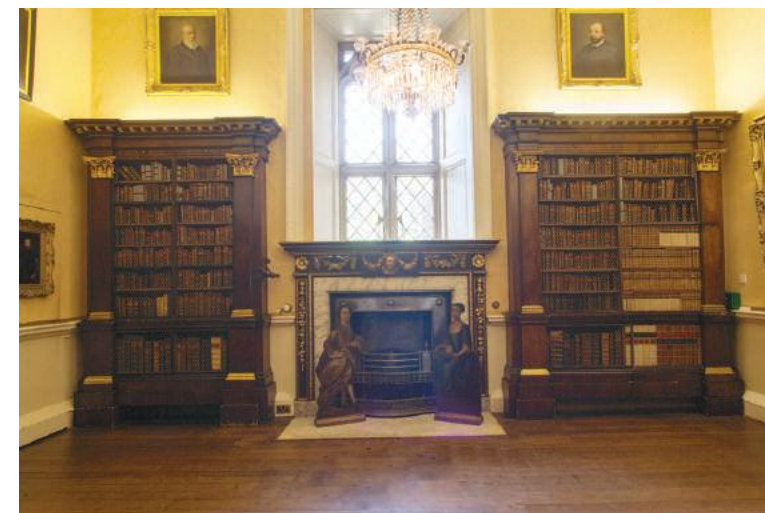
Figure 5: View of the north side of the room with the sliding window open. Fowler referenced the Channon bookcases to provide balance when he designed these bookcases on the other side of the room. (Photo: Zara Bhatti)

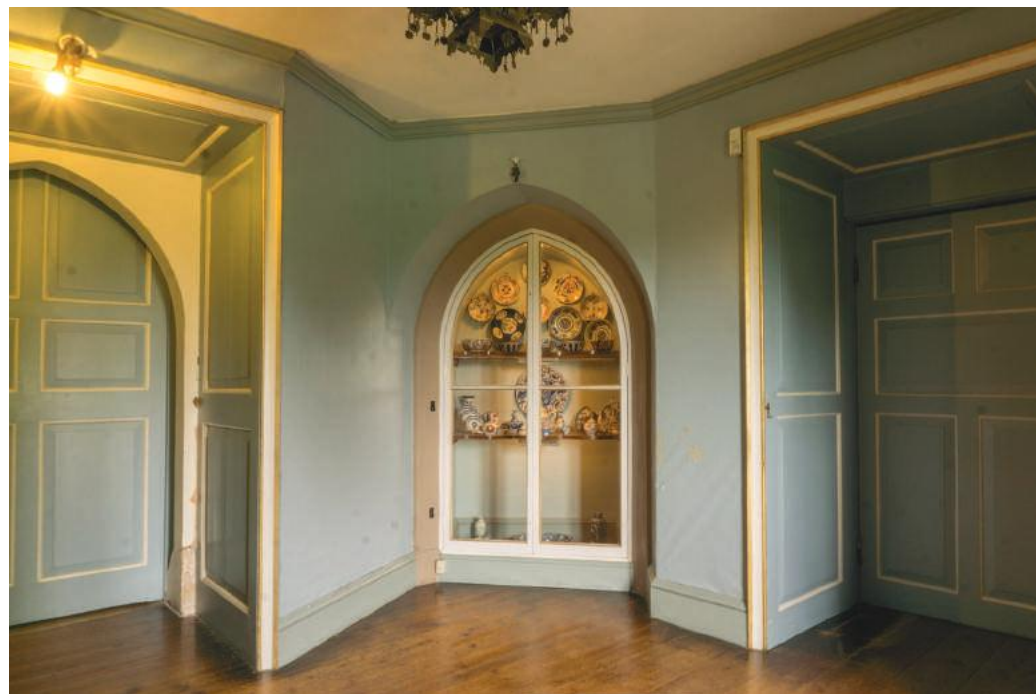
Figure 4: View of the tower stair entry-turned china cabinet at the northwest corner of the China Room. It is unknown whether or not the remnants of the Medieval newell stair remain behind the cabinet. (Photo: Zara Bhatti)

Charles Fowler recorded repairs made in the China Room in his Account of Works. He mentions cutting out the wall to form the Gothic Doorway to connect the China Room and the Terraced Garden outside and mentions "Removing [the] old staircase... putting up shelves and fittings."

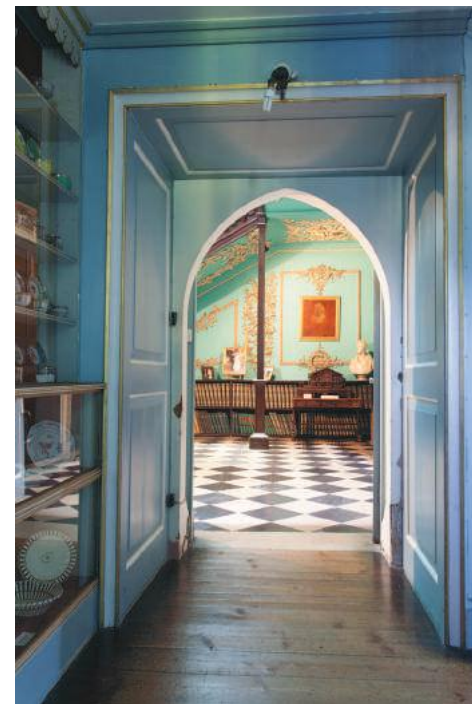
Figure 1: Looking from the China Room to the Stair Hall through Fowler's modified arch doorway. (Photo: Starr Herr-Cardillo)

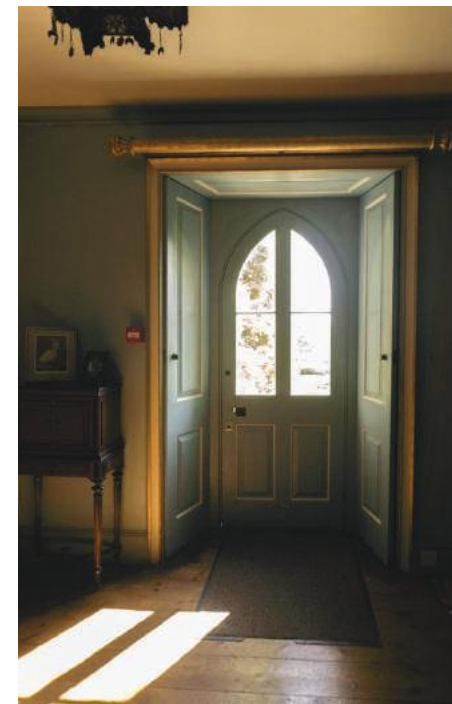
Figure 2: The doorway from the China Room to the exterior. (Photo: Zara Bhatti)

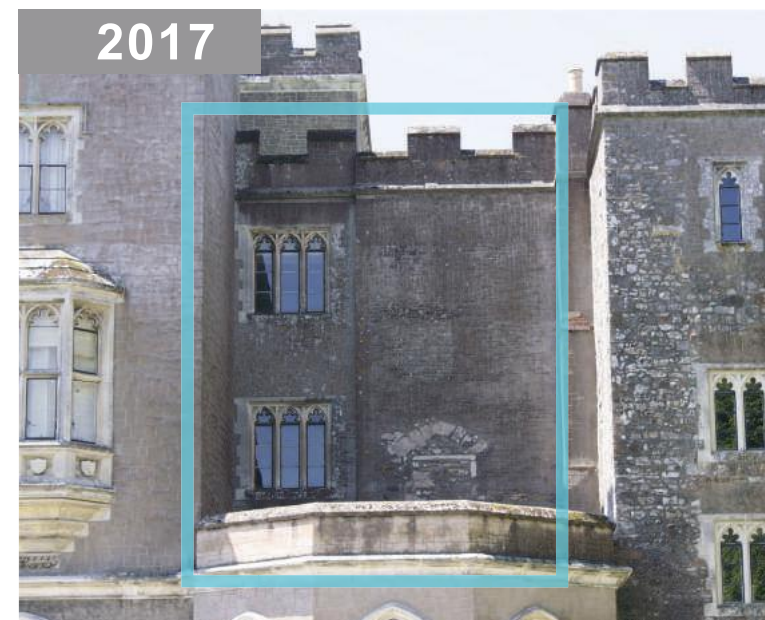
Figure 4: East elevation of Grand Staircase showing window infill. (Julia Cohen, 2017)

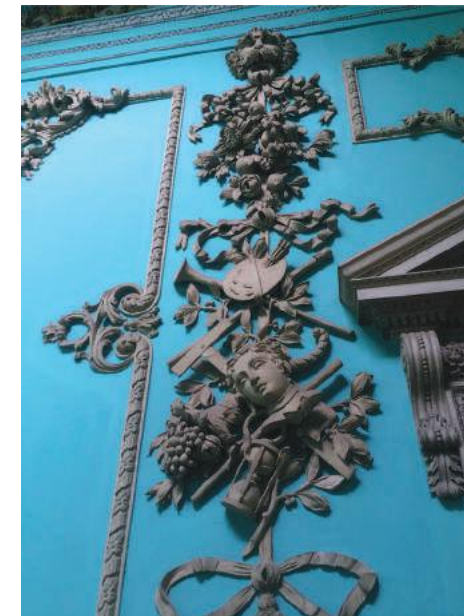
Figure 5: One of the elaborate, hand-modeled plaster pendants. (Julia Cohen, 2017)

John Jenkins and two assistants installed the ornate rococo stuccowork, which included twenty-eight panels, with ornately carved, hand modeled decoration accenting more linear stuccowork that was produced in wooden molds. The patterns and motifs were inspired by engravings such as Jacques Dumont and Gilles-Marie Oppenord's 1737 *Nouveaux Trophéz*. A receipt held at the Devon Heritage Centre confirms that his project cost £355 14s. instead of the quoted £217 8s. _

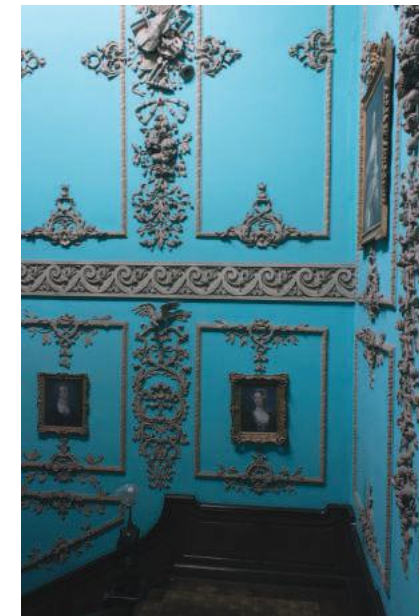
Figure 6: The "Vitruvian scroll" that runs along the south wall of the Stair Hall, ending abruptly at the west wall was mentioned in the original receipt of work. (Starr Herr-Cardillo, 2017)

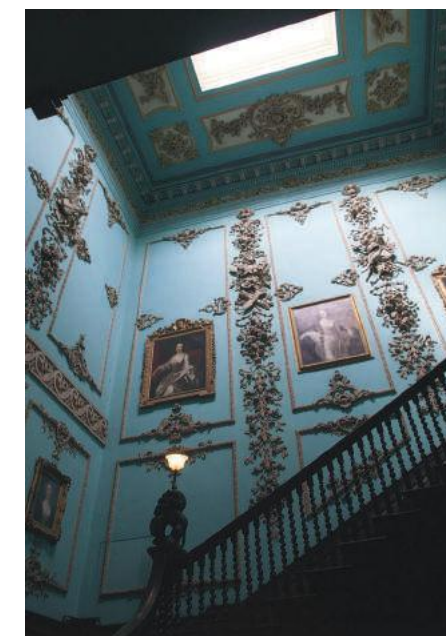
Figure 7: The west wall of the Stair Hall, showing Fowler's lantern. (Starr Herr-Cardillo, 2017)

Charles Fowler enclosed two windows on the west side of the room when he added the State Dining Room. To provide natural light to the space, Fowler added a lantern to the ceiling (Figure 7). In his "Account of Works at Powderham Castle from 1835 to 1840 Inclusive" Fowler notes "taking down plaster ornaments to be altered & reinstated" after the windows were closed. (Fowler 23) He also playfully restored and integrated the remaining medieval detailing in the castle, including "re-medievalizing" the arch that connects the Stair Hall and the China Room by plastering the gothic peak along with repointing and exaggerating the rustic stone which are revealed behind the 18th century door (right).

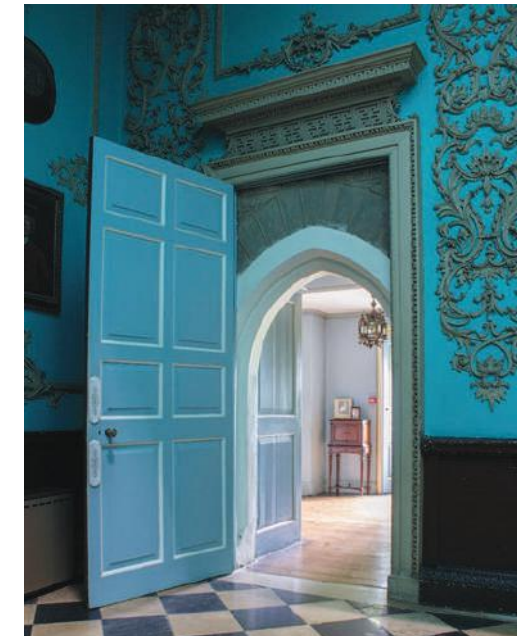
Figure 8: The doorway from the Stair Hall to the China Room reveals a medieval arch. (Starr Herr-Cardillo, 2017)

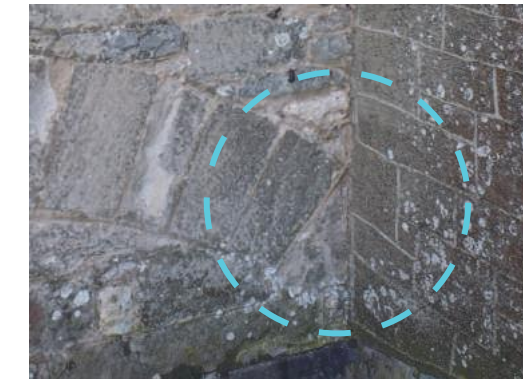
Figure 11: The very last stone in the relieving arch of the full Phase II arch is partially concealed by the west tower (shown intersecting in the photo), suggesting that the tower was a later addition that followed the second window campaign.

The Phase 2 arches are made from a darker stone and likely date to the Tudor period; it has been hypothesized that some construction, including re-fenestration, took place during the 16th century. (Waterstone) When projected onto the interior elevation, the Phase 2 windows do not align with the stair case. (Fig 14) Additionally, a portion of the southernmost stone of the full Phase 2 arch is slightly concealed by the addition of the West Tower, indicating that the windows were in place before the tower was added. (Fig.11)

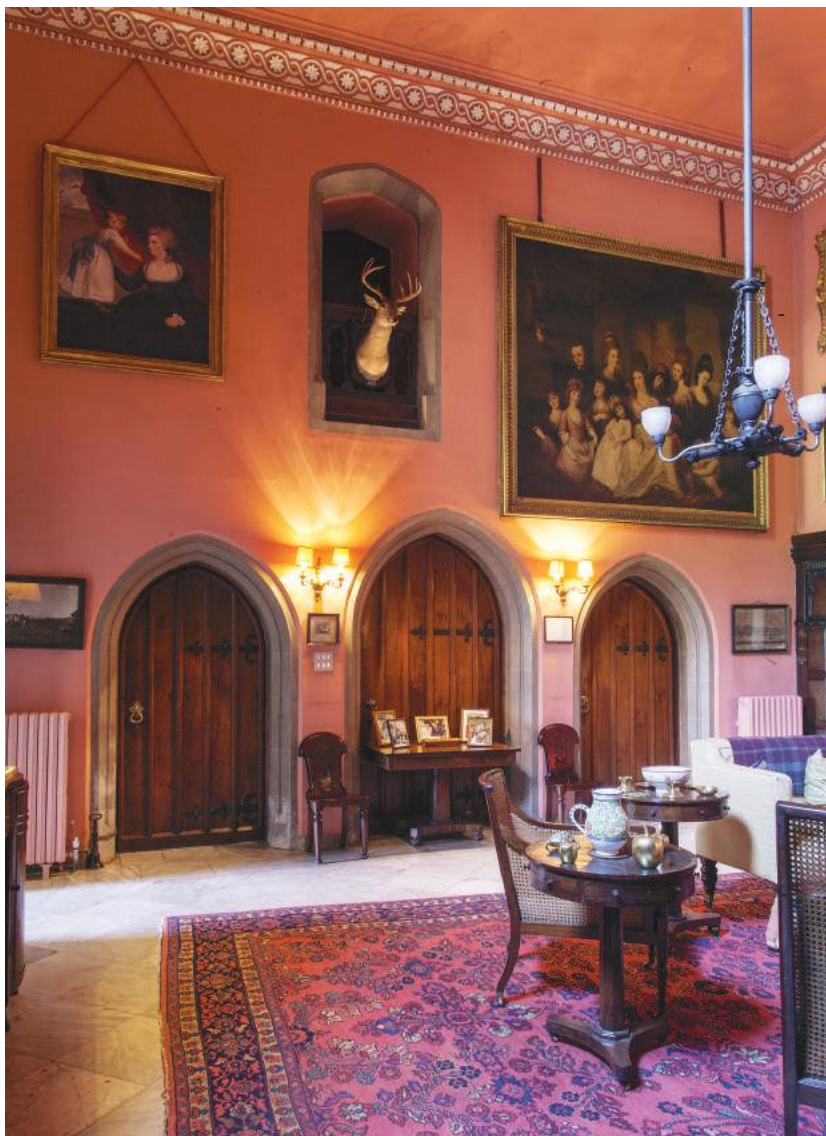
Figure 3: The three medieval arches referenced by Charles Fowler in his Account of Works at Powderham Castle. Fowler re-finished the arches in 1835; the right two doors are not functional due to a reconfiguration of the Kitchen in the private quarters, located on the opposite side. (Starr Herr-Cardillo, 2017)

Fowler's plans drawn before commencement of the renovations show that the two doorways were blocked prior to his work, and they remain so to this day, although with Fowler's imitation doors.

Prior to Fowler's alterations, the easternmost archway was a rectangular door. Fowler, in keeping with his vision to re-medievalize the castle, understood that the configuration had likely been a trio of archways, as was common in medieval architecture, and refinished the three doorways accordingly.

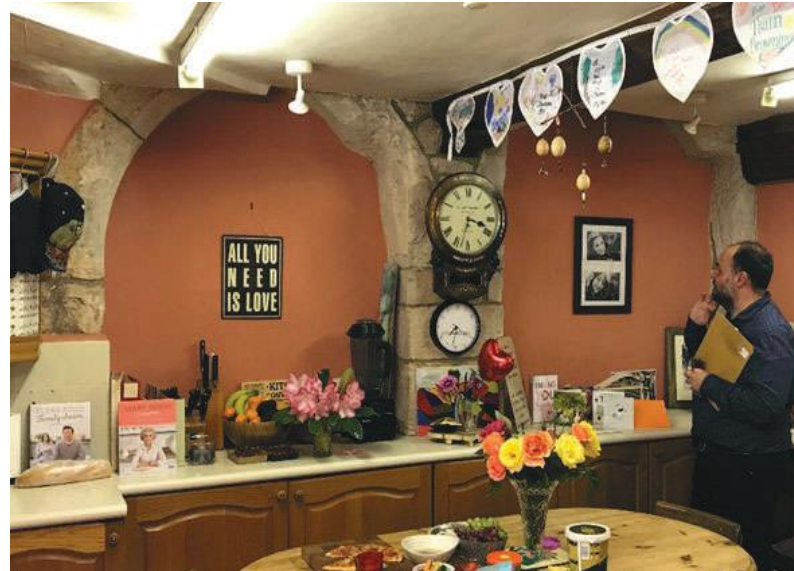
Figure 4: View of the same arches from the Private Kitchen reveals that they were constructed of rough hewn light red sandstone. (Alberto Calderón-González, 2017)

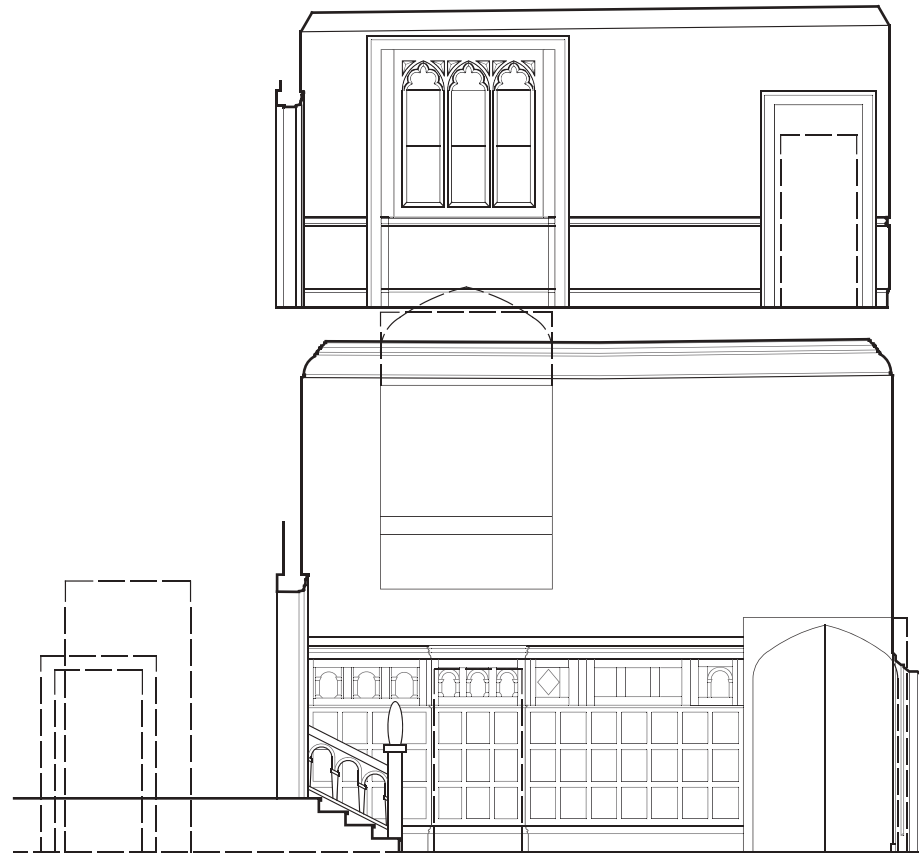
0014 & 0113
(1)

EAST ELEVATION/SECTION

Evidence regarding the height of the original medieval Great Hall is inconclusive so far. A hall occupying the full height of the castle would be unusually and impractically tall, and of fairly unusual proportions, though not unheard of. However, there is so far no evidence of any pre-eighteenth century horizontal division in the space, and all divisions seem to have been installed at the same time. The large window on the ground floor (pictured left) extends beyond the ceiling of the room, suggesting that it may have lit the earlier Hall.

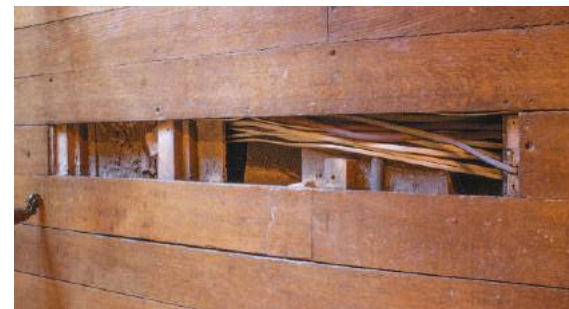
Figure 11: By removing some of the floorboards in the sitting room, we could discern that they were pit-sawn and observe the structure underneath. (Photos: Alberto Calderón-González)

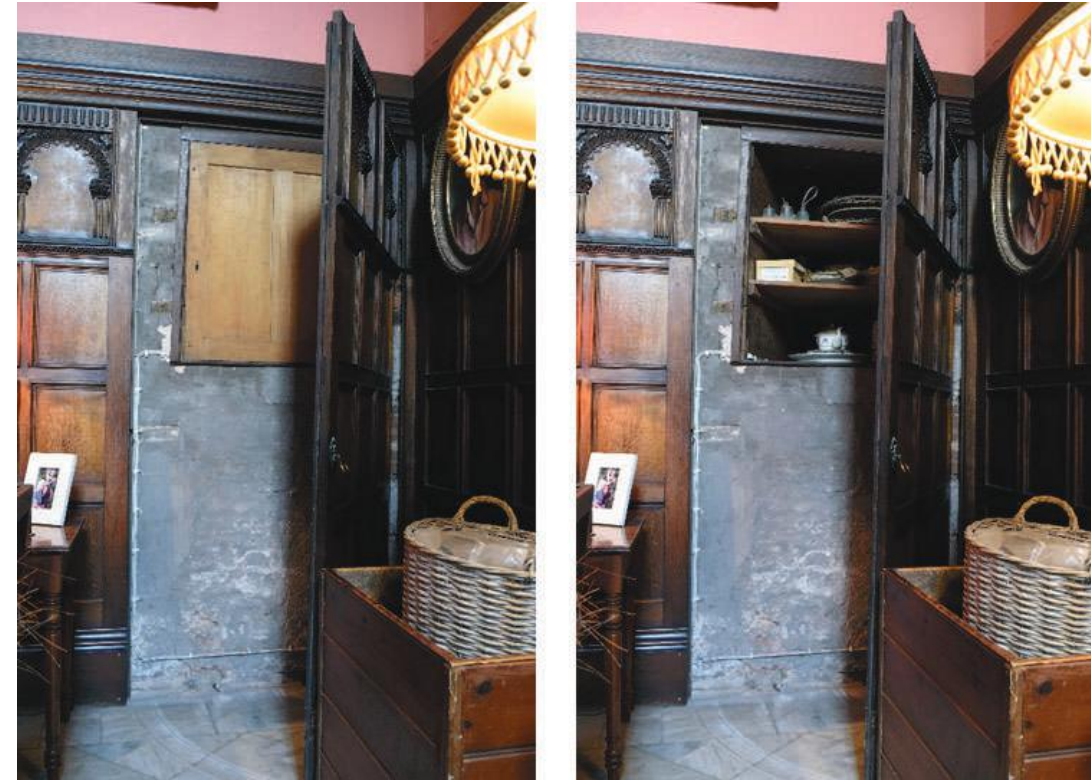
Figure 10: When the door leading to the cupboard on the west side is opened, a section of the medieval wall is exposed. This is a rubble wall covered in plaster, except the framing for the cupboard opening which is made of brick. On the right side of the opening there is a carved stone with cavetto moldings on both sides, which cannot be seen completely. This stone could have been part of an architectural feature such as a window or a fireplace, though it may not be in its original position. (Photo: Alberto Calderón-González)
