POWDERHAM PRAXIS, 2017-2018

University of Pennsylvania Graduate Program in Historic Preservation
Cornerstone Praxis, University of Plymouth
Powderham Castle

1: INTRODUCTION

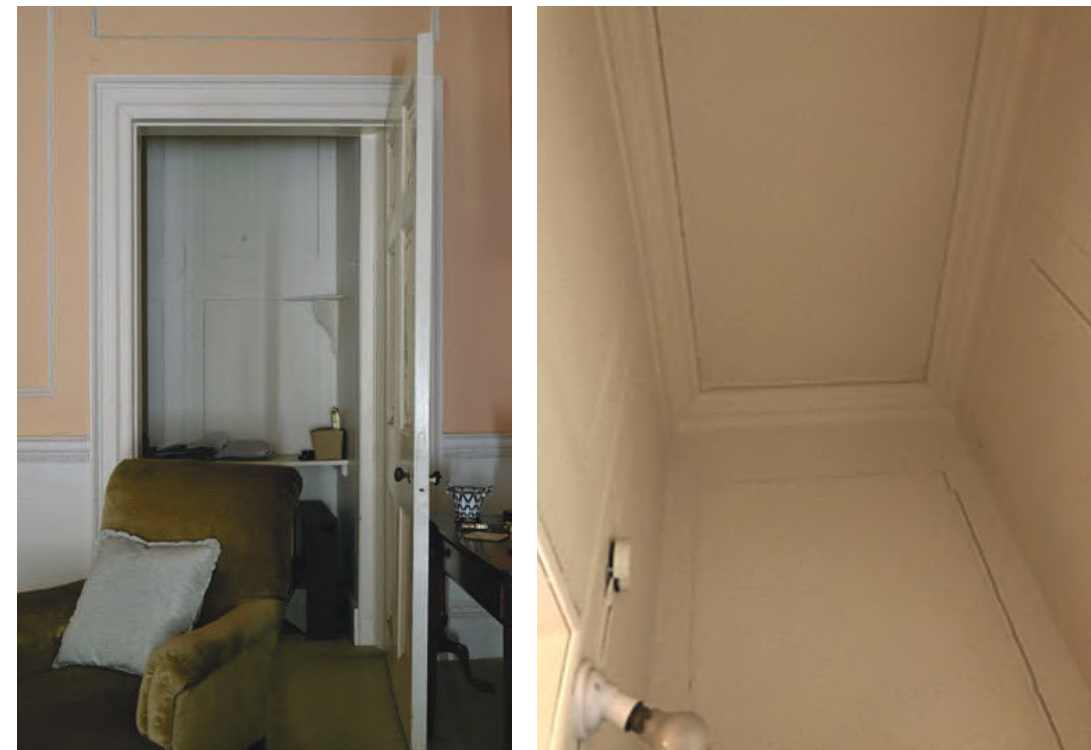
Figure 12: Inside the White Drawing Room there is a closet built into the stone wall of the medieval structure. The closet is not aligned with its door, and is much taller than is necessary (Figure 12); this strongly suggests that the closet was inserted into a major opening in the wall – it is the tallest opening encountered in our investigations thus far. Given that this was originally the main façade of the castle, we speculate that it may have possibly been an entrance to the Great Hall. (Photo: Alberto Calderón-González)

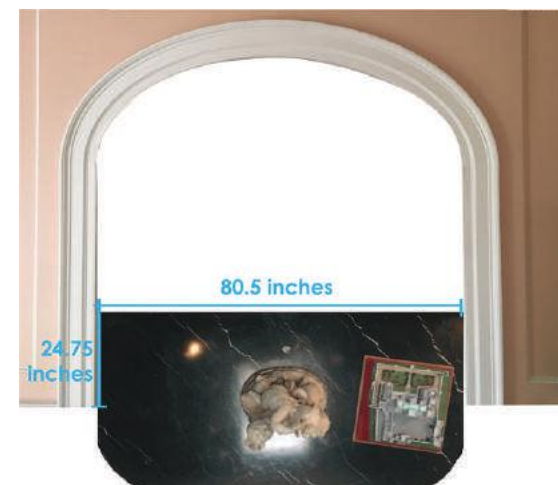
Figure 6: Measurements of the White Drawing Room alcove compared to the sideboard in the Stair Hall (Illustration: Kallie Kothman)

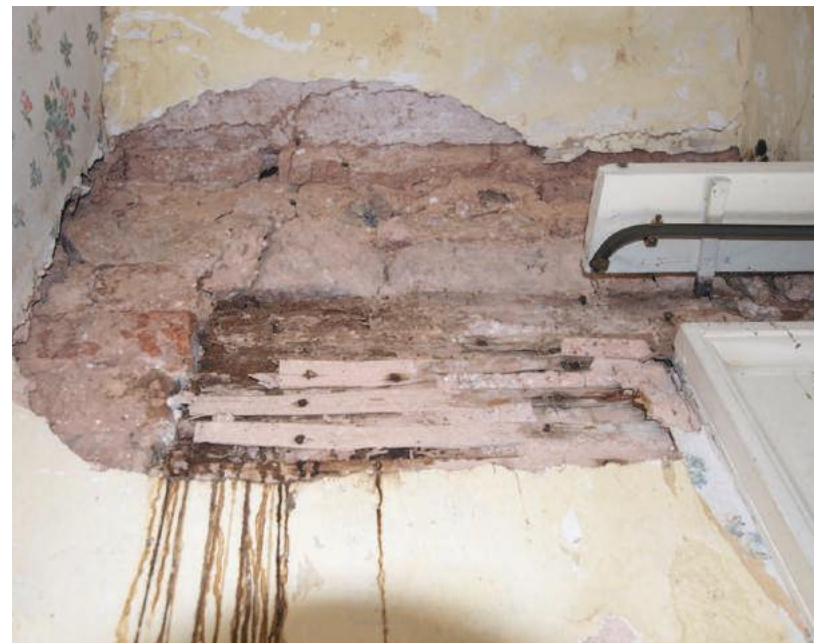
Figure 4: Large exposed wooden lintel in second floor bedchamber. (Image Credit: Allison King)

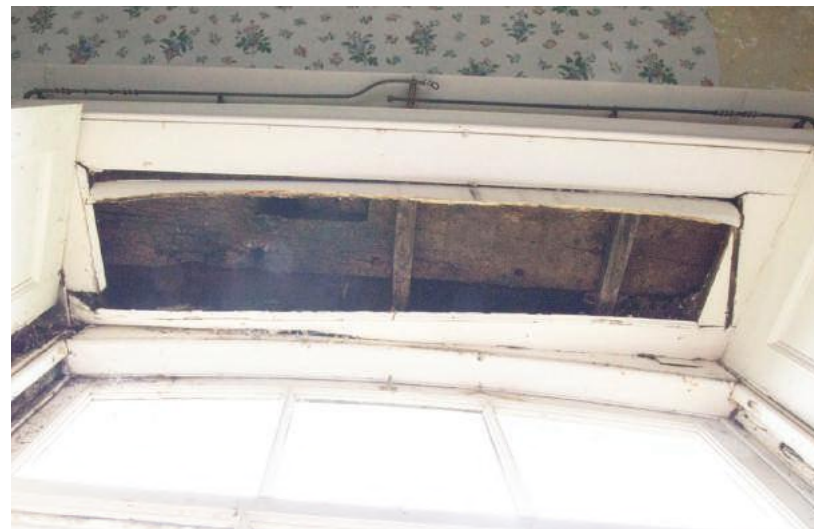
Figure 6: Tenon opening in large wooden lintel (Image Credit: Allison King)

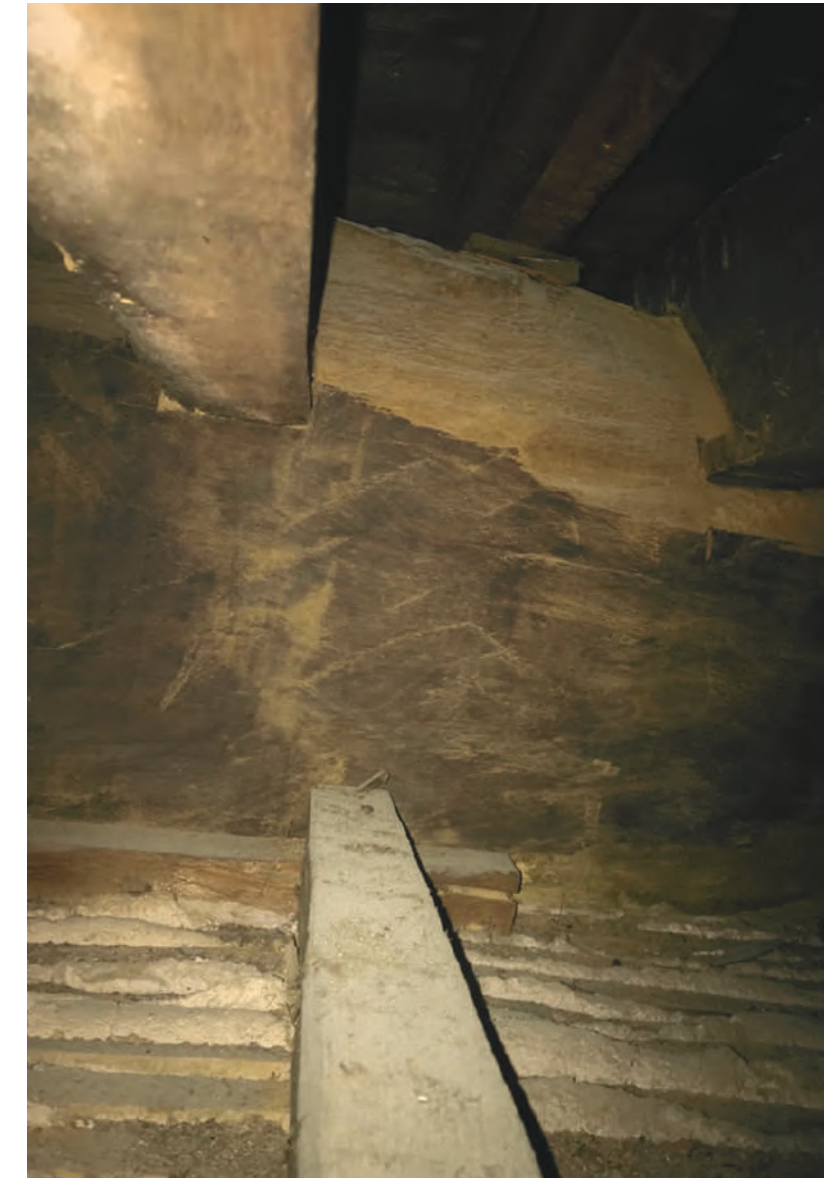
Figure 7: Mortise and tenon joinery from the ceiling of the medieval core above Room 17 (Image Credit: Allison King)

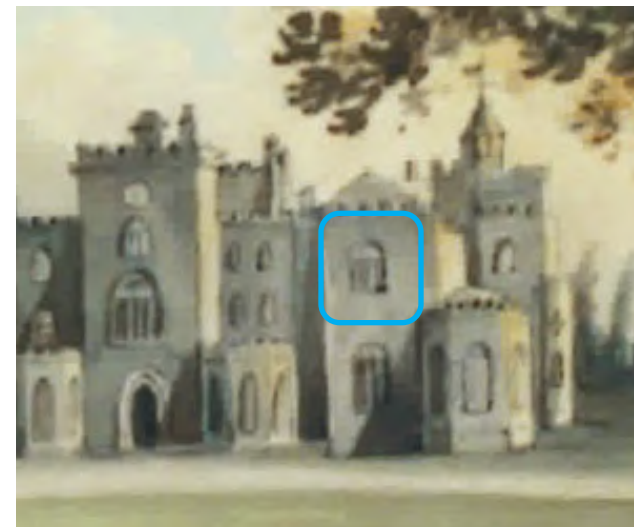
Figure 8: 1978 depiction showing arched muntins in the State Bedroom. (Swete, 1798)

While all six windows found in the State Bedroom and Rose Room are depicted in the Buck view, the muntins appear to be straight. The sash are shown in their present arched form in a illustration by Swete (Figure 8) dated 1798. The change may relate to the addition of the Music Room by James Wyatt to the north in 1794. The small window on the west elevation of the State Bedroom is not shown in either depiction

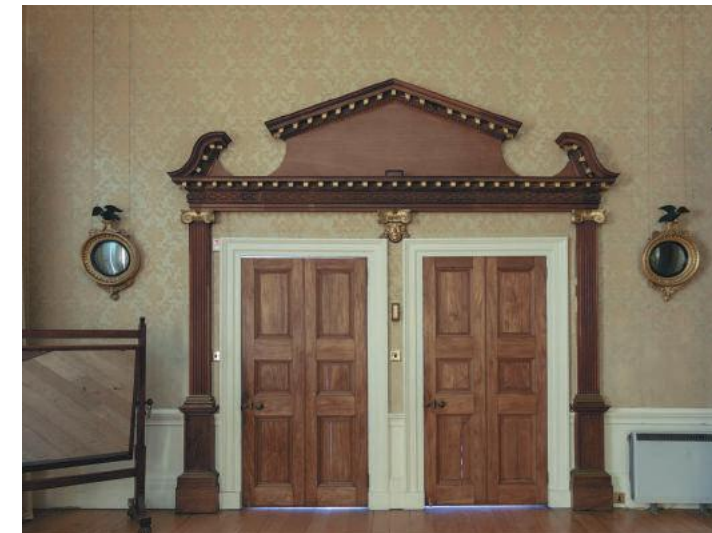
Figure 9: The door surround on the west wall was installed by Fowler to match the elaborate fireplace and provide access to rework rooms to either side. (Photo by Mia Maloney)

(Figure 9) to match "the style of the original work," i.e. the fireplace. This likely replaced an earlier opening centered in that wall and leading to the anteroom or lobby. Fowler also makes note of "coloring" the ceiling, which suggests that a decorative plasterwork ceiling may have once existed in the room.

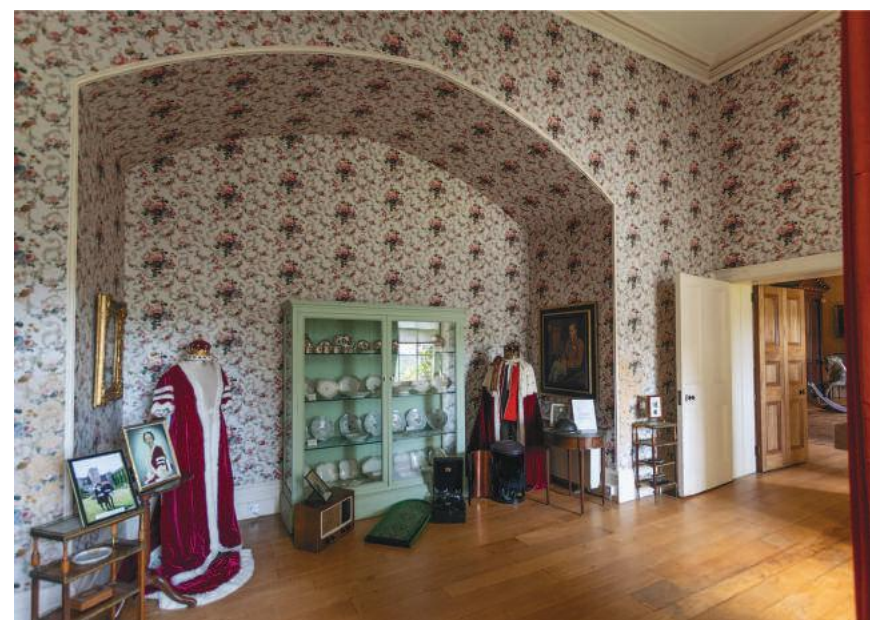
Figure 10: An alcove in the Rose Room was installed by Charles Fowler when he partitioned the spaces. (Photo by Mia Maloney)

Between 1837 and 1838 a "trussed" partition was built (see Figure 10), subdividing the spaces of the Ante-Room, Chinese Hallway, and Rose Room. The "truss" likely referred to the framing of the Rose Room's arched alcove, but it is unclear whether it was constructed for structural or aesthetic reasons. Had the room been intended for use as a bedroom, the alcove could have functioned as a space to place the bed, but the room was identified as a dressing room. Thus, the truss and alcove may have been intended to support the ground floor ceilings or the roof over the attic. Preliminary investigation of the attic space reveals metal bands connecting the ceiling beams to the roof trusses, which may have been part of a system of support designed by Fowler (Figure 11).

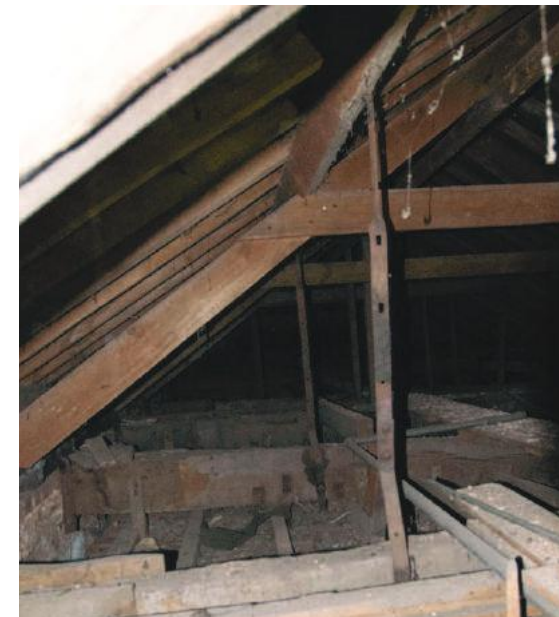
Figure 11: Metal straps connecting ceiling beams to trusses. (Photo by Mia Maloney)

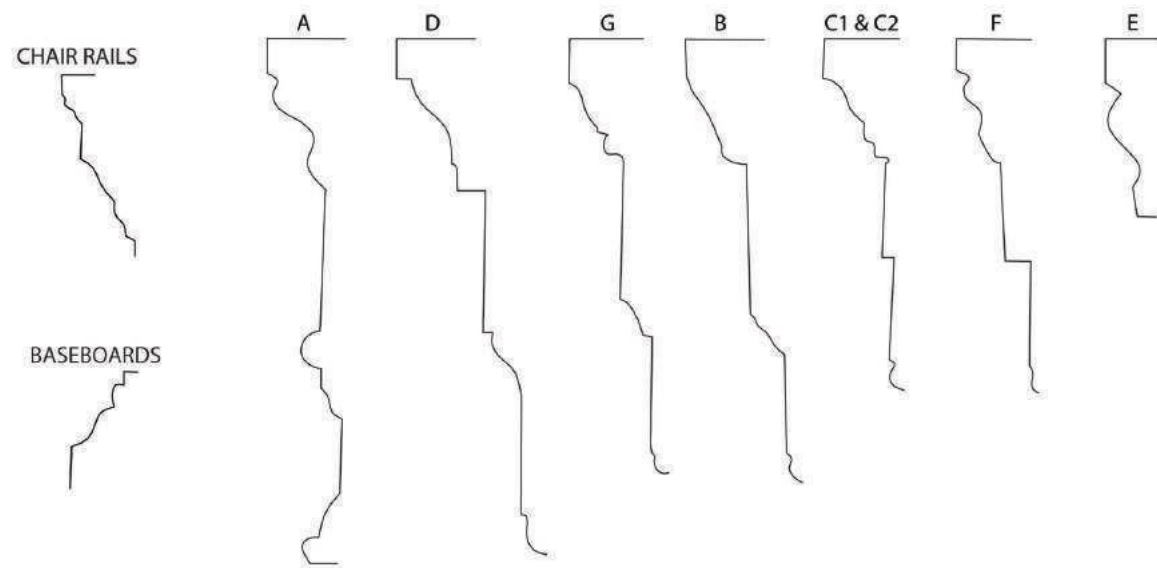
Figure 13: Moulding profiles found in the State Bedroom, Rose Room, Ante Room, and Chinese Hallway.

With the partition came extensive changes in the woodwork. The interior partitions in the Rose Room, Ante-Room, and Chinese Hallway all required new baseboards and cornices, and addition and alterations to windows and doors meant that new casing mouldings were needed as well. In addition to one baseboard profile and one chair rail profile, six different moulding profiles were found on the door and window surrounds of the four rooms, identified with a letter from A-F (Figure 13) One of the mouldings, profile C, was given two variations: C1 and C2. This is due to a slight variation in the hand carved details on the otherwise identical profile, which would have required the same moulding plane to produce. The combined moulding profiles and paint analysis suggest that the majority of the mouldings in the four rooms date to at least Fowler's period, though it is unclear why so many different profiles were used.

The paint analysis of the wainscoting and window sashes in the Rose Room were too inconclusive, and paint analysis was not done on the mouldings around the closet door (profile F). Because profile F is less ornate than any of the other mouldings and is not found anywhere else, it may date to a later period, potentially when the sink was added in the closet. It is unclear why a different moulding profile was used on the doors and windows of the Rose Room. One possibility is that the window mouldings were original to the space, and were stripped of their paint before being refinished by Fowler. However, because of their similarity in proportions to the door mouldings, it seems more likely that, like the window and door mouldings in the State Bedroom, both were created by Fowler but several years apart.

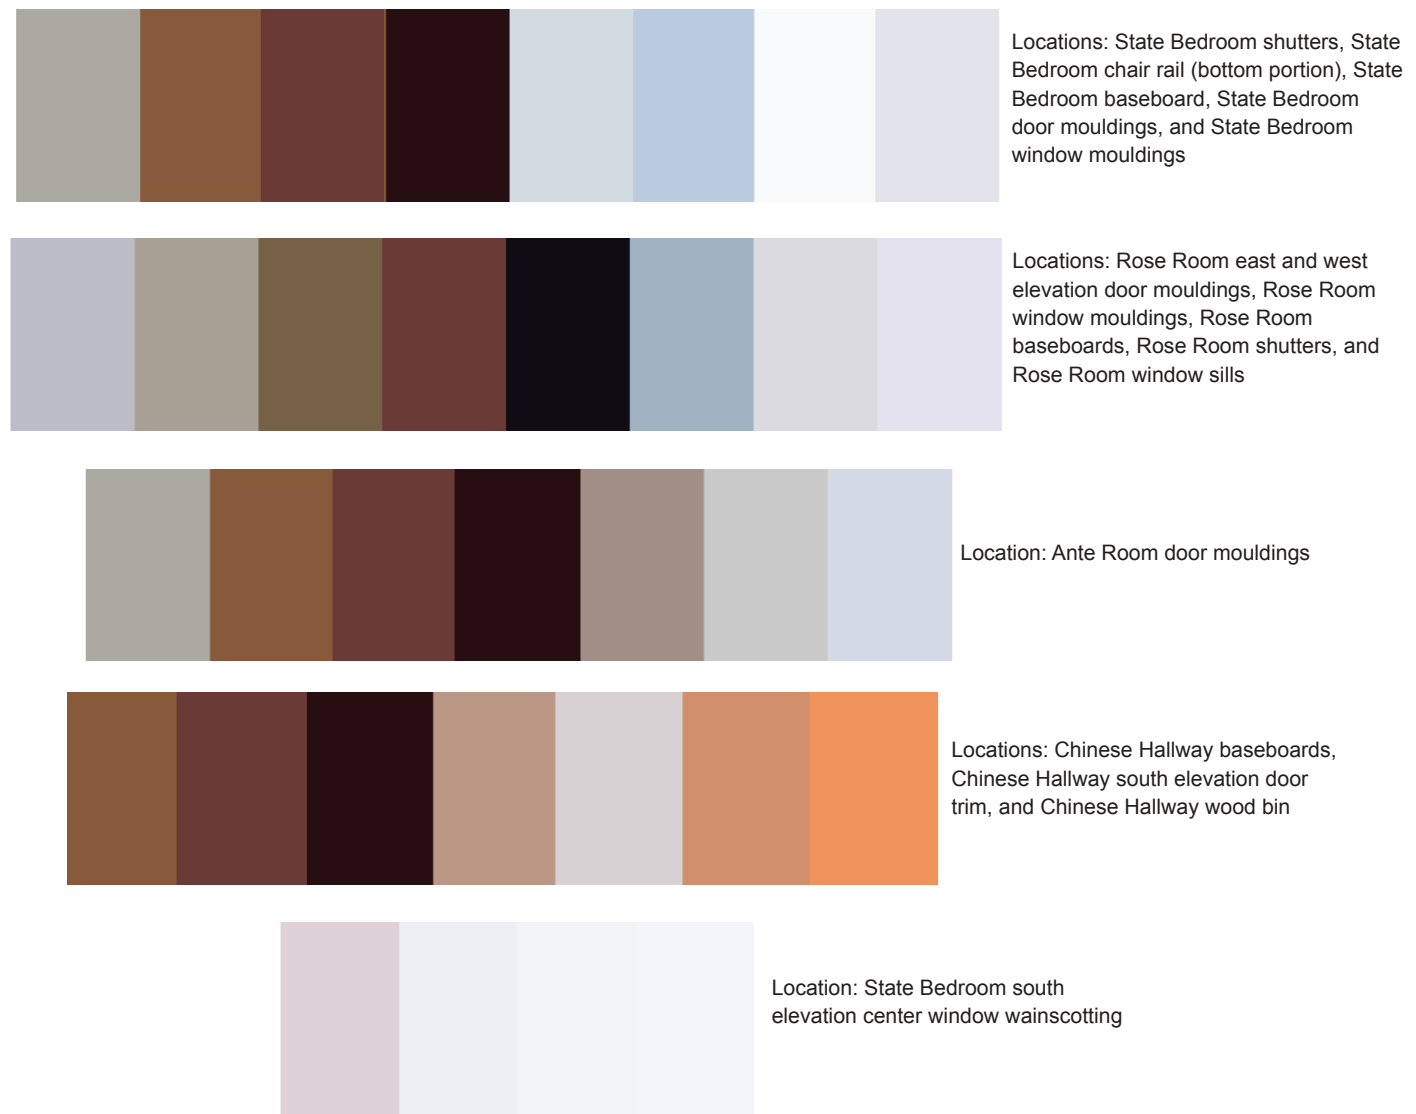
Figure 14: Examples of paint stratigraphy from the State Bedroom, Rose Room, Chinese Hallway, and Ante Room (Mia Maloney.)

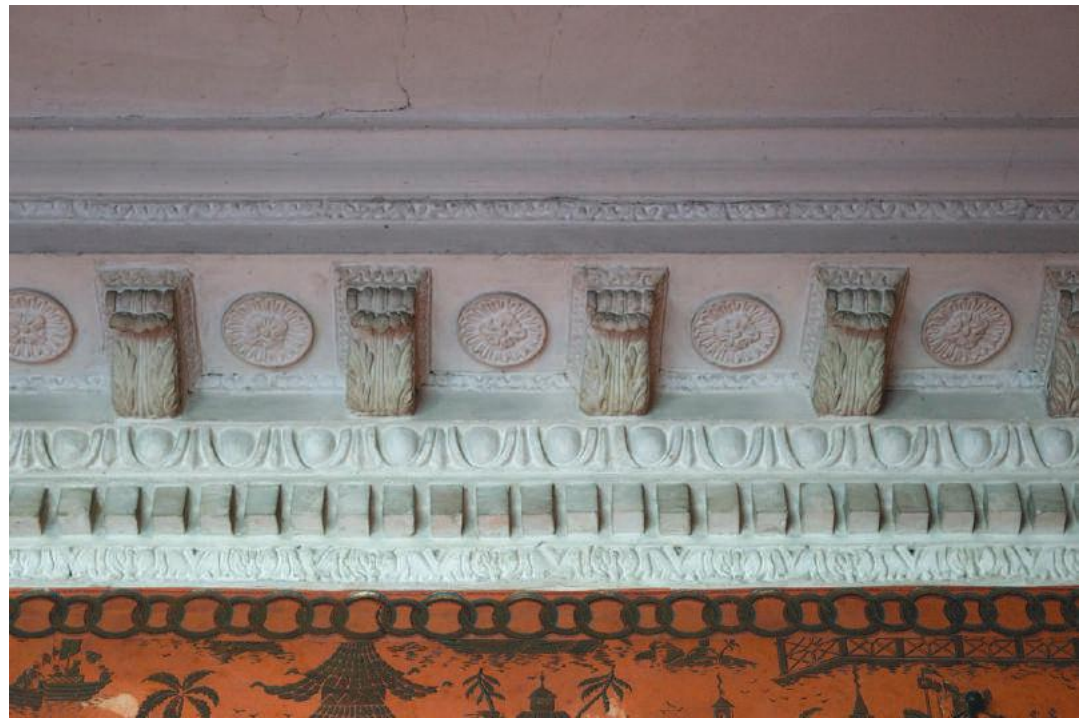
Figure 15: The cornice in the Chinese Hallway, which may be a copy of the original cornice in the State Bedroom (Photo by Mia Maloney.)

It is unlikely that any of the rooms feature an original cornice. In order to maintain some of the original detailing when partitioning the space, Fowler copied the cornice that was in the State Bedroom for the other rooms. That is likely the cornice which remains in the Chinese Hallway (Figure 15), which is similar to one seen in early 20th century photos of the State Bedroom (Figure 16). The date of the cornices in the Ante-Room and Rose Room are unknown, though their relative age could be determined by comparing their paint stratigraphy to other woodwork in the rooms.

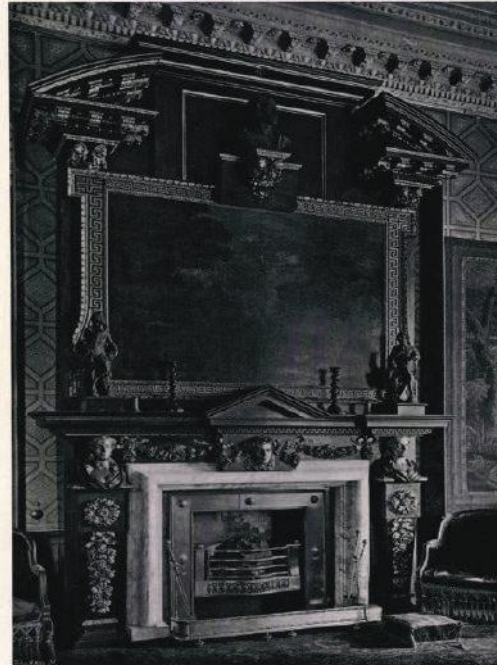
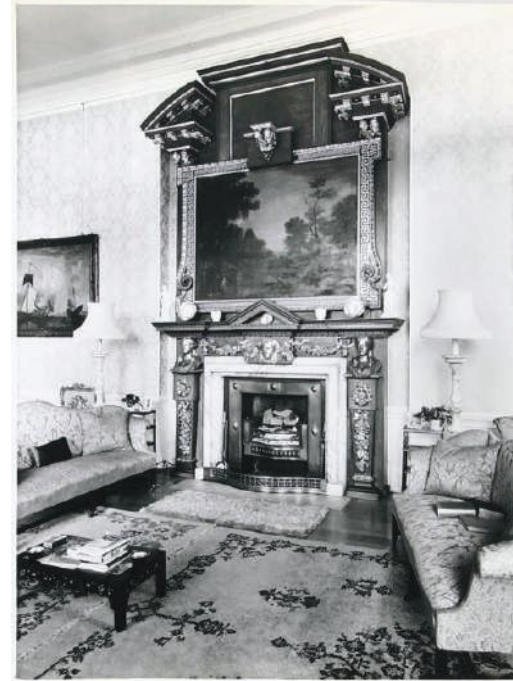
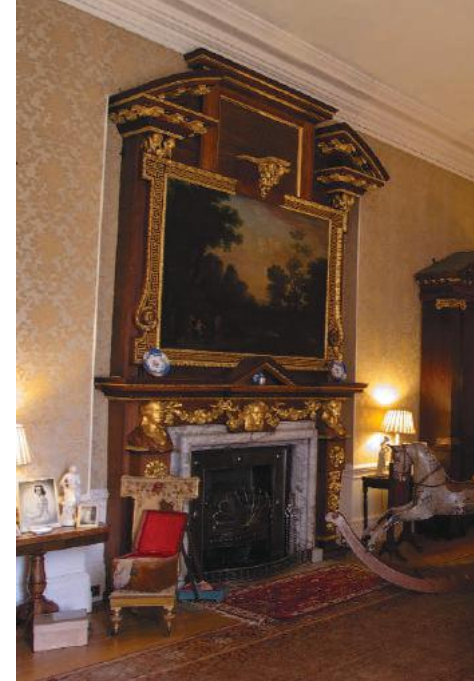
Figure 16: The view on the left from a 1908 issue of Country Life shows an elaborate cornice installed in the State Bedroom. In the center photo, from the 1962 issue of the same magazine, the cornice has been removed. The photo on the right shows the space today. (Photos: Country Life Magazing, Mia Maloney)

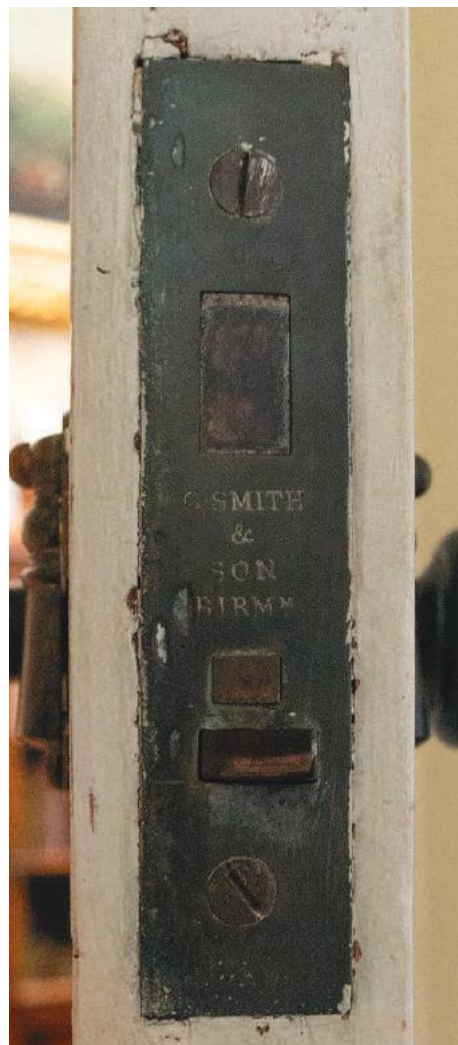
Figure 17: Mortise lock on the door between the Ante-Room and Rose Room (Photo by Mia Maloney).

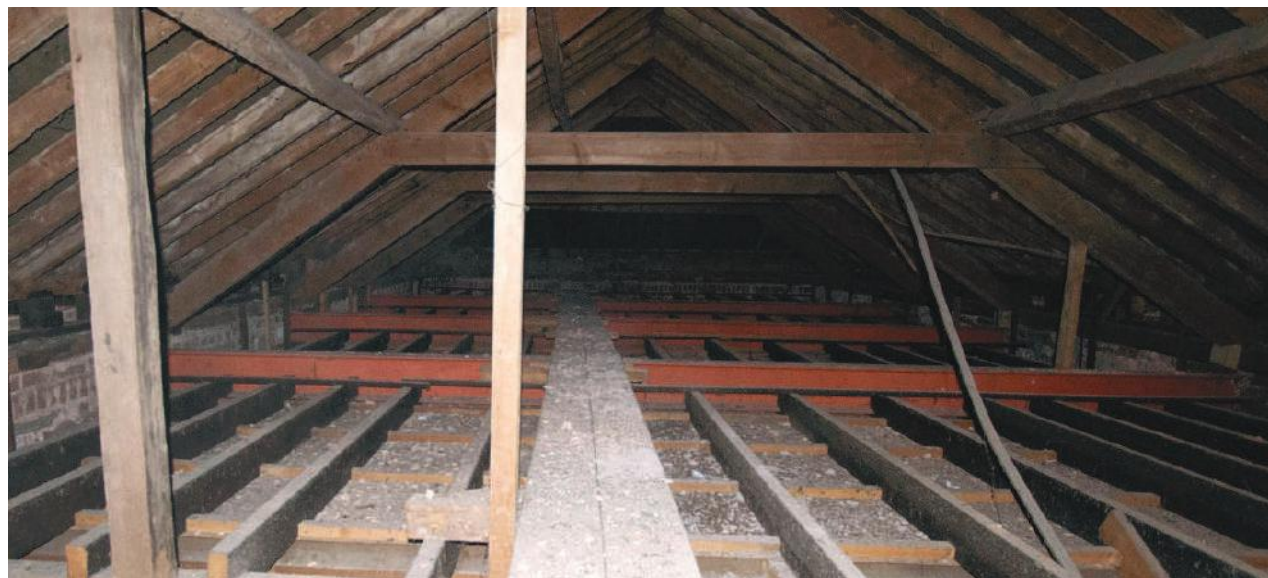
Figure 20: Steel beams over the State Bedroom (Photo by Mia Maloney).

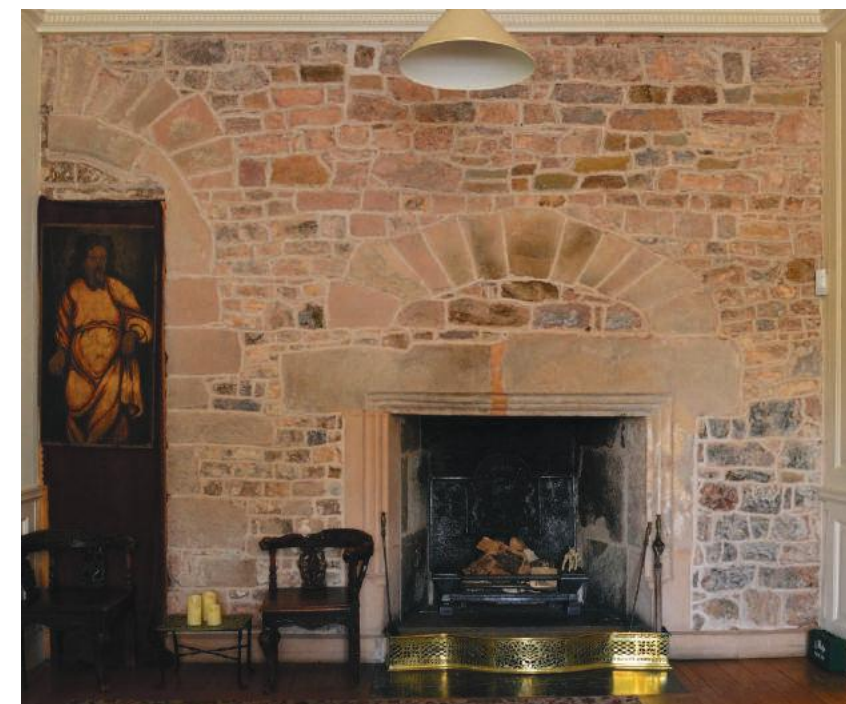
Figure 4: The exposed stone wall reveals the construction behind the Medieval-era hearth and a door opening to the left. (Photo: Zara Bhatti)

Third Floor Apartment (Room 0301). The current third floor apartment was created by Fowler, who subdivided the second story space below the roof. Fowler preserved an opening to the spiral staircase here, citing its retention as a means of "private access" to the tower's upper levels (Fowler 1840, 20) (Figure 11). He also modified openings in the space, moving a window from the west elevation to the north elevation and replacing it with a fireplace (Fowler 1840, 16) (see Figure 4), and creating access to the roof via a hallway to the southeast.

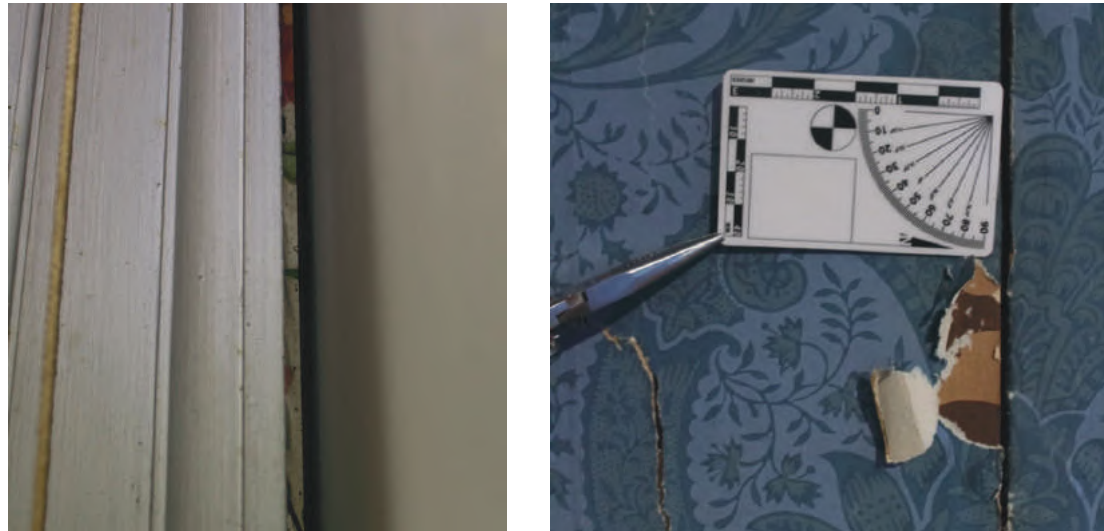
Figures 5-6: Evidence of three phases of wallpaper visible in Lord Courtenay's study—a Chinois-style floral paper (left), a brown and cream Victorian paper (small tear, right), and the current blue Edwardian paper (left) (Photos by Anthony Hita)

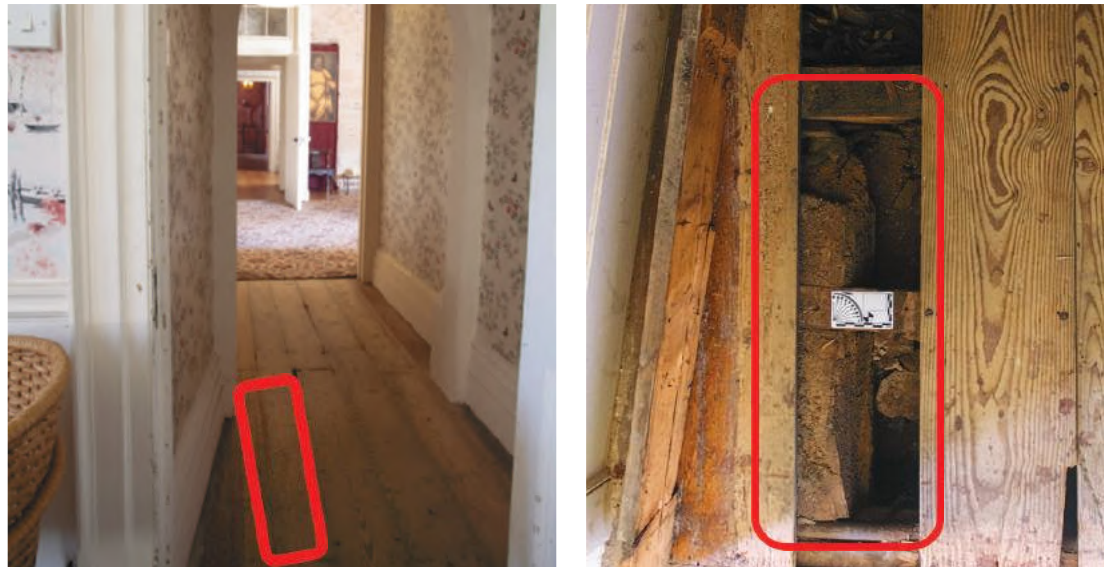
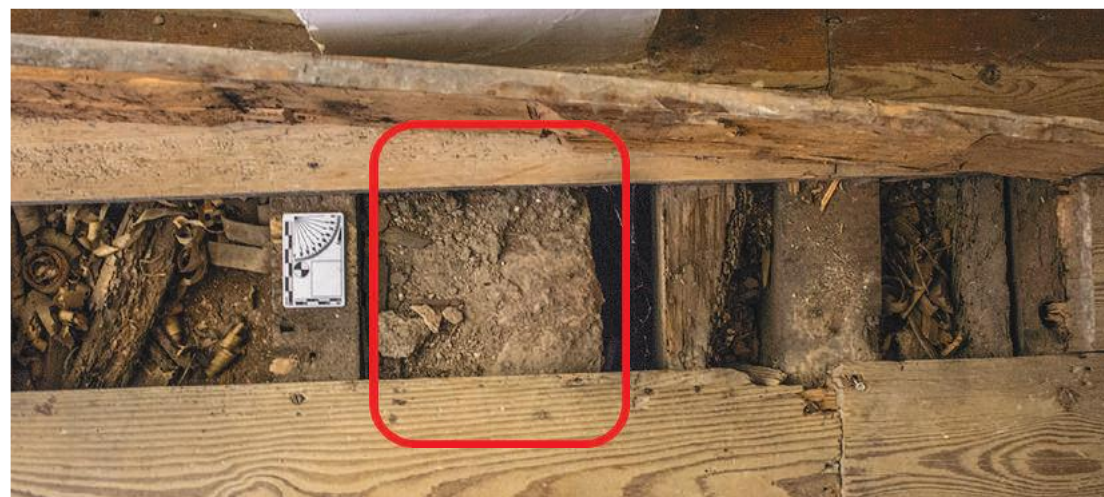
Figures 7-8: Evidence of Fowler's modification and medieval fabric under the floorboards in the hallway connecting the Dressing Chamber to the Solar on the southeast side of the North Tower's first floor. Top left: context for location. Top right: A possible medieval hewn timber cut by Fowler's floor joists. Bottom: A stone threshold, likely the medieval entrance to the tower. (Photos by Anthony Hita.)

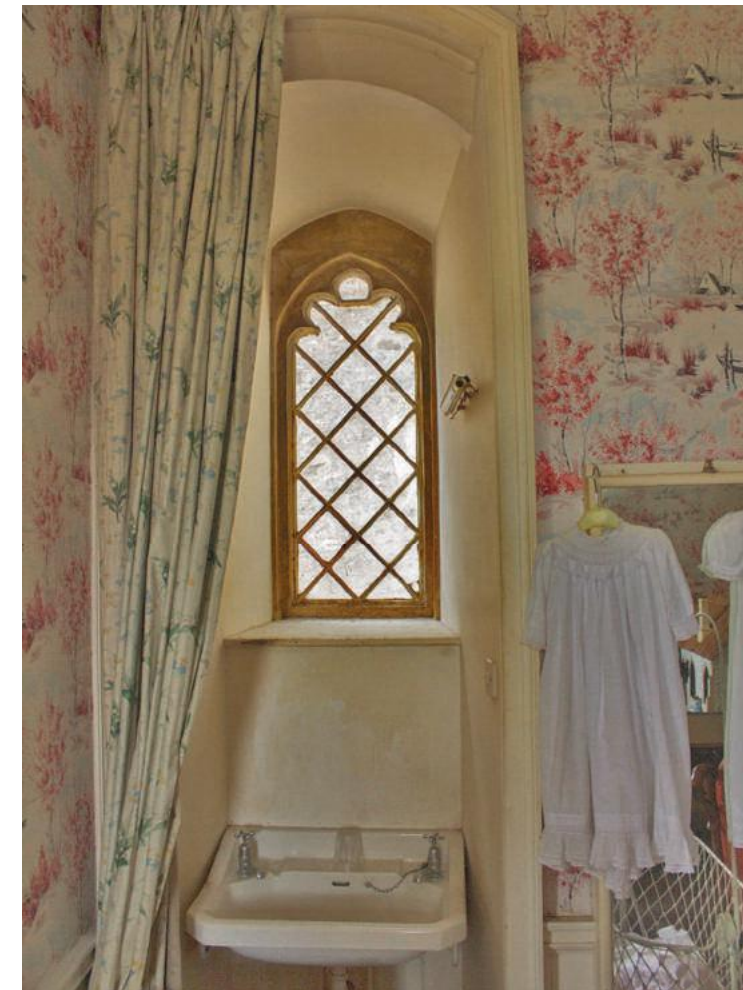
Figure 9: The possible location of a medieval privy in the northeast corner of the first level, now occupied by a modern sink. Fowler mentions removing an old privy and installing new water pipes in this room (IPhoto by Anthony Hita)

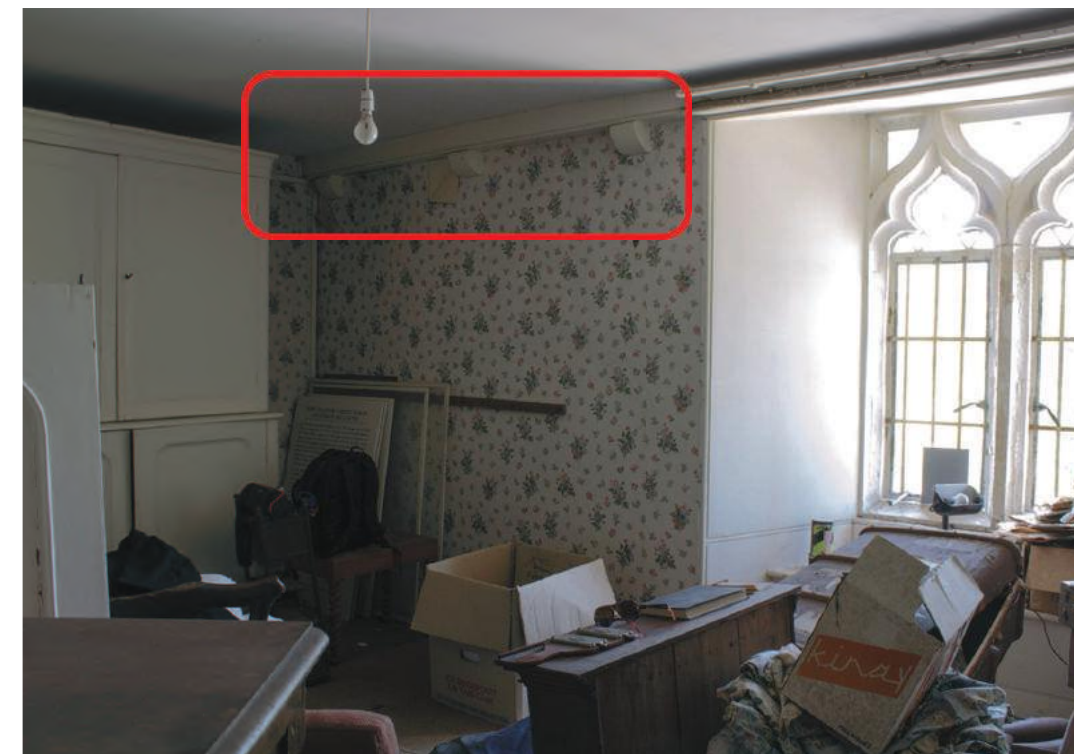
Figure 10: Corbels in the North Tower's second level, southwest corner, possibly hinting at an original pre-Fowler third story that was gone by Fowler's time. (Photo by Anthony Hita)

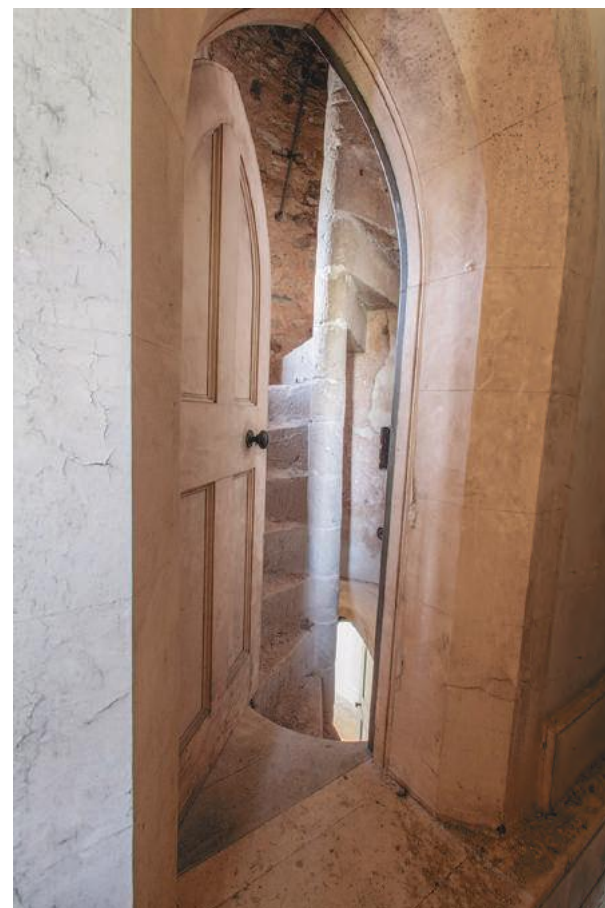
Figure 11: The opening to the spiral staircase on the east side of the North Tower connecting levels one through three. Fowler claims to have retained these openings to allow private access throughout the tower. (Photo by Starr Herr-Cardillo)

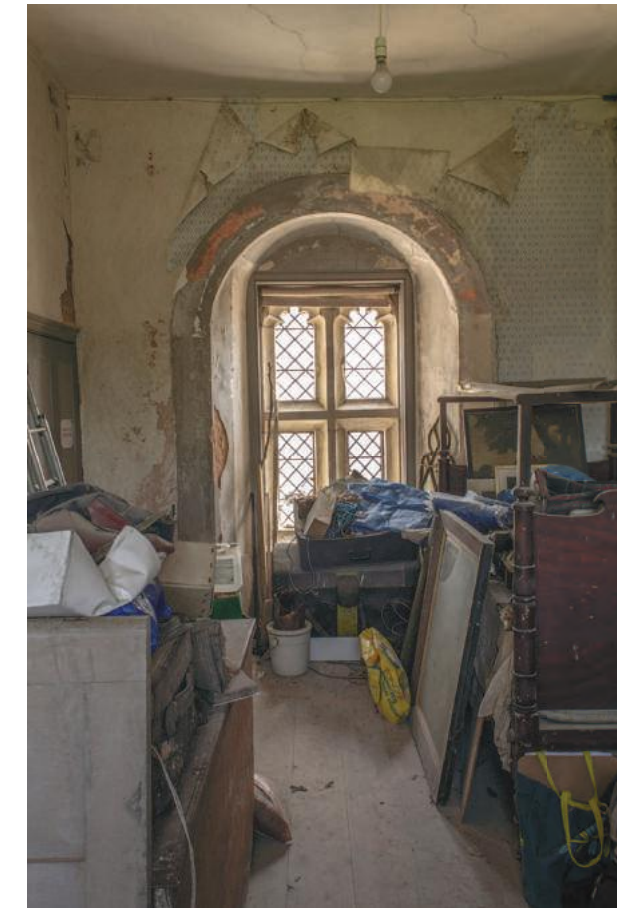
Figure 13: Two phases of paint visible in the third story of the North Tower's south side. The coloration of these phases matches the color scheme of the two layers of wallpaper also visible in the room. (Photo by Rebekah Yousaf)

There are two layers of wallpaper in the space corresponding to two visible layers of paint (Figures 12 and 13). The earliest is a red and white fleur-de-lis pattern on a grey background, which corresponds to a red paint scheme visible where the present blue-grey paint has weathered. The present paper features blue flowers within a blue diamond grid on a white background. A search of materials available in the Whitworth Collection suggests this top layer likely dates to the late Victorian period, circa 1870-1890, while the earlier paper is similar to patterns common during Fowler's time, circa 1850 (Whitworth).

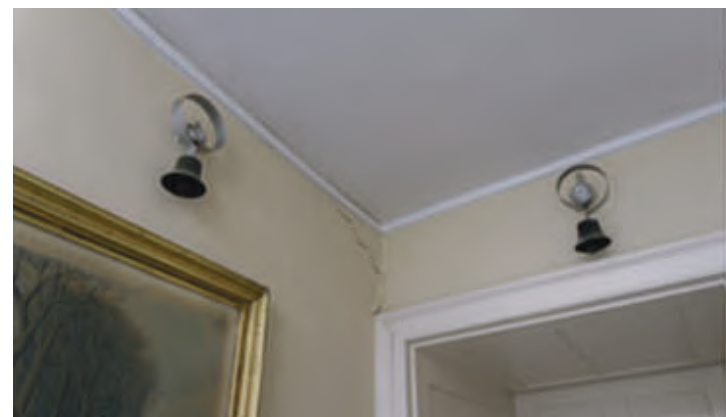
Figures 3 & 4: Bells in the hallway outside of the room correspond with bells in the kitchen of the private quarters. (Photos: Rebecca Clemente)

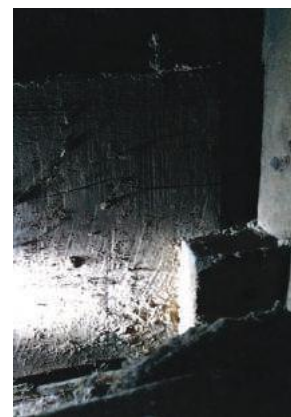
Figure 5: Pit saw marks visible on a floor joist. (Becca Flemer)

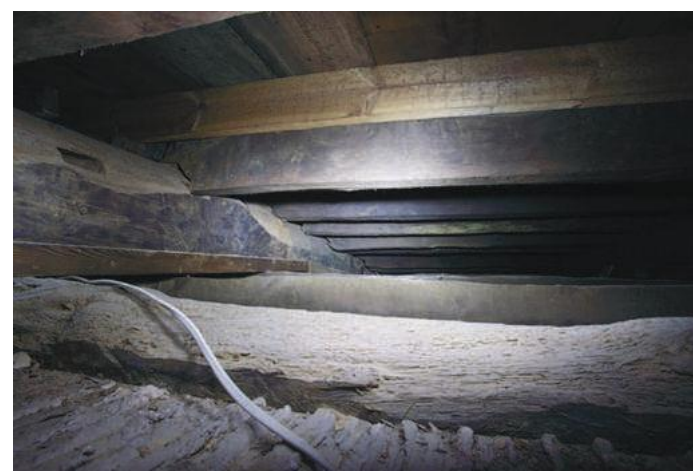
Figures 7: Ceiling beams visible through an access panel in the ceiling. (Photo: Starr Herr-Cardillo)
