GERMANTOWN Town Hall

Preservation Plan

HSPV 701: Preservation Studio | Fall 2011

Graduate Program in Historic Preservation | University of Pennsylvania

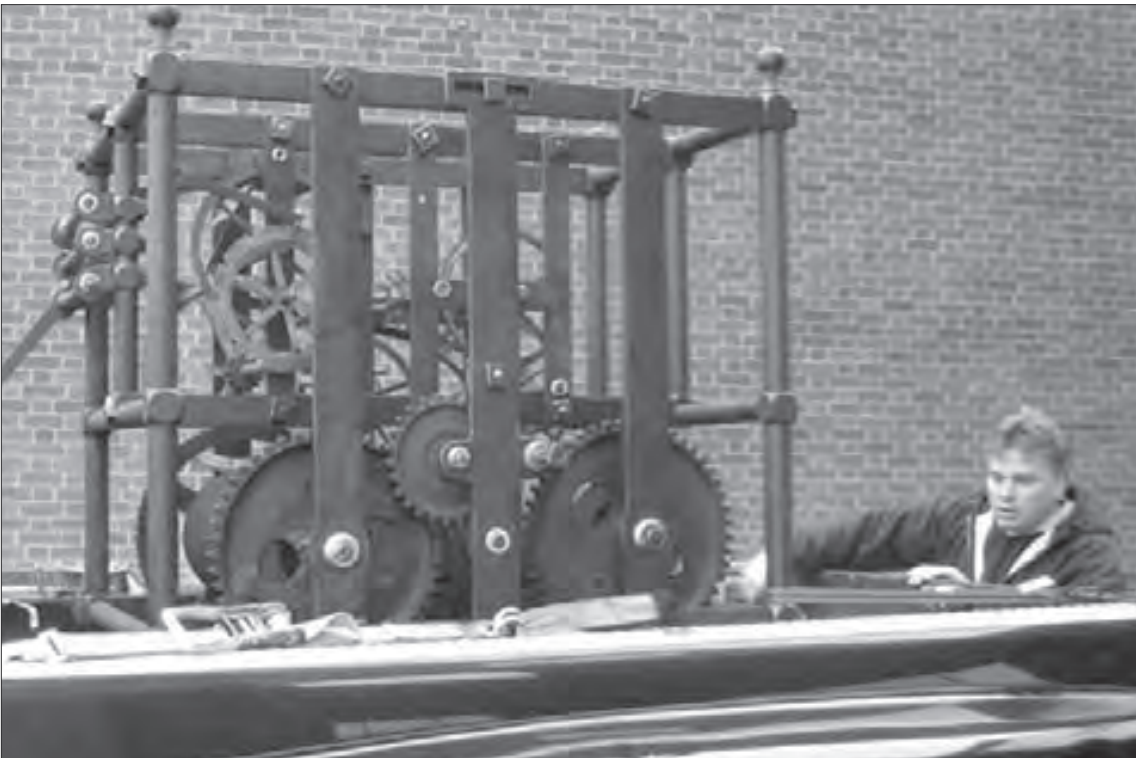
Figure 42. Image of Lukens clock gear removal, Source: *Lukens Clock + Stereoview Return to Independence Park*, p.2.

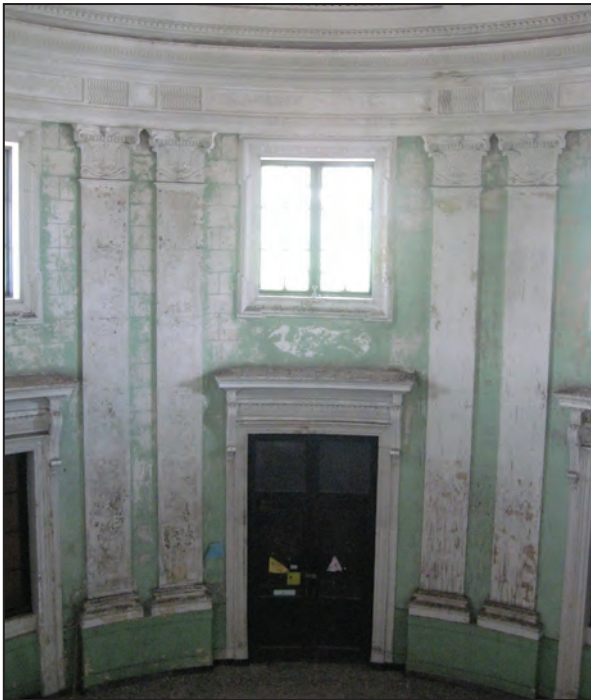
Figure 46. Interior image of Rotunda, Source: K.McNabb, 2011

Despite its current condition, the Rotunda commands a presence and is an important space. The ultimate goal of this study was to perform a paint and finishes analysis of the main Rotunda within Germantown Town Hall. Currently, the Rotunda is in a deteriorated state with abundant flaking and extensive loss of the interior paint. Current photographs show that there are several different paint layers behind the current green layer. Early images drawn during the opening of the building show that the interior was originally painted with a faux stone finish to appear like white ashlar blocks. Current photographic documentation also supports this claim as later layers have deteriorated, showing the original finish in several locations. Other later layers also appear to be beige or brown. The marble WWI tablets were not directly sampled, but were visually studied to determine how they fit in with the entire design. Currently there is evidence of gilding on

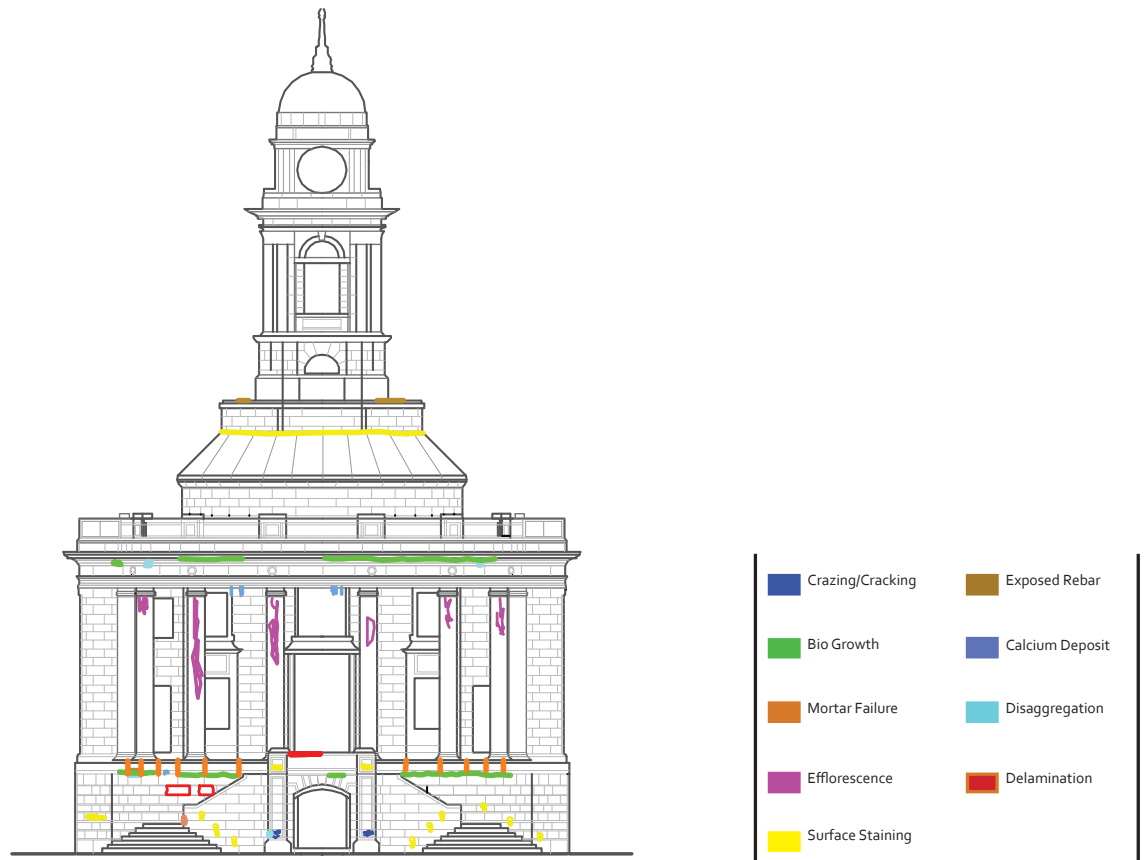
NORTH FACADE

Since a general conditions assessment and an analysis of construction techniques for precast concrete has been introduced, this section will narrowly focus on conditions found on the north façade. Though the issues identified exist on all facades, the north façade's conditions are exacerbated by the site's orientation and the portico's high level of detail.

The northwest facade of the building receives significantly less sunlight than the northeast, resulting in a decrease in the number of conditions. Rapid freeze-thaw cycles on the northeast elevation, however, intensify complications that exist on that section. Key issues affecting the north façade include: delamination, leaching deposits, exposed rebar, efflorescence, mortar failure, biological growth, crazing/cracking, and surface staining.

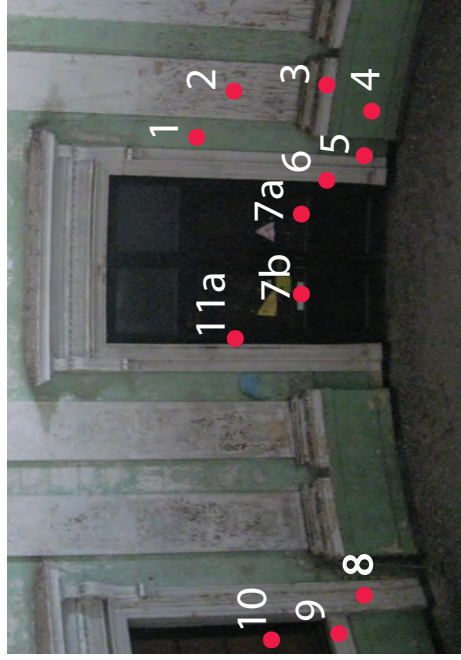
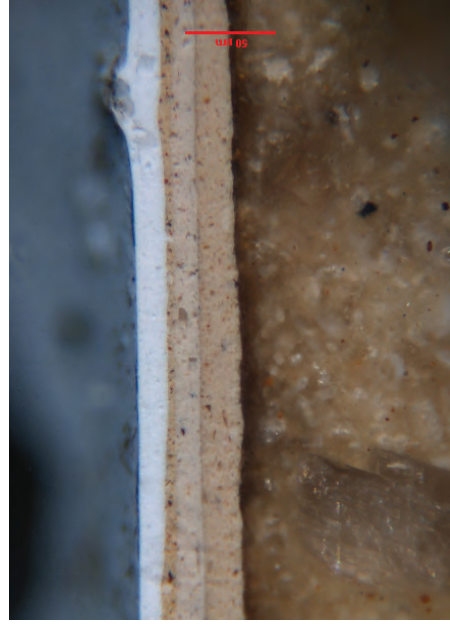
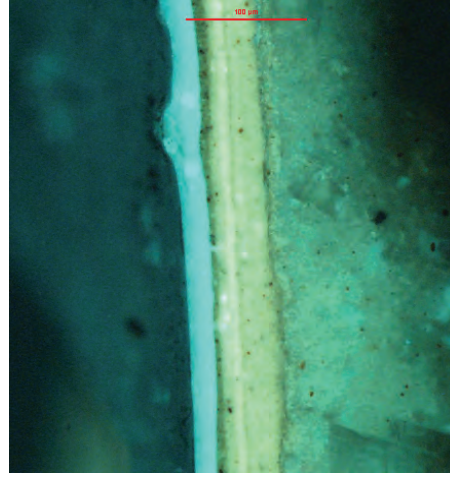
LOCATION: ROTUNDA

LAYER	SCHEME	COLOR
4	White	
3	Beige	10YR 7/4
2	Tan	10YR 9/2
	Black (soiling)	
1	Beige	10YR 7/4
Substrate	Brown

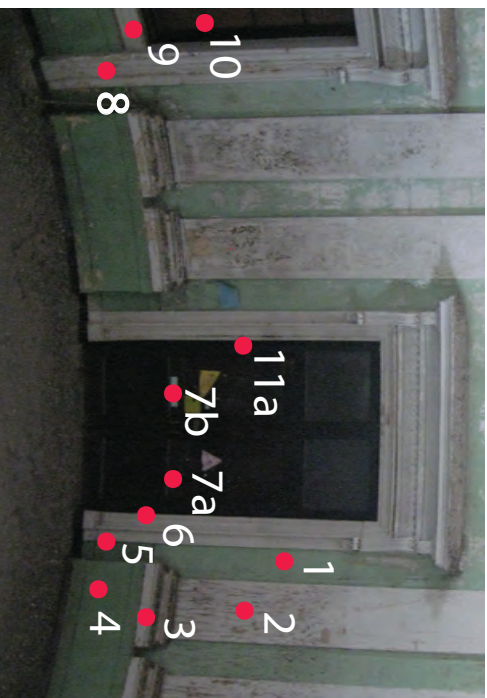
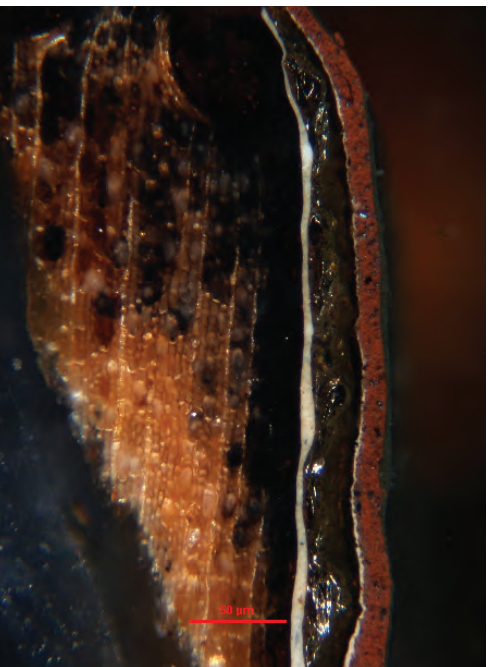
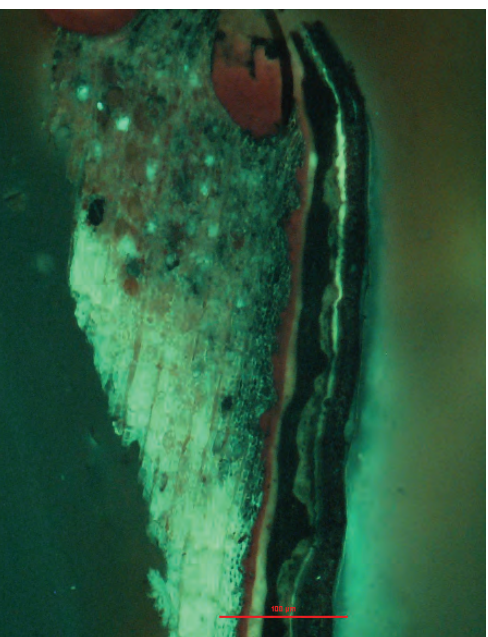
LAYER	SCHEME	COLOR
9	Black	5G 2.5/1
8	Red	7.5R 4/6
7	Brown	10R 4/4
6	Tan	10YR 9/2
5	Brown	7.5R 4/6
4	Dark Brown	10R 4/4
3	Resin	7.5R 4/6
2	Tan	10YR 9/2
1	Red (primer)	10R 3/4
Sub- strate	Brown

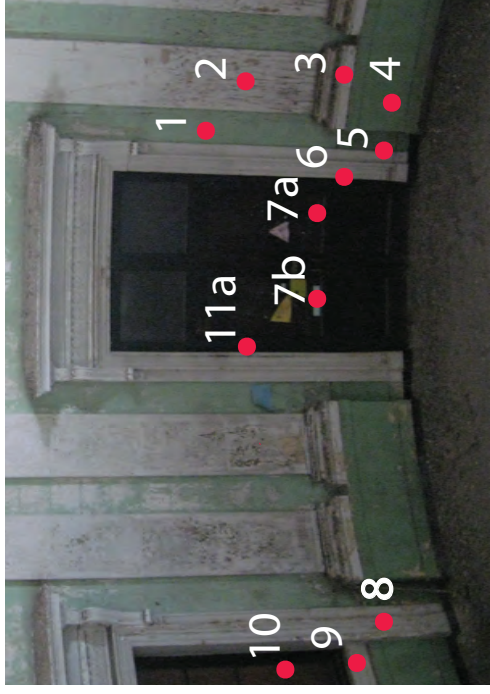
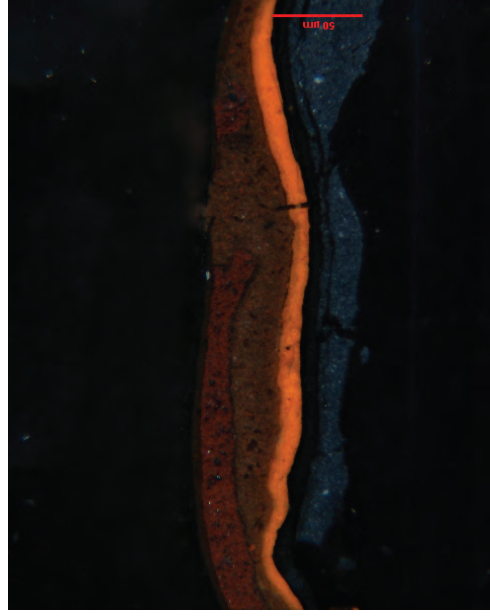
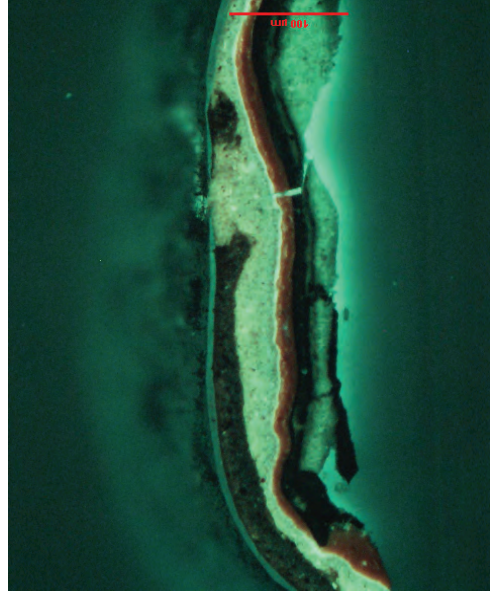
LOCATION:
ROTUNDA

LAYER	SCHEME	COLOR
5	Black	SG 2.5/1
4	Red	10YR 5/6
	Black (soiling)	
3	Brown	2.5YR 5/4
2	Red	10YR 5/6
1	Orange (primer)	2.5YR 6/1.4
Substrate 2	Black (corrosion)	10PB 2.5/1
Substrate 1	Gray	10YR 3/1

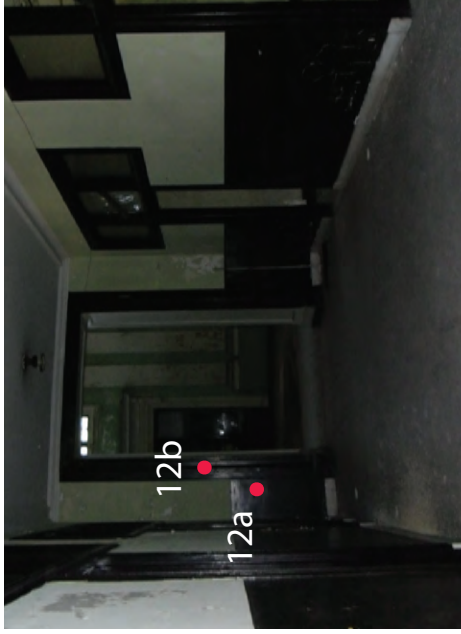
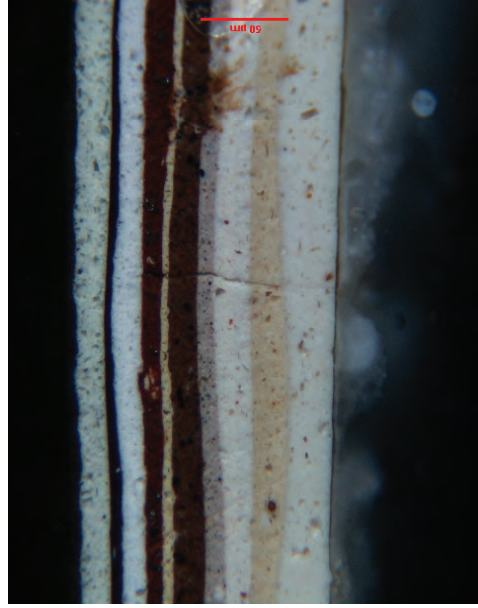
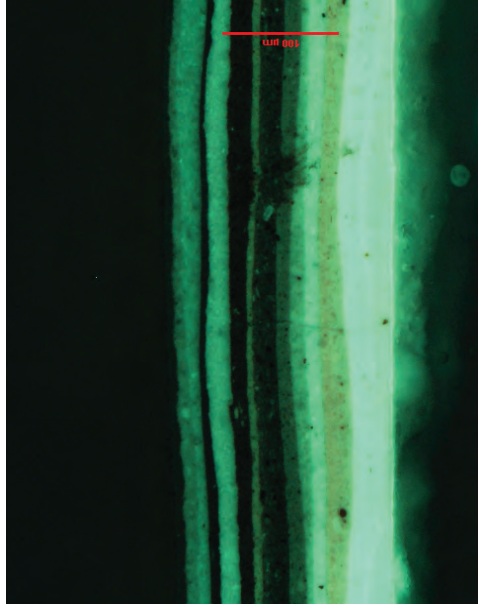
LOCATION:
1ST FLOOR HALLWAY

LAYER	SCHEME	COLOR
12	Black	10YR 3/1
11b	Mint Green	7.5GY 7/4
11a	Mint Green	7.5GY 7/4
10	Black	2.5YR 2.5/2
9	White	N9.5
8	Red	7.5R 4.6
7	Beige	10YR 7/4
6	Brown	10R 4/4
5	Gray	N 8.75
4	Tan	10YR 9/2
3	Beige	10YR 7/4
2	Tan	10YR 9/2
1	Brown (size)	10YR 6/10
Substrate	White

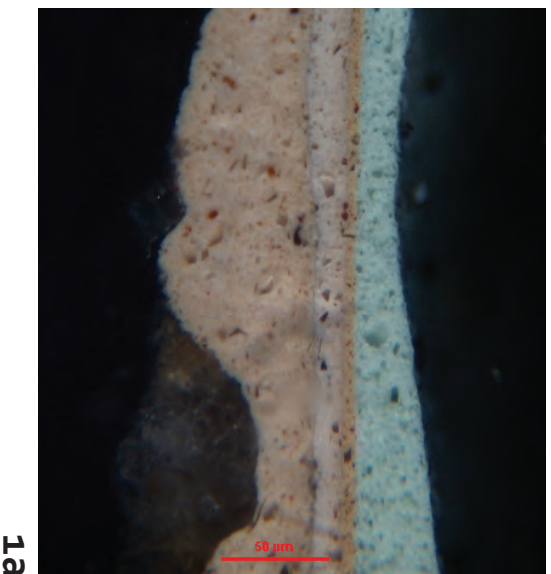
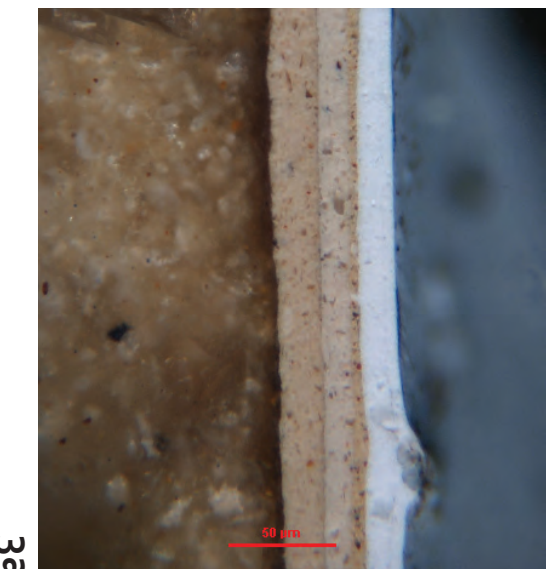
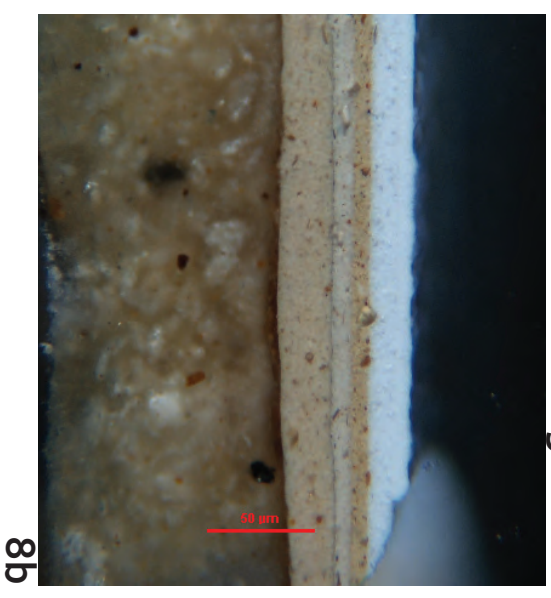
- All plaster elements within room painted the same until the most recent painting campaigns
- Likely first layer original finish as indicated by strong dirt layer directly above

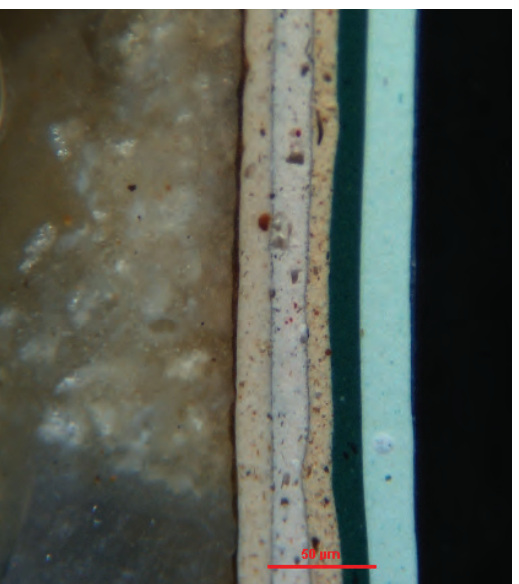
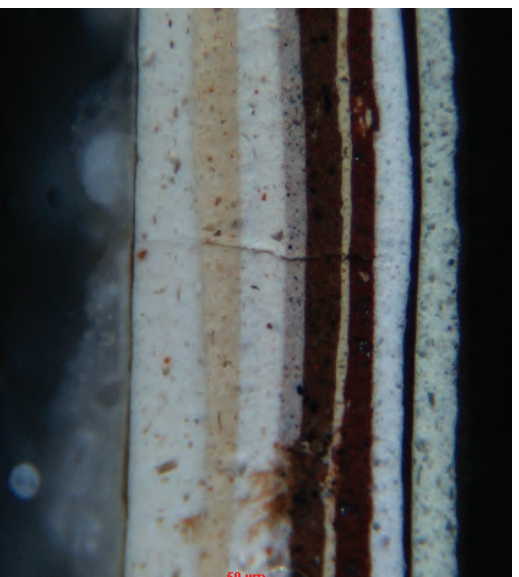
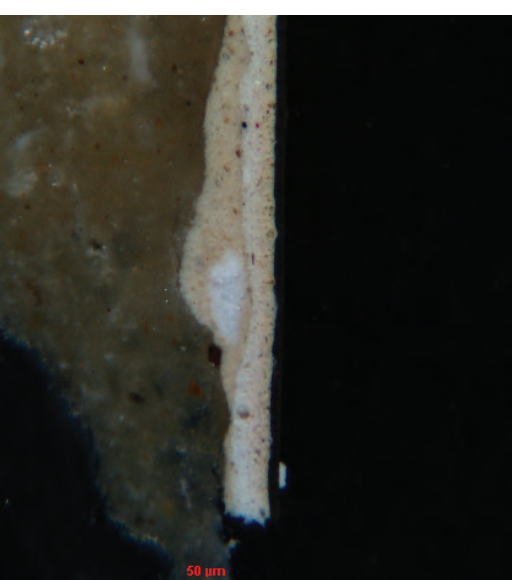
- Green finish on lower edge in Rotunda
- Hallway appears to have been painted numerous times
- Possible evidence of an inverted color scheme
