St. Andrew's Chapel

Preservation Plan

Preservation Studio, Fall 2010

Graduate Program of Historic Preservation,
University of Pennsylvania

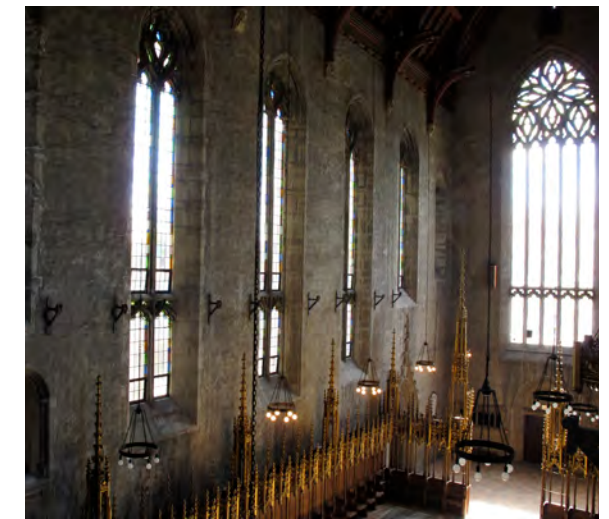
Figure 7 Intended temporary glass panel windows, south and east wall.

It was once common practice to fill church windows with temporary panels of leaded glass. These were composed mostly of clear or tinted glass in a simple, rectangular shape that was easily cut and assembled, (*Figure 7*). It was assumed that these temporary panels would be replaced with figural stained glass.

However, in St. Andrew's Chapel the rolled cathedral, textured, and seedy glass have remained as permanent fixtures. Similar replacement would cost approximately \$50 per square foot, whereas replacements of the quality originally intended, similar to that of the Medary Memorial window, could cost more than \$700 per square foot.²⁷ The current condition, as observed from the nave floor, is similar to that described in at 1993 Glass Survey. The good condition is attributed to high quality construction, simplicity of design, stout lead comes, and horizontal lead lines which have prevented bulging. D'Ascenzo's jewel in St. Andrew's Chapel is the Milton Bennett Medary Memorial window of the north wall, the crown above the alter, (*Figure 8*). The tripartite narrative window has the central figure of Christ with eleven cloaked men below, looking up. "Go Teach All Nations," at the foot of Christ, reflect the original use of the chapel as a collegiate seminary school. Red, blue, green, and gold-rod glass dominate the piece and it appears to be in good condition. Similar quality, yet smaller, windows found in the ambulatory space behind the alter are adorned with a simple floral motif.

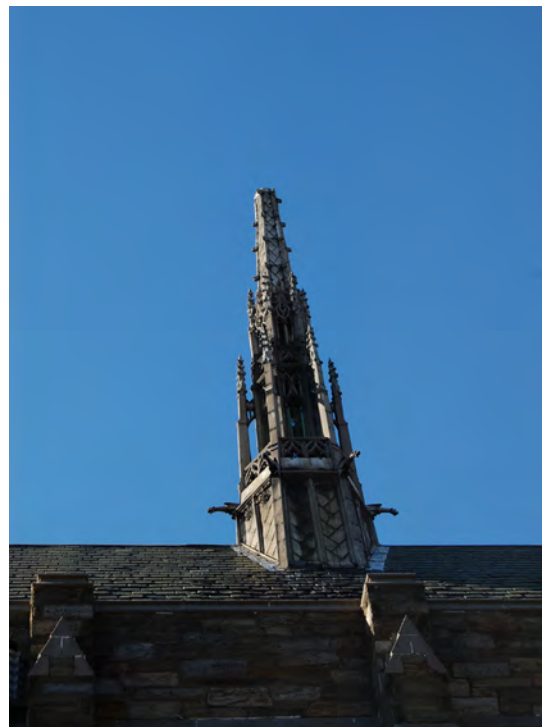
masonry walls at a base plate that bears adjacent to the interior face of the wall. The rafters were found to deflect slightly under the dead load of the slate roof, causing an outward thrust of the walls. This was aggravated by differential thermal expansion of the steel roof structure and masonry walls. This condition has caused cracking in the walls of the chapel, but the cracks were not reported to be a structural threat. The report recommended installing a longitudinal slide plate at the bearings of the trusses closest to each end wall to combat the outward thrust of the walls. On the exterior walls of the chapel, cracking in the voussoirs of the buttresses was noted as a result of tensile stresses from the outward drift of the east and west walls. Additionally, the report found the flèche to be in poor condition, noting buckling on the top third of the structure.

Figure 6 Flèche, top third removed due to structural problems

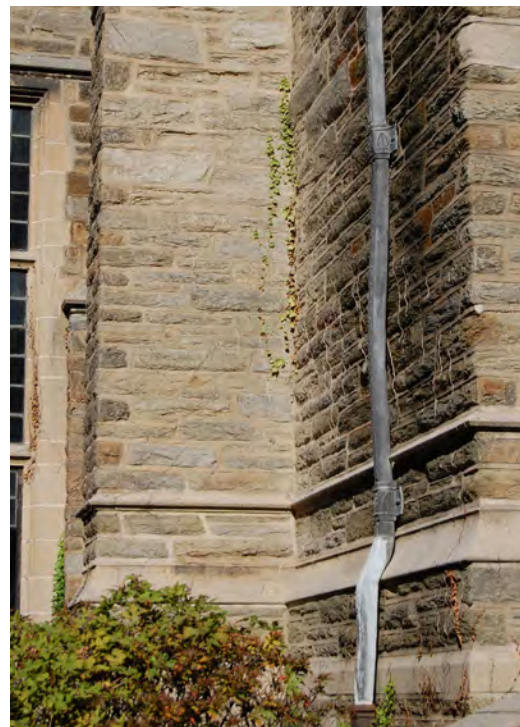
from deferred maintenance and various acts of vandalism. The current state of conservation of St. Andrew's Chapel and the deanery will have serious implications for the building's future. The main mechanism of deterioration effecting the buildings is moisture infiltration. An insufficient drainage system and a failing roof have been responsible for numerous problems, from deterioration of the masonry on the exterior to staining of cement finishes and plaster deterioration on the interior. Despite a significant amount of surface deterioration, the chapel and deanery remain in fairly good condition, owing to a robust structure and an owner that continues to monitor the building and see to immediate maintenance needs. The University of Pennsylvania has undertaken various

Figure 7 Failing downspout, southwest corner of chapel

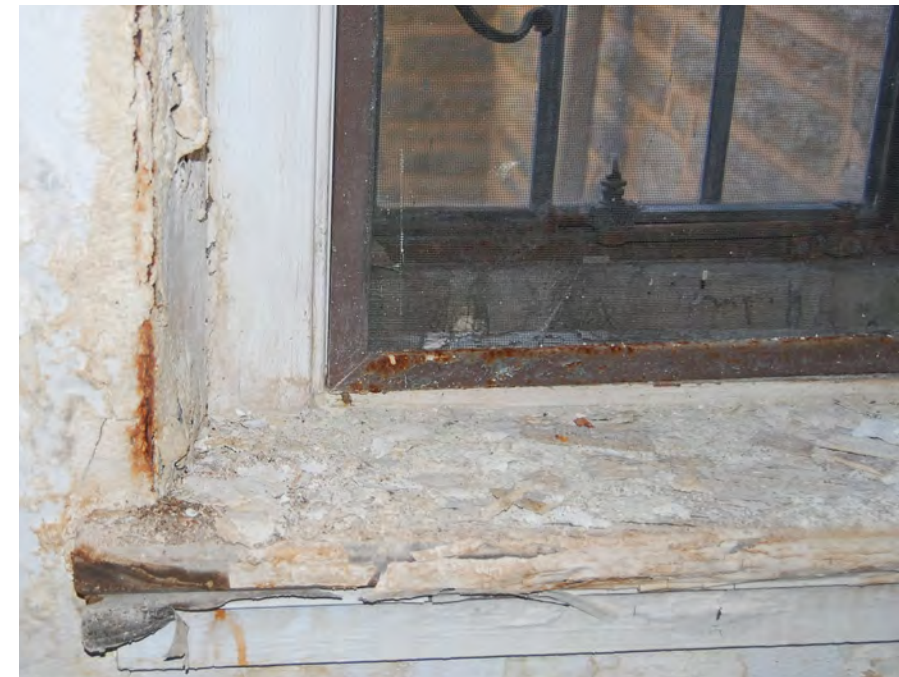
Figure 7 Interior screen set into wood jamb, possible location for interior casement storm window

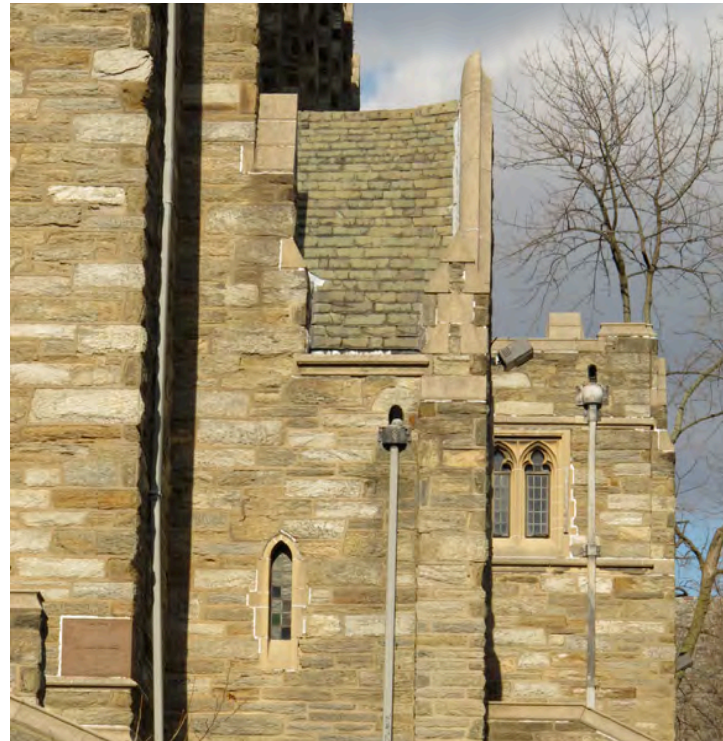
The exterior of St. Andrew's Chapel is composed of Wissahickon schist, a local material used throughout the Philadelphia region. The stone ranges in color from gray to beige with silver streaks of mica. A portion of the stone has a light, highly reflective appearance due to high proportions of quartz and mica, and may indeed be better characterized as a quartzite stone. These stones may be replacement for deteriorated schist. The more intensely colored stones contain higher proportions of minerals such as feldspar, (Figure 1).

Figure 1 The variegated stone exterior of St. Andrew's Chapel.

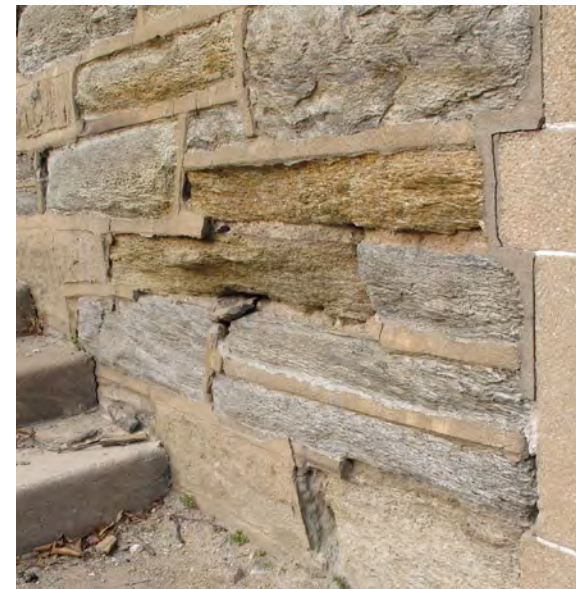
Figure 2 Decomposing schist on the southern elevation at the entrance to the crypt, exhibiting loss of material and brownish coloration.

gypsum encrustations and delamination along the bedding planes of vertically bedded stones. The most serious condition by far, however, is the disaggregation of individual stones, identifiable by a masonry unit's lowered profile (below the surrounding pointing and stones) and an orange-brown coloring, (Figures 2, 3).

Wissahickon schist is naturally predisposed to kaolinization, but this chemical transformation can be prevented by completion of the following steps. First, the current roof drainage system must be repaired or augmented so that rainwater can be effectively directed away from the building walls and foundations. In addition, the entire façade should be repointed with a soft lime-based mortar to create a preferential path for water to evaporate through mortar joints rather than through stone.

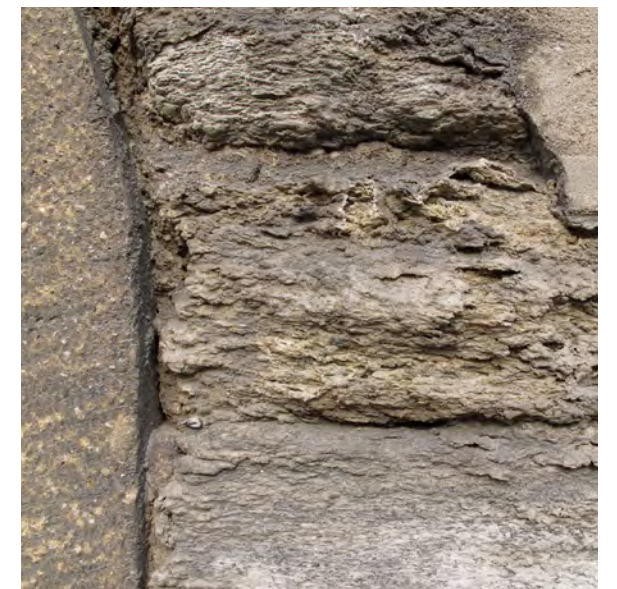
Figure 3 Salt deposits, likely gypsum, have formed a crust over stones on the southern elevation.

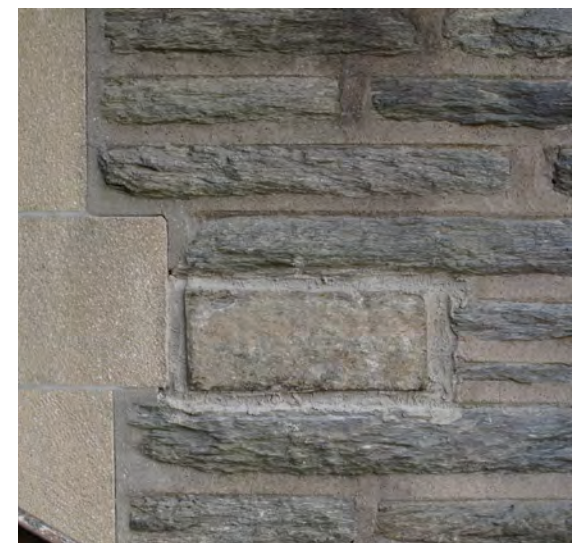
Figure 5 A December 2010 replacement on the western elevation of the Deanery that does not replicate the color, texture or size of surrounding masonry.

It also appears that the current masonry contractors are using a gneiss or granitic stone that does not match the original schist's color or texture. Furthermore, the size and shape of replacement stone is inconsistent with the existing coursing of the walls. Wissahickon schist is still available and replacement should be made in kind and bedded using the existing masonry patterns, (Figure 5, 6).

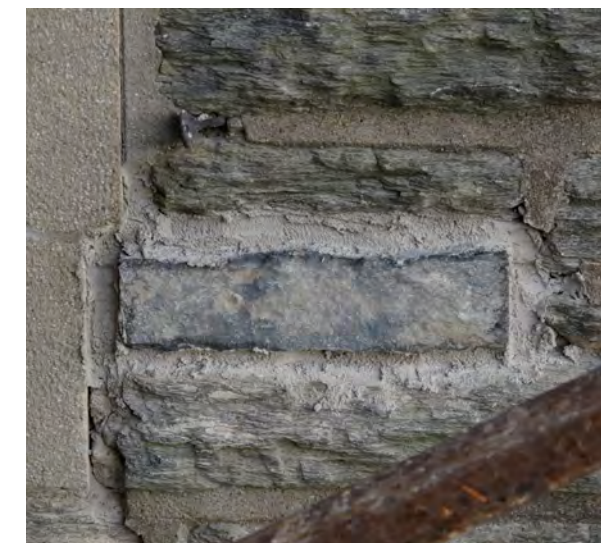
Figure 6 A second inappropriate replacement on the western elevation of the Deanery.

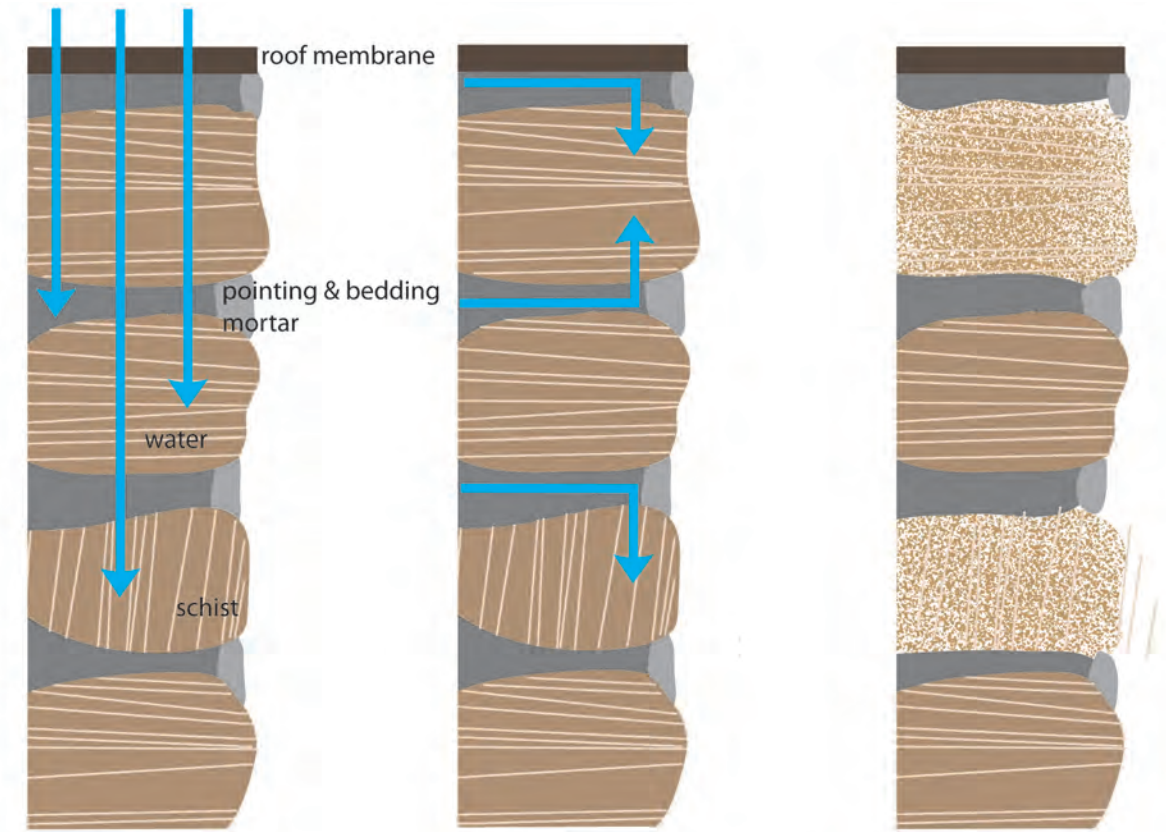
Moisture enters the wall through faulty roof membranes and drainage systems

Moisture cannot exit the wall through the mortar joints and enters schist

Feldspar decomposes chemically and salt crystallization causes mechanical damage

Recommendations:

Stop water infiltration

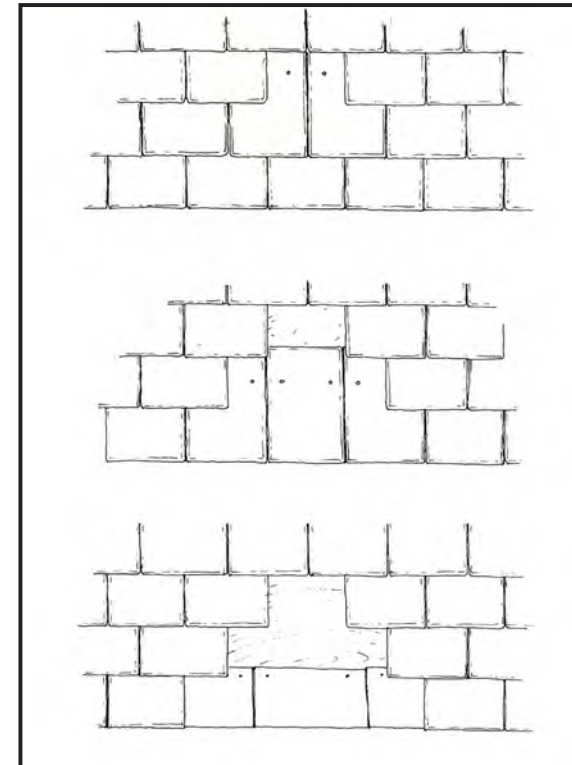
Figure 2 Diagram of slate roof removal for replacement.

been cost effective. The current condition of the roof leads to a full reroofing as the best solution. When 20% of a slate roof requires replacement it becomes more cost effective to reroof due to the number of additional slates that need to be removed in order to access the damaged slates for replacement and the additional cost of preserving the other slates without damaging them, (Figure 2).^{1,2}

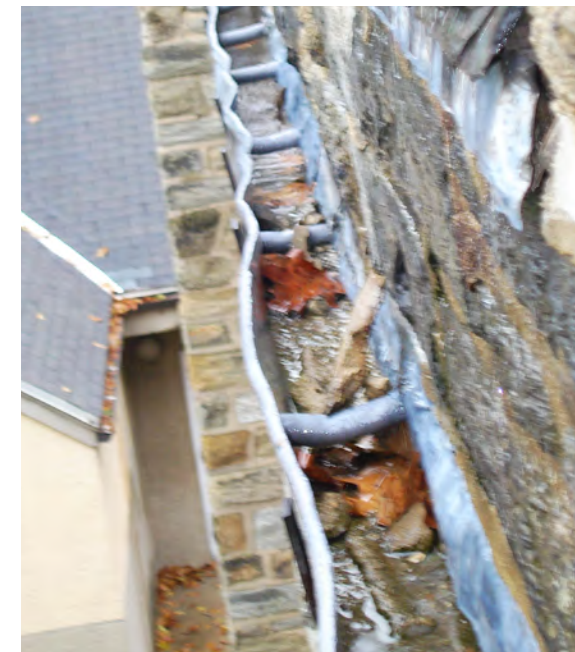
Figure 1 Debris on gutters

1. Failing gutters and downspouts should be cleared of debris throughout the Chapel and Deanery (Gutters: 560 linear feet at \$2/lin.ft.).
2. Connections between scuppers and downspouts should be properly secured throughout the Chapel and Deanery.
3. Clean interior of the Deanery and get rid of debris that holds moisture to help prevent biological growth.

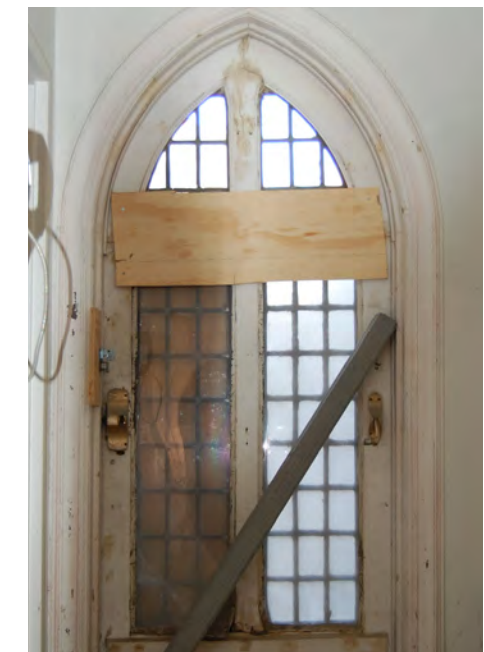
Figure 2 Door in very poor condition on the Deanery leading to courtyard

4. Replace severely damaged door on the north wall of the Deanery by recreating Gothic design as to not change the character of the building.
5. Interior missing doors in the Deanery should be replaced with doors that are similar in aesthetics to the existing doors. Assume six doors.
6. Replace severely damaged windows in the Deanery using the same design and technique as in the original casement windows to preserve the aesthetics of the building. Assume five windows.
7. Replace broken glazing on windows in the Chapel. Assume 30 panes.
8. Exterior doors throughout the Chapel and Deanery should be repaired.
9. Monitor cracks on cement walls and inspect roof of the Chapel to ensure performance of the building structure has not being compromised, (Figure 1, 2).

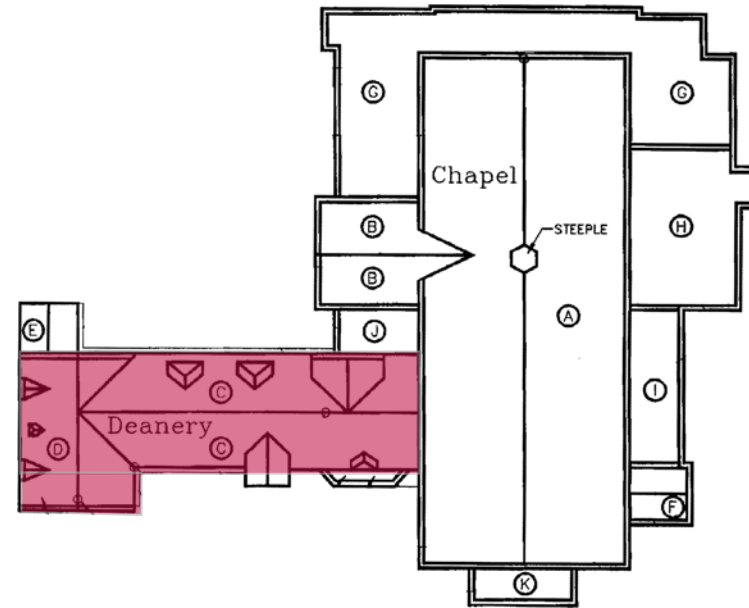
Figure 5 Roof plan showing area needed reroofing

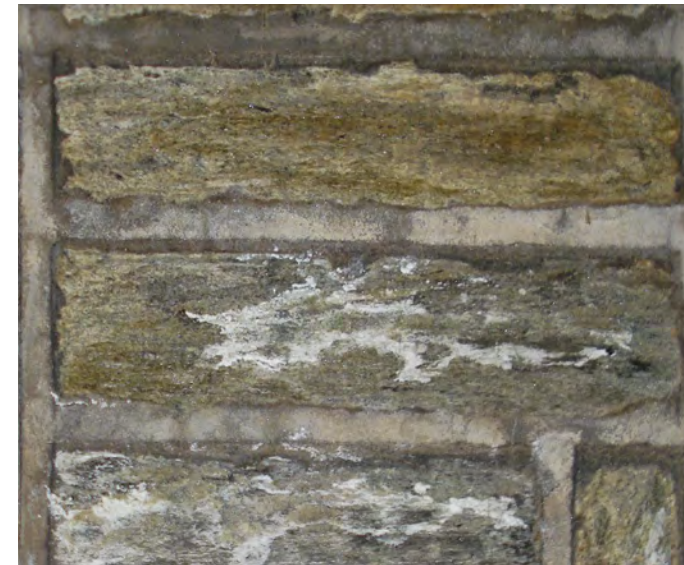
Figure 6 Severely deteriorated schist in the interior of the Chapel
