PADULE
SPANNOCCHIA 1987

VISUAL INSPECTION OF PADULE

SPANNOCCHIA, ROSIA, ITALY

Submitted by PAD 1 Team
"Preservation Practice in Italy"
Graduate Program in Historic Preservation
University of Pennsylvania
July-August, 1987

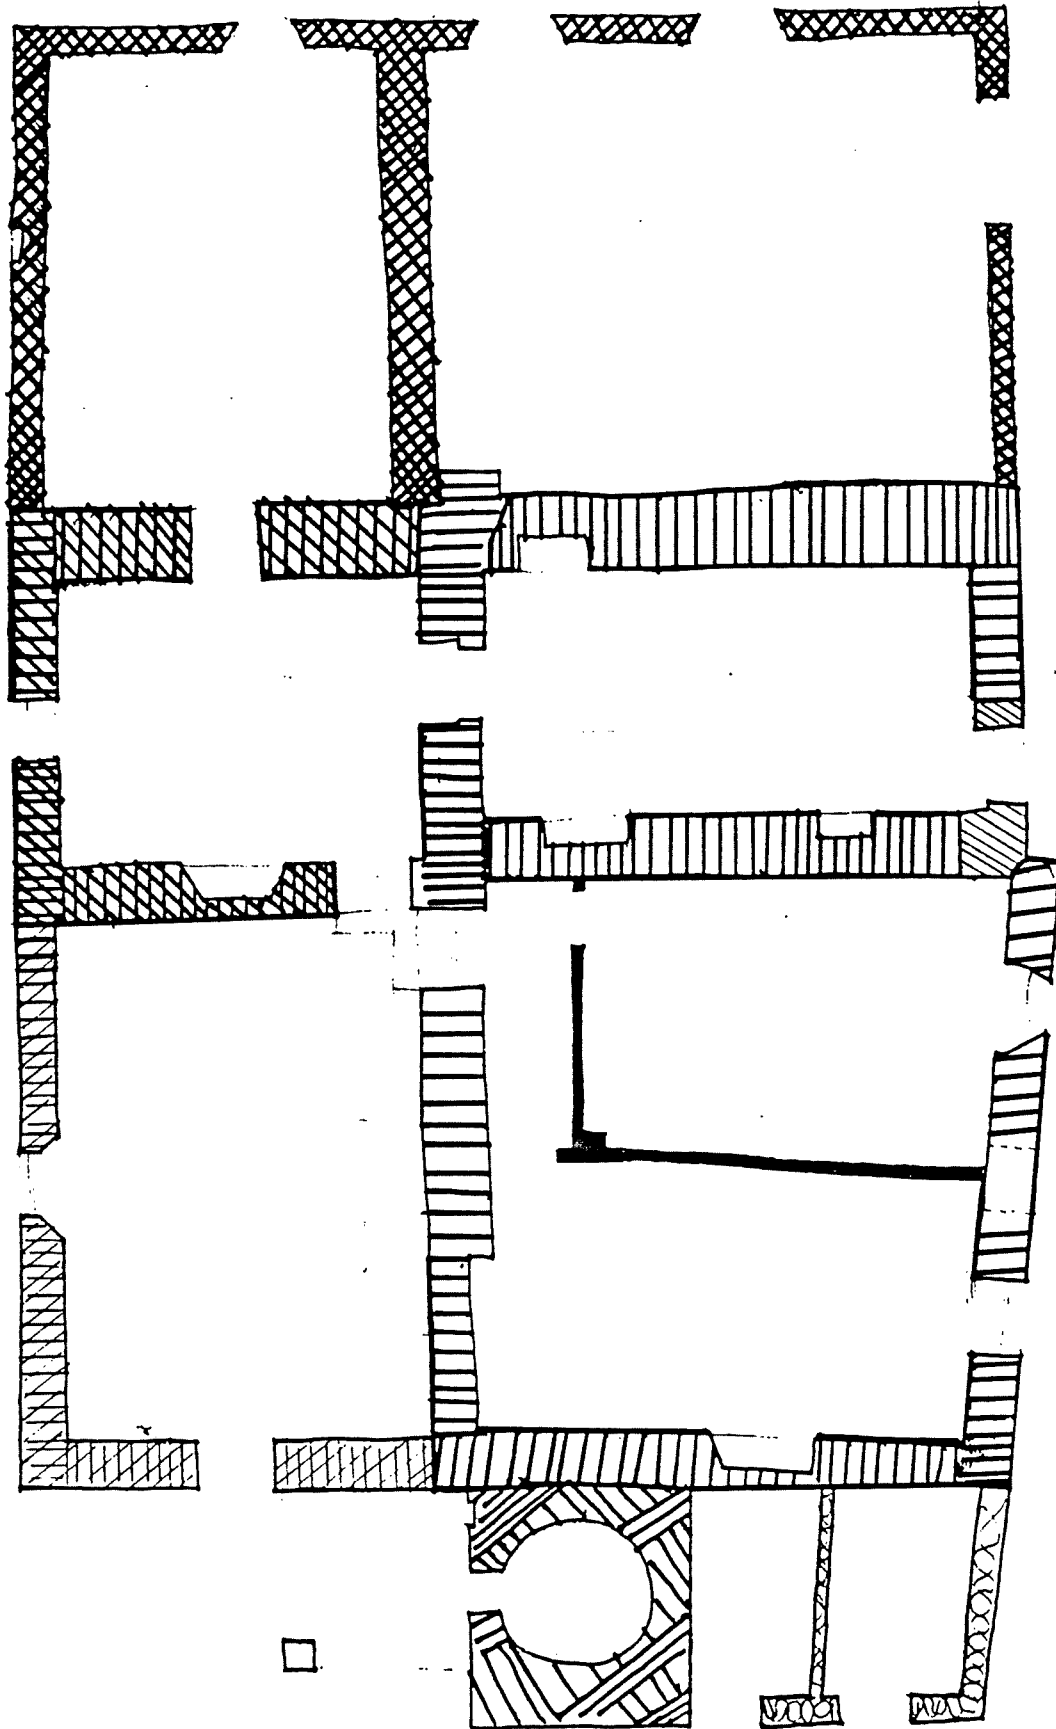
STRUCTURAL EVOLUTION

THE VARIOUS COLORS AND PATTERNS INDICATE
DISTINCTLY DIFFERENT WALL CONSTRUCTION
TECHNIQUES AND POSSIBLY DIFFERENT PERIODS
OR BUILDING CAMPAIGNS.

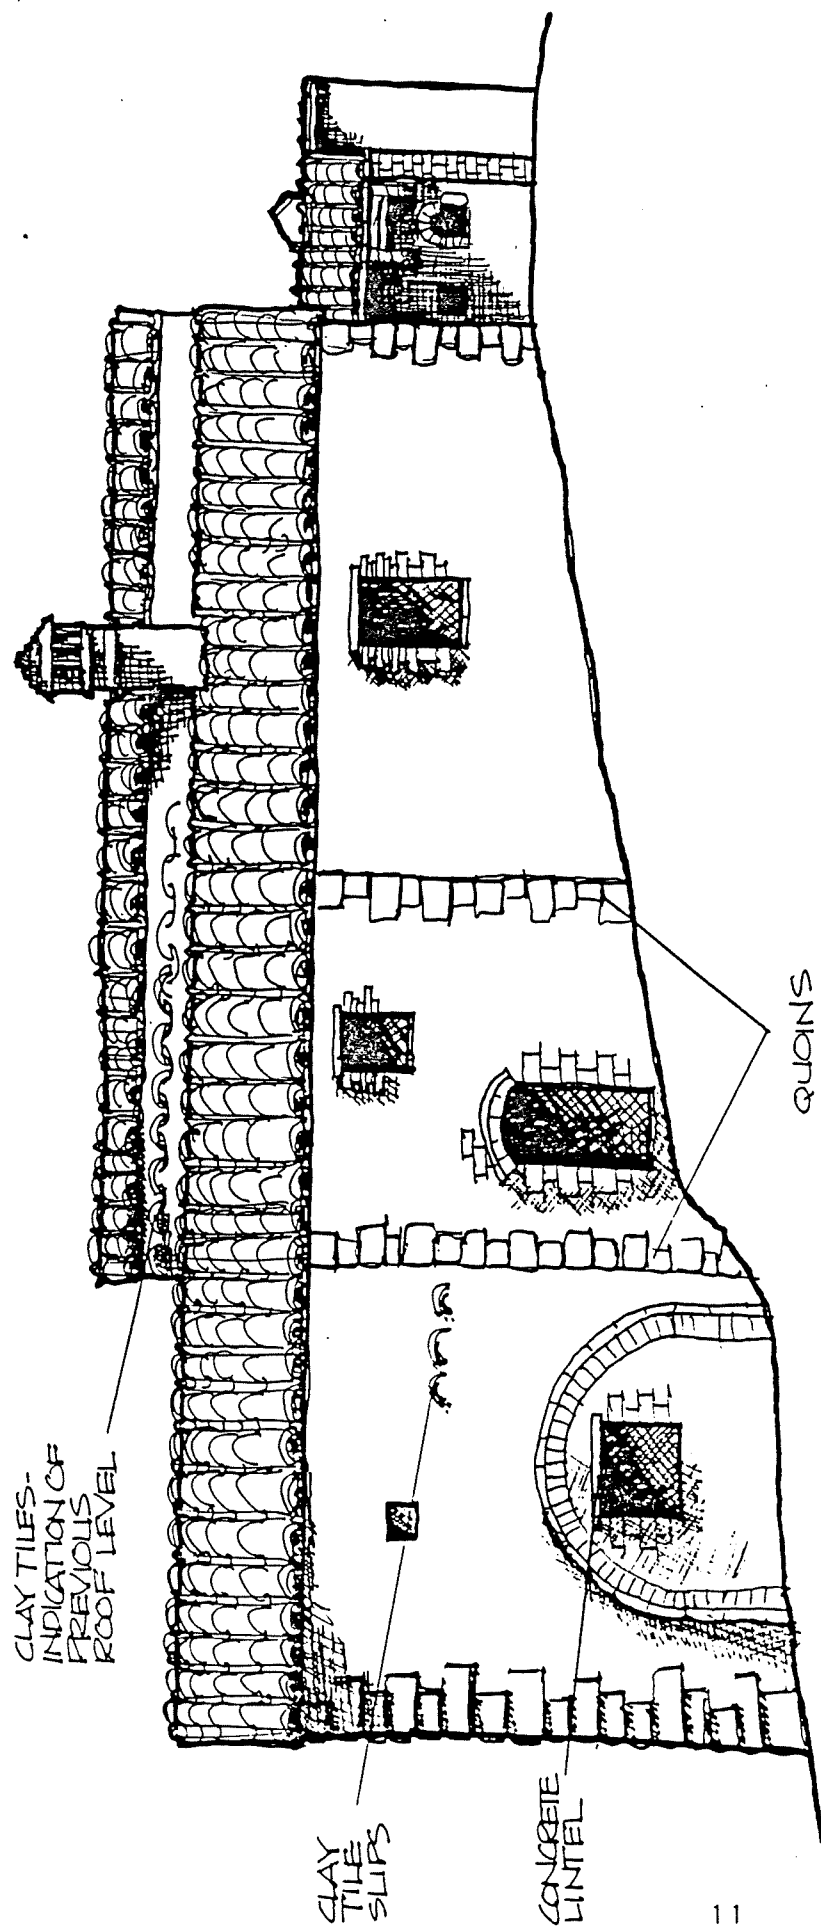
NORTH ELEVATION

The third story unit is defined by a large walled up arch on the first floor with a concrete window in the center. The second story has a small square opening that has been bricked in. This unit has a strong coursing in rubble fieldstone construction. Limestone quoins square off this unit.

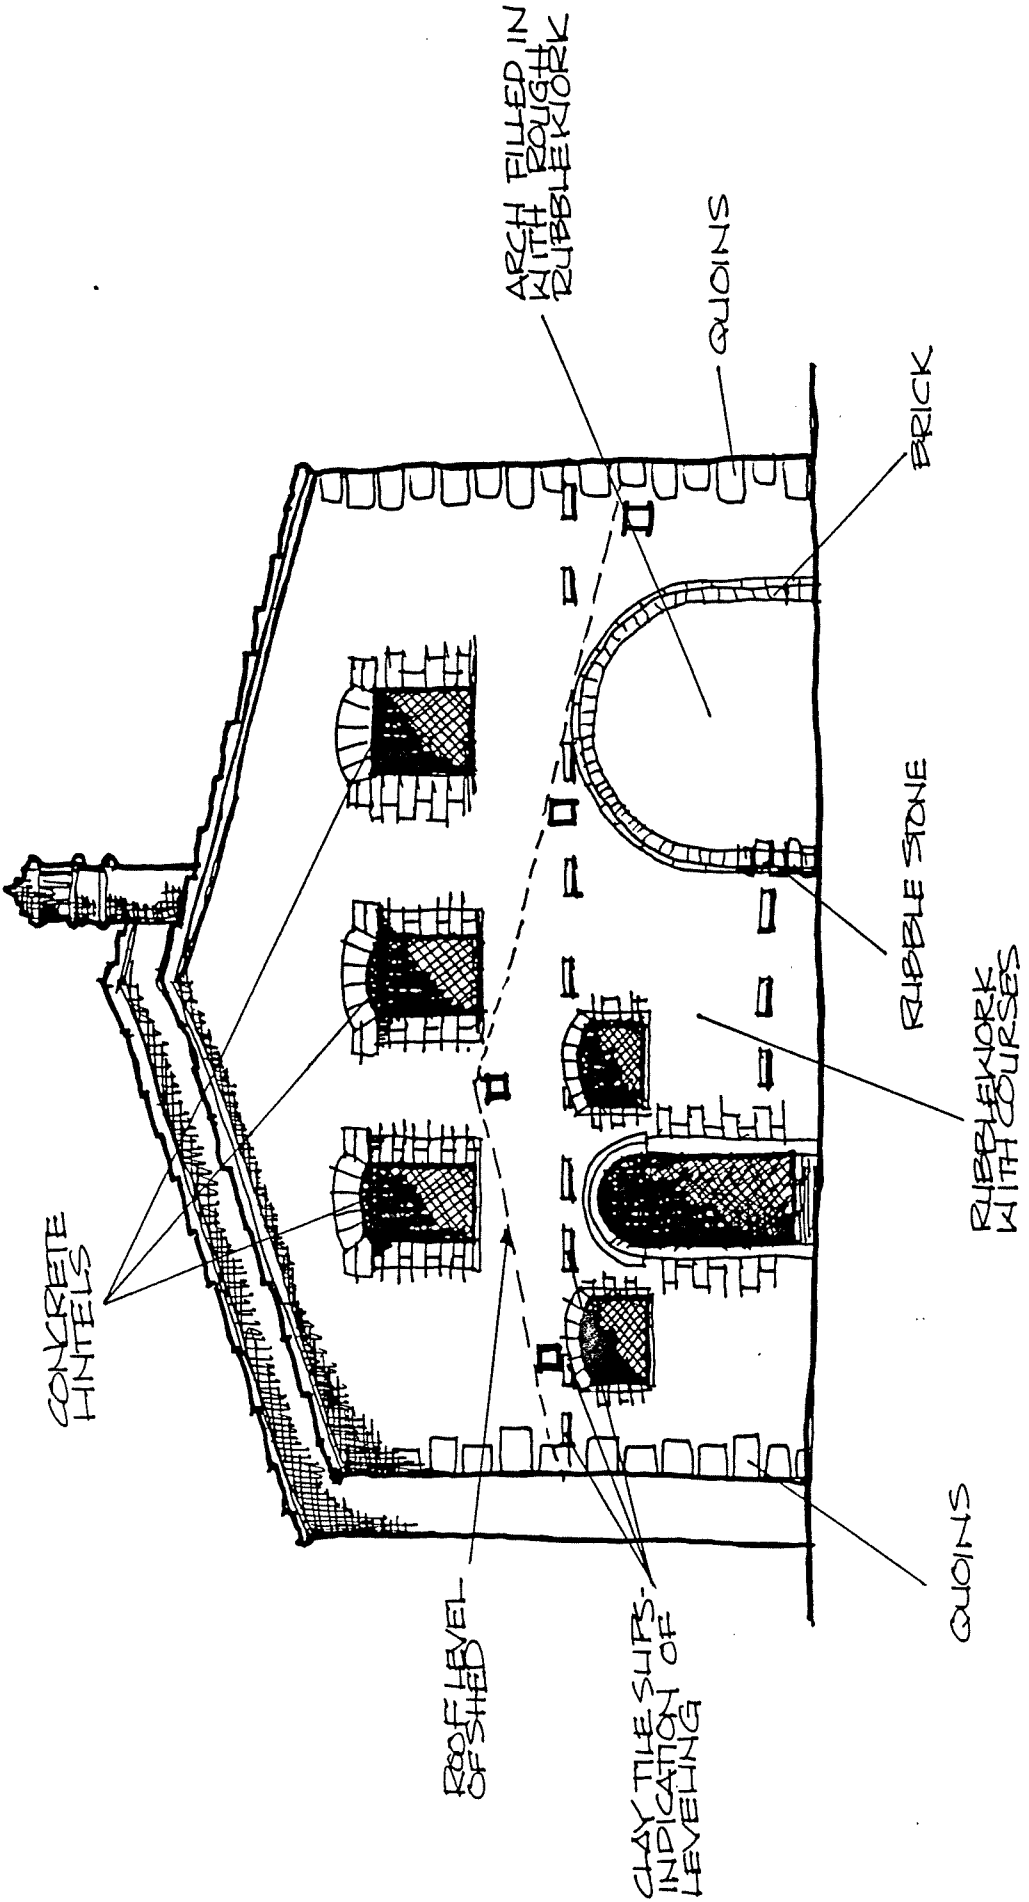
EAST ELEVATION

The east elevation is a two story structure and is faced with rubble fieldstone and is framed by limestone quoins. At regular intervals the rubble work is leveled with a horizontal row of brick or stone shards. The ground level has a door in between two windows and a filled in large brick arch. It is possible the archway was used as an entrance for farm vehicles. The upper story is pierced by three segmental arch windows with concrete lintels. A modern roof extends from the back of the wall between the lower and upper story to form an outdoor shed.

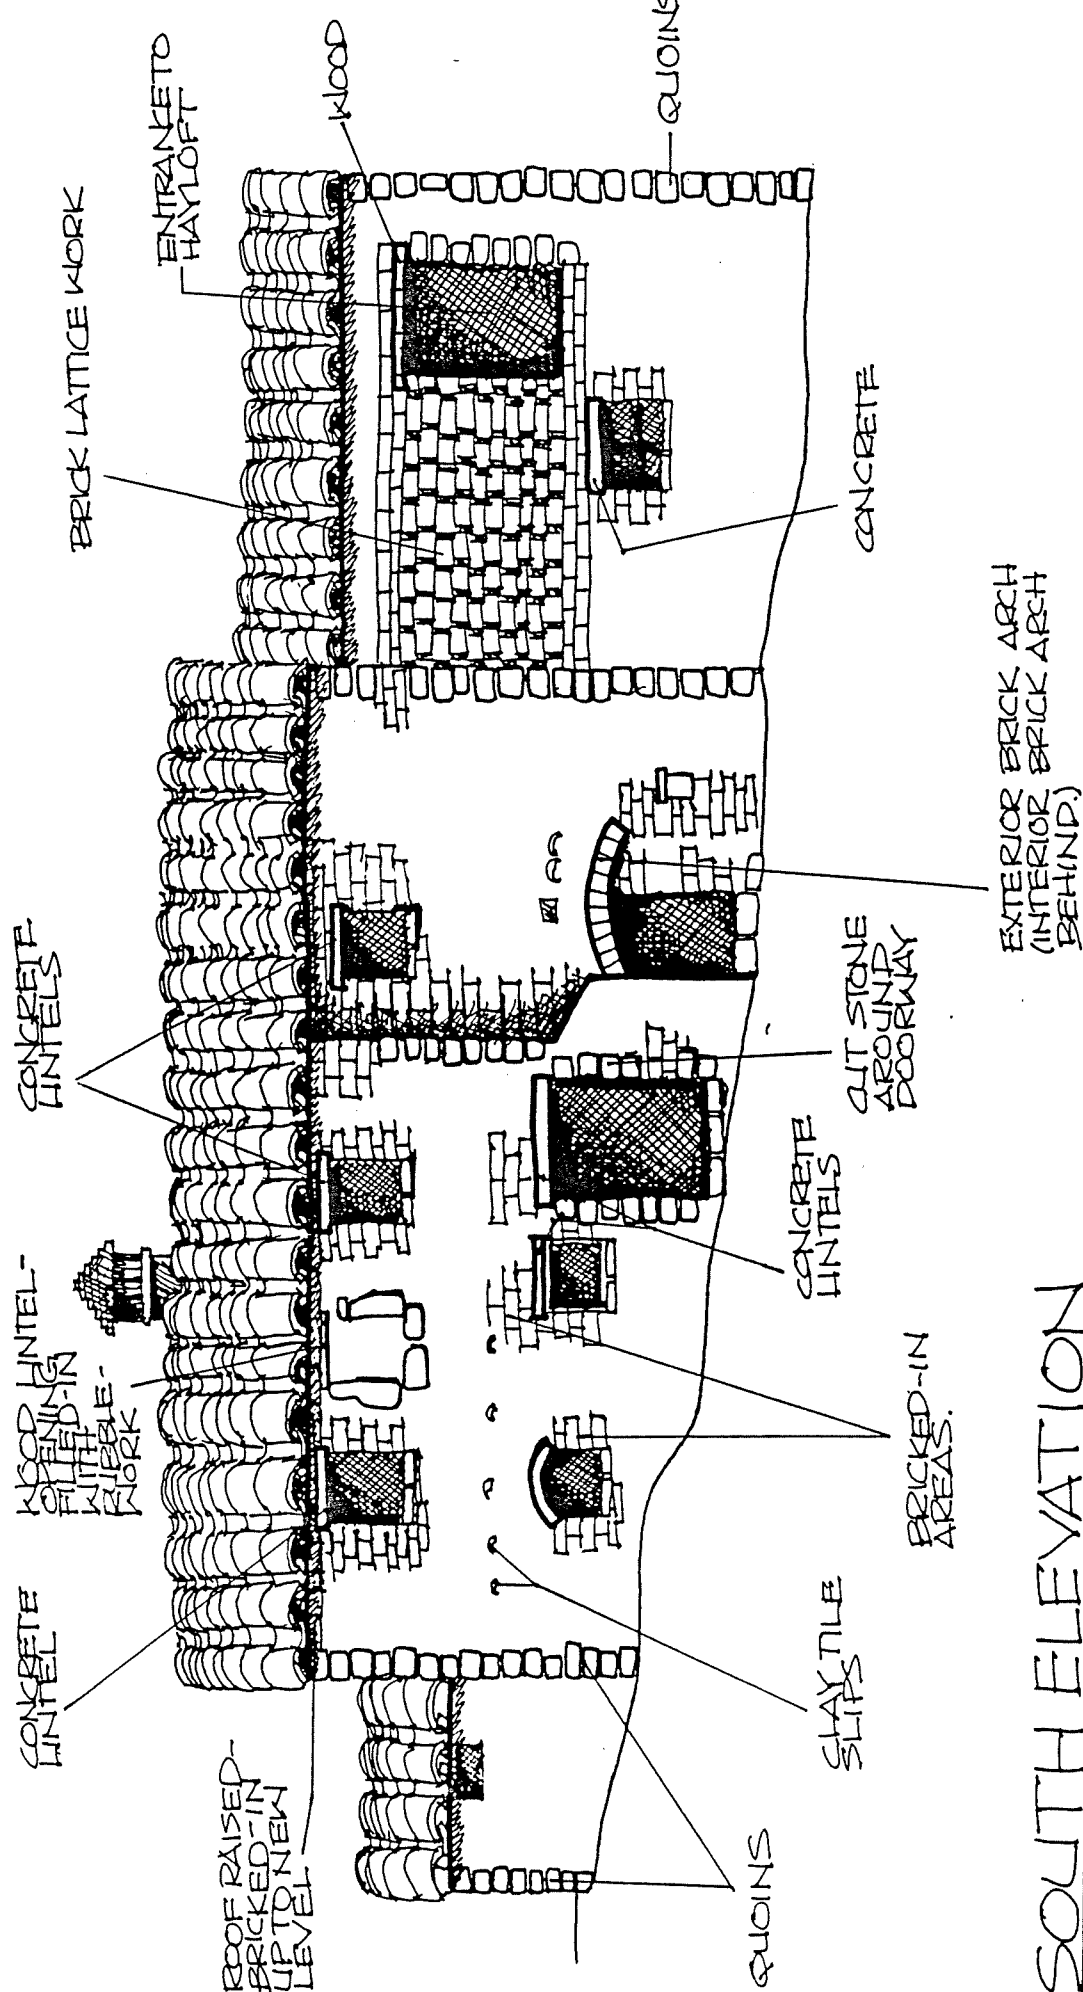
SOUTH ELEVATION

The wall construction of the southeast facade is notably different from the other facades of Padule; the fieldstone is slightly coursed or leveled. The walls of the southeast unit are a combination of rubble fieldstone and an open weave tile. The lower floor and a corner section to the roof is of rubble fieldstone. A large doorway separates the stone section from the open weave tile. The west door jamb is of brick with a wood lintel. A concrete window is in the center of the basement level wall. Cut limestone quoins terminate this section.

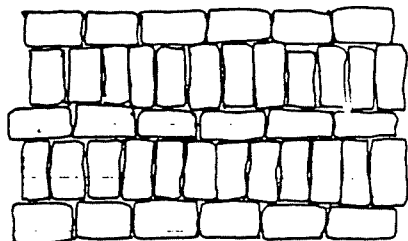
- Ceiling and floor are peeling and stained.
- Crack near the doorway reveals brick pier supporting rafter.
- There are interior cracks where changes in the exterior have occurred.

Red tile pattern of the floor in
7A

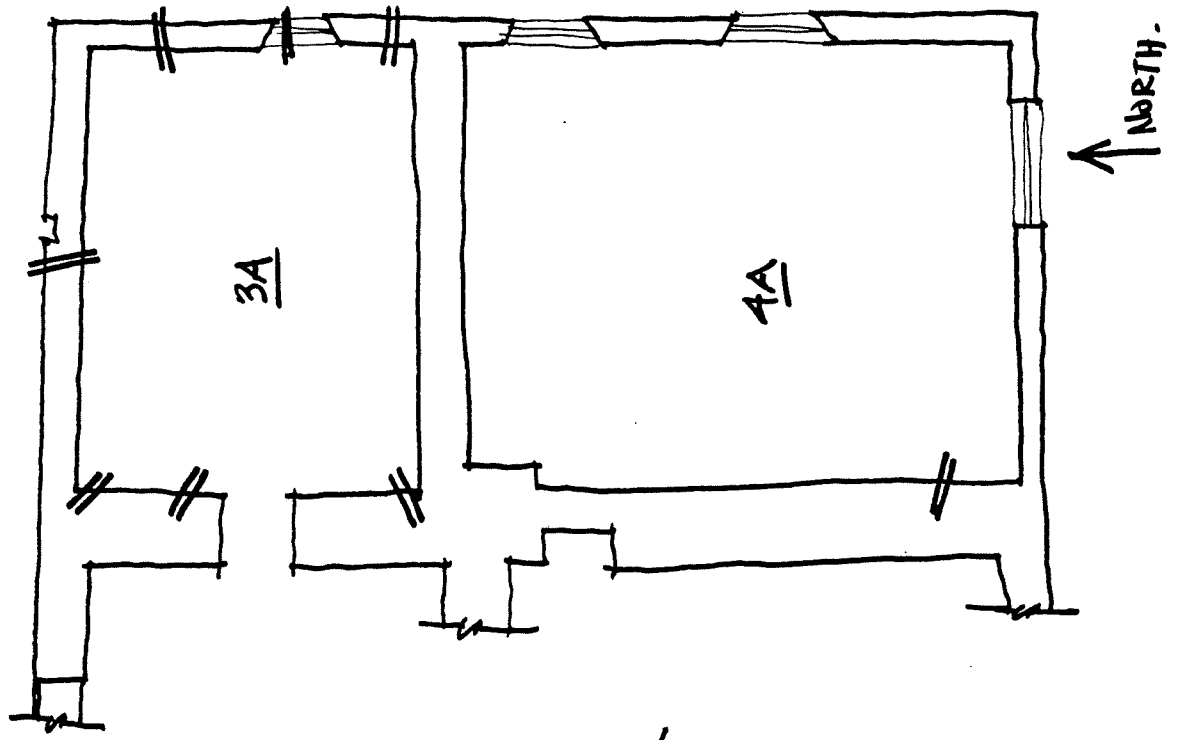
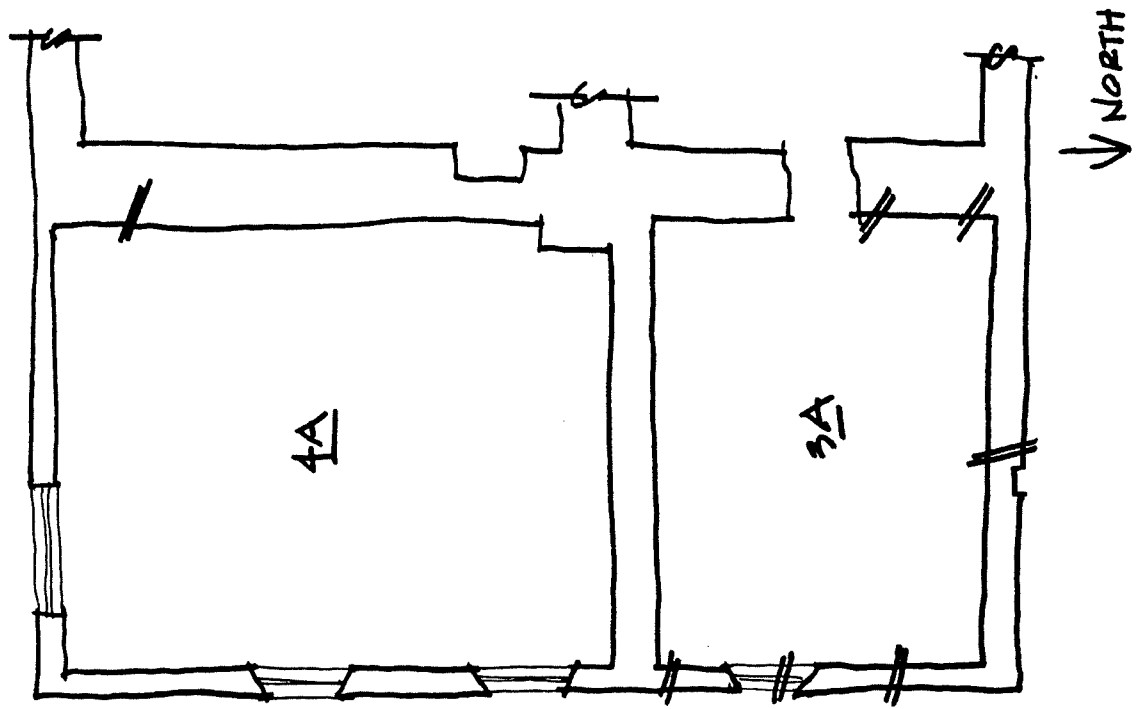
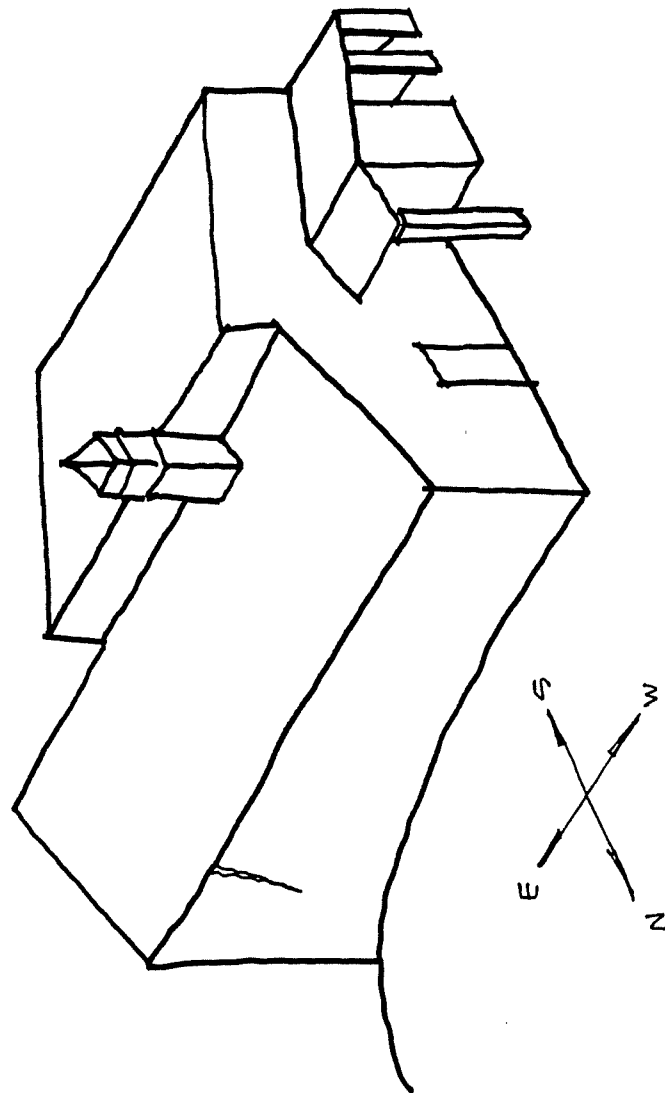
MAJOR CRACKS INDICATED BY // IN PLAN. ALL CRACKS TO BE ASSESSED BY PROFESSIONAL.
