THE COLTRANE CULTURAL CENTER:

AN ADAPTIVE USE PROJECT

AT ARNEST

HSTPV 700 Studio

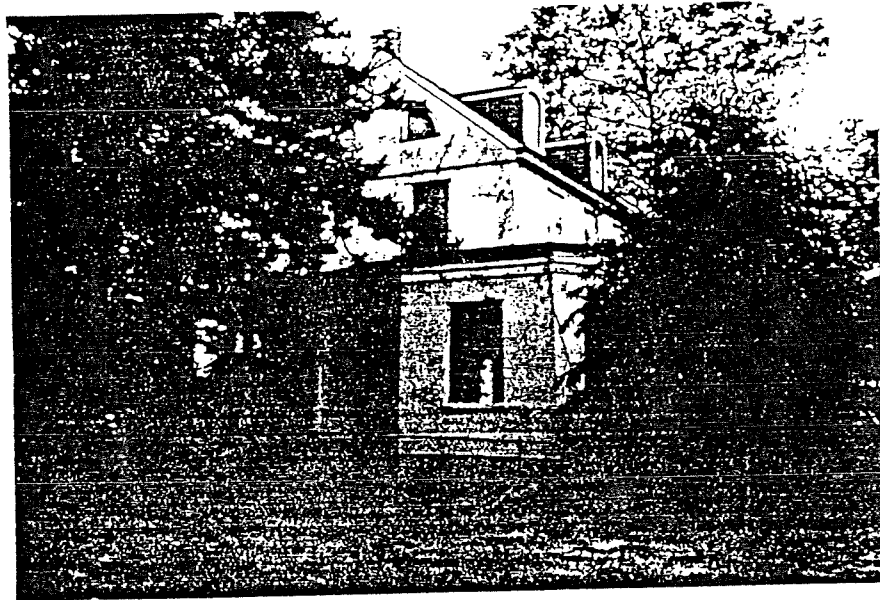
2. North facade.

The octagonal bay and the porch are later nineteenth century additions to the original house. The bays, this on the north and its mate to the south, may date to c. 1865 based on documentary evidence that James Arnest spent \$5,000 in improvements on the house just prior to its sale to the Fairmount Park Commission in 1868. The bays appear on a field note sketch prepared c. 1868; see Appendix. Neg. 19-17.

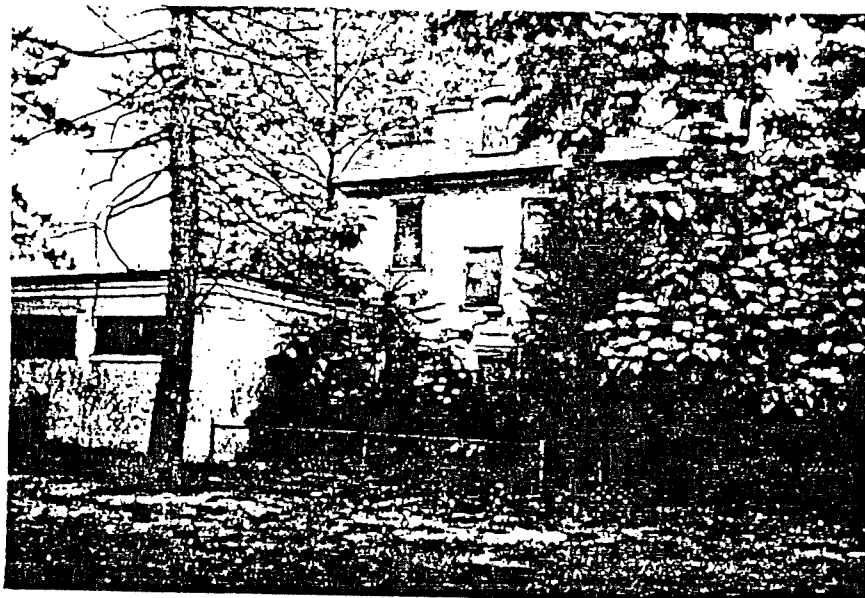
3. East facade.

The east facade is more informal than the west because of its asymmetrical arrangement of windows. Their placement reflects the interior arrangement of rooms as well as several alterations. The east door aligns with that on the west facade, creating a cross-ventilated center hall. The window just above the door lights the staircase. The window to its right on the second floor was punched into the wall some time after 1868 as it does not appear on the field sketch. The chimneystack to its right, probably original, has an unusual location on the slope side of the roof. The second chimneystack, on the south side of the house, has the more usual placement in the gable end of the house. Neg. 19-16.

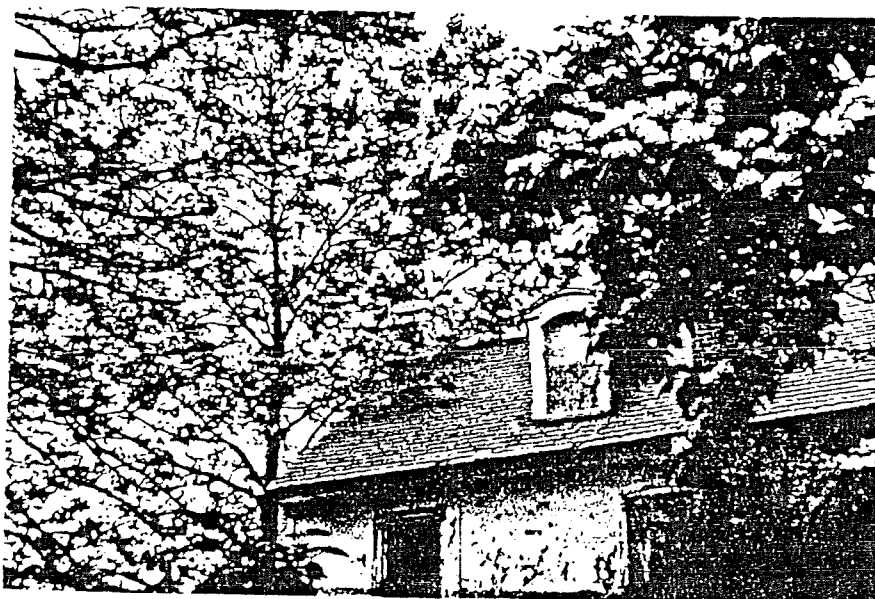
4. Dormer window, east facade.

The elliptically arched window with its restrained neoclassical molding is in a style popular with Philadelphia carpenters from 1790 to 1840. Neg. 19-15.

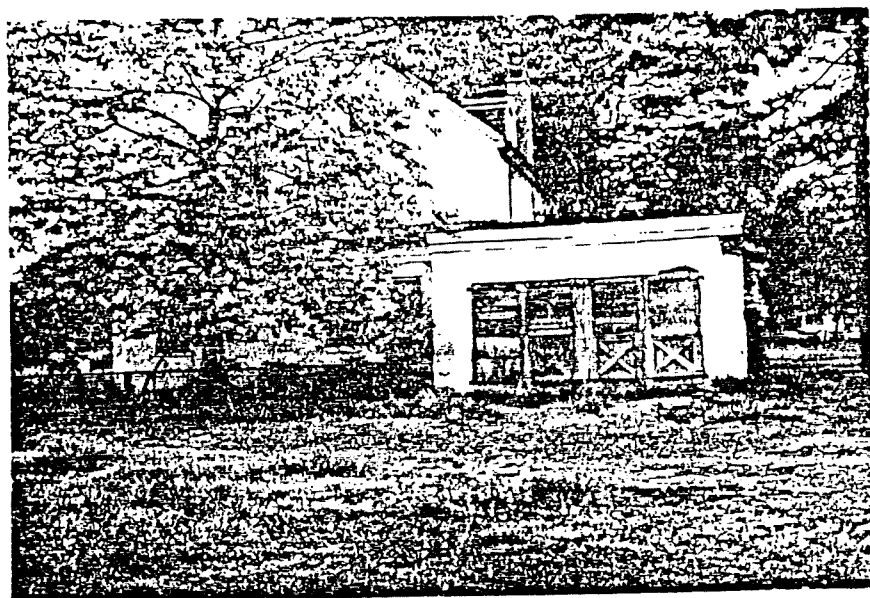
✓ 5. South facade.

The octagonal bay and immediately adjacent kitchen wing are additions to the original house made by 1868 when they appear in the field sketch. The brick garage dates to the twentieth century. Neg. 19-19.

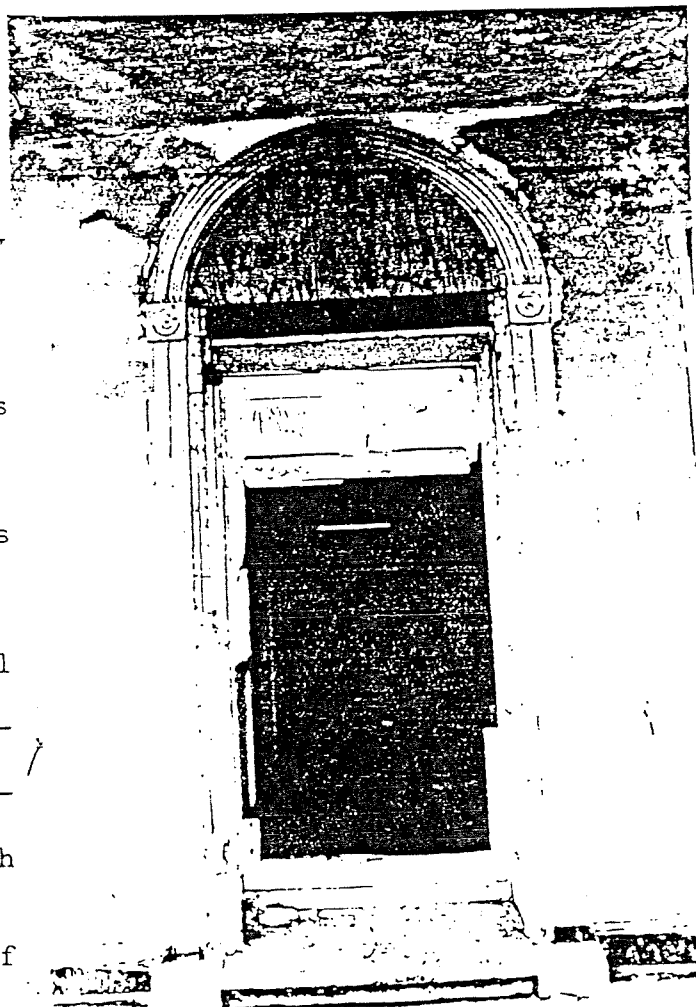
/ 6. Front door frame, west facade.

The door frame, with its distinctive moldings, rosettes and semi-circular fanlight, is probably original to the house. The neoclassical design of the door frame would have been highly fashionable when Arnest was constructed and would have created an elegant front entrance off Log House Lane. The basic style of the moldings and rosettes was used on many of the interior door frames and window frames. Some of these moldings, notably on the interiors of the front door and large dining room windows, appear to have the same profile as those on the exterior door frame; they are, therefore, likely to have been applied at the same time. Others, notably the door frames to the octagonal bays, are similar but not identical. This evidence suggests that during various alterations of Arnest, carpenters continued to use the same style of molding that was nonetheless the product of a different molding plane or mill. Such evidence, combined with paint and structural analyses, will help untangle the complex architectural development of the house. Neg. 21-12.

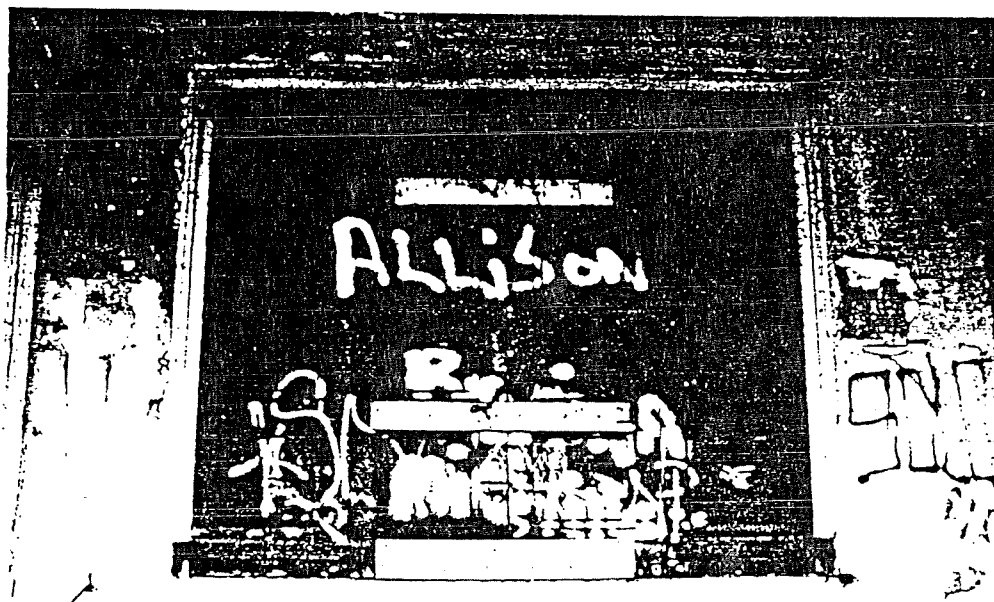
8. East facade, south window.

The pair of double-hinged shutters, probably original to the house, survives on this oversize window. Neg. 2-1.

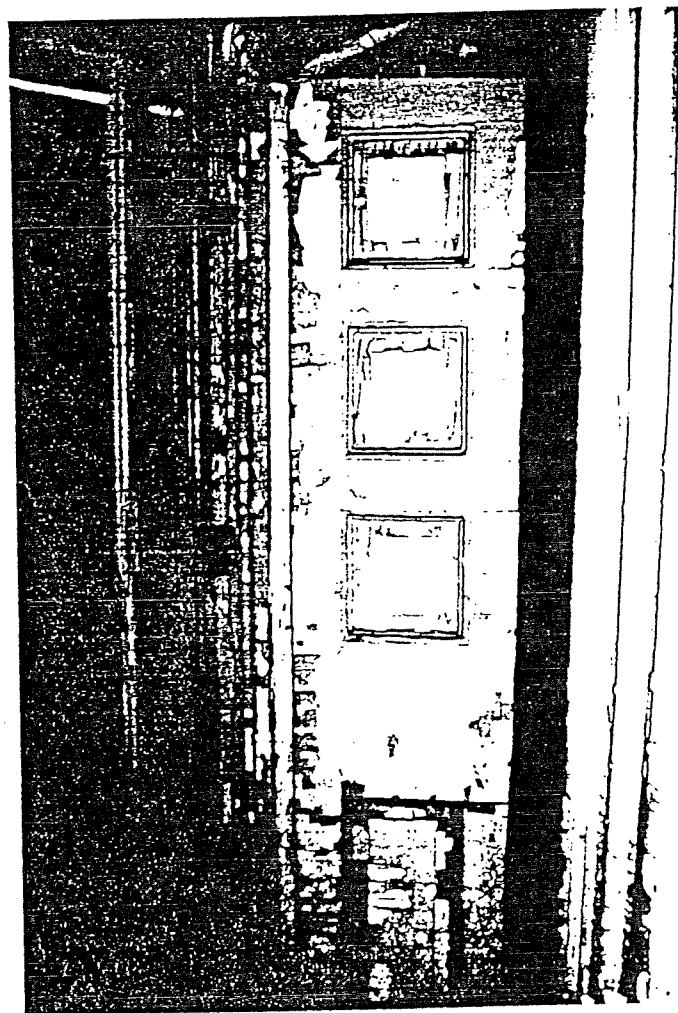
✓ 12. First floor, door to basement and paneled frame of east exterior door.

The relatively flat profiles of the paneling of the door and frame suggest that they are later nineteenth century additions or replacements. These details form part of the evidence that there has been substantial replacement and addition of woodwork in Arnest dating from the mid-nineteenth century through perhaps the twentieth. Neg. 2-3.

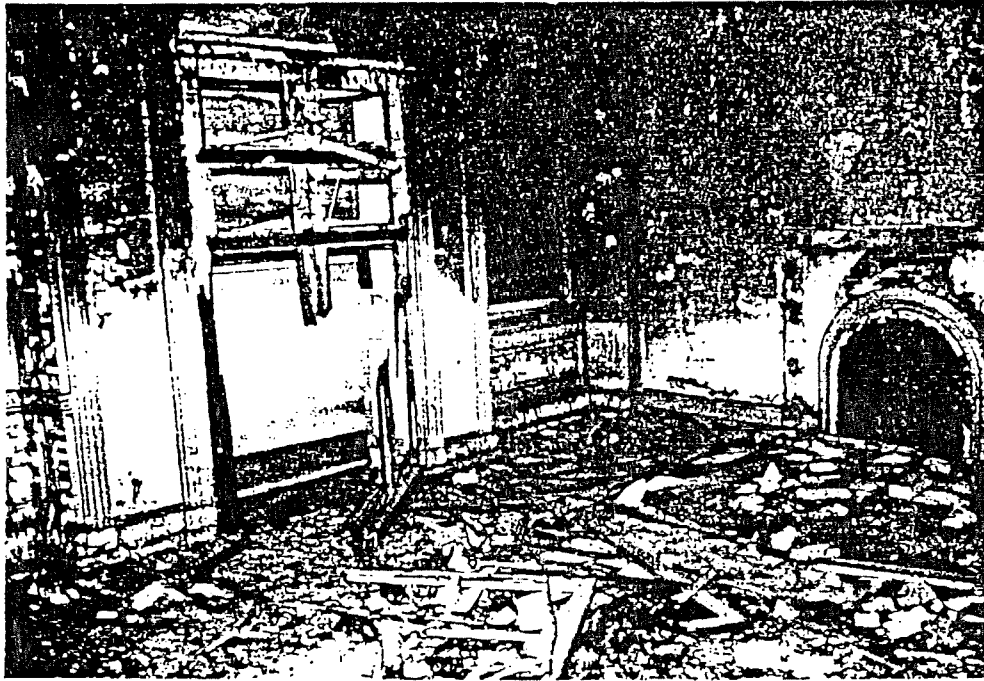
✓ 13. First floor, north parlor, north and east walls.

Two recessed windows with distinctive wainscot paneling flank the remains of a double door with fanlight. The paneling within the door frame and fanlight match that of the west door, indicating that they are of the same period and, therefore, original to the house; see Photographs 14 and 15. The molding surrounding the two doors, however, is similar though not identical. Paint and structural analyses are required to determine whether the parlor moldings are original or additions. The double door is likely to have originally opened to a piazza, perhaps similar to that at Lemon Hill. Neg. 2-5.

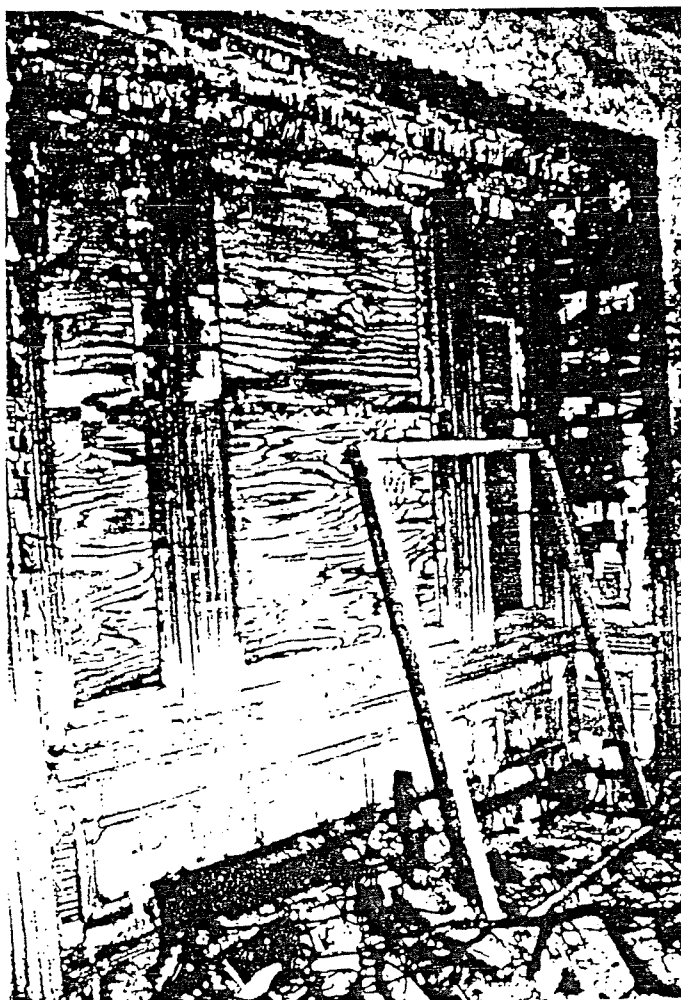
16. First floor, parlor window, west wall.

This three-part window flanked by two narrow sash is a variation of a Venetian or Palladian window. A matching window is on the west wall of the dining room, and a similar window is found on the second floor, south facade, of Rockland. The flat, grooved molding surrounding the windows is like that of the parlor door frame. It is distinct from the contoured molding used on both the west hall door and the window moldings of the west dining room window; see Photograph 20. Neg. 2-6.

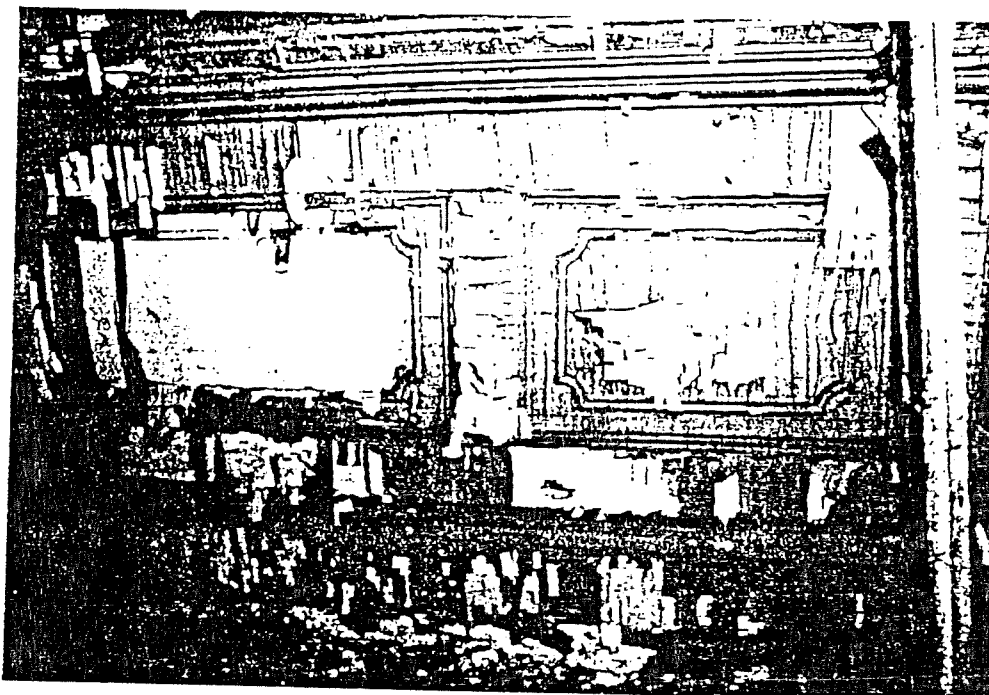
- ✓ 17. First floor, parlor, west wall, wainscot paneling.
 Paint and structural analyses are required to determine whether this flat paneling with raised moldings is original to the house. If original, it is highly unusual and worthy of preservation, according to John M. Dickey, FAIA. It is more likely an addition linked with the different window and door moldings found in the parlor. Regardless, the wainscoting is particularly well executed and lends sophisticated refinement to the formal room of the house. Neg. 2-7.

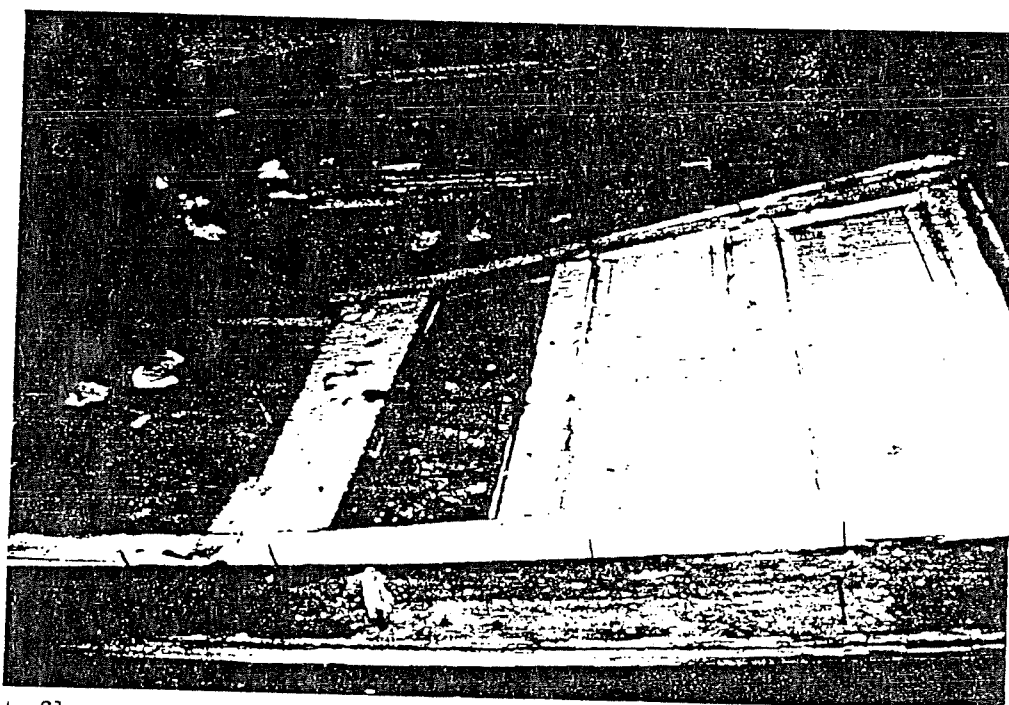
- ✓ 18. First floor, exterior door to north octagonal room.
 The brick octagonal bays are additions to the main block of the house, probably dating to the 1860's. This door with its arrangement of small panels above large panels repeats a design used throughout the house. Neg. 2-8.
