Architectural Investigations and Archival Research

English Garden House and

French Garden House

Mount Edgcumbe House and Country Park

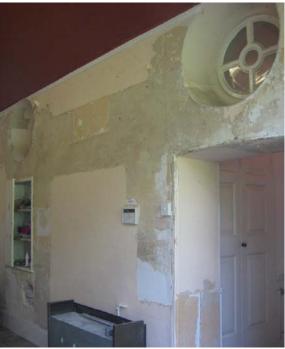
Figure I.1: View of the original north façade from the northwest (in current Kitchen). Original clerestory windows appear at the top: original scored stucco exterior finish revealed under modern wall paper. *Source: University of Pennsylvania*.

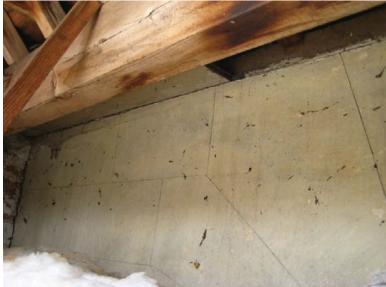
Figure I.2: View of the original west façade from the west (in the attic space above the Bathing Room ceiling). The original scored stucco exterior finish is largely intact; the radiating scoring lines at the left relate to the circular clerestory window, the top of which is still in place. *Source: University of Pennsylvania.*

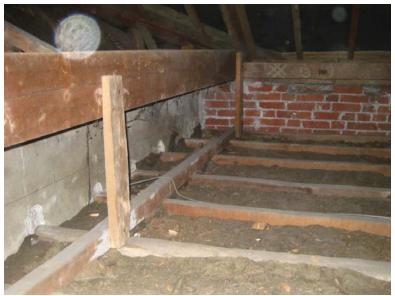
Figure I.3: View of the original west façade from the northwest (in the attic space above the West Room ceiling). The original scored stucco exterior finish is largely intact. *Source: University of Pennsylvania.*

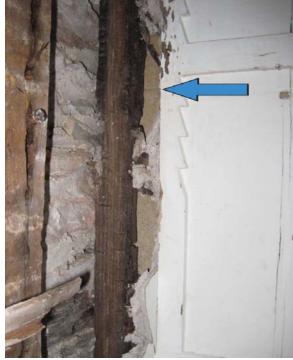
Figure I.4: View from the south of the butt joint between the north wall of the Bathing Room (at the left) and the west façade of the original building (at the right). A portion of the original scored stucco exterior finish on the west façade has survived in this joint. *Source: University of Pennsylvania.*

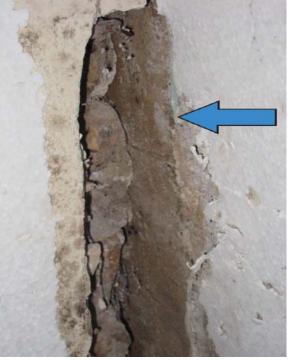
Figure I.5: View from the northwest (inside of the bottom cabinet on the south wall) of the butt joint between the south wall of the Bathing room (at the right) and the west façade of the original building (at the left). A portion of the original scored stucco finish on the west façade has survived in this joint. *Source: University of Pennsylvania.*

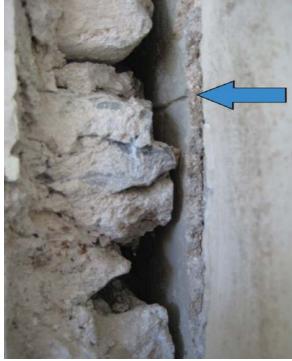
Figure I.6: View from the north in the Toilet of the butt joint between the south wall of the Toilet (at the left) and the east façade of the original building (at the right). A portion of the original scored stucco exterior finish on the east façade has survived in this joint. Source: *University of Pennsylvania*

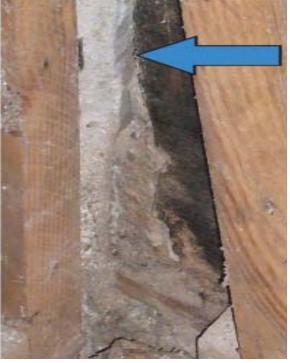
Figure I.7: View from the south of the butt joint between the north wall of the East Room (at the right) and the east façade of the original building (at the left). A portion of the original scored stucco exterior finish on the east façade has survived in this joint. *Source: University of Pennsylvania.*

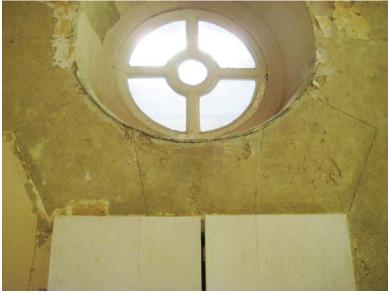
- The stucco on the original exterior north wall is scored to resemble keystones above these locations (*Figures I.8 and I.9*).
- Investigation of the blind opening, below the existing cupboard (in what is now the modern kitchen), revealed that the stucco and scoring turned the corner into the reveal and continued to a flat surface recessed approximately 8½ inches from the plane of the wall (*Figure I.10*).
- There is no evidence of a through-wall opening in the location of the blind opening on the south side of the wall in the Storage/Bathing Room (the 18th century interior plaster wall surface is uninterrupted across the location of the exterior blind opening) (*Figure I.11*).

Figure I.8: View from the north of the original scored stucco below the circular window in the Storage/Dressing Room. *Source: University of Pennsylvania.*

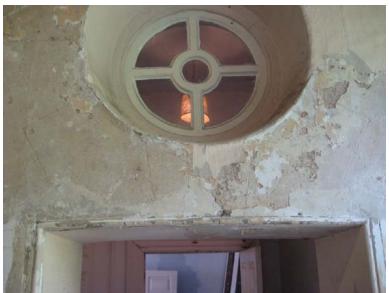
Figure 1.9: View from the north of the original scored stucco below the circular window in the Privy. *Source: University of Pennsylvania.*

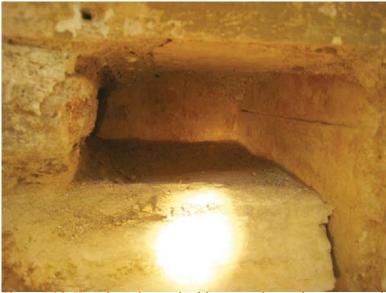
Figure I.10: View from the north of the original scored stucco extending into the reveal of the blind opening below the circular window to the Storage/Dressing Area. *Source: University of Pennsylvania.*

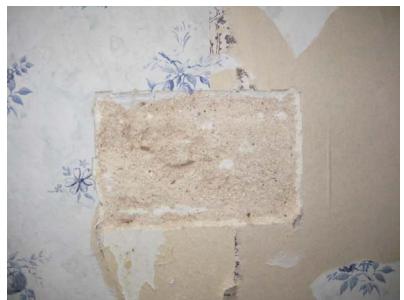
Figure I.11: View from the south of the original plaster on the north wall of the Storage/Dressing Area inside of the blind opening which did not extend through the wall. *Source: University of Pennsylvania.*

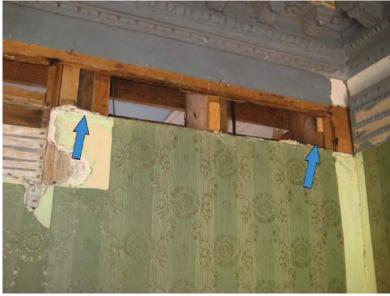
Figure I.12: View from the south in the location of the eastern jamb of the original balustraded opening. The original stud has no evidence of lath and plaster. *Source: University of Pennsylvania.*

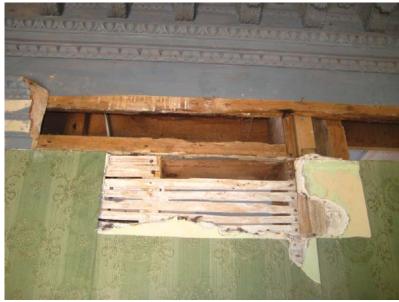
Figure I.16: View from the south of the unpainted south edge of the original soffit board spanning across the balustraded opening. The architrave of the cornice was originally nailed directly to the soffit board. *Source: University of Pennsylvania.*

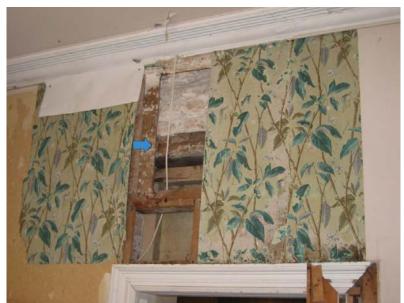
Figure I.17: View from the east in the East Room showing the original wood lintel above the east window in the original building. *Source: University of Pennsylvania.*

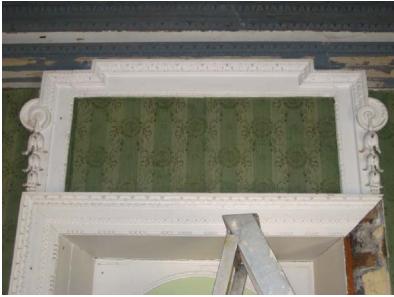
Figure I.18: View from the west of the top portion of the interior frame for the original east window. *Source: University of Pennsylva-nia.*

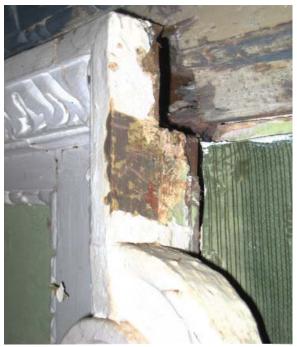
Figure I.19: View from the south west of the corner of the original east window frame that was designed to be partially recessed in the original wood paneling. The portion of the frame to the right of the red primer/grey paint line was recessed. *Source: University of Pennsylvania.*

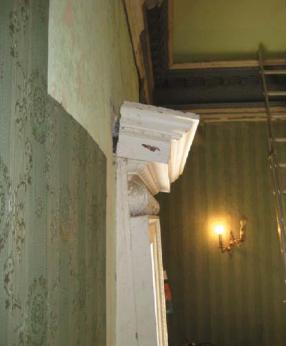
Figure I.21: View from the east of the cornice for the south interior door surround. The cornice was pulled away from the wall after the paneling was removed to facilitate plastering of the south wall. *Source: University of Pennsylvania.*

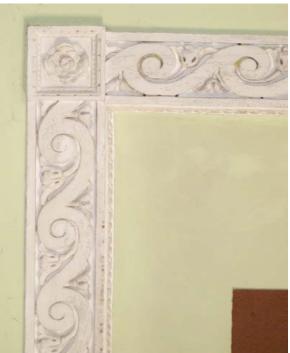
- Analysis of the plaster forming the existing cove ceiling indicates that it was installed in Phase II.
- The original ceiling in the Outer Hall may have been flat, although evidence to confirm this has not been found.
- The existing carved wood frame with corner blocks in the coved ceiling may have existed with the flat ceiling and been reinstalled in Phase II (*Figures 1.22 and 1.23*).

Figure 1.23: Detail of the carving in the ceiling frame. *Source: University of Pennsylvania.*

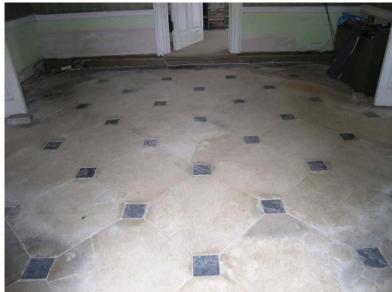
Figure I.24: View from the south of the original masonry floor in the Outer Hall. *Source: University of Pennsylvania.*

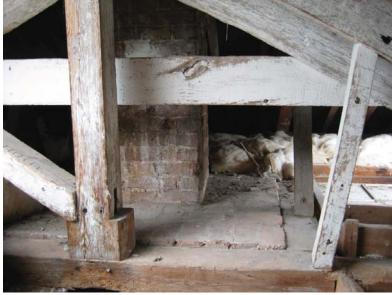
Figure 1.25: View from the south in the attic above the Inner Hall. The framing is original and was fabricated and installed to accommodate the brick chimney mass. *Source: University of Pennsylvania.*

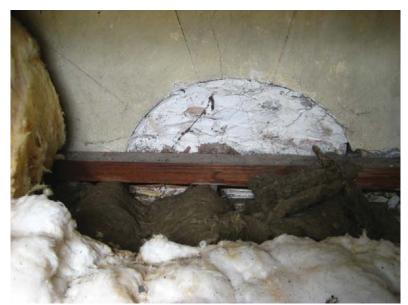
Figure I.26: View from the west of the top portion of the original circular clerestory window in the west façade. *Source: University of Pennsylvania.*

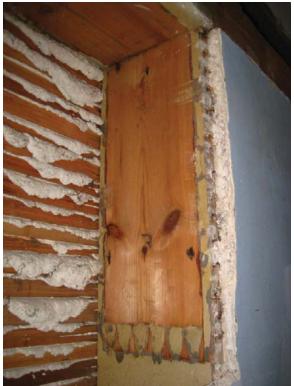
Figure I.28: View from the east of the paint evidence for the bracket at the top of the original balustraded opening. *Source: University of Pennsylvania.*

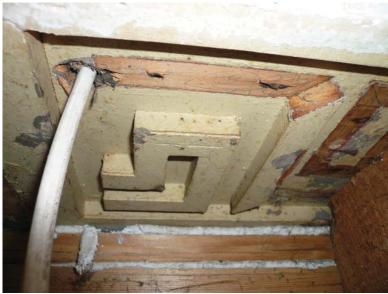
Figure I.29: View looking up at the Greek key that has survived on the soffit of the original balustraded opening. *Source: University of Pennsylvania.*

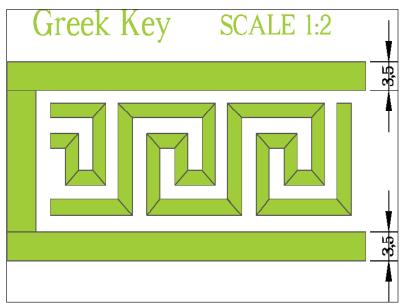
Figure 1.30: Scale drawing of the Greek Key pattern found on the original soffit. *Source: University of Pennsylvania.*

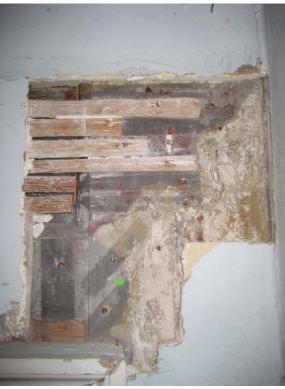
Figure I.32: View from the south of the original paneling that had been concealed by later decorative applications. *Source: University of Pennsylvania.*

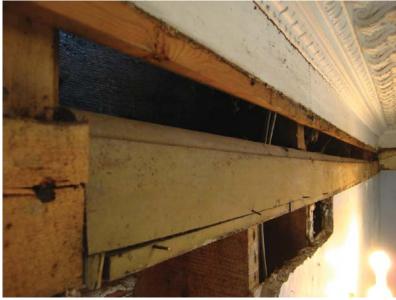
- Removal of the architrave of the decorative cornice on the south wall revealed a painted paneling rail above the balustrade. The rail is finished on its top edge with an ovolo moulding and a groove to receive an inset panel above. The rest of the original paneling above and flanking the opening is missing. While the rail currently only extends the length of the balustrade opening, it is evident that it originally extended further, based on the lack of connection details for stiles (*Figure 1.33*). The existing original balustrade jamb boards contain 1½-deep rebates to accommodate wall paneling, and ¾-inch beads on their outer edges to transition with the paneling (*refer to Figure 1.13*).

Figure I.33: View from the east of the surviving rail of original paneling that existed on the south wall of the Inner Hall above and around the balustraded opening. *Source: University of Pennsylvania.*

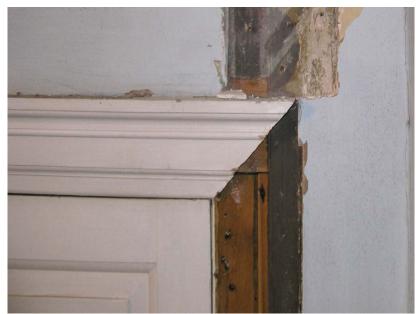
• Removal of the existing door frame moulding revealed paint lines indicating the original door opening and frame width. The blocking that currently frames the door jambs was originally wider, but was trimmed and replaced, as shown by previous mortise and tenon joints and paint lines. The head blocking dates to Phase II (*Figures I.34 and I.35*).

Figure I.34: View from the south of a portion of the eastern doorway into the Storage/Dressing Area (following removal of the current door surround) showing evidence of the Phase I door opening and frame. *Source: University of Pennsylvania.*

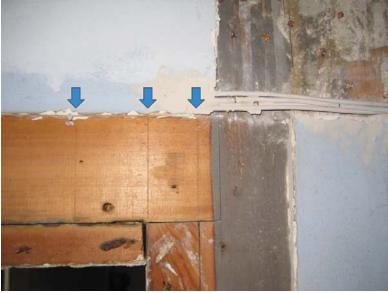
Figure I.35: View from the south of a portion of the western doorway into the Privy (following removal of the current door surround) showing evidence of the Phase I door opening and frame. *Source: University of Pennsylvania.*

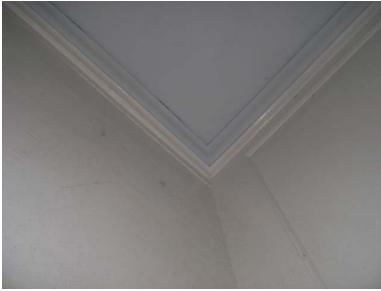
Figure I.37: View looking up at the original cornice molding in the Privy which is similar in dimension to the evidence found on the north paneled wall of the Inner Hall. *Source: University of Pennsylvania.*

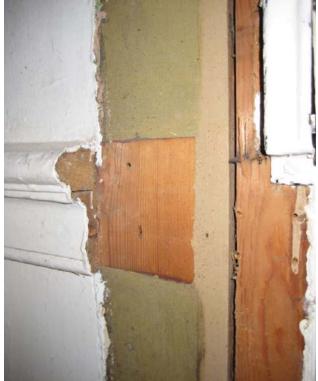
Figure I.39: Profile of the original chair rail existing in the Privy. *Source: University of Pennsylvania.*

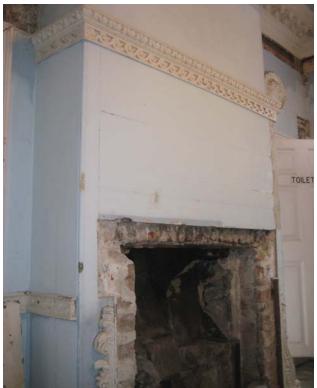
Figure I.40: View from the southwest of the original chimney breast sheathed with flush boards and trimmed with a carved egg and dart moulding. *Source: University of Pennsylvania.*

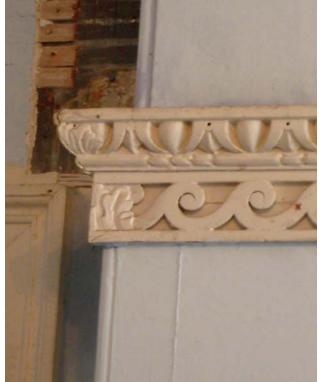
Figure I.41: Detail of the carved moulding at southwest corner of the chimney breast. *Source: University of Pennsylvania.*

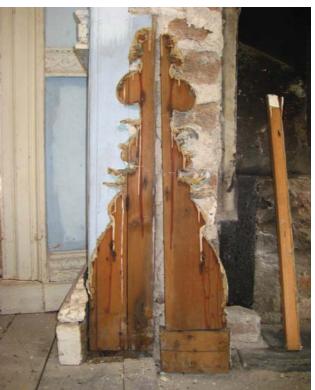
Figure I.42: View of the carved console applied to the west stile of the wood chimney breast. The console has been removed in this image and is laid back to the right. The paint evidence indicates that the console is original to this location. *Source: University of Pennsylvania.*

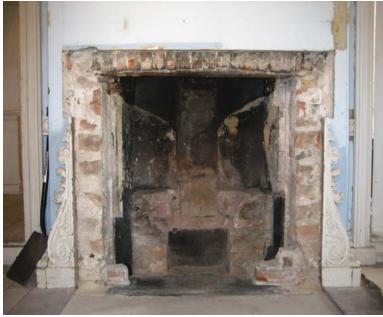
- Partial removal of the fireplace infill revealed a dog-eared pattern left in the mortar, as well as several pieces of what appears to be the Ashburton marble from the original surround. A small mitered corner piece of the carved backband moulding from the dog-eared surround was found as well (*Figures I.43, I.44 and I.45*).

Figure I.43: View from the south of the fireplace following removal of a portion of the later infill, revealing the evidence of a previous (not original) fireplace insert. *Source: University of Pennsylvania.*

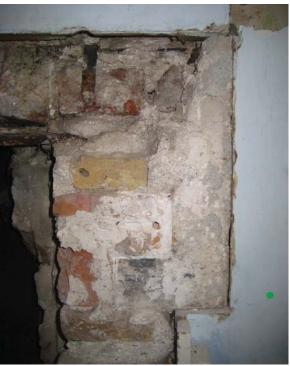
Figure I.44: View from the south showing the outline of the original dog-eared stone fireplace surround. *Source: University of Pennsylvania.*

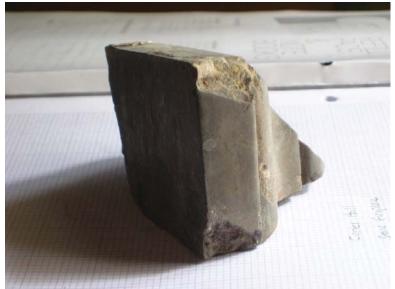
Figure I.45: Fragment of the original mitered corner piece of the dog-eared marble fireplace surround. *Source: University of Pennsylvania.*

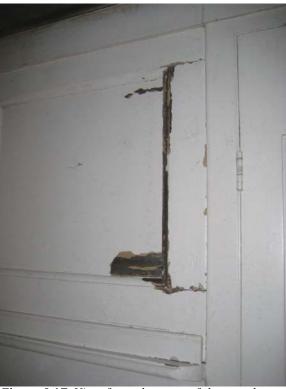
Figure I.47: View from the west of the wood paneled wainscot in the Privy. The stile to the left has been moved and refitted to accommodate the installation of a pair of closet doors on the east wall. *Source: University of Pennsylvania.*

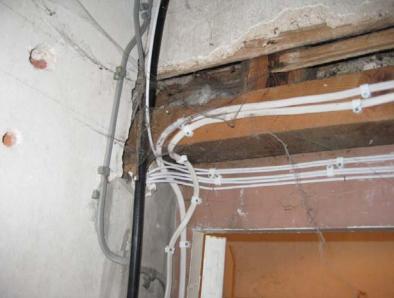
Figure I.48: View from the east (inside of the closet) of the surviving upper portion of the original east wall of the Privy. *Source: University of Pennsylvania.*

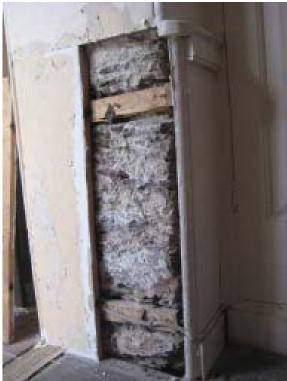
- Original scoring of the exterior stucco on the north side of this wall has keystones that indicate a narrower door opening *(refer to Figure I.9)*.
- Removal of the east wainscot jamb of the current door opening indicated that the stonework had been rebuilt to accommodate the current wider doorway (*Figure 1.49*).

Figure 1.49: View from the west of the eastern jamb of the doorway from the Privy to the Kitchen. The stonework has been rebuilt to accommodate the wider opening. *Source: University of Pennsylvania.*

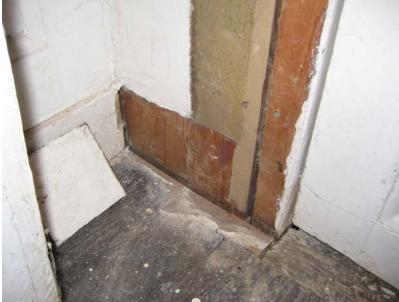
• Removal of the existing baseboard in the Privy revealed paint lines on the stile of the panel partition between the Privy and the Inner Hall that confirm the existing floor level is original, as the paneled partition is unpainted below the current floor level in the Privy (*Figure I.50*).

Figure 1.50: View from the northwest at the intersection of the east Privy wall with the wood partition to the west of the chimney mass. The original baseboard was removed to reveal original paint lines and evidence of modifications in the doorway width and surround. *Source: University of Pennsylvania.*

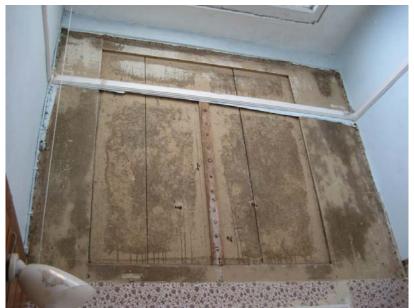
Figure I.51: View looking south at the north face of the eastern paneled wall. *Source: University of Pennsylvania.*

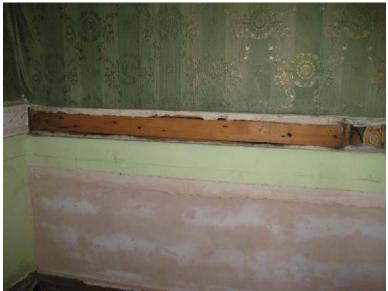
Figure II.3: View from the south of the west end of the north wall at its intersection with the west wall. Removal of the chair rail revealed that it was attached with hand-wrought nails to a furring strip that was in turn nailed to the studs with hand-wrought nails. The furring strip and chair rail were secured to the original wall framing before the plaster was installed. The furring strip terminates on the right at the western jamb of the balustraded opening. New chair rail was installed to the right when the balustraded opening was filled in in Phase III. *Source: University of Pennsylvania.*

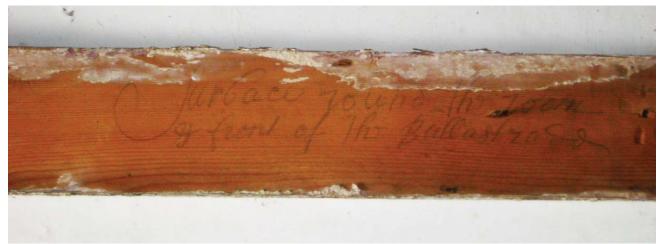
Figure II.4: The chair rail in the corresponding location on the eastern end of the north wall, to the east of the balustraded opening, was removed for investigation. This inscription in pencil was found on the back side of the chair rail, indicating that the balustrade was in place when the chair rail was installed. The nails and nail holes relating to this installation indicated that it is in its original position. *Source: University of Pennsylvania.*

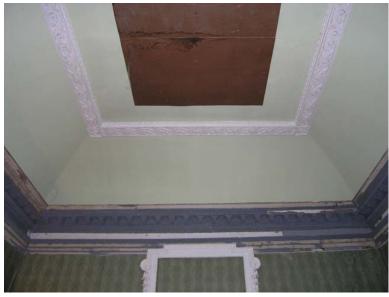
• The carved frame was likely installed at the center of the ceiling at this time, having been relocated from the Phase I ceiling (*Figure II.5*).

Figure II.5: View from the west looking east and up at the cornice, plaster cove ceiling and carved ceiling frame. The brown fiberboard panel at the center of the carved frame was installed following removal of a circular glass glazed sash that borrowed light from a skylight in the roof. This feature was not original, although its position in the building's chronology has not yet been determined. The carved frame is addressed in the Phase I discussions, and may have been relocated from an earlier flat ceiling the Outer Hall. *Source: University of Pennsylvania.*

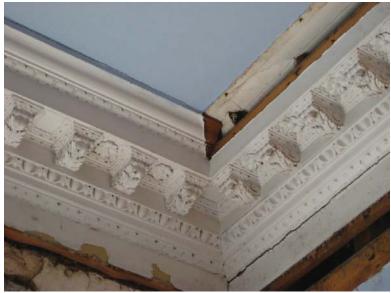
Figure II.6: View from the northwest of the southeast corner of the cornice in the Inner Hall. The design, detailing and installation of the cornice indicate that it was intended specifically for this room and not recycled from another location. The coped crown moulding is supportive of this point. *Source: University of Pennsylvania.*

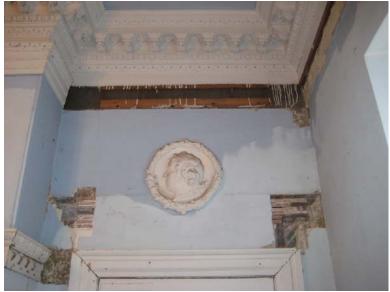
Figure II.7: View from the south of the upper portion of the north wall to the east of the chimney mass. Sections of the architrave of the cornice were removed for investigation, and the paint evidence and installation methodology supports the Phase II chronology. *Source: University of Pennsylvania.*

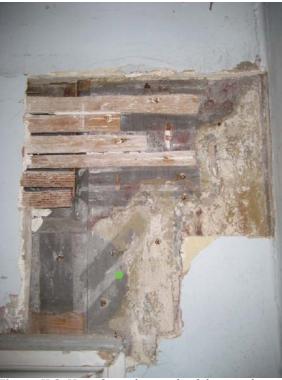
Figure II.8: View from the south of the wood paneled wall above the door in the north wall to the Storage/Dressing Area. Evidence of the previous position of a decorative overdoor is clearly discernable in the painted surface. *Source: University of Pennsylvania.*

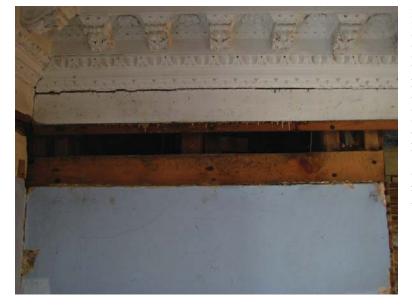
Figure II.9: View from the north of the cornice at the east end of the south partition wall, east of the original balustraded opening. The white plaster at the far left of this image ends in a straight line where it abutted the original wood paneling on the south wall. After the paneling was removed, the new elaborate cornice was installed, and the plaster was applied abutting the bottom edge of the archirave and the $34^{"}$ bead (now missing) at the far right of this image. The plaster also abutted the new chair rail and baseboard that were attached to the wall framing. *Source: University of Pennsylvania.*

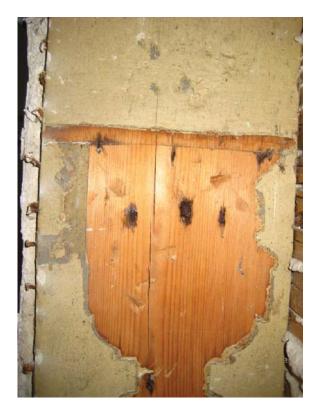
Figure II.10: View from the west of the painted profile at the top of the balustrade on the east jamb board of the balustraded opening. The paint evidence indicates that the carved chair rail, installed at the time the south wall was plastered, was also applied to the Inner Hall side of the balustrade hand rail since it overlays earlier paint. The fact that a similar chair rail profile exists on the Outer Hall side of the hand rail with no evidence of earlier paint may indicate that the chair rail was also used in conjunction with the original Outer Hall paneled walls. *Source: University of Pennsylvania.*

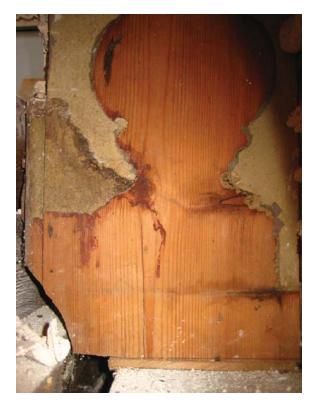
Figure II.11: View from the west of the painted profile at the bottom of the ballustrade on the east jamb board of the ballustraded opening. The paint evidence indicates that the baseboard present in the inner hall once turned the corner into the ballustraded opening. The outline overlays earlier paint indicating that this baseboard was installed in Phase II. *Source: University of Pennsylvania.*

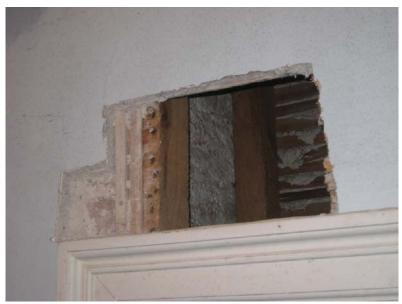
Figure II.12: View from the east looking into the void above the doorway in the west wall to the Bathing Room. This section of wall was replastered, perhaps in Phase III. *Source: University of Pennsylvania.*

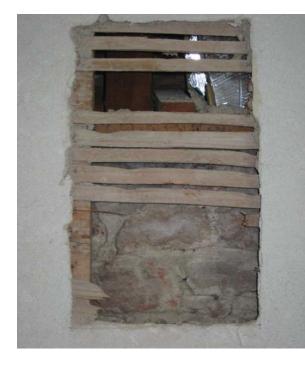
Figure II.13: View from the east showing the west wall of the Bathing Room. A section of lath and plaster was removed revealing that the original west wall terminated at a point approximately 6 ½ feet above the floor. The framing above the stone wall appears to date from the twentieth century, probably when the current hipped roof was installed over the Bathing Room. *Source: University of Pennsylvania.*

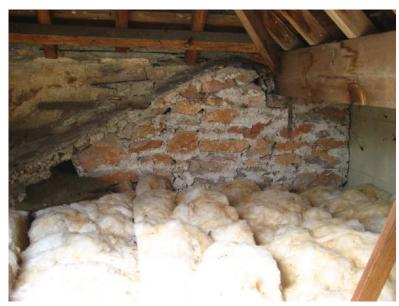
Figure II.14: View from the south in the attic space above the ceiling of the Bathing Room. The evidence of the original sloping roof over the Bathing Room is apparent. The parapet wall above the sloping roof is covered in stucco, and fragments of what appears to be slate cap flashing project from the wall. No evidence of interior finish exists on the north parapet wall below the roof slope. *Source: University of Pennsylvania.*

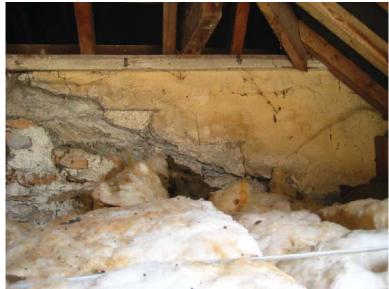
Figure II.15: View from the north in the attic space above the ceiling of the Bathing Room. The evidence of the original sloping roof is a mirror image of photo II.14. The parapet wall above the sloping roof is also covered in stucco. *Source: University of Pennsylvania.*

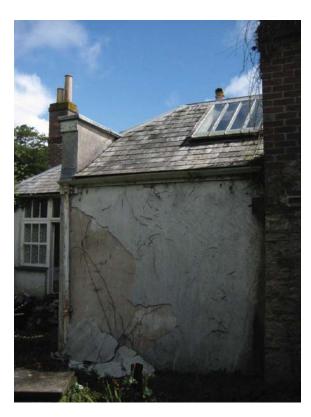
Figure II.16: View from the west showing the later-hipped roof over the bathing room and the north parapet wall which was original to the bathing room. *Source: University of Pennsylvania.*

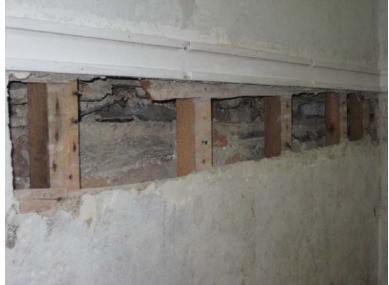
Figure II.17: View from the west wall of the bathing room showing space for a wood nailer in the masonry at chair rail level. *Source: University of Pennsylvania.*

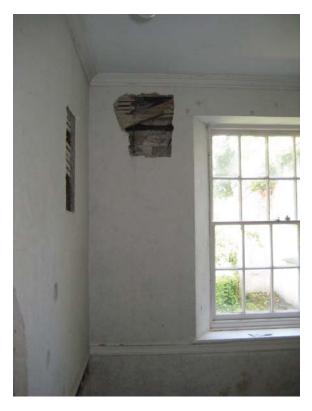
• Given the slope of the original Bathing Room roof, the opening for the existing window in the north wall would not have fit. This window and the niche protruding through the south wall have eliminated any evidence of possible original window openings in those locations (*Figure II.18*).

Figure II.18: View from the south of the north wall of the Bathing Room. An indication of the original sloping roof can be seen on the left, indicating that the current position of the window is in conflict with that slope. *Source: University of Pennsylvania.*

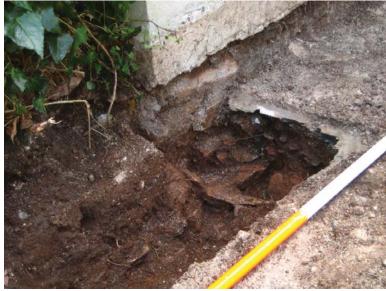
- Archaeological investigations uncovered the remains of a partial foundation wall for a symmetrical East Wing (*Figure II.19*).
- Removal of the chair rail revealed no evidence of a door opening in the east wall of the Inner Hall, indicating that the Conjectural Wing must have been accessed through another entrance, perhaps from outside (*Figure II.20*).

Figure II.19: View from the northeast showing the northeast corner of the existing East Room. Archeological excavations, concurrent with the compilation of this report, revealed the existence of a stone foundation wall integral with the north stone wall of the East Room and extending to the north. This evidence supports the hypothesis that an eastern wing, symmetrical with the Bathing Room wing, existed prior to the construction of the East Room. *Source: University of Pennsylvania.*

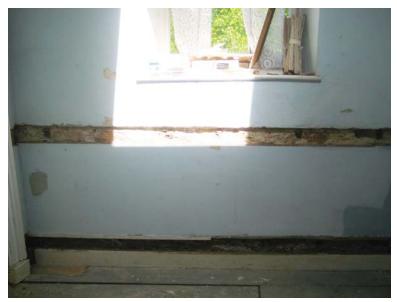
Figure II.20: View from the west at the east wall of the Inner Hall. Removal of the existing chair rail exposed the stone masonry which contained no seams or other evidence of a doorway connecting with a wing to the east. *Source: University of Pennsylvania.*

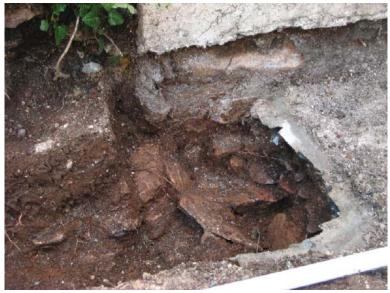
- Archaeological investigation revealed a render on the below grade north face of the north wall of the East Room. It is not currently possible to determine whether this is an interior or exterior finish (*Figure II.21*).

Figure II.21: View from the northeast showing the archeological excavations at the northeast corner of the East Room. Fragments of what appears to be exterior stucco survived along the lower portion of the north wall of the East Room. This is likely the original finish applied to the north wall after the earlier wing had been demolished. Also found in situ was a layer of 1 inch thick slate that could represent the floor of a lean-to structure attached to the north wall, perhaps to tend the fireplace that originally served the earlier wing and was converted to a heating device to serve the new East Room. *Source: University of Pennsylvania.*

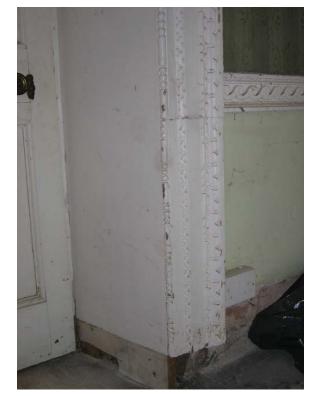
Figure III.1: View from the west of the lower portion of the door frame leading to the east Room. New pieces were added to the bottoms of the east and west door frames to reconfigure them as doorways. *Source: University of Pennsylvania.*

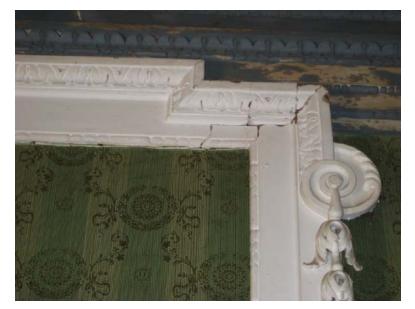
Figure III.2: View from the west of the overdoor at the doorway to the East Room. As previously mentioned, this overdoor is the top portion of the original frame for the east window in the Outer Hall. It was salvaged and used as a decorative element in Phase II when the paneling was removed, the walls were plas-tered and the window openings fitted with new carved frames. When the doorways were added to access the new East and West Rooms, the Phase I and Phase II frames were widened to fit the wider door openings. The 3 inch insertion at the top edge of this frame is evident. A symmetrical 3 inch piece was also added at the other side of the frame. Source: University of Pennsylvania.

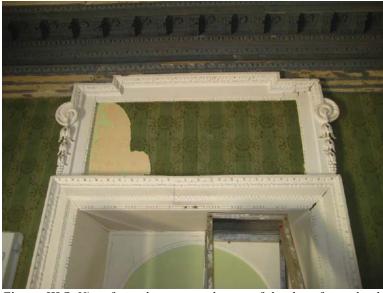
Figure III.3: View from the west at the top of the door frame leading to the East Room. The top piece of the carved frame was pieced to accommodate the wider doorway. The top piece of the overdoor was also pieced as shown in the previous image. *Source: University of Pennsylvania.*

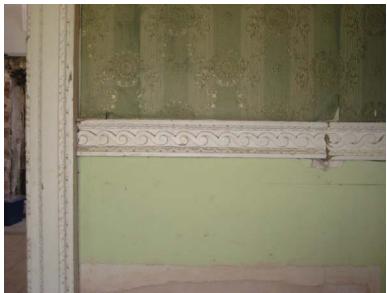
- Seams in the chair rail moulding reveal that additional pieces were installed when the balustrade opening was filled (*Figure III.4*).
- The carving in the added chair rail varies slightly from the original, and the piece on the east side of the wall is installed incorrectly (*Figure III.4*).

Figure III.4: View from the south at the chair rail to the east of the central doorway leading to the inner hall. The seam in the chair rail coincides with the eastern jamb of the original balustraded opening that was filled in as part of the Phase III renovations. The piece of chair rail to the left (west) of the seam was installed to span the eastern in-filled section of wall. *Source: University of Pennsylvania.*

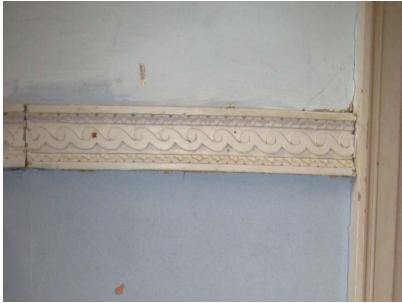
- The chair rail to the east of the new door has a seam at the edge of the previous balustrade opening *(Figure III.5).*
- The chair rail to the west of the new door was replaced with one continuous piece.

Figure III.5: View from the north of the south wall of the Inner Hall to the left (east) of the central doorway inserted in the in-filled balustraded opening. The chair rail and baseboard were pieced out to span the eastern in-filled section of the wall. *Source: University of Pennsylvania.*

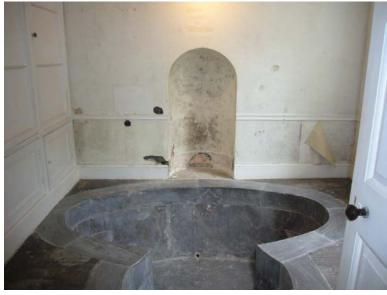
- The niche may have served as a location for the bronze dolphin taps (*Figure III.6*). These taps are now located in a fountain behind the main house (*Figure III.7*).
- The plaster in the niche matches the existing wall plaster in the Bathing Room, however, indicating that the niche may have been re-plastered at a later date (the existing Bathing Room wall plaster dates to when the roof and ceiling were raised, likely in the early 20th century).

Figure III.6: View from the east of the west wall of the Bathing Room. The cabinets to the left (south) mask the alcove of the West Room which encroaches on the Bathing Room. The niche at the center of the west wall accommodated the bronze dolphin spouts that delivered hot and cold water to the tub. The date of installation of this niche is not known, although it is likely concurrent with the Phase III renovations. *Source: University of Pennsylvania.*

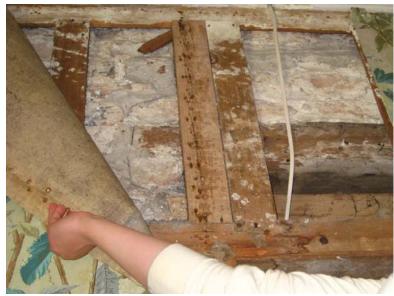
Figure III.8: View from the east of the west wall above the doorway leading to the Outer Hall. Fragments of original stucco exterior finish remain on the east face of the stone wall. The system of furring strips to which the wallpaper was applied is visible. The hand-hewn wood lintel behind the furring strips relates to the original east window in the original building. *Source: University of Pennsylvania.*

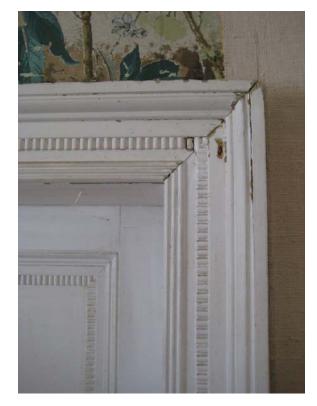
Figure III.10: View from the east of the top right corner of the door frame leading to the Outer Hall. The frame is attached to the furring strips behind it with hand-wrought nails, and is in its original Phase III position. *Source: University of Pennsylvania.*

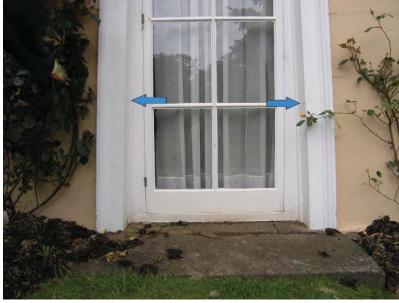
- The 1860-1865 W. Hake engraving depicts the early configuration of the window (*Figure 52*).⁵
- The seam where the frame was extended can be seen on the exterior (*Figure III.15*).

Figure III.15: View from the south of the south doorway in the East Room. The seams in the stone frames suggest that this feature was originally a window as depicted in the 1860-65 engraving. *Source: University of Pennsylvania.*

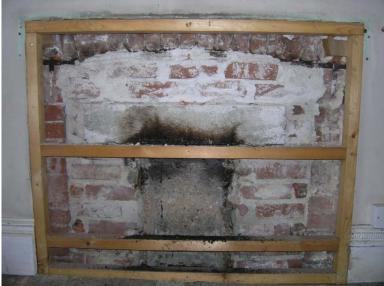
Figure III.16: View looking west at the fireplace centered in the west wall of the West Room. This feature has not been further investigated, but apparently incorporates a rather unique narrow flue imbedded in the west wall and rising diagonally to a chimney stack incorporated in the west wall of the Bathing Room. *Source: University of Pennsylvania.*

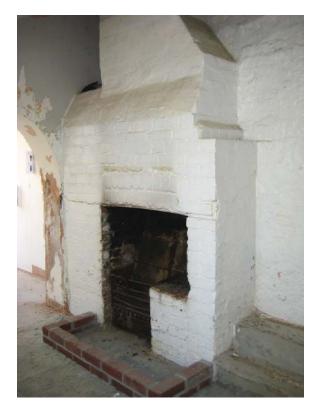
- There is a utilitarian fireplace along the south wall (*Figure IV.3*).
- With the demolition of the Conjectural East Wing, the English Garden House may have needed additional service space.

Figure IV.3: View from the northwest of the fireplace on the south wall of the Rear Room. Its purpose and function relative to the English Garden House are not known. *Source: University of Pennsylvania.*

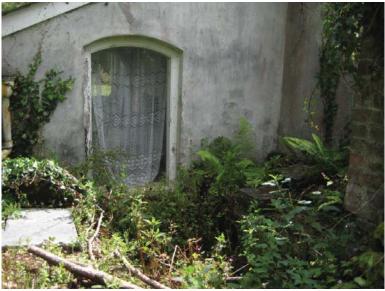
- The 2005 Conservation Plan states that the kitchen was added between 1868 and 1880 based on the Ordnance Survey maps.²
- A door was inserted in the brick wall of the rear building and the original west door was converted to a window *(refer to floor plans and Figure V.1)*.
- The original privy door was widened (*Figure V.2*).

Figure V.1: View from the west of the exterior west wall of the Rear Room. The previous door in this location was converted to a window. *Source: University of Pennsylvania.*

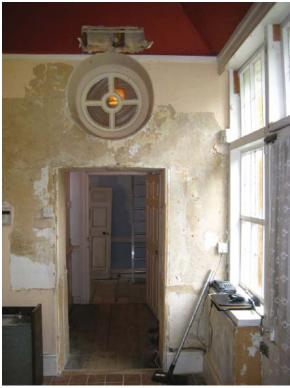
Figure V.2: View from the north (in the existing Kitchen) of the doorway leading to the current Corridor and former Privy. This doorway was widened, probably when the Kitchen was constructed. *Source: University of Pennsylvania.*

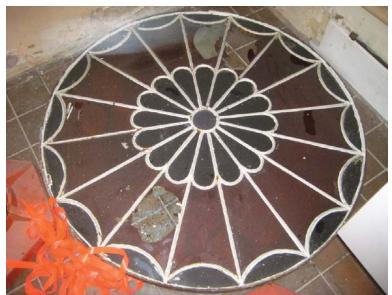
The date of installation of the round colored-glass skylight in the Outer Hall is unknown, and should be investigated further (*see Figure V.9*).

Figure V.9: View of removed round colored-glass skylight from Outer Hall coved ceiling. *Source: University of Pennsylvania.*

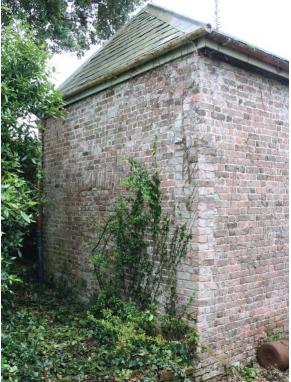
Figure I.1: East wall of French Garden house. The butt joint between the east and rear wall is clearly visible - an indication that the side was added onto the rear wall. *Source: University of Pennsylvania.*

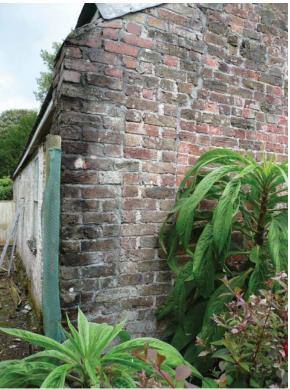
Figure I.2: West wall of French Garden House. Two butt joints are visible. The joint on the left shows where a buttress was added later in construc¬tion, and the joint on the right shows the intersection between the original wall and the west wall. *Source: University of Pennsylvania.*

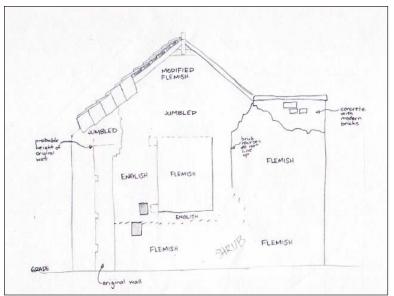
Figure II.5: Illustration of the different brick bond work on the west wall. Note the consistent Flemish bond along the bottom portion of the wall. Solid lines indicate obvious seams. Dashed lines indicate less obvious seams. Slashed lines delineate the boundaries of the brick work. *Source: University of Pennsylvania.*

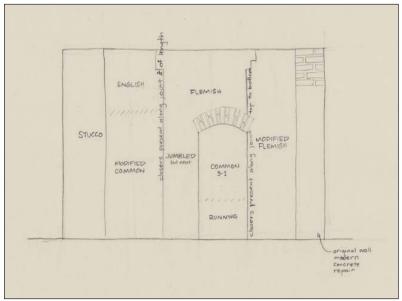
Figure II.6: Illustration of the different brick bond work on the east wall. The north seam runs the entire height of the wall on the right side of the relieving arch. *Source: University of Pennsylvania.*

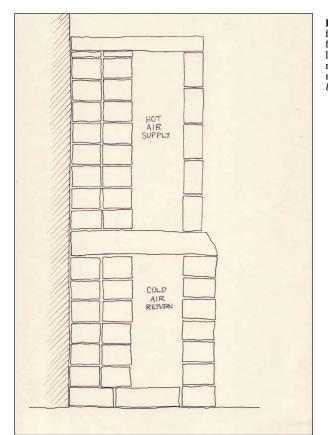
Figure II.7: Section of rear flue. The top portion was used for hot air supply, with bricks laid edge to pro¬vide a thinner wall through which could more easily escape. *Source: University of Pennsylvania.*

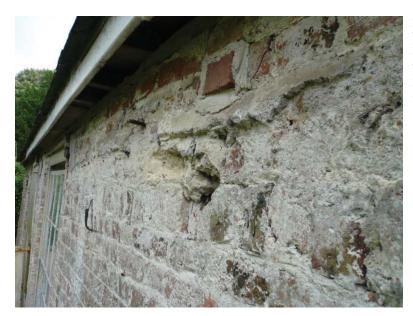
Investigations on-site also revealed evidence for a lean-to structure on the rear of the building. Many greenhouse designs of the time included a small rear structure to shelter the stove and perhaps serve as a seed shed or storage space for firewood. Early nineteenth century maps of the French Garden House show a lean-to footprint. A shadow is visible around where the stove opening is located and mortar flashing and slate remains were observed along the top of the wall in this section *(see Photo Mosaic of Rear Wall in Appendix and Figure II.8 below)*. Further evidence includes a wall anchor that held a ledger

Figure II.8: Remains of mortar flashing and slate roof tiles in rear wall, visible just underneath the modern brick. Mortar was commonly used as flashing be-fore lead became readily available. *Source: University of Pennsylvania.*

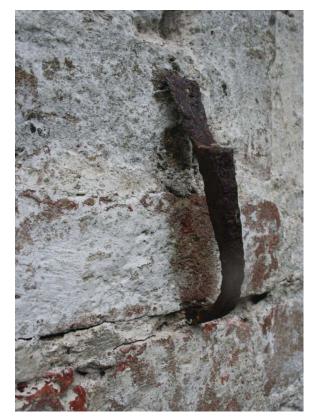
for the roof frame and several replacement bricks that may infill where framing members entered the wall to form a barrier wall to the northwest wind *(Figure 11.9)*. The shed was likely closed, but the only remaining physical evidence of the structure is of the roof and rafters. The existence of a lean-to implies that the stove for the heating system was an exterior feature, stoked on the outside and heat directed in. The location and design of the chimney could not be determined.

Figure II.9: Hand-wrought wall anchor. The ledger holding the rafters for the rear lean to sat on the flat portion at the top of the anchor and a nail was driven through the hole in the anchor into the wood. *Source: University of Pennsylvania.*

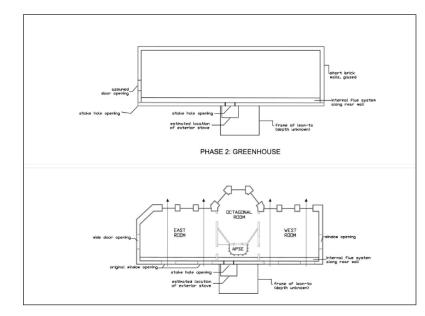
The unusual footprint of the garden house points to the adaptation of a former structure. The building appears symmetrical from the front, but in fact the rear wall is slightly longer than the front wall on the east end of the building. To create symmetry from the front of the building while still making use of the stove built for the greenhouse, the east wall was canted to create a shorter front wall, further evidence that the side walls were in existence before the third phase design (*Figure II.10*).

Figure II.10: A comparison between the footprint of the phase 2 greenhouse and phase 3 garden house il¬lustrates the need to cant the east wall. The rear windows were framed on the rear wall around the lean-to to retain use of the stove. These windows are placed directly in line with the front sash windows. To maintain the symmetrical on the front, the east wall of the greenhouse was adapted to the new facade. *Source: University of Pennsylvania.*

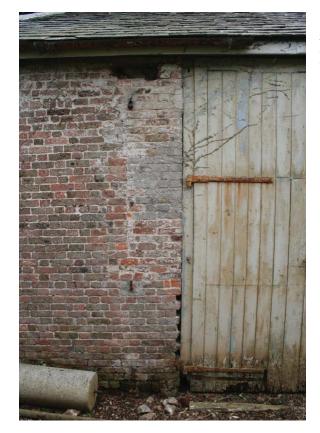
Figure III.1: The brick infill in the openings of the original window are visible to the left of the rear door. The insertion of the rear doors re¬quired the removal of the window. *Source: University of Pennsylvania.*

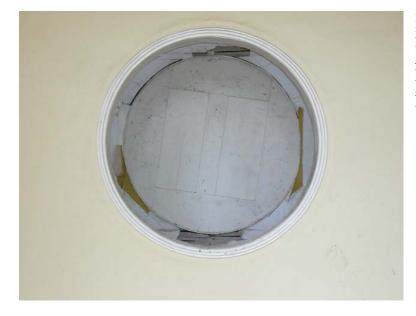
Figure III.2: The circular frame in the apse is constructed in the tradi¬tional way one would build a large circle out of wood. A small lip around the edge of the front of the circle indicates that it was intended to hold something. *Source: University of Pennsylvania.*

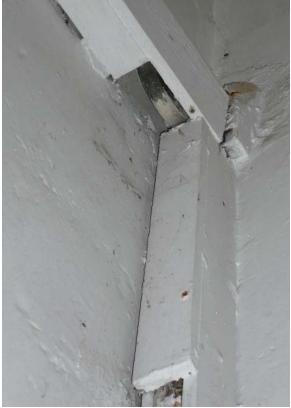
Figure III.3: The pulleys within the track system appear bronze and are thought to be original to the room. *Source: University of Pennsylvania.*

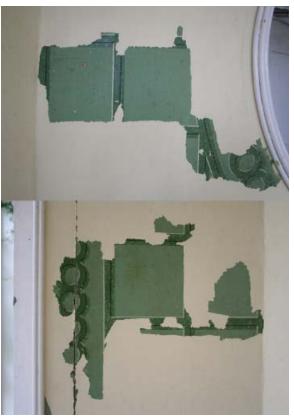
Figure III.4: The circular pattern found on the walls outlines the elements with trim in the room. The rest of the walls are deco¬rated with a repeating square pattern, the texture visible through the top layer of paint. *Source: University of Pennsylvania.*

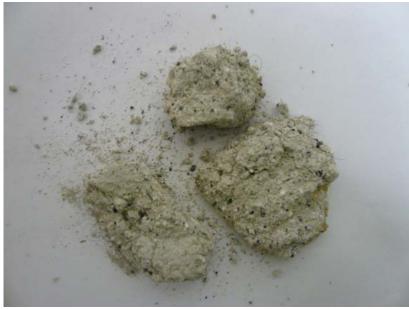
Figure III.5: The plaster from the octagonal room walls and the apse are identical and are thought to be of the same campaign. Note the black in¬clusions, use of hair, and the same gray color. *Source: University of Pennsylvania.*

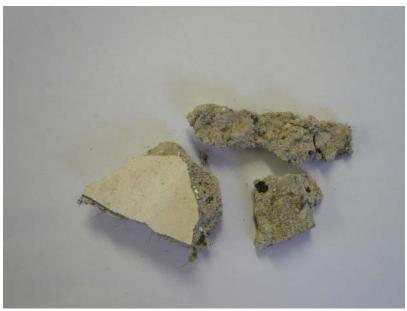
Figure III.6: The plaster from the octagonal room walls and the apse are identical and are thought to be of the same campaign. Note the black inclusions, use of hair, and the same gray color. *Source: University of Pennsylvania.*

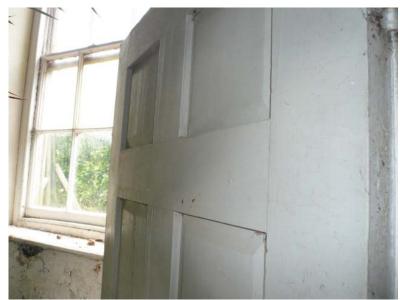
Figure III.7: The doors to the back room all appear to be hand-planed. Note the uneven surface, evidence of the hand crafting. *Source: University of Pennsylvania.*

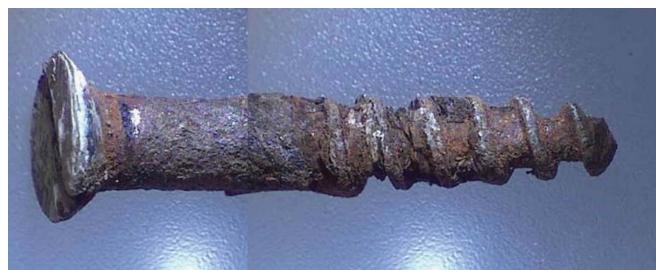
Figure III.8: This blunt end screw used in the cabinetry dates it pre-1846. Source: University of Pennsylvania.

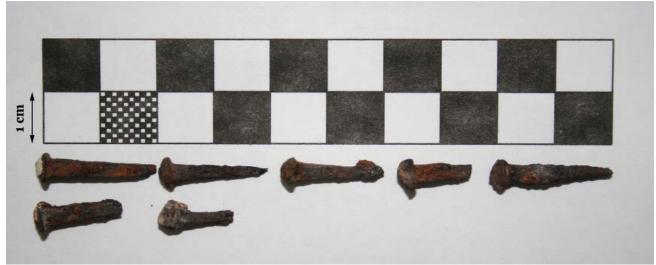
Figure III.9. All of these nails came from the interior and exterior lath of the circular part of the apse. All ap¬pear to be cast iron. *Source: University of Pennsylvania.*

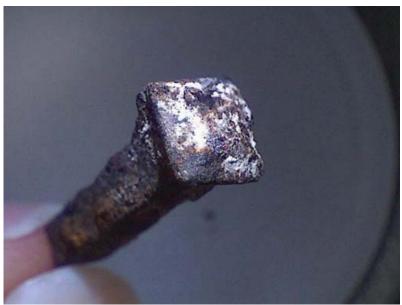
Figure III.10: Cast iron nails often had square heads, a detail that would not be possible with hand-wrought metal. *Source: University of Pennsylvania.*

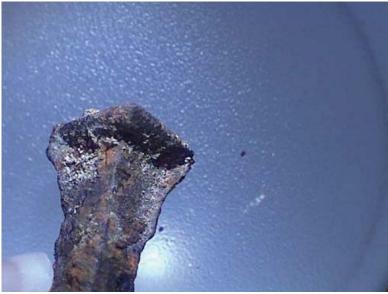
Figure III.11: The flashing on this nail indicates the use of a mold. Wrought iron or machine-made nails would not have this evidence of a seam. *Source: University of Pennsylvania.*

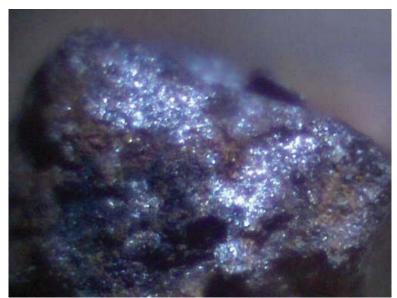
Figure III.12: Cast iron has a crystalline structure, as seen in this microscopic view of a lath nail. *Source: University of Pennsylvania.*

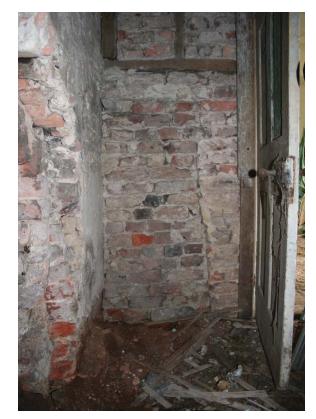
Figure III.13: Behind the east door in the back room is the visible infill of the flue. The partition wall was clearly built around the flue, and the wall was infilled at a later date. *Source: University of Pennsylvania.*

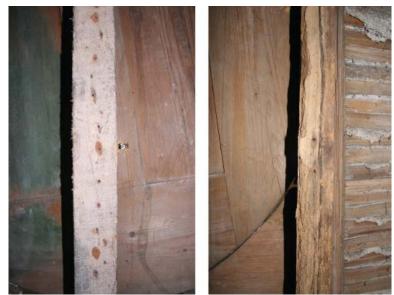
Figure III.14: The plaster on the rear of the apse never continued around the entire arc. Visible here on the left are lath nail holes in a stud about halfway around the arc. The adjacent stud, on the right, is clean. *Source: University of Pennsylvania.*

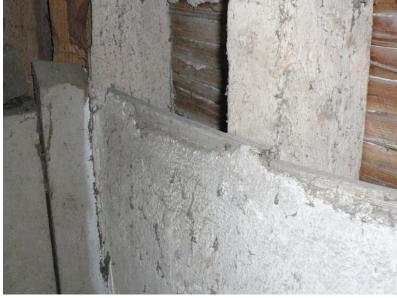
Figure III.15: The top of the plaster around the rear of the apse appears finished, as the edge is smoothed over the edge of the apse. Likewise, there are no lath nail holes above the plaster, and the studs are painted. *Source: University of Pennsylvania.*

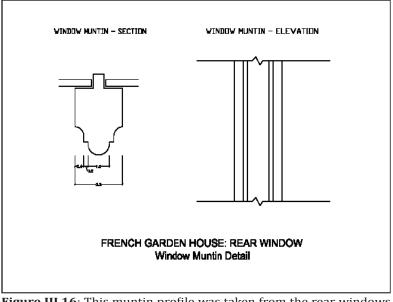
Figure III.16: This muntin profile was taken from the rear windows. The profile is typical of the early 19th century. *Source: University of Pennsylvania.*

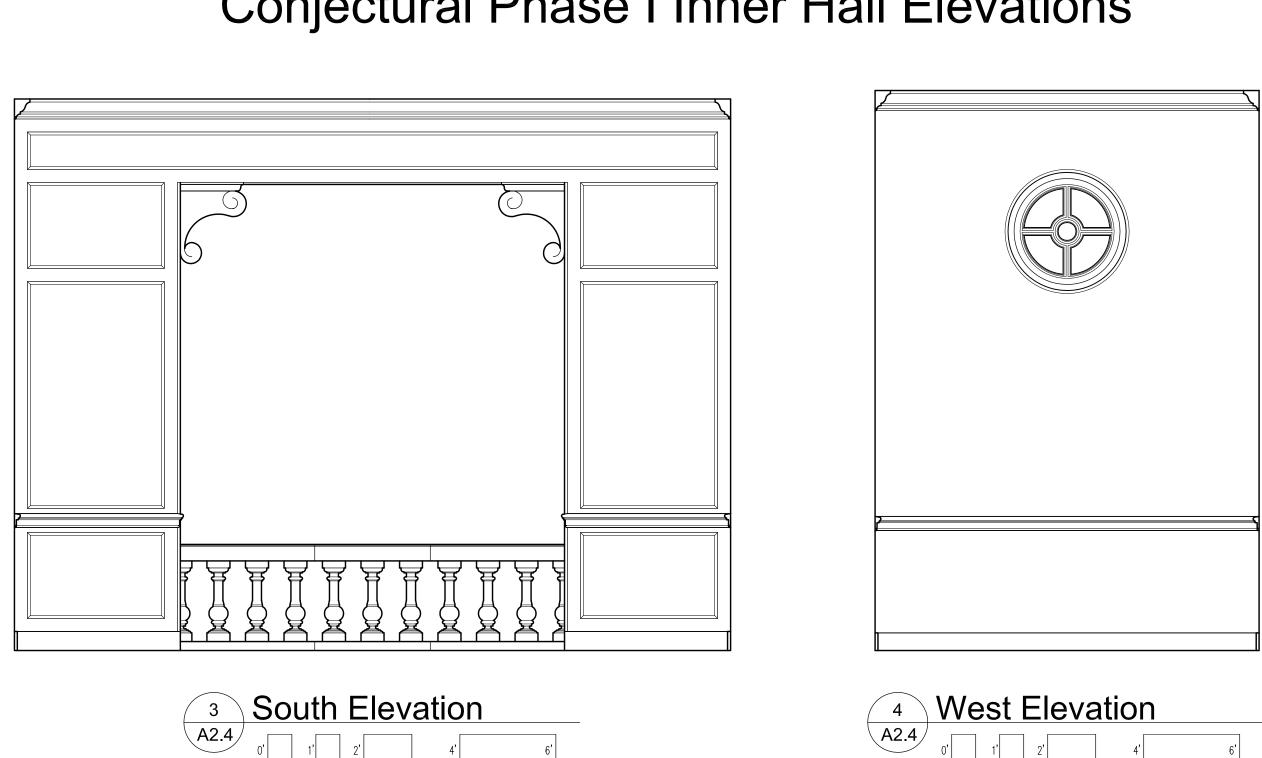
Conjectural Phase I Inner Hall Elevations

Panel dimensions are conjectural; center portion of bottom rail of top panel was exposed during investigation.

Baluster profile is based on painted profile found on jamb boards. Gate dimension is conjectural.

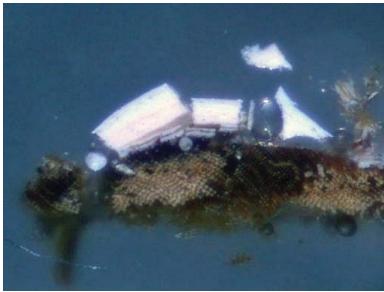
Fig. D1 Sample #2 - Inner Hall - Paint on wood from scroll work left of fireplace

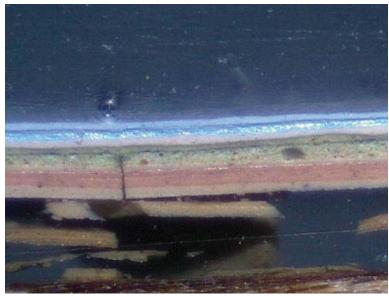
Fig. D2 Sample #3 - Inner Hall - Paint on Wood from corner bead left of chimney
