Architectural Investigations and Archival Research

English Garden House and

French Garden House

Mount Edgcumbe House and Country Park

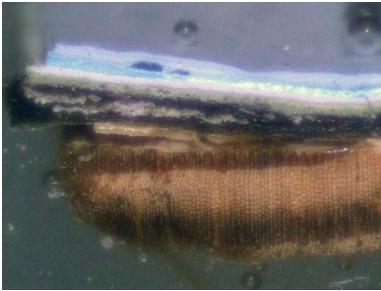
Fig. D3 Sample #6 - Inner Hall - Paint on wood from board over fireplace

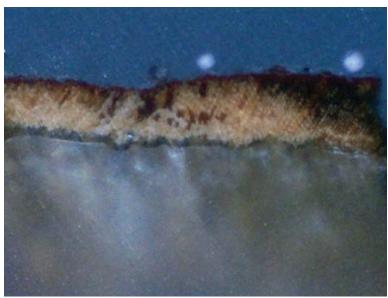
Fig. D4 Sample #9 - Inner Hall - Wood panel under plaster above door to water closet

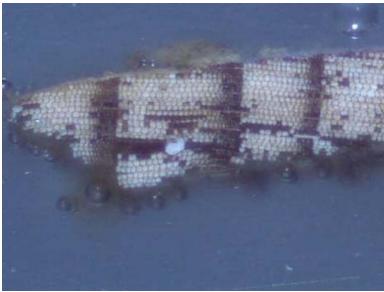
Fig. D5 Sample #12 - Inner Hall - Wood panel on east side of chimney behind removed chair rail

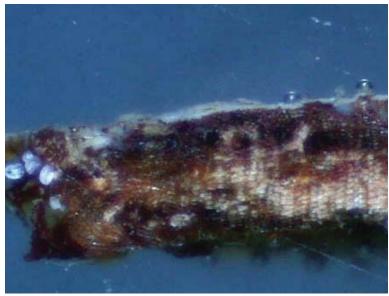
Fig. D6 Sample #20 - Inner Hall - Paint on wood from Greek key in soffit inside partition wall

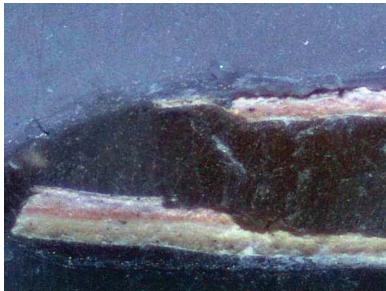
Fig. D7 Sample #101 - Outer Hall - West wall, chair rail

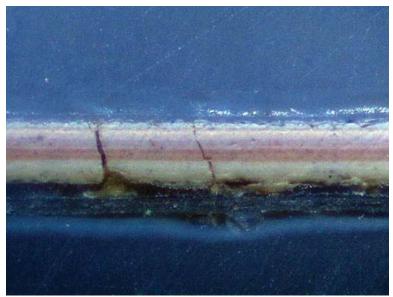
Fig. D8 Sample #102 - Outer Hall - South entrance, overdoor trim

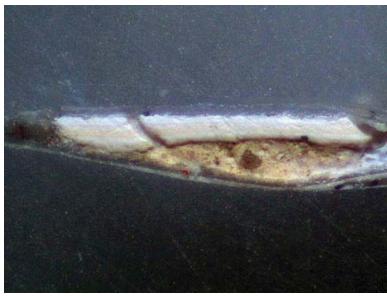
Fig. D9 Sample # 103 - East Closet - North face of door

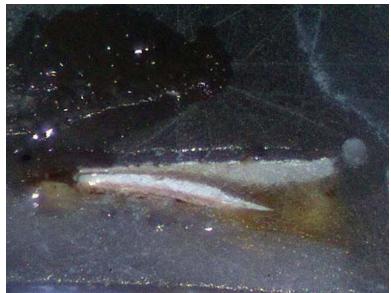
Fig. D10 Sample #104 - Outer Hall - East wall, trim from panel above door trim

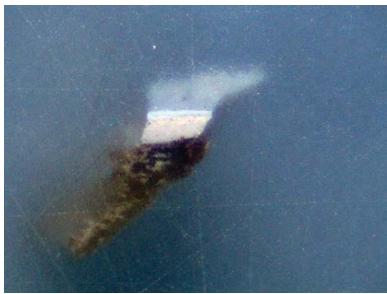
Fig. D11 Sample #108 - Outer Hall - East wall, upper cornice

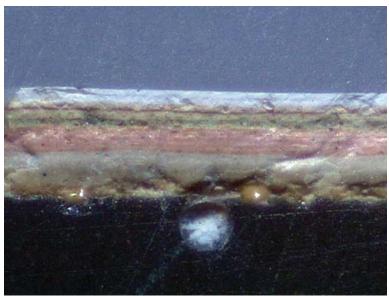
Fig. D12 Sample #109 - Inner Hall - East wall of west closet, southeast paneling

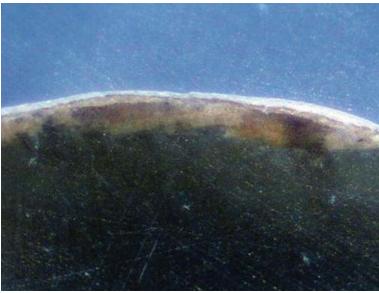
Fig. D13 Sample #110 - East Room - East wall, cabinetry trim, rounded tripart

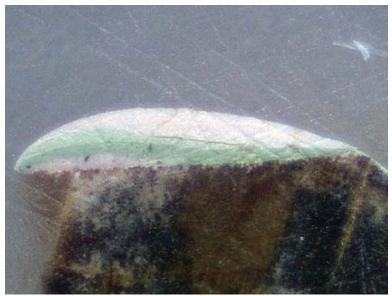
Fig. D14 Sample #111 - East Room - East wall, back panel of cabinet under wallpaper

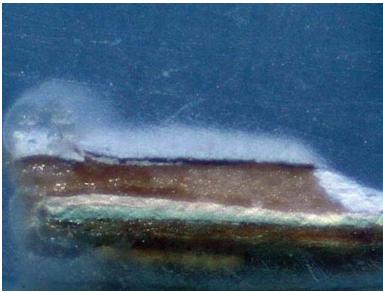
Fig. D15 Sample #112 - East Room - North wall, back face of cabinet

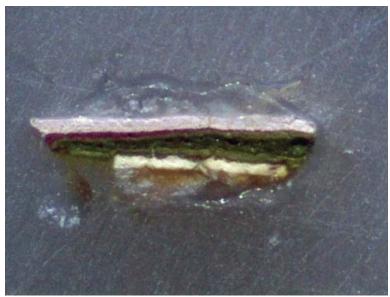
Fig. D16 Sample #116 - East Closet - South wall, north face of door to Inner Hall

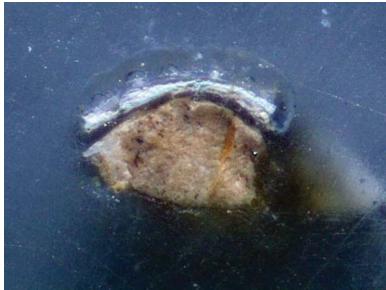
Fig. D17 Sample #118 - Bathing Room - North wall chair rail

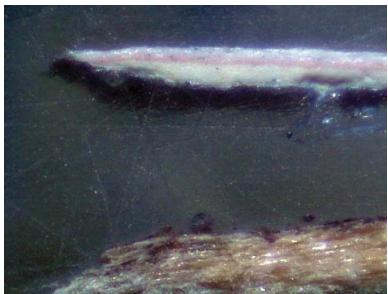
Fig. D18 Sample #134 - Outer Hall - North wall, lower cornice bottom flat portion

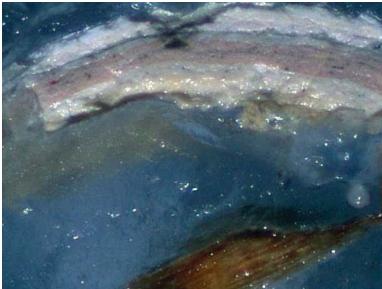
Fig. D19 Sample #135 - Outer Hall - South wall top portion of chair rail

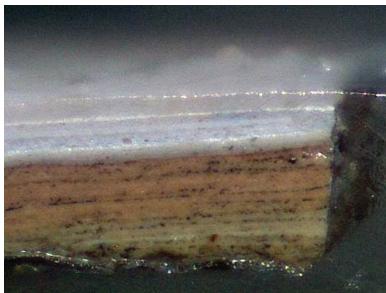
Fig. D20 Sample #137 - Inner Hall - East wall baseboard top quarter round

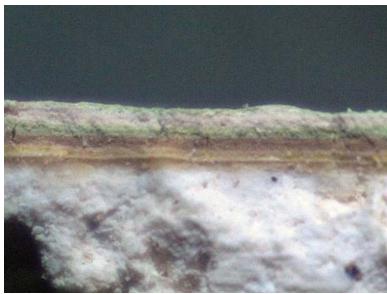
Fig. D21 Sample #201 - Outer Hall - East wall right of door

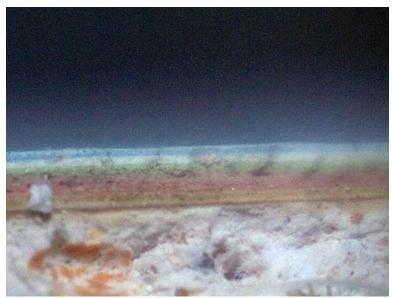
Fig. D22 Sample #203 - Inner Hall - North wall at overdoor

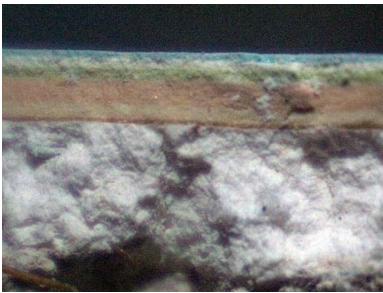
Fig. D23 Sample #205 - Inner Hall - South wall left of door within balustrade infill

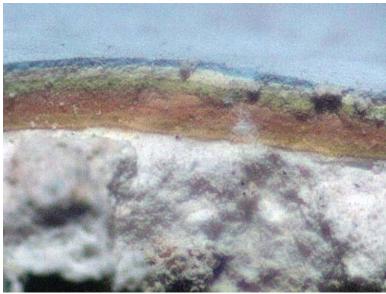
Fig. D24 Sample #206 - Inner Hall - West wall over door to bathing room

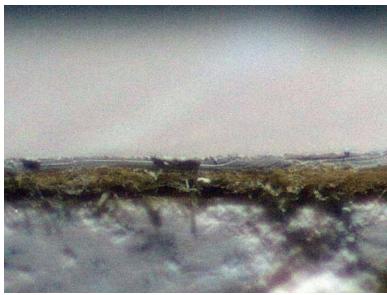
Fig. D25 Sample #207 - West Room - Ceiling, northeast corner

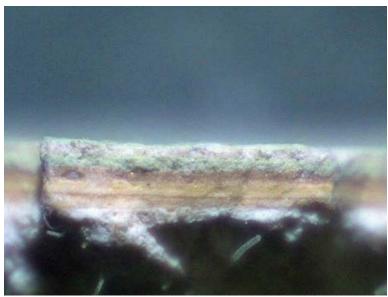
Fig. D26 Sample #209 - Outer Hall - North wall east corner

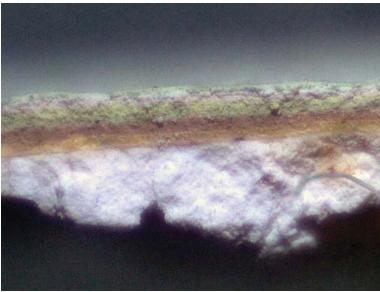
Fig. D27 Sample #210 - Outer Hall - North wall, right of door within balustrade infill

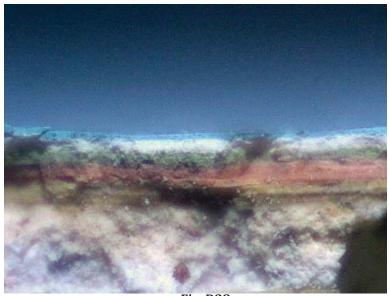
Fig. D28 Sample #211 - Inner Hall - South wall, far east corner above chair rail. Typical stratigraphy for samples 211 - 214.

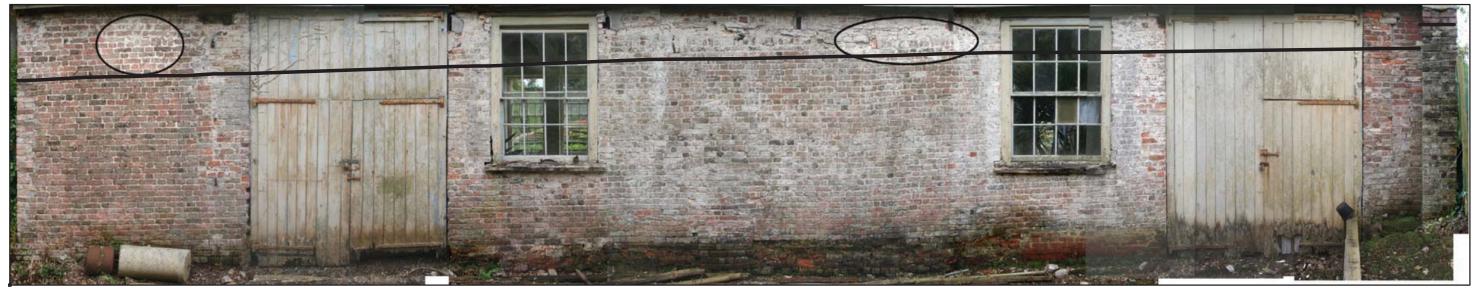
Photo mosaic of entire rear wall of French Garden house. The black line highlights the original height of the wall, and the ovals highlight areas where the coursing was increased to level the wall. Source: University of Pennsylvania.

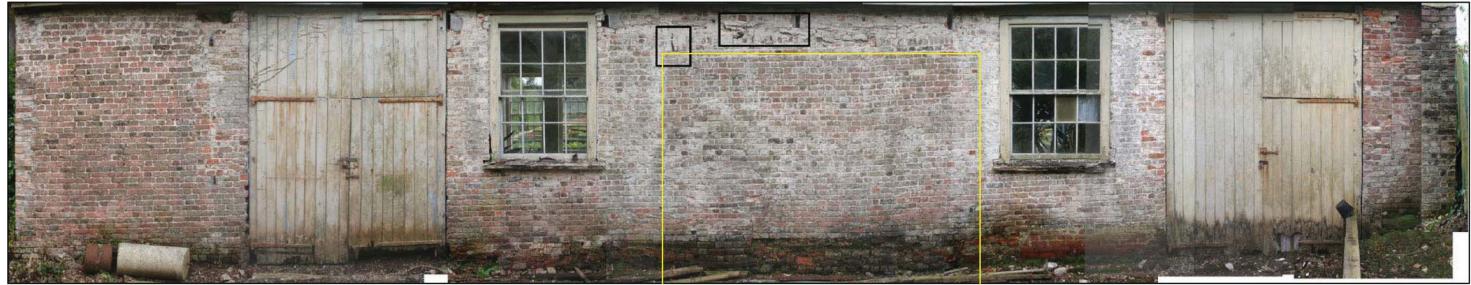
Photo mosaic of rear wall, with outlined shadow of lean-to and highlights of the location of the wall anchor and mortar flashing. Source: University of Pennsylvania.
