Historic Structure Report The Cabaret at Taliesin West

12621 N Frank Lloyd Wright Blvd, Scottsdale, AZ 85259

Prepared for: The Frank Lloyd Wright Foundation
Fred Prozzillo, Vice President of Preservation

HSPV 7210 Capstone Studio: Materials + Materialities
University of Pennsylvania, Stuart Weitzman School of Design
Contributors: Yi-Ju Chen, Priyanka Gorasia, Yuxuan Wu, Anyuan Ji
Advisor: Irene Matteini, Frank Matero
Spring, 2023

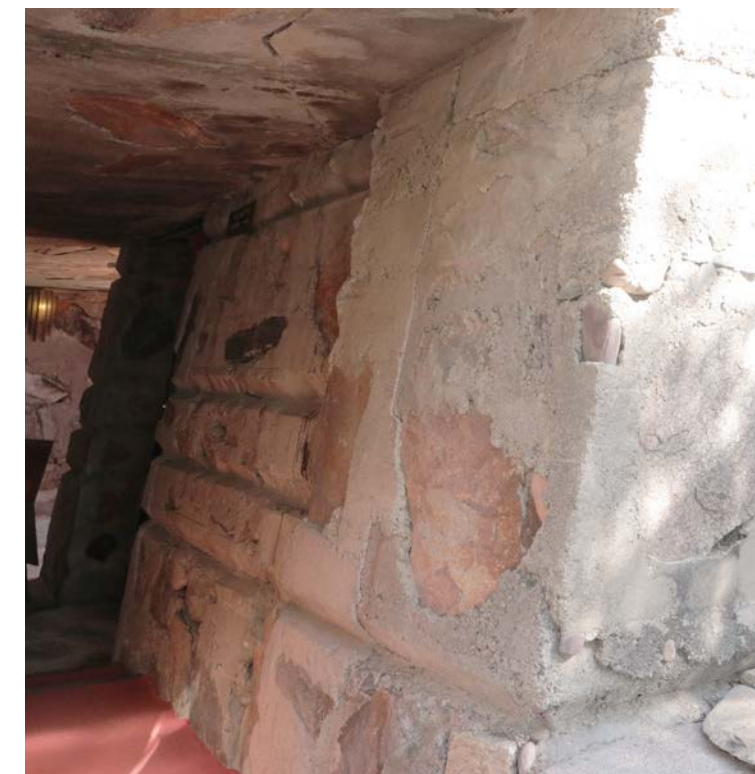
Figure 2.2 View looking South towards the exit, showing the masonry differences between Wright's office and the Cabaret addition.
Image credit: Author, March 2023

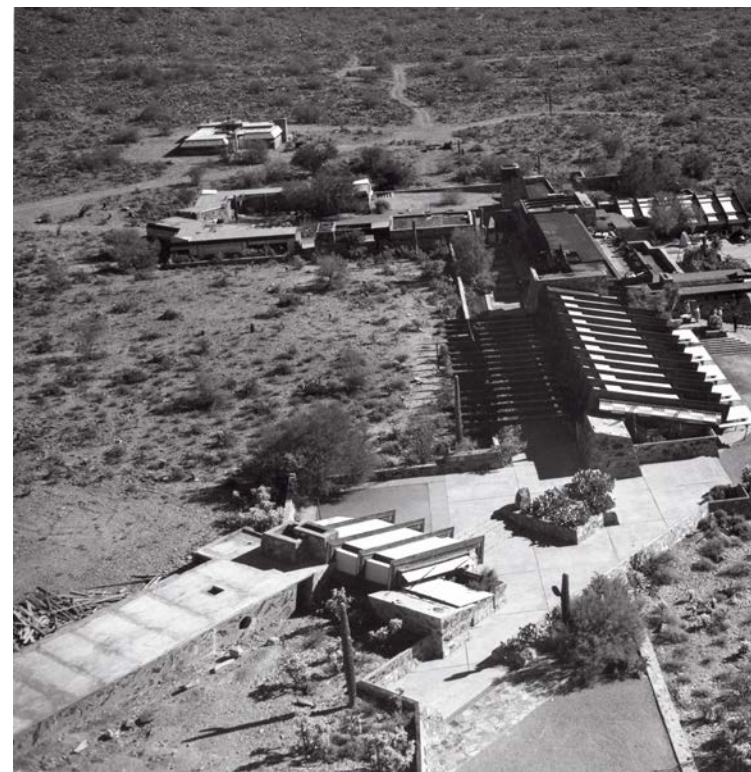
Wright's Office was constructed between 1938 and 1939 as a free-standing building (Figures 2.3 & 2.5). When the Cabaret was built 10 years later in 1948, it was placed adjacent to Wright's office on the southwest exterior end (Figures 2.4 & 2.6). This is clearly discernible at the junction of the original rusticated exterior Office wall with the Cabaret's non-rusticated interior entrance wall (Figure 2.2). According to the historic site plan, the Office's original bathroom was also converted into a coat room and a bathroom for the Cabaret at the same time. Construction of the Cabaret's masonry form work was completed by the summer of 1950 and left to cure. When the Fellowship returned the following winter and removed the form work, large cracks developed in the desert masonry roof. Wright's solution was to add desert masonry beams with reinforcement on top of the roof slab (Figure 2.6).¹

Figure 2.6 Close-up of historic aerial photo, showing the roof of the Cabaret before the beams were added.
 Source: Frank Lloyd Wright Foundation Archives

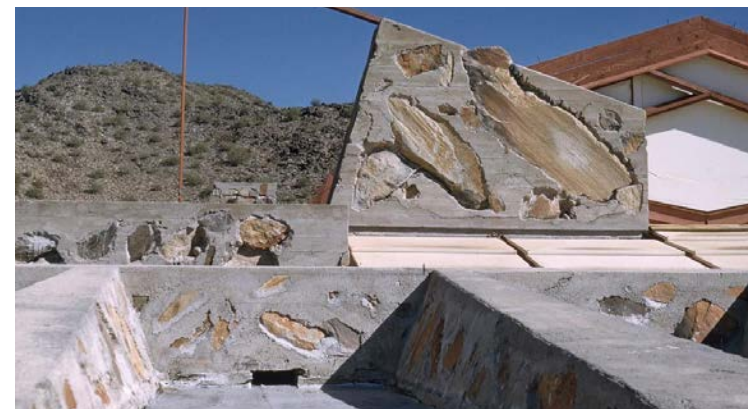
Another change in the 1960s was the replacement of the operable canvas panels to plywood. This alteration was accompanied by a change in the roof drainage direction from east-west to west-east (Figures 2.20 & 2.21). The original drains in the parapet were later filled in due to this change of drainage direction (Figure 2.22).

Figure 2.22 Historic photo showing the original drains in the parapet
 Source: Frank Lloyd Wright Foundation Archives

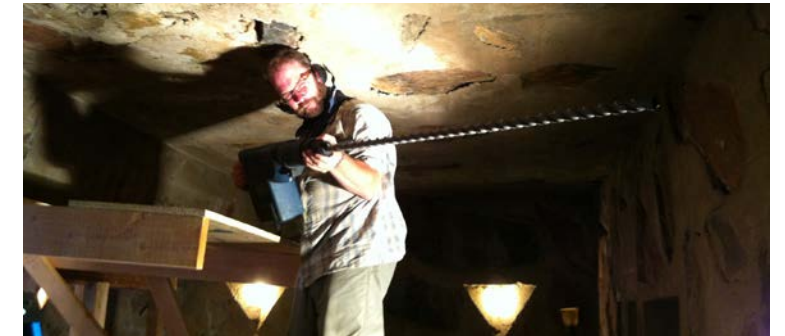
Figure 2.23 2012 structural roof repair
 Source: Frank Lloyd Wright Foundation Preservation Records

Recent preservation of the Cabaret includes the 2012 structural roof repairs (Figure 2.23), the 2014 waterproofing along the east and west walls and entrance door replacement (Figure 2.24), the 2015 roof system replacement with new waterproof membrane (Figure 2.25), and the 2020 entry and corridor stone paver floor restoration that removed the cementitious topping added to the entry and corridor of the Cabaret Theater between 2001 and 2012 (Figure 26).⁸

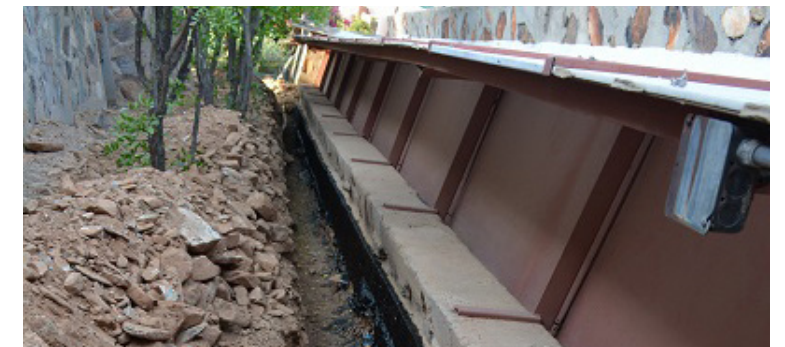
Figure 2.24 2014 waterproofing along the East wall
 Source: Frank Lloyd Wright Foundation Preservation Records

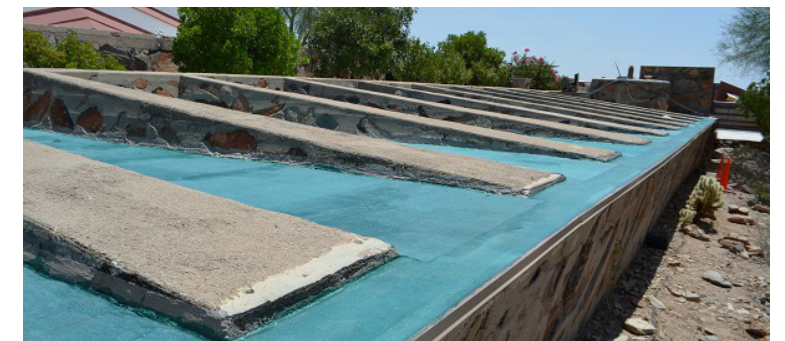
Figure 2.25 2015 roof system replacement
 Source: Frank Lloyd Wright Foundation Preservation Records

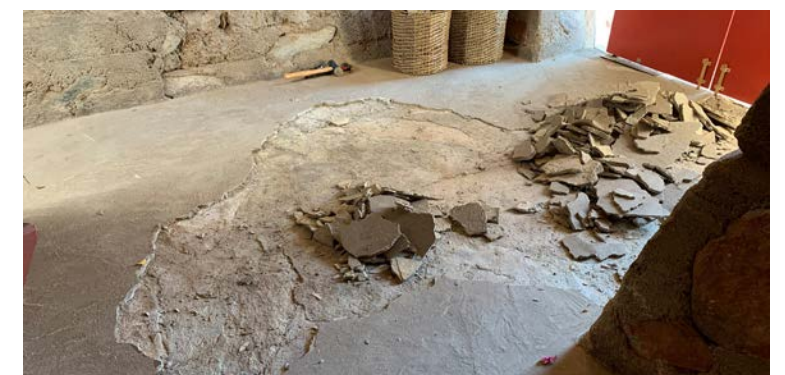
Figure 2.26 2020 stone paver restoration
 Source: Frank Lloyd Wright Foundation Preservation Records

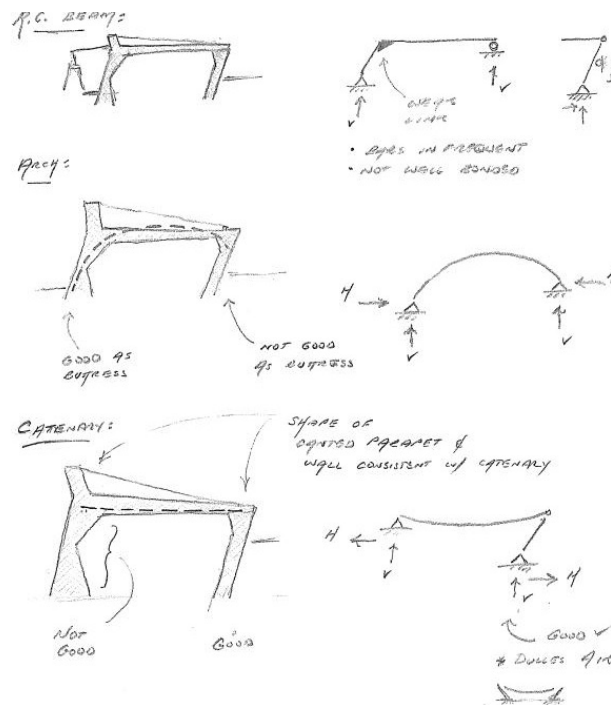
The roof of the structure is flat with a slight slope to the west end, concealed by a low parapet. The northern end is slightly lower. The roof provides stability to the structure, with the slab spanning from east to west like a beam or catenary, and from north to south like a box between the building masses of the projection booth and the south entrance areas (Figure 3.4)

Figure 3.4 Sketches evaluating fundamental structural behavior
 Source: 1200 Architectural Engineers, 2013 Field report

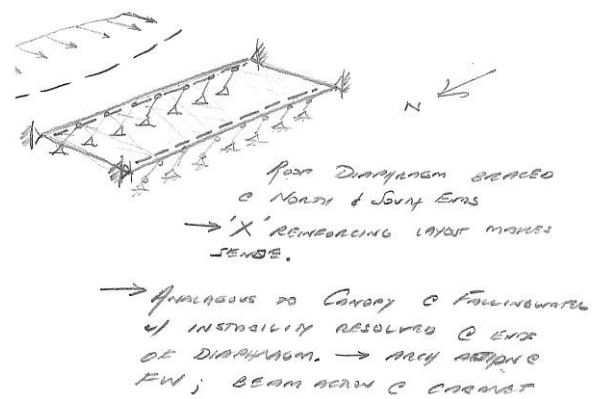
The in-plane diaphragm behavior of the roof slab also contributes to the overall stability of the structure (Figure 3.5). The steel reinforcement layout of the roof slab further enhances this stability by creating a horizontally spanning X-braced truss stretching from north to south. Tapering concrete beams spaced 5'4" apart and running east to west were added immediately upon completion of the structure due to structural instability. The flat roof is currently covered with a Roof Mate liquid roofing system installed in 2015.³

Figure 3.5 Diaphragm Behavior of roof slab
 Source: 1200 Architectural Engineers, 2013 Field report

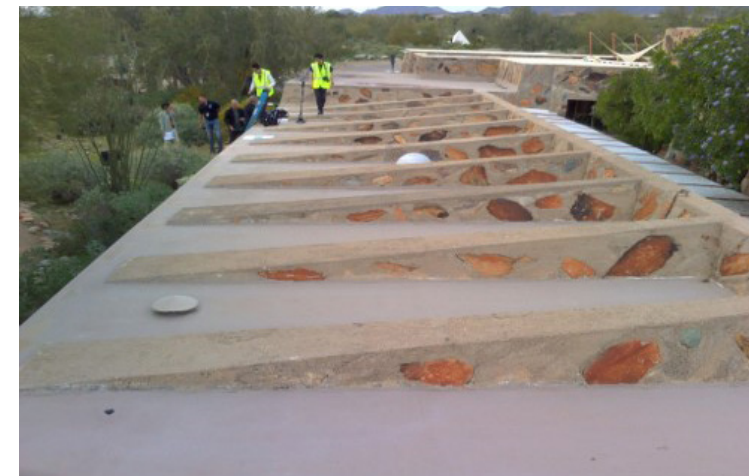
The Cabaret's ceiling/roof is constructed using reinforced concrete desert masonry. Similar to the walls, the roof deck itself dates to the original construction phase in 1950 and has successfully maintained its material integrity over the years. The slab varies in thickness from approximately 6" on the west end to around 11" on the east end. It is supported by a system of tapered upturned beams with the eastern ends of the beams extending above the roof slab and connecting to a north-south parapet, while the western ends of the beams taper down to the roof surface (Figure 3.7)

These reinforced concrete beams were immediately added to the roof when the initial concrete slab showed signs of failure after the removal of the form work and shoring in 1950.⁵

Figure 3.7 Image of the roof looking north showing the upturned beams.
 Image Credit: Author, March 2023

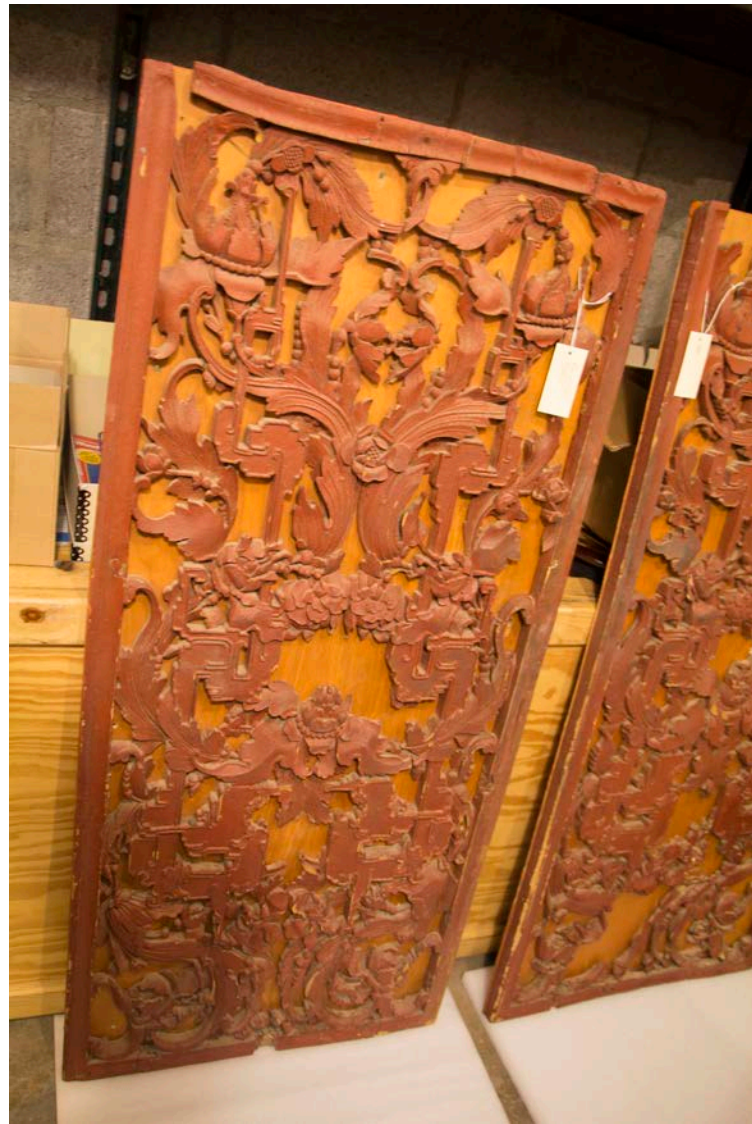
Other Chinese wood carvings once installed on the interior side of the main entry doors were original but were removed in 2014. (Figure 3.13) These two identical panels depict dimensionally complicated flora and geometric motifs painted in brownish red. These panels were removed to the Archives for preservation due to their deterioration.

Figure 3.13 Original flora-motif wood carving installed on the interior side of the main entry door
 Image Credit: Author, March 2023

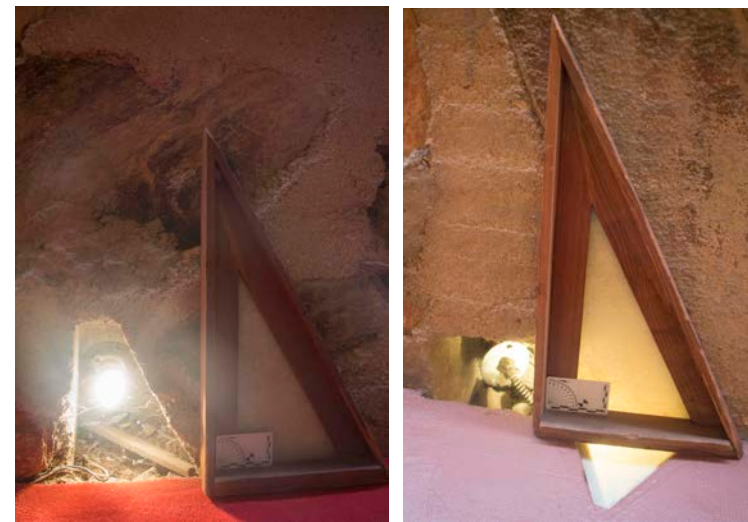
The wall sconces have a triangular lampshade, originally Japanese paper (now modern fiberglass) with a wooden frame. Their design is very similar to the light fixtures in the Beth Sholom Synagogue and have been suggested to be the prototype for the synagogue project. Only the hanging fixture in front of the fireplace retains the original paper shade. The base lights along the corridor are small glass bulbs placed in a small triangular cove. The original base lights along the aisle are similar but have a triangular shade. Wright was one of the first to use low-level pathway lighting in a theater setting. In the alteration in 1964, the ramp of the aisle was raised and some lights were blocked (Figures 3.21 & 3.22).

As a result, the apprentices made triangular covers over the original lights. At the same time, up-lighting was in-

Figure 3.21 Left: Original base light Right: New triangular covers and original lights are blocked by the new ramp
 Image Credit: Author, March 2023

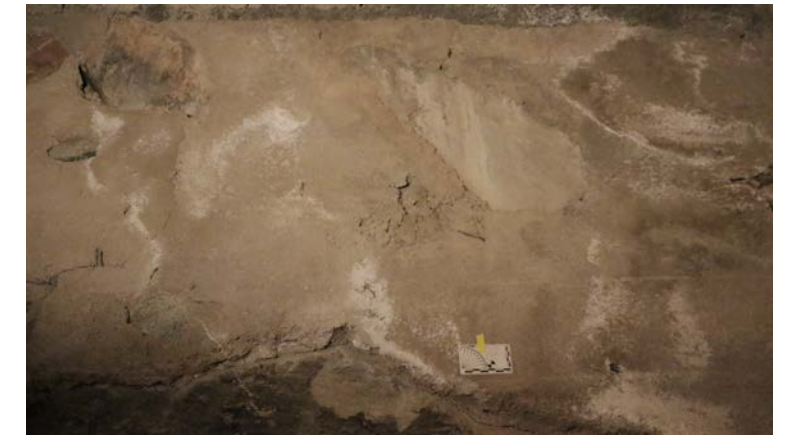
Most of the interior walls exhibit large, localized areas of efflorescence, with this condition being most notable in the west, north and the east walls corresponding to A, B-C and D. Salts are mainly located in the mortar as opposed to the stone of the desert masonry walls (Figure

4.4). As mentioned earlier, the structure is partially below grade. As such, the west and east face walls have direct contact with the soil below ground. The salts in this case can be attributed to rising and penetrating damp. While rising damp is caused by capillary action causing moisture to be drawn up through porous elements of a building’s fabric,¹ penetrating damp is the moisture that travels laterally through the fabric of the building from the outside.² Salts travel along with the moisture and crystallize on the surface upon evaporation (Figure 4.3)

Figure 4.4 Salts found across the entire expanse of the West Wall in the Cabaret interior
 Image Credit: Authors, March 2023

However, it is worth noting that the wall closer to the entrance on the east side was not waterproofed beyond the corridor at that time. The continued presence of salts on the walls after the new waterproofing was added is a cause for concern as it indicates continued high moisture levels in the masonry.

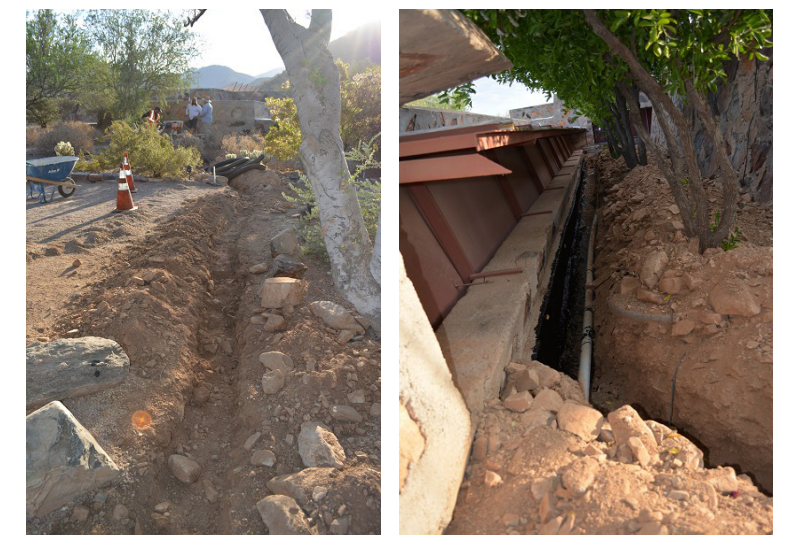
The Frank Lloyd Wright Foundation initiated a waterproofing campaign in 2014 to tackle this recurrent problem. The waterproofing campaign involved two different approaches for the west and east exterior walls (Figure 4.5).

For the west wall, a catch basin and an underground flexible drainpipe were installed to prevent heavy saturation of the wall and water infiltration into the interior.³ For the east wall, the wall was excavated, patched, and treated with a cold-liquid-fluid applied waterproofing membrane. A French drainpipe was added to the trench and emptied into a newly created catch basin,

Figure 4.5 Waterproofing campaign undertaken by the Frank Lloyd Foundation in 2014
 Image Credit: Frank Lloyd Wright Foundation

preventing water from soaking the wall and the corridor and leaving standing water on the corridor floor during heavy rains.⁴

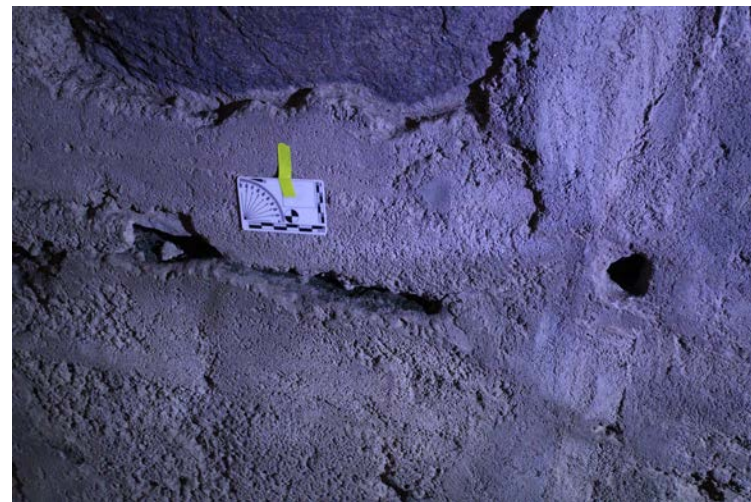
During inspection, it was discovered that bio growth (algae) was visible in the crevices of the rocks located on the east wall in proximity to the south entrance (Figure 4.6), probably due to the ideal combination of moisture and light. Given that the waterproofing campaign was executed up to the corridor, it is plausible that this issue may have resulted from the untreated portion of the wall.

Figure 4.6 Bio growth (algae) found in the rock crevices in the West Wall interior
 Image Credit: Authors, March 2023

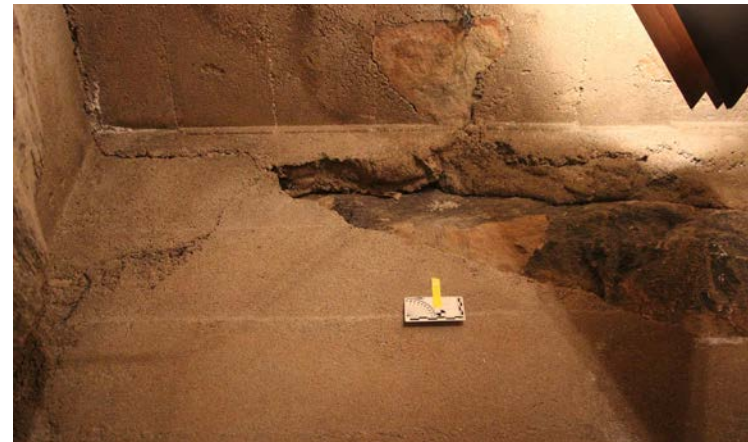
During fieldwork, the team recorded the presence of a few cracks with some traversing east-west across the ceiling slab on the interior which extend to the masonry wall (Figure 4.7). It is important to note that none of these cracks appear to be of a structural nature. It is our opinion that these cracks could be attributed to the experimental nature of the desert masonry construction, which may be prone to some level of settling and movement over time. Therefore, while the cracks may be a cause of concern, they do not appear to pose an immediate threat to the structural integrity of the building.

Figure 4.7 Cracks found across the desert masonry walls
 Image Credit: Authors, March 2023

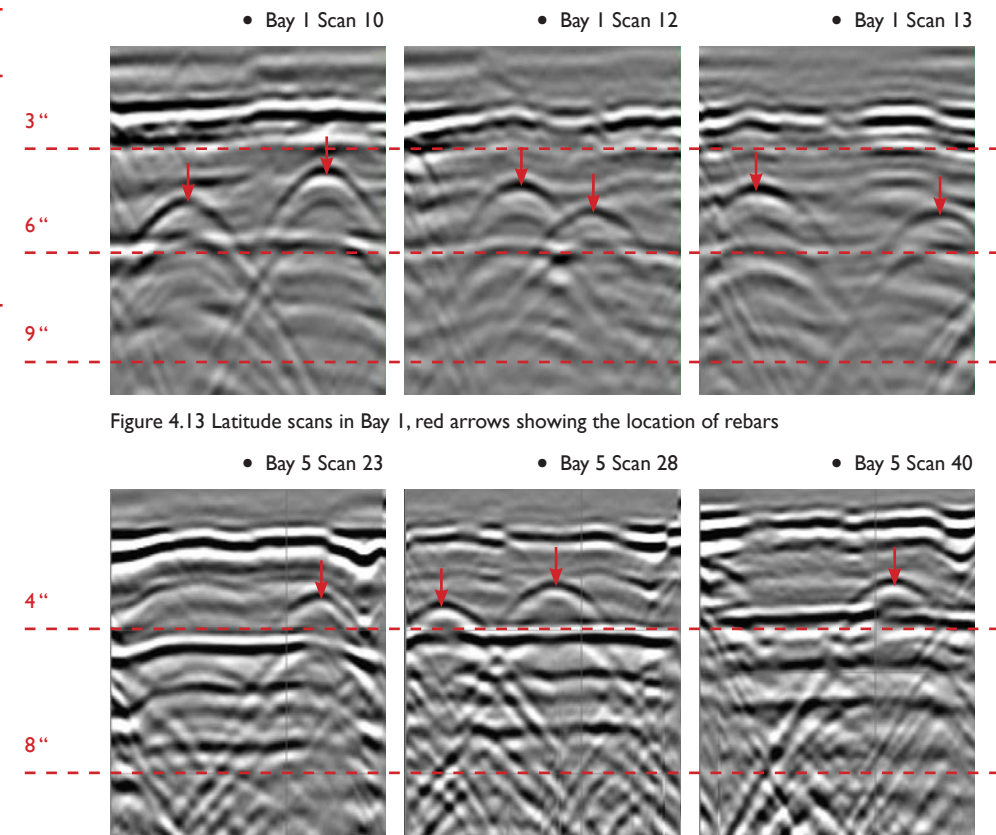
The data collected by the GPR allowed us to determine the concrete cover. The majority of the steel reinforcement shows a cover of more than 3” from the topside (Figures 4.13, 4.14 & Table 4.1). From the inside, several of the squared original rebars are exposed (Figures 4.15 & 4.16). This condition could potentially lead to further deterioration of the steel reinforcement. This should be addressed and is included in our Recommendation section of the report.

Figure 4.13 Latitude scans in Bay 1, red arrows showing the location of rebars

Figure 4.14 Latitude scans in Bay 5, red arrows showing the location of rebars

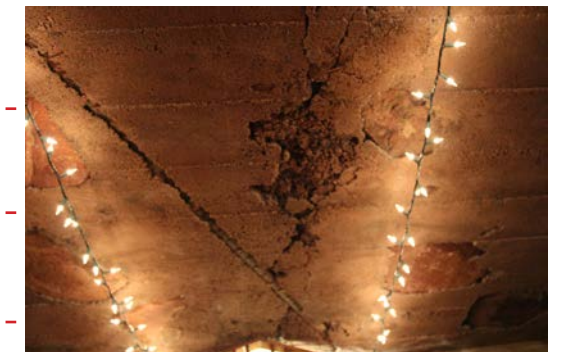
Figure 4.15 Photo taken from underside of the roof slab showing the exposed rebars
 Image credit: Author, March 2023

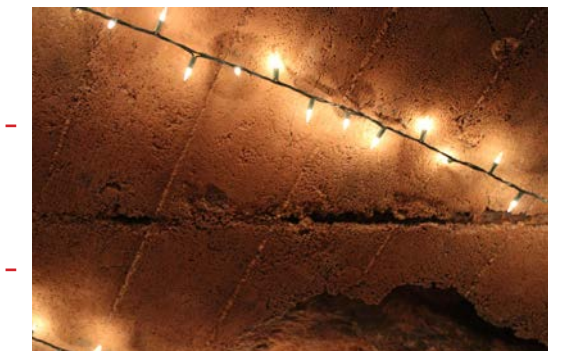
Figure 4.16 Photo taken from underside of the roof slab showing the exposed rebars
 Image credit: Author, March 2023

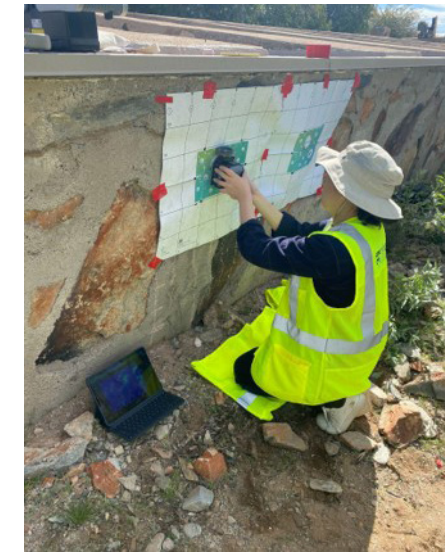
Figure 4.24 Student taking the GPR scan along the West wall
 Image Credit: Author, March 2023

with a spacing of 1 foot between each scan (Figure 4.23). These line scans were performed in both directions (Figure 4.24). However, no rebar was discovered in the west wall (Figure 4.25). This confirms that no steel reinforcement was used for the construction of the walls using desert masonry.

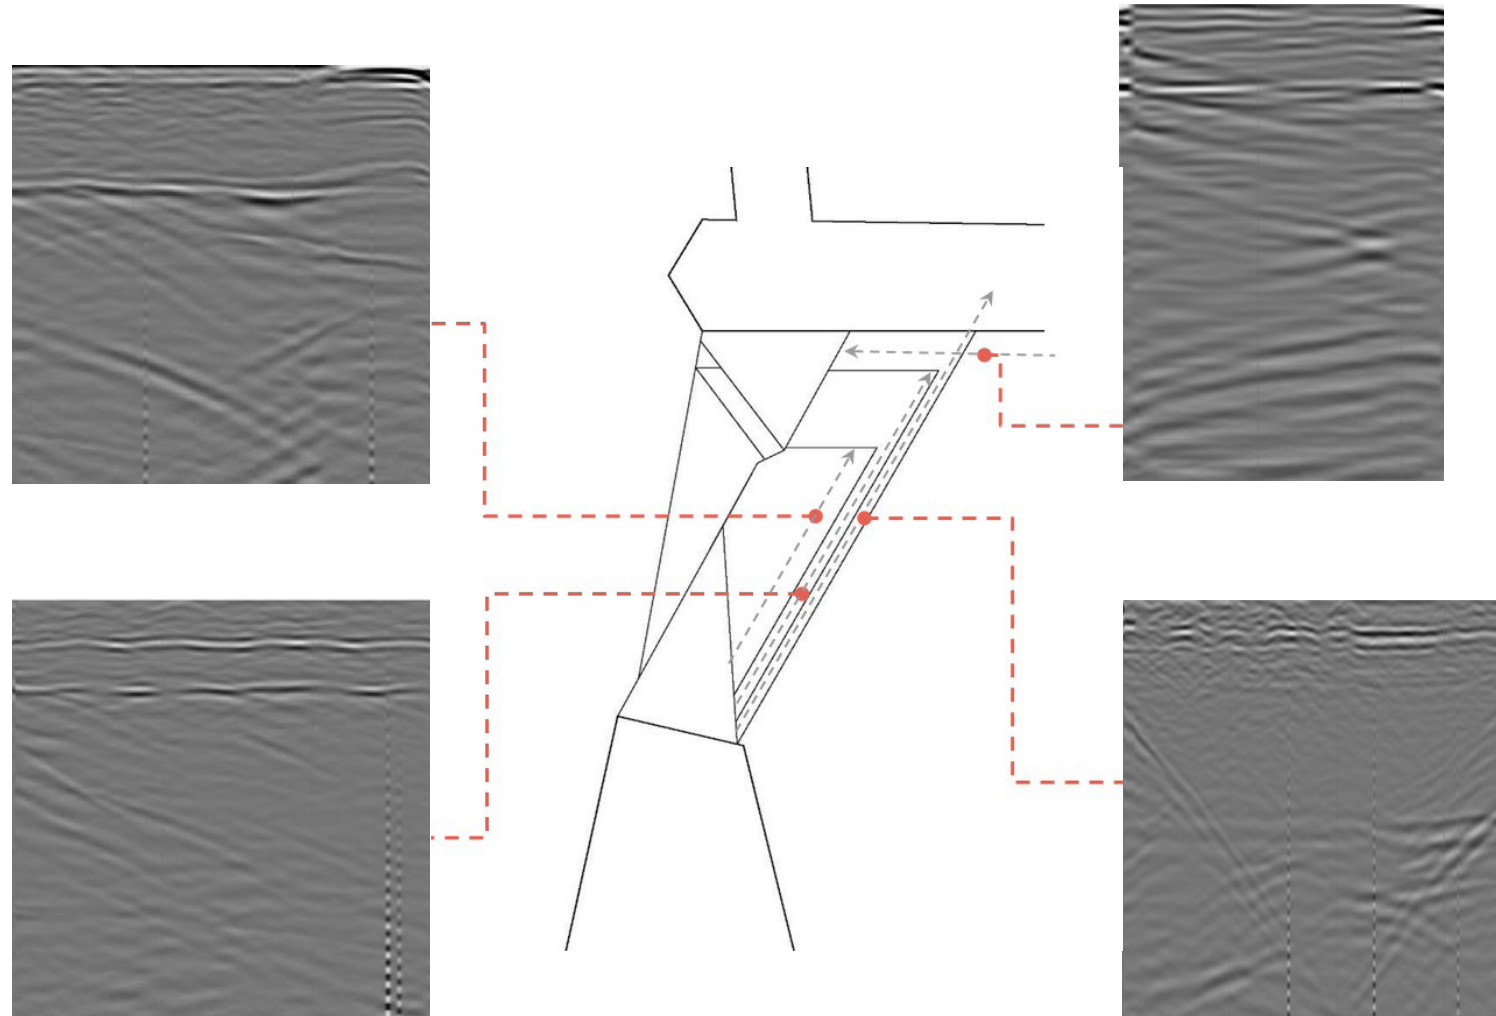
Figure 4.26 Line Scans of the East Pier

the 1950 construction period. To determine the presence of any reinforcements inside the piers, we carried out a GPR survey. Limited data could be acquired given the configuration of the pier, which did not allow us to collect enough scan (Figure 4.26).

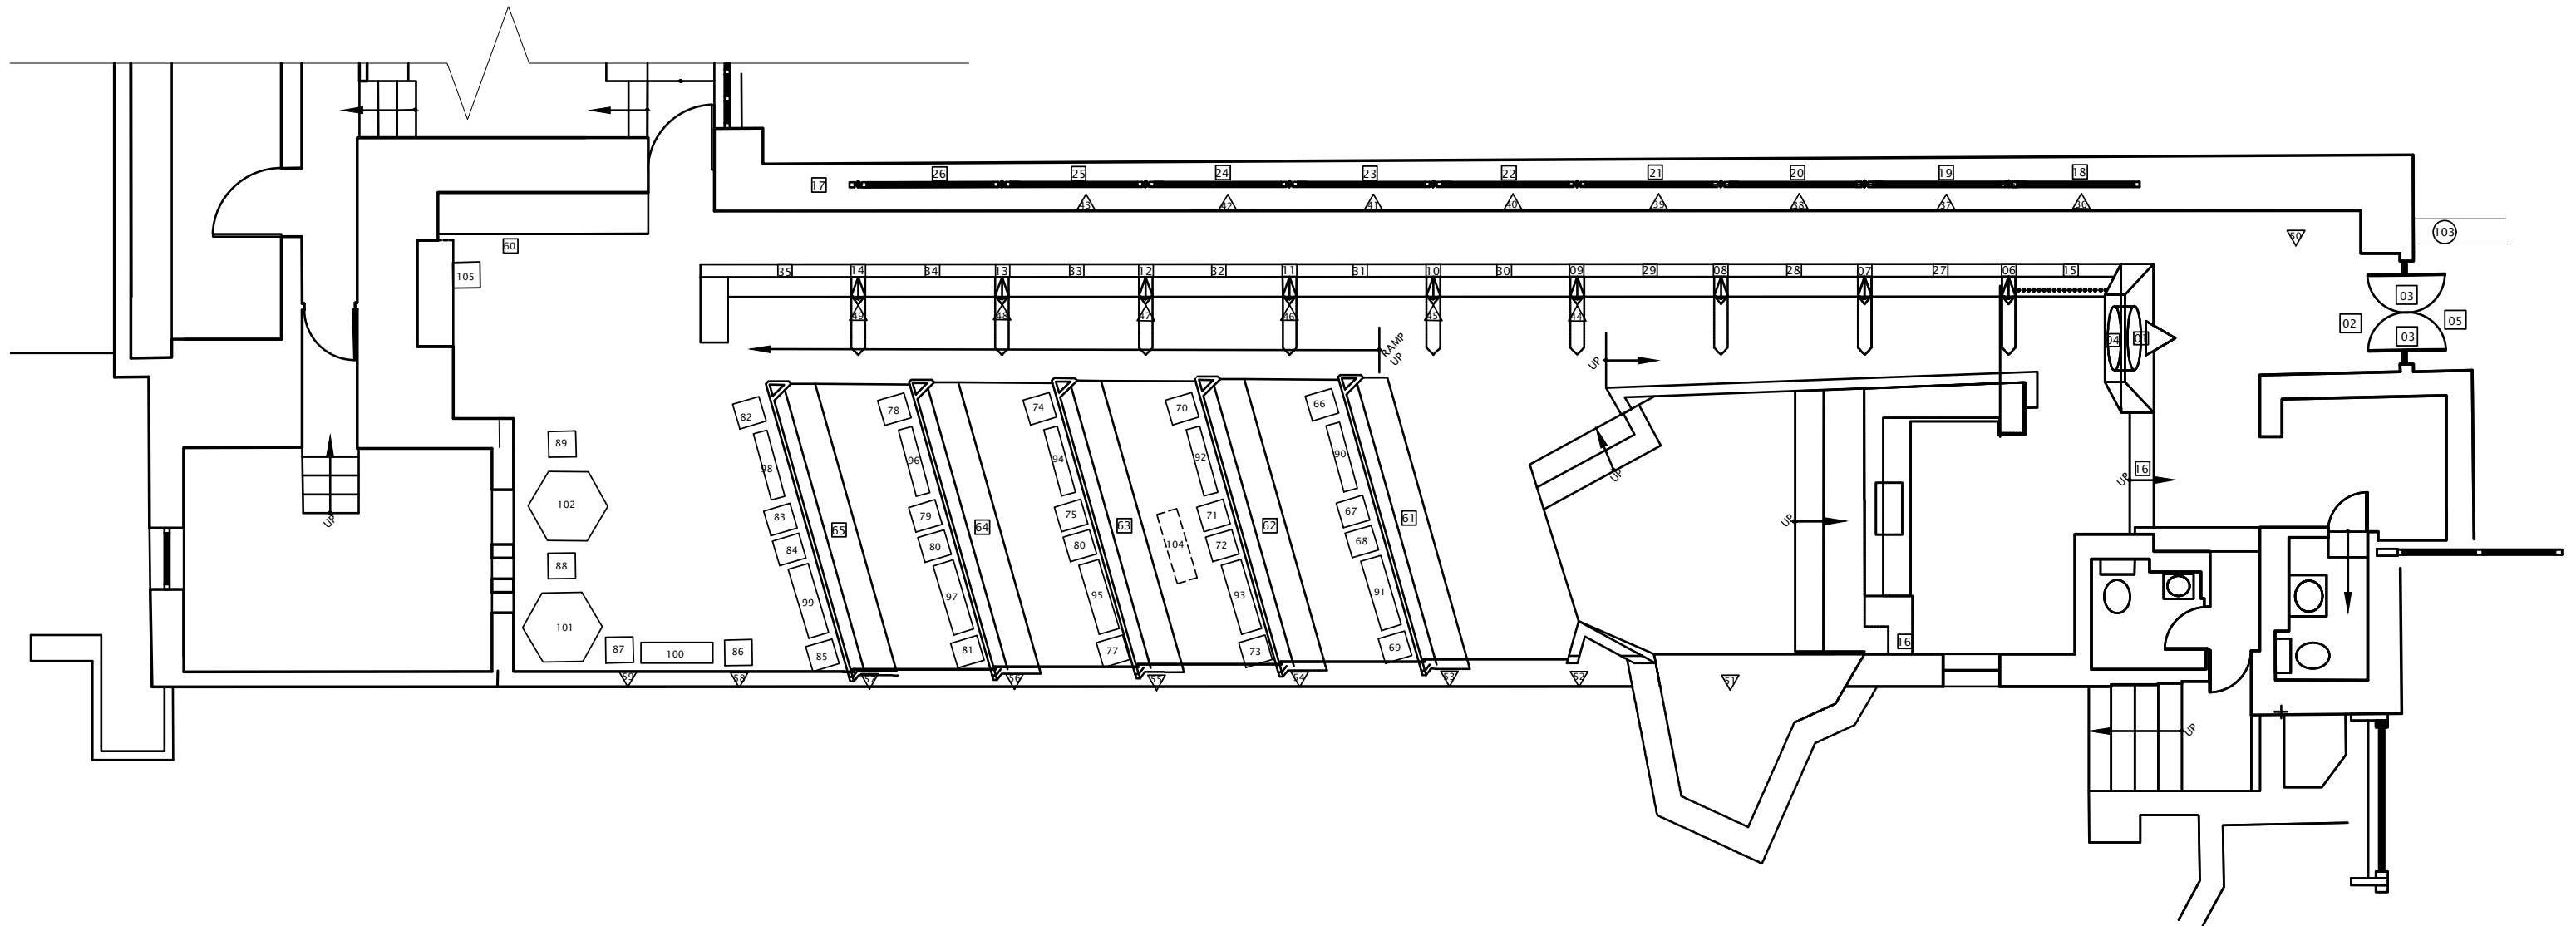
Figure 4.27 Furnishing locator map

Operable panels	18-26	East side of the corridor	Generally good. #22, #24: cracking near the hinge
Operable panels	27-35	West side of the corridor	Generally good. #28, #33: cracking near the hinge.
Base lights	36-43	Along the corridor	Generally good. #36 glass bulb is missing
Base lights	44-49	Along the aisle	Good.
Wall sconce	50-60	Along the west wall	Good
Hanging light	61	In front of the fireplace	Generally good. The Japanese paper lampshade is broken
Row of benches	62-66	Center of the theater, facing the screen at an angle	Generally good. #65 upholstery is worn off.
Freestanding hexagon-back chairs	67-90	Behind each row of benches	Generally good. Discoloring of the Cherokee Red paint on the metal frame is a common problem.
Freestanding drop-leaf tables	91-103	Behind each row of benches	Good
Gong	104	Beside the entry door	Good
Strip lights	105	On the ceiling	Good
Pot and shovel	106	In the fireplace	Good

3. The circuits of all lamps and lighting should be checked, and the damaged and aging wires and bulbs should be replaced. For example, the bulb in the base of the Buddha's head is not working correctly, and the relevant

4. Since the benches are heavily used, some obvious cracks should be addressed, such as those connections between the bench and the wall. The seat fabric, where damaged, should also be replaced.

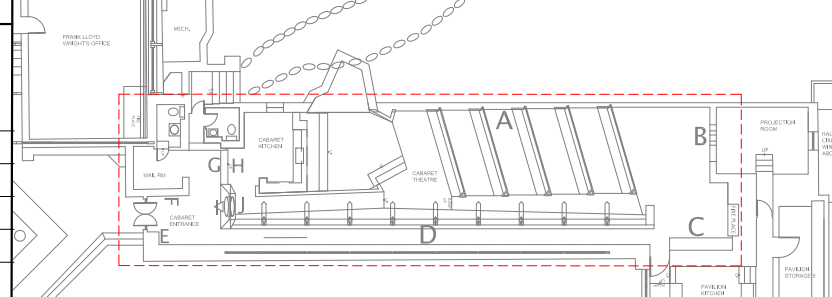
01 Reflected Ceiling Plan - Condition Mapping
 Scale: 1/8"=1'-0"
 Drawn By: Priyanka Gorasia

Another long-term program that should be implemented is monitoring the movement of cracks located on the downside of the roof slab. Previous preservation records indicate a structural retrofitting campaign in 2012 that revealed structural displacement, which is a potential threat to the overall structure of the Cabaret. Crack motion monitoring is necessary to determine whether these cracks and displacement are still active and progressive. One way to conduct this monitoring program is to use crack monitor discs, which are small and not very visible to visitors. However, this device requires the use and reading of a caliper. Another way is to use scratch-a-track motion monitors, which cause more visible impacts but are easy to check for any motion.

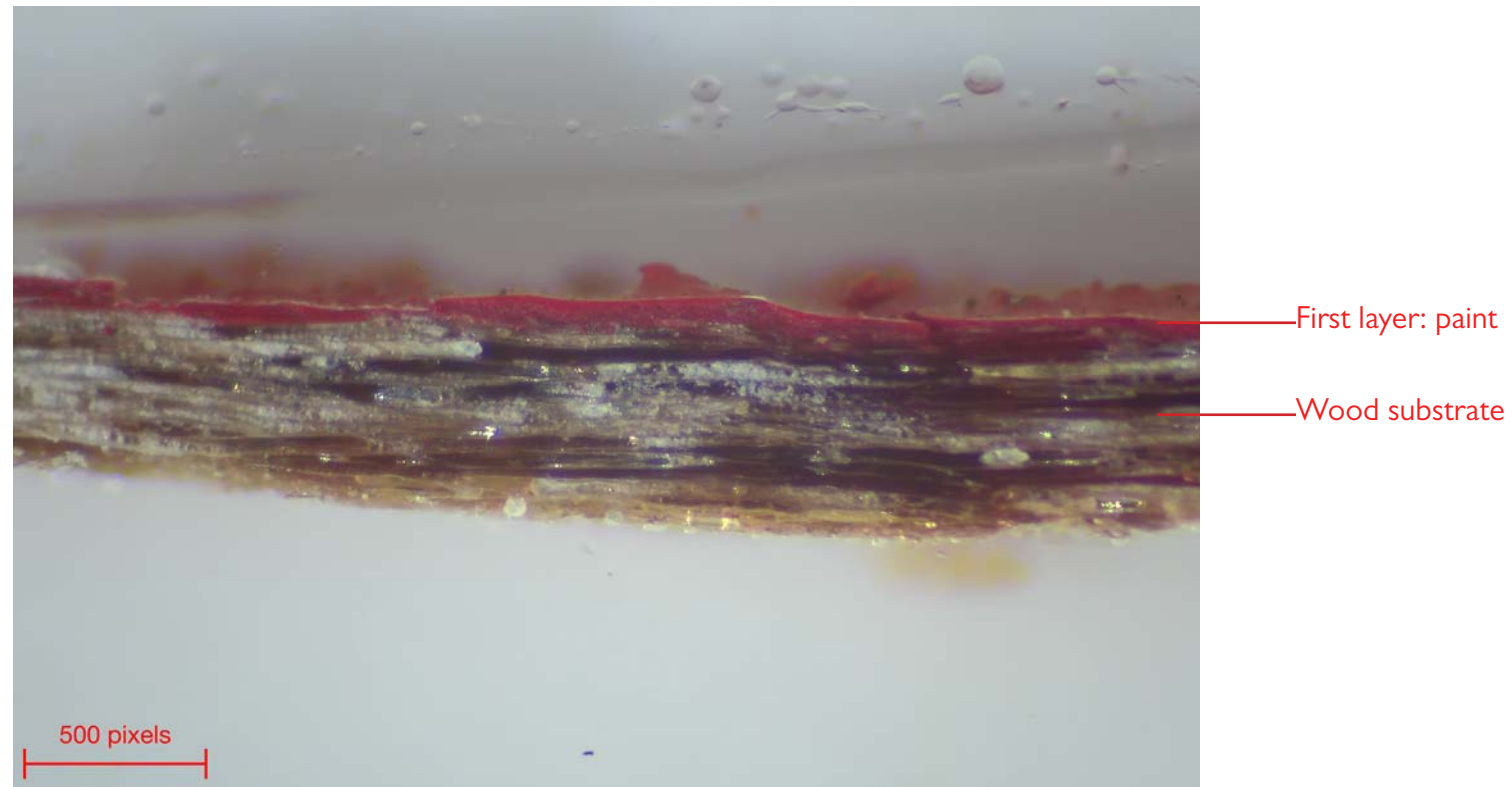
Figure 3. Sample 01

Layer 1: Red

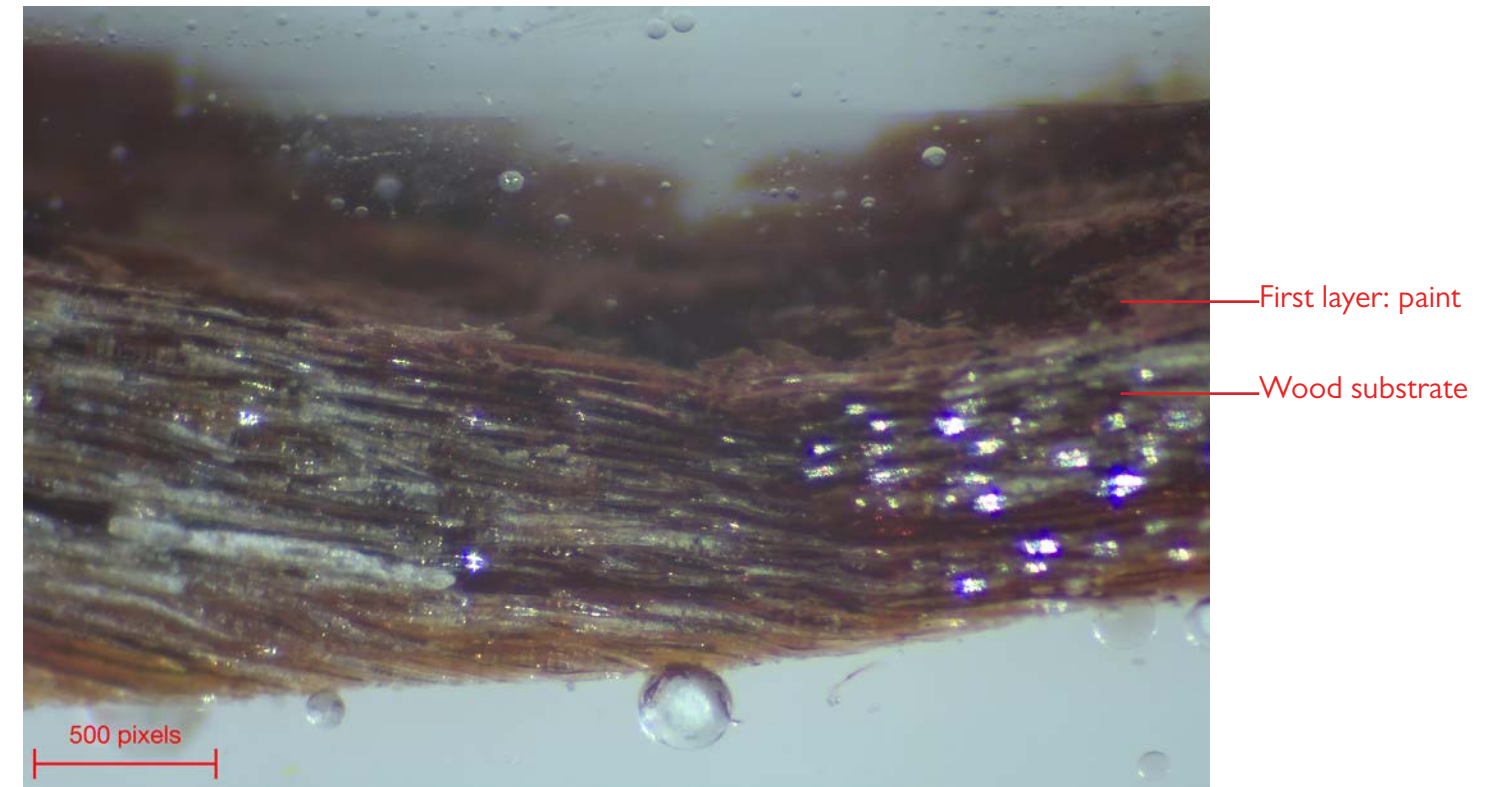
Figure 4. Sample 02

Layer 1: Brown

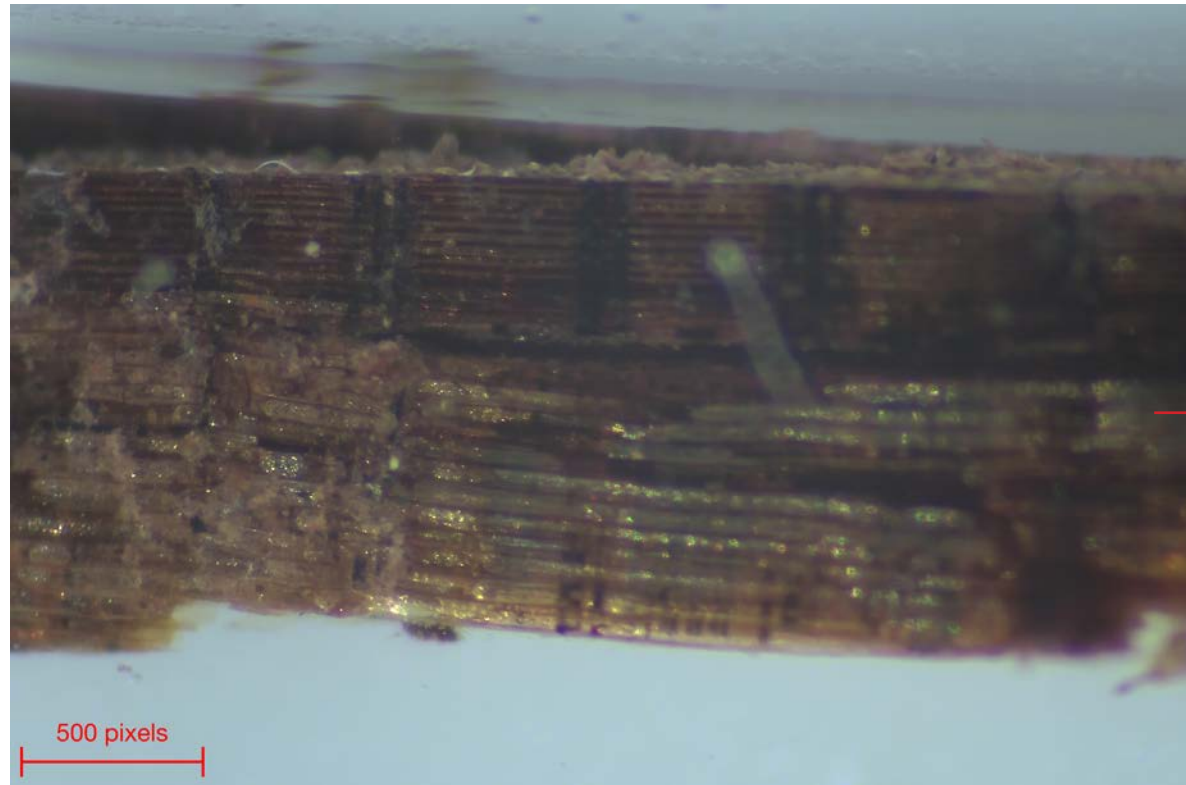
Figure 5. Sample 03

No painted layer

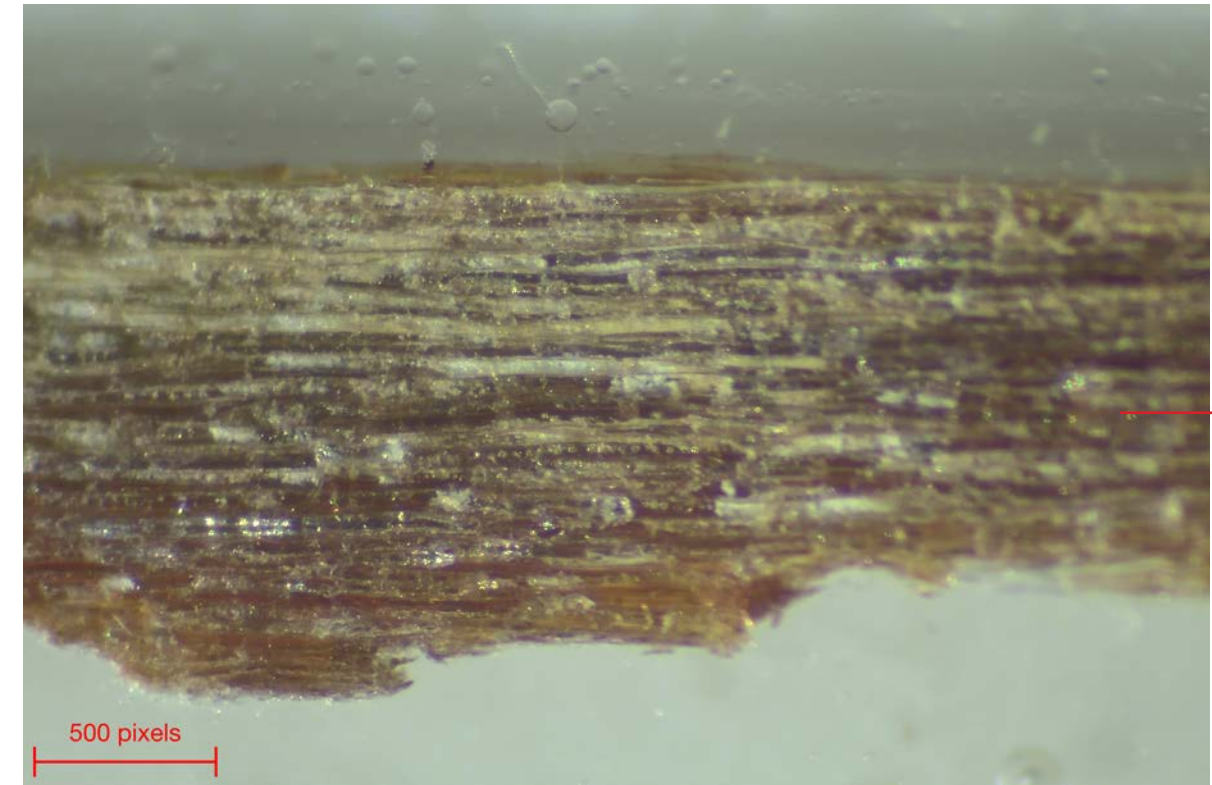
Figure 6. Sample 04

No painted layer

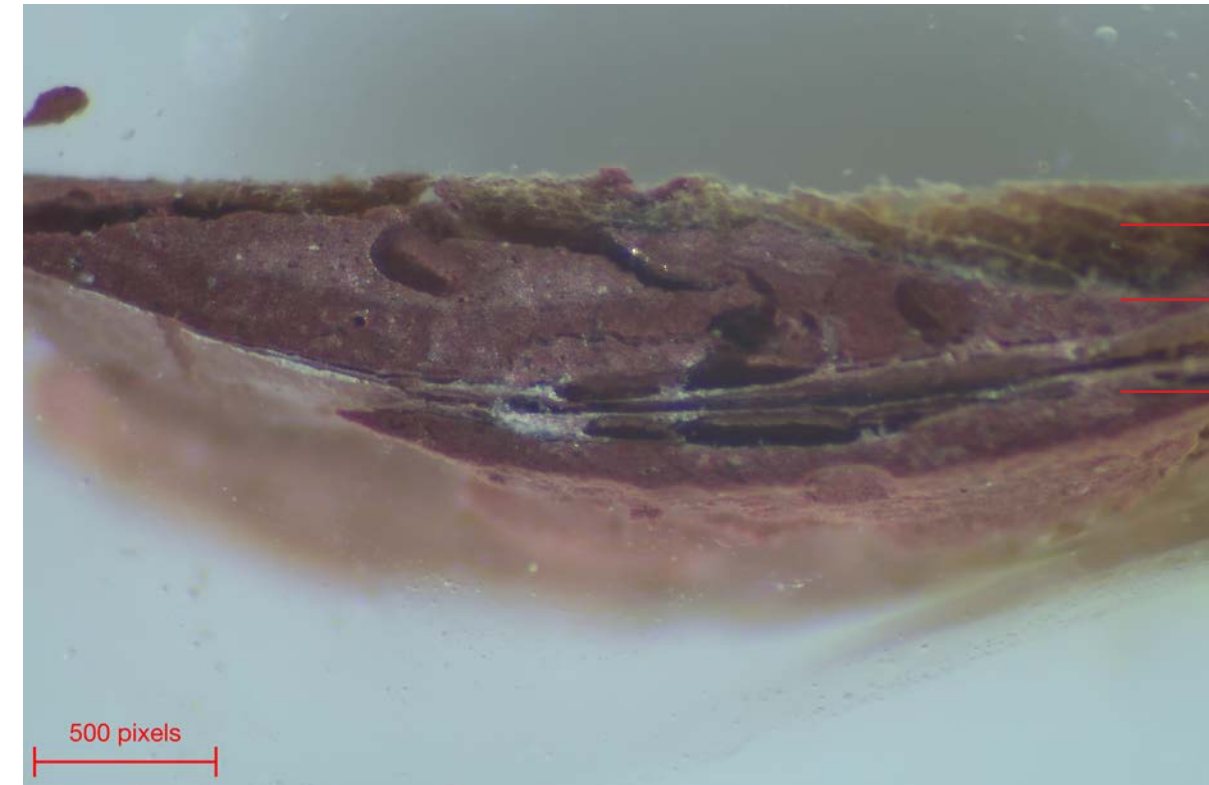
Figure 8. Sample 05

Layer 1: Red brown

Layer 2: Red brown

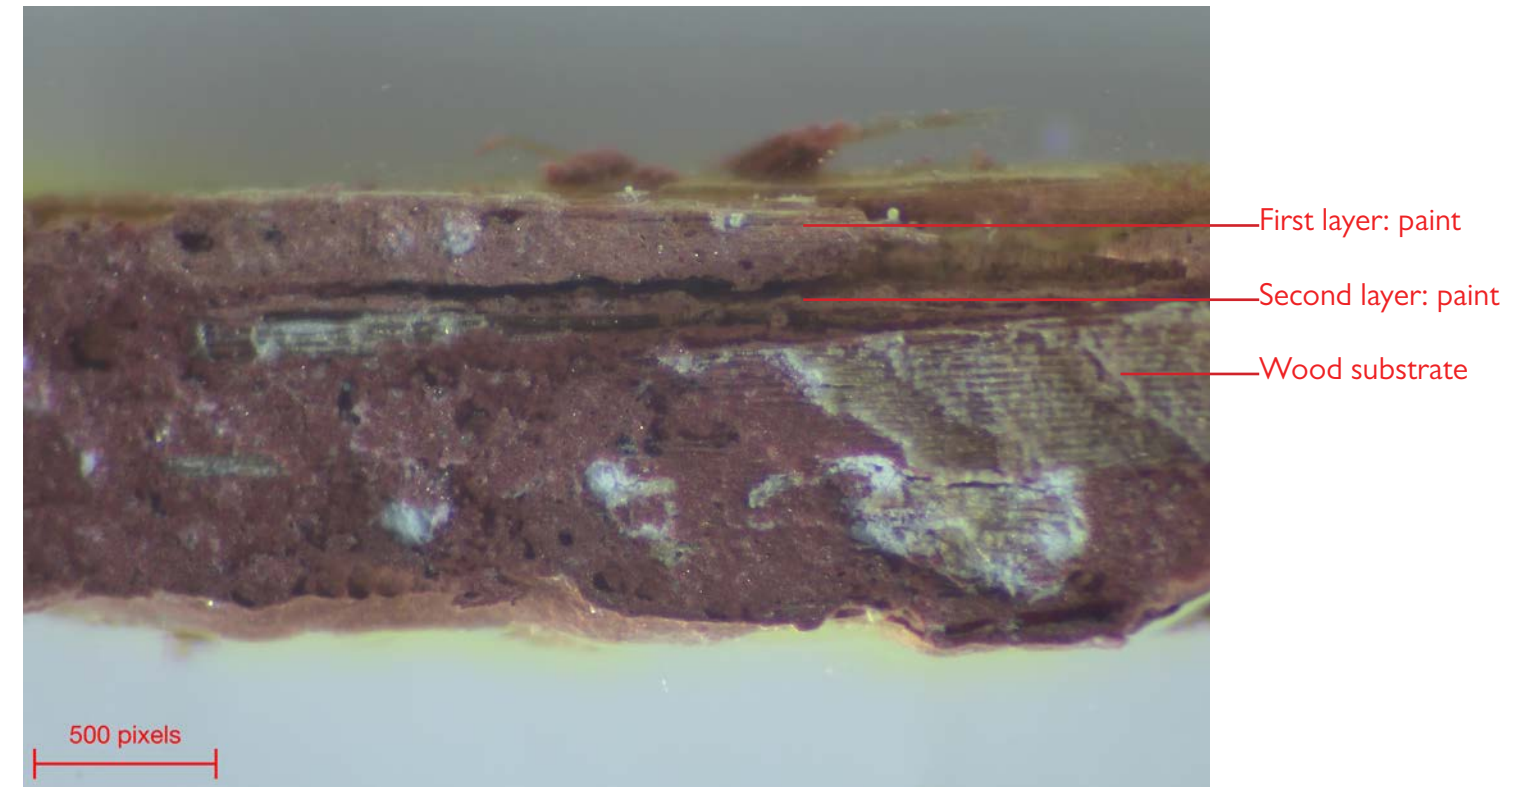
Figure 12. Sample 07

Layer 1: Red brown

Layer 2: Red brown
