Historic Structure Report The Cabaret at Taliesin West

12621 N Frank Lloyd Wright Blvd, Scottsdale, AZ 85259

Prepared for: The Frank Lloyd Wright Foundation
Fred Prozzillo, Vice President of Preservation

HSPV 7210 Capstone Studio: Materials + Materialities
University of Pennsylvania, Stuart Weitzman School of Design
Contributors: Yi-Ju Chen, Priyanka Gorasia, Yuxuan Wu, Anyuan Ji
Advisor: Irene Matteini, Frank Matero
Spring, 2023

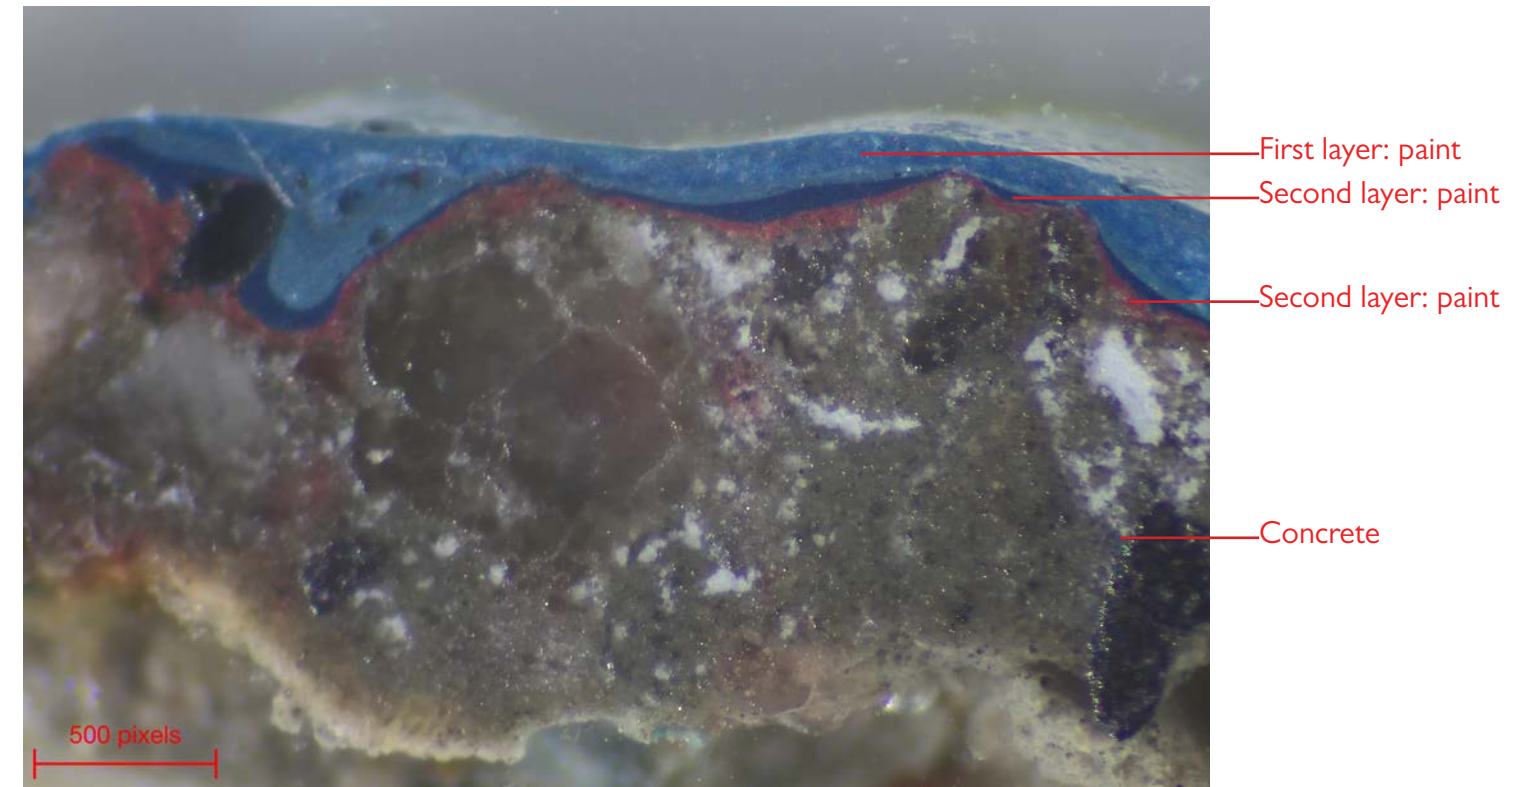
Figure 14. Sample 09

Layer 2: Dark blue

Layer 2: Red

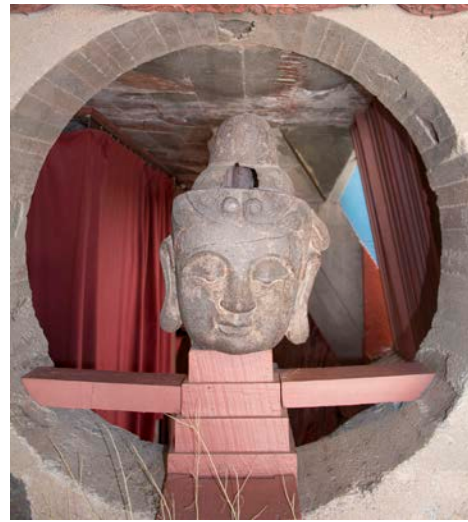
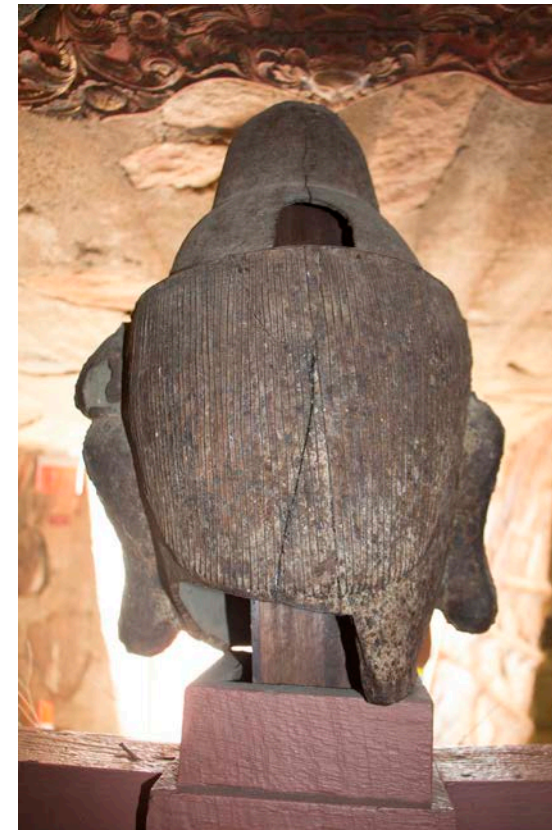
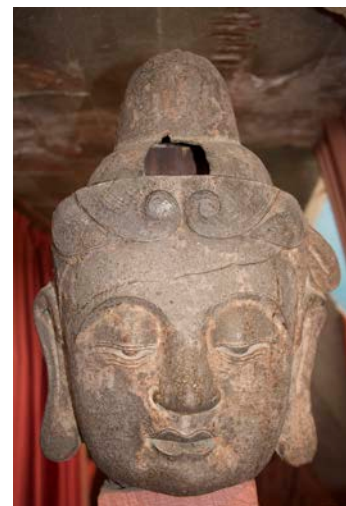
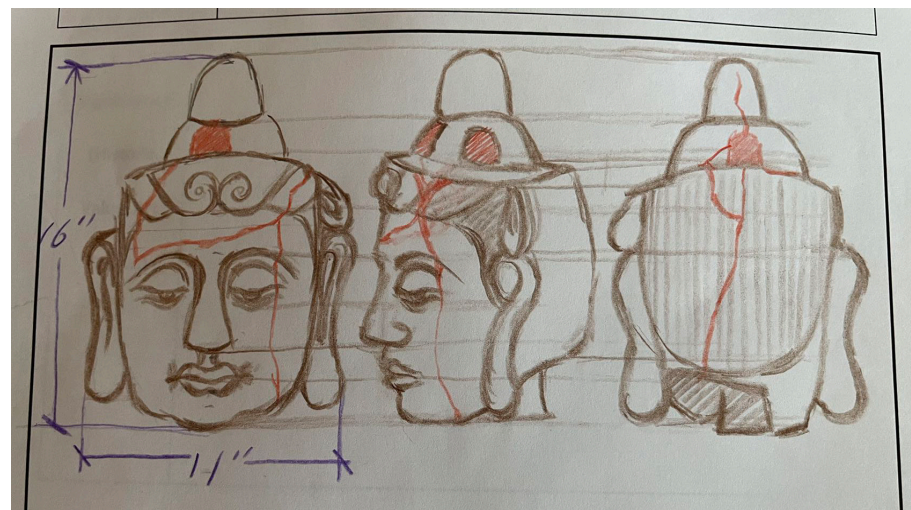
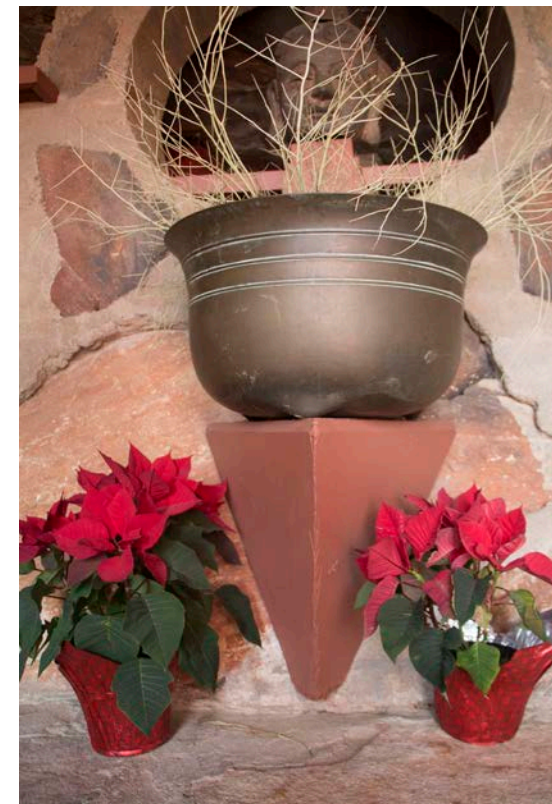
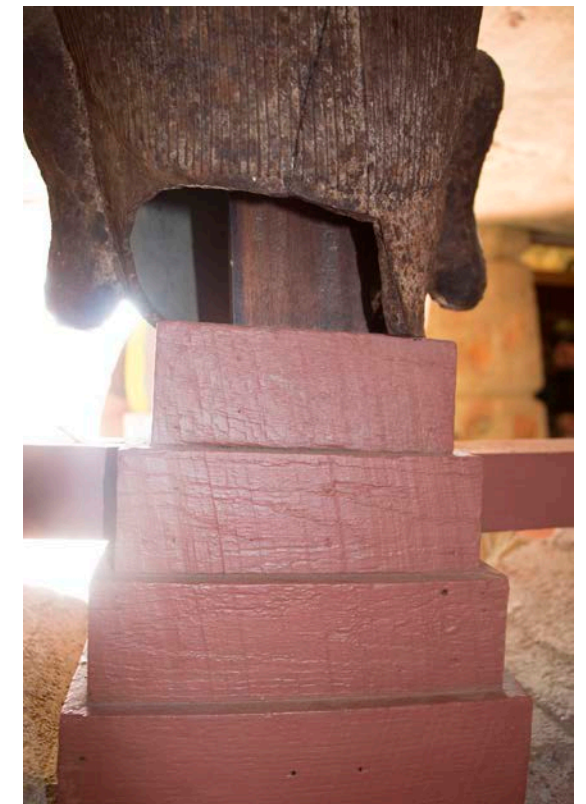
Object Name: Studio Buddha
Quantity: 1
Date of original installation: 1951
Current Location: Center behind the entry door
Material : Cast Iron
Condition: Three cracks can be observed on the surface and have been restored with some kind of glue on the interior side

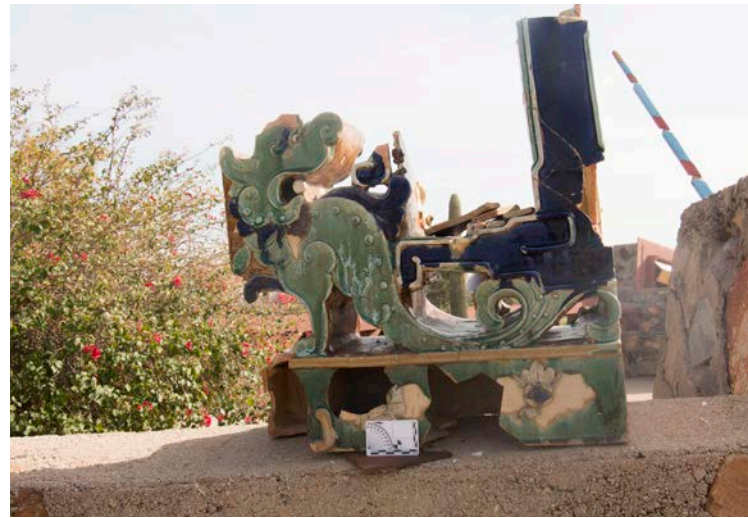
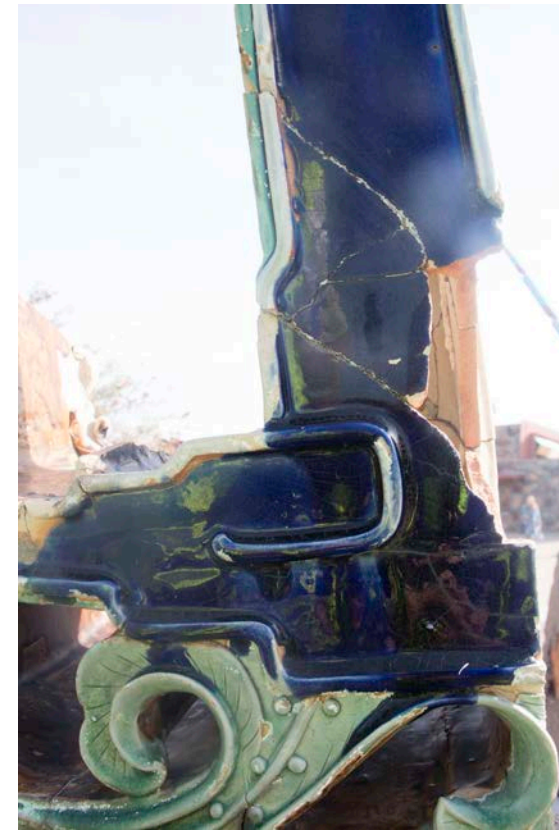
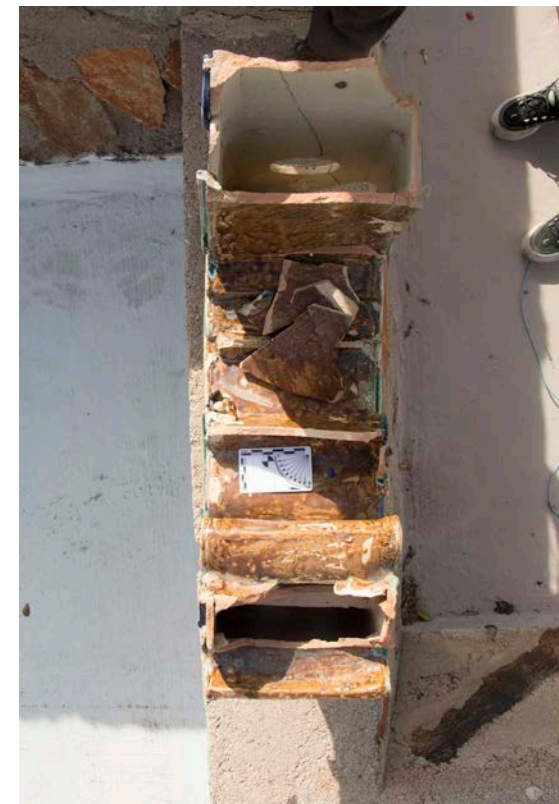
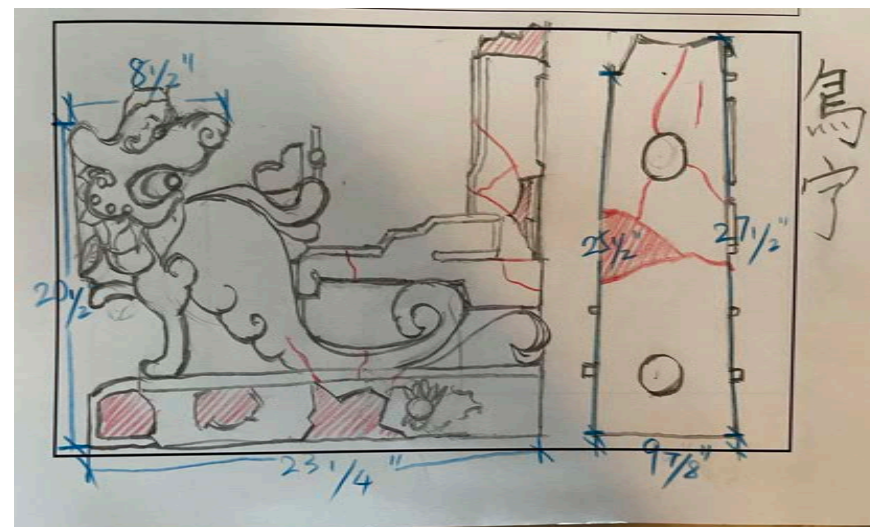
Object Name: Chiwen-motif decorative roof tile
Quantity: 1
Date of original installation: Between 1969 and 2004
Current Location: On the roof above the entrance
Material : Color glazed ceramic
Condition: The upper part is broken. Several separate fragments are piled on the top. Discoloration of the glaze can be observed at several spots.

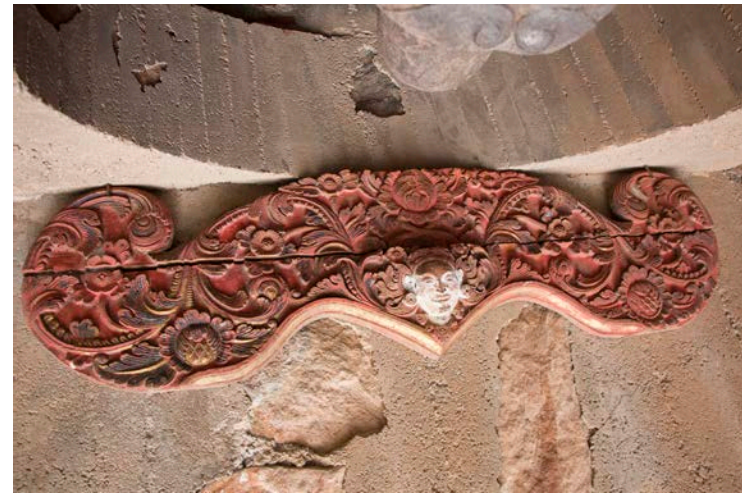
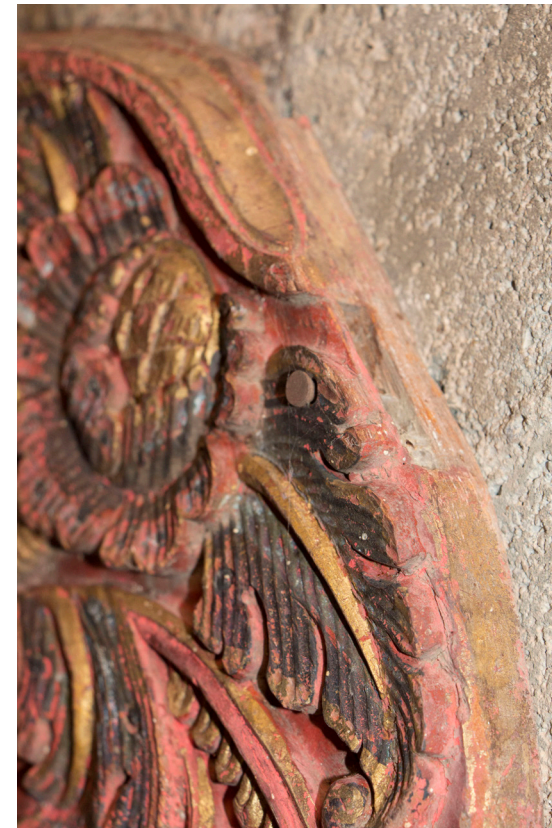
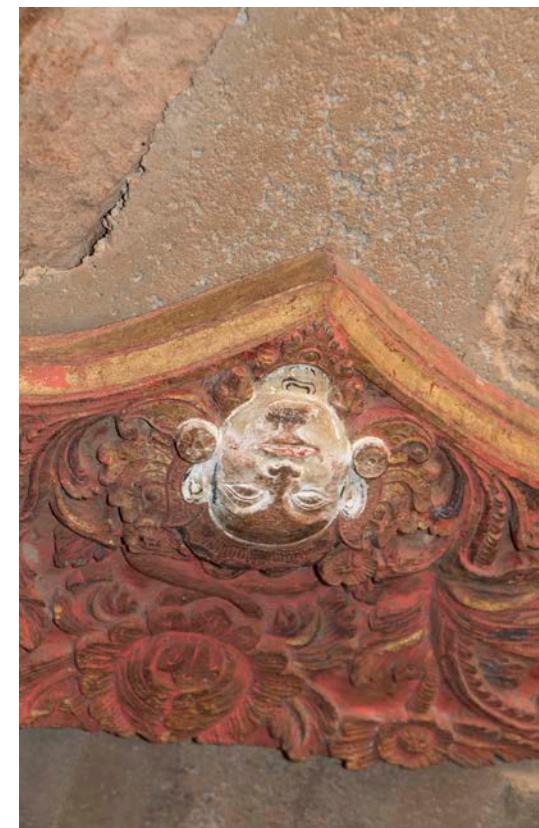
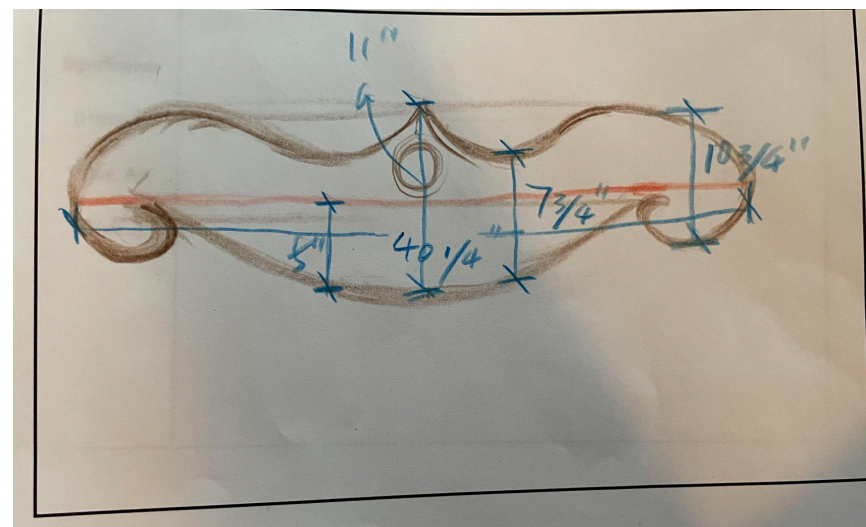
Object Name: Buddha-motif carved wood plaque
Quantity: 1
Date of original installation: 1951-1952
Current Location: Above the buddha head
Material : Wood with finishes
Condition: A deep vertical crack in the center. Discoloring of the paint.

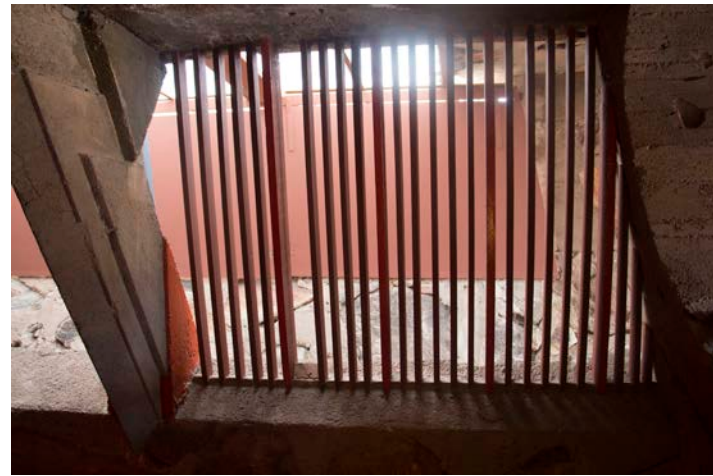
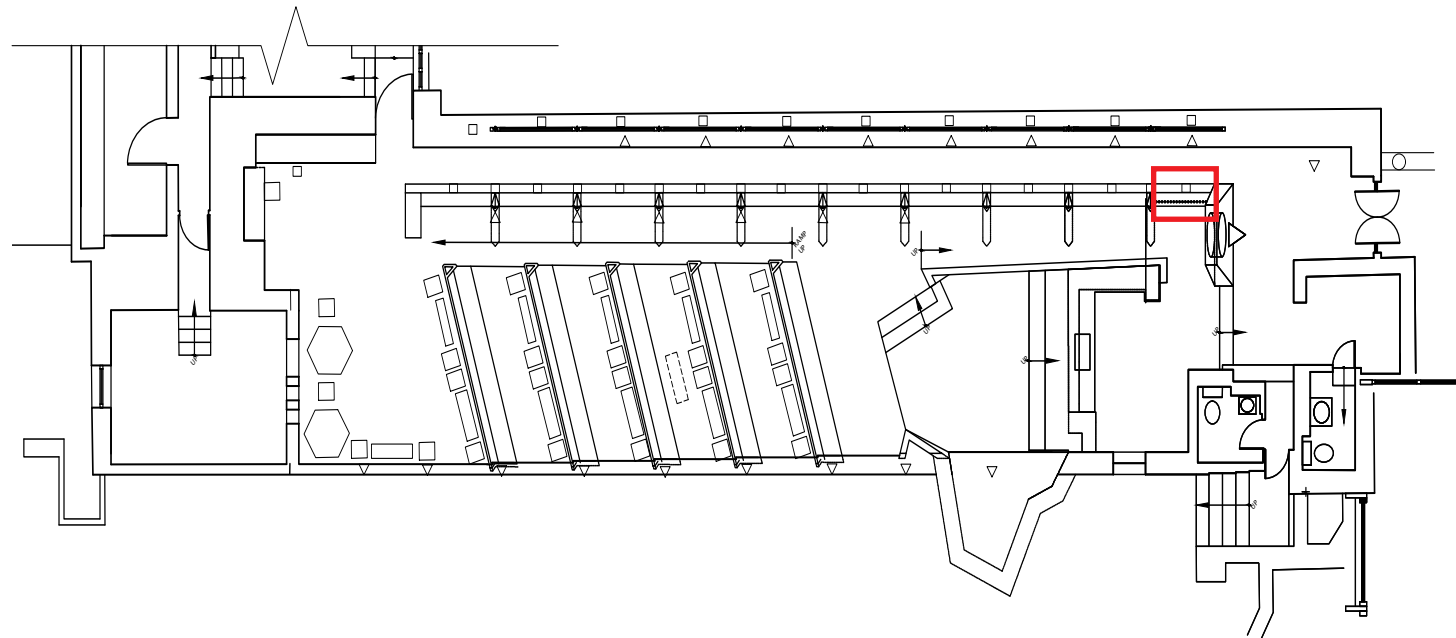
Object Name: Wood Screen
 Quantity: 1
 Date of original installation: After 1952
 Current Location: Between the first and second pier
 Material : Wood with finishes
 Condition: Good

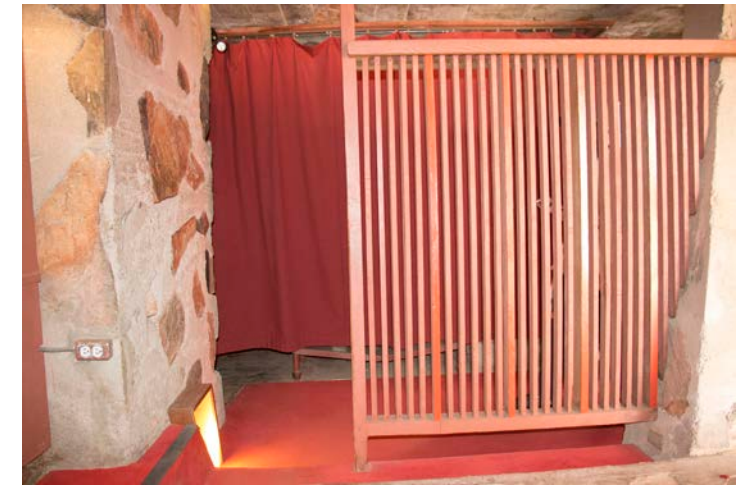
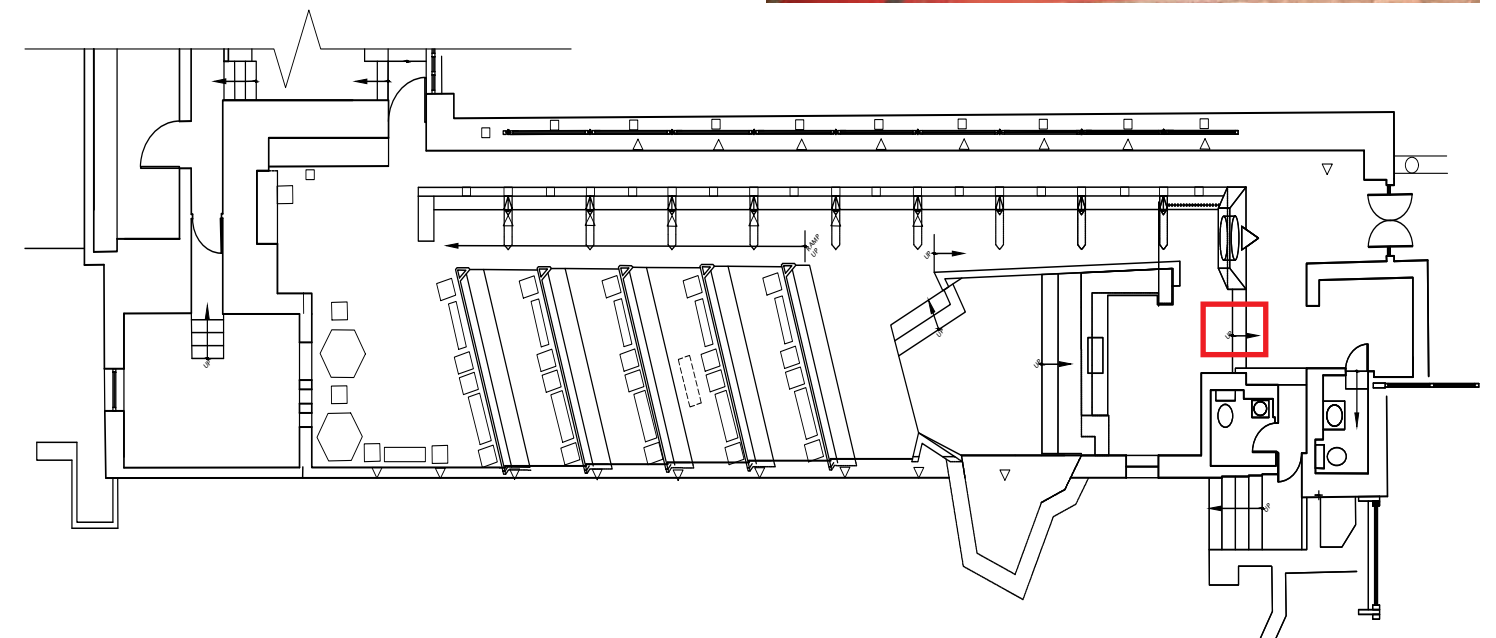
Object Name: Wood Trim Screen
 Quantity: 1
 Date of original installation: After 1956
 Current Location: Between the first and second pier
 Material : Wood with finishes
 Condition: Generally good, small cracks can be seen on the joint near the base and top part.

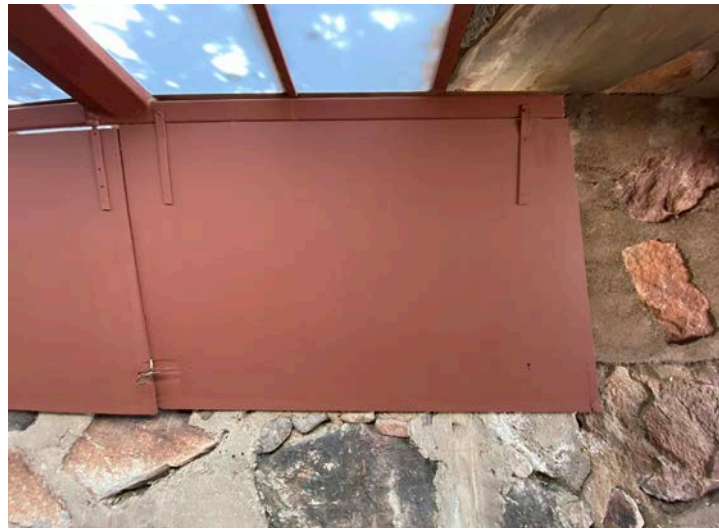
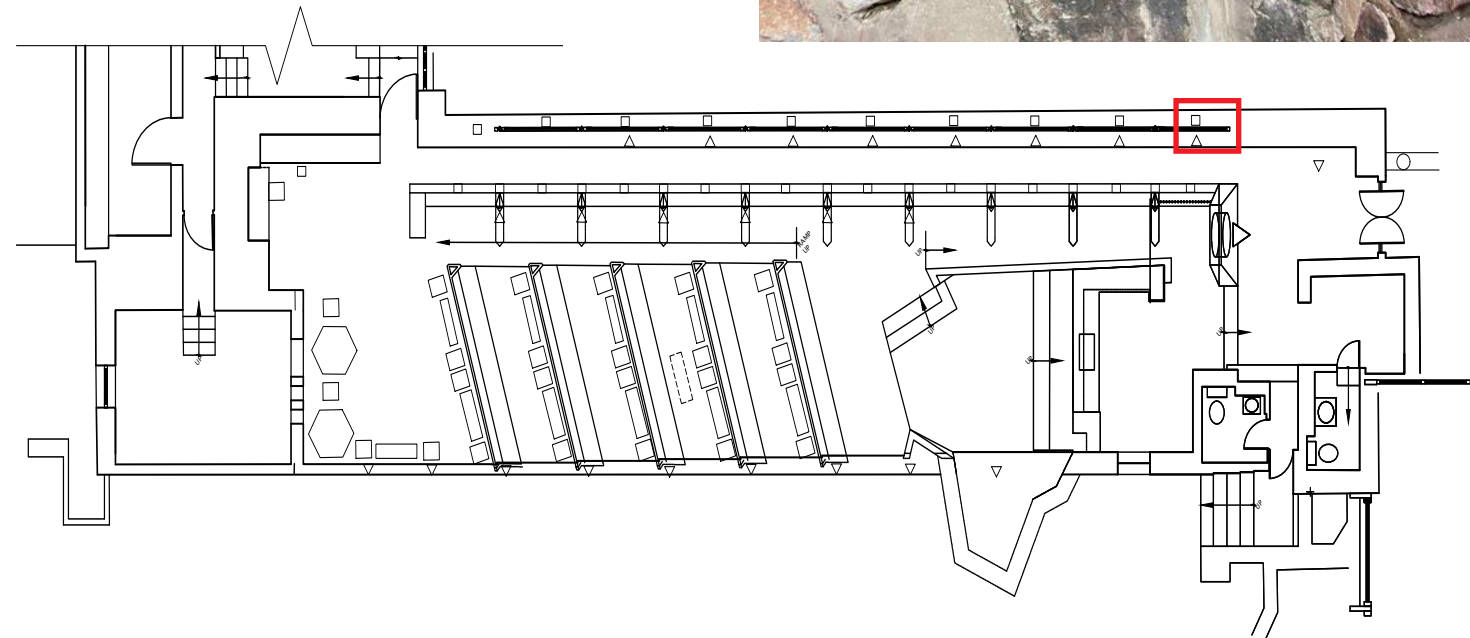
Object Name: Operable Panel
 Quantity: 9
 Date of original installation: 1960s
 Current Location: Along the west wall
 Material : Plywood with finishes
 Condition: Generally good. Peeling paint can be observed at some spots.

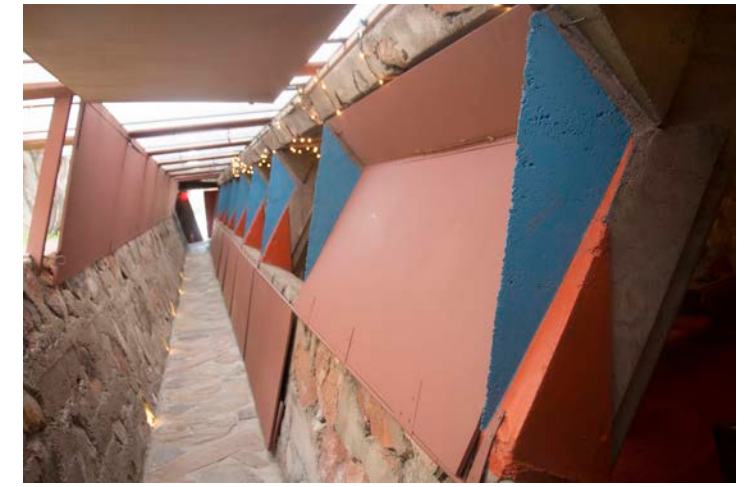
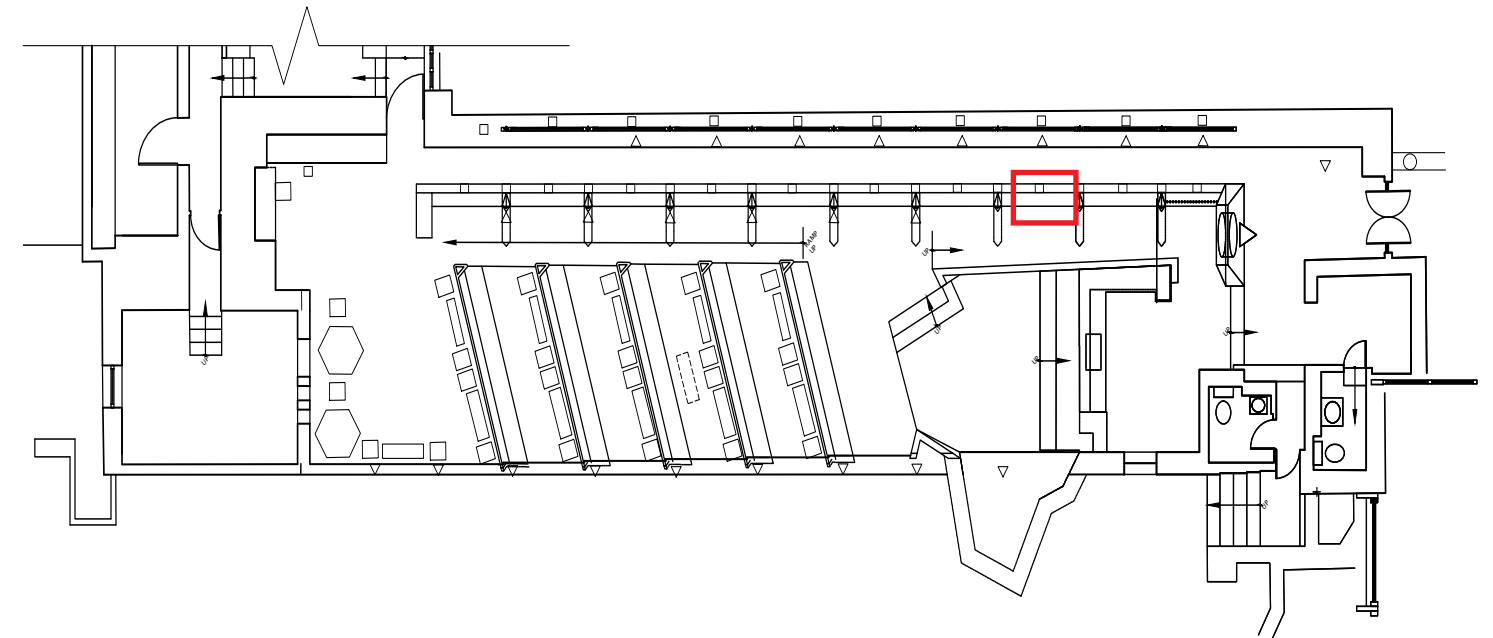
Object Name: Operable Panel
 Object Number: 12
 Quantity: 9
 Date of original installation: 1960s
 Current Location: Between decorative piers
 Material : Plywood with finishes
 Condition: Generally good. Some have a cracking near the hinge

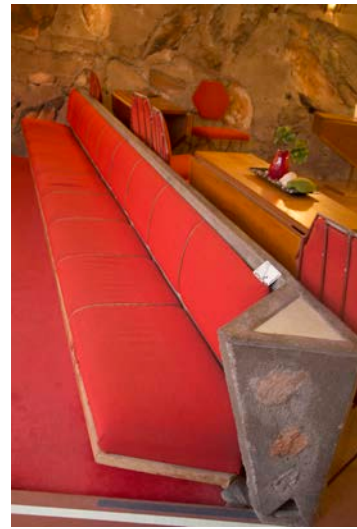
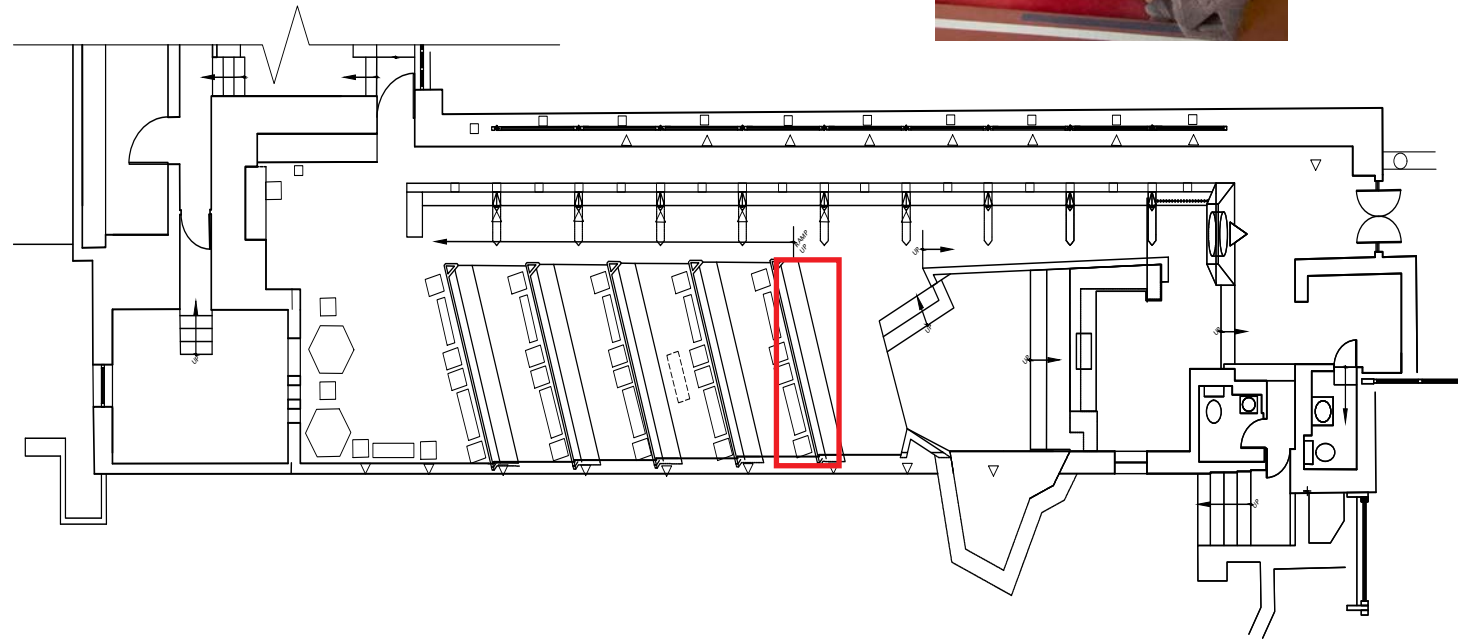
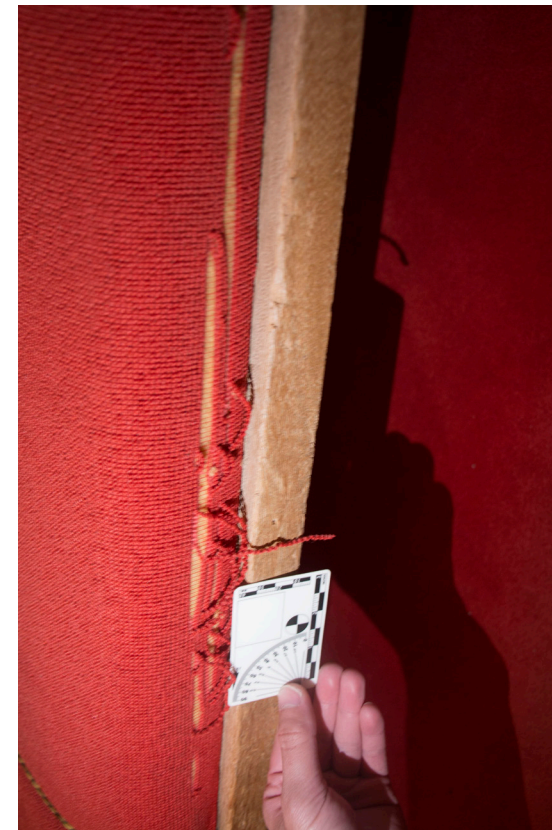
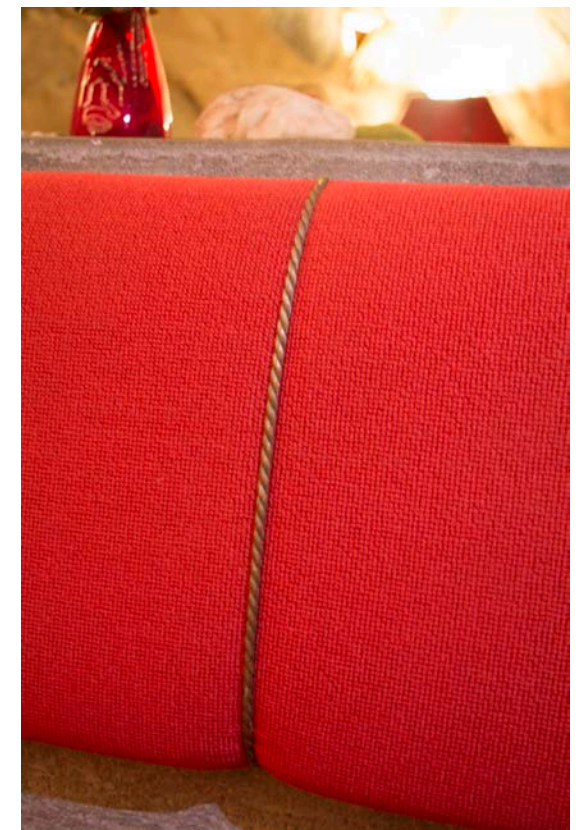
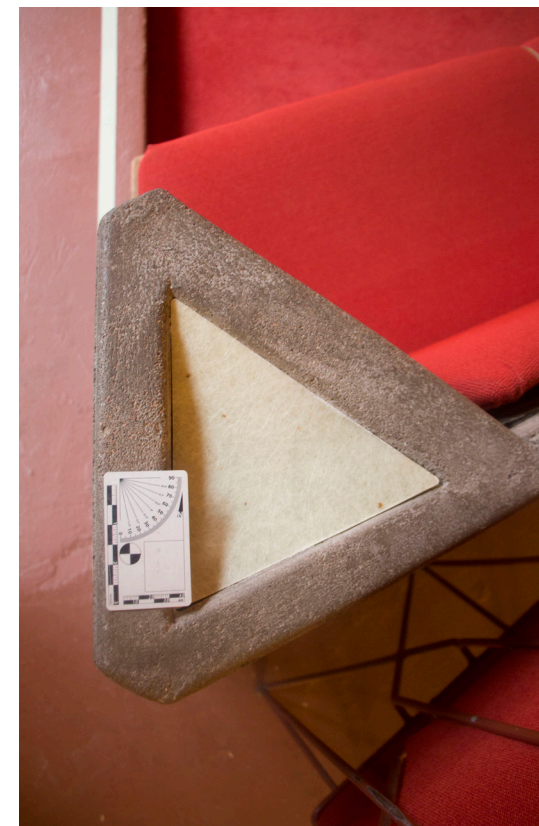
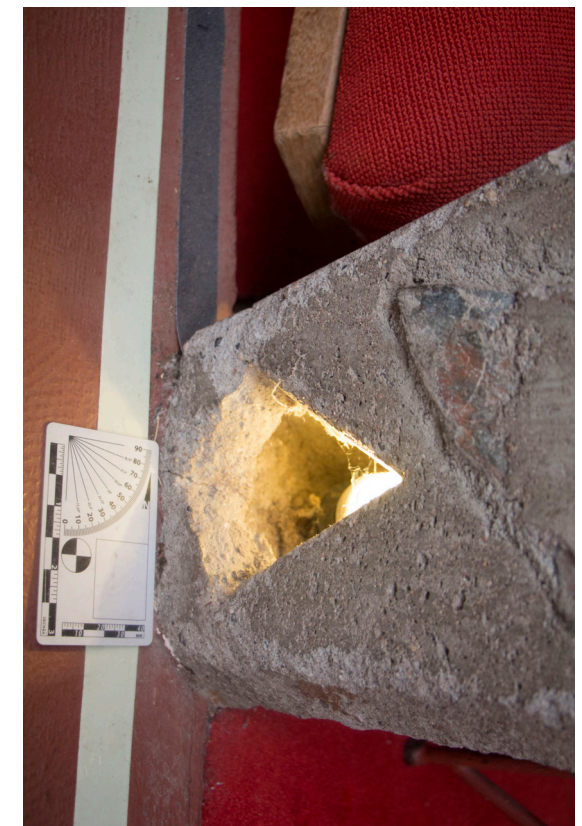
Object Name: Benches
Quantity: 5
Date of original installation: 1964
Current Location: Center of the theater, facing the screen at an angle
Material : Concrete back and pillar, wood seat, fabric upholstery
Condition: Generally good. Upholstery is worn.

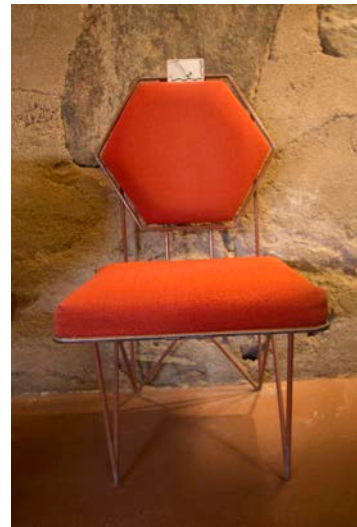
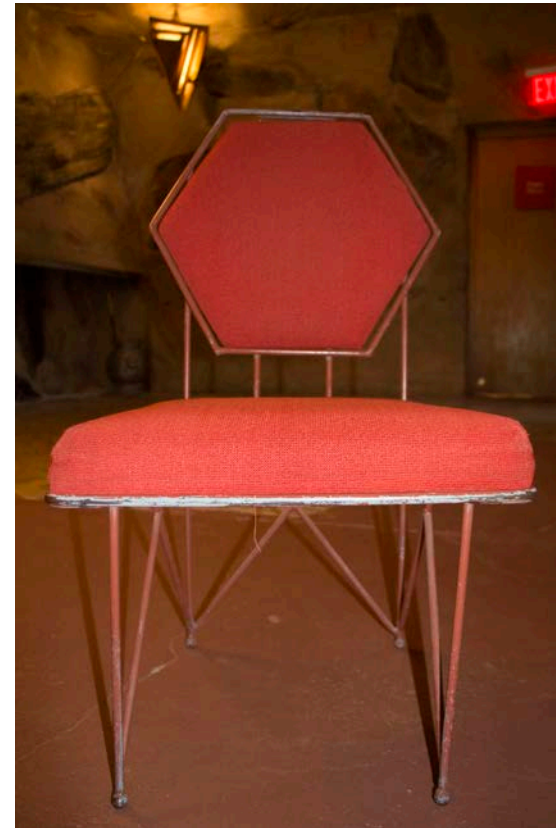
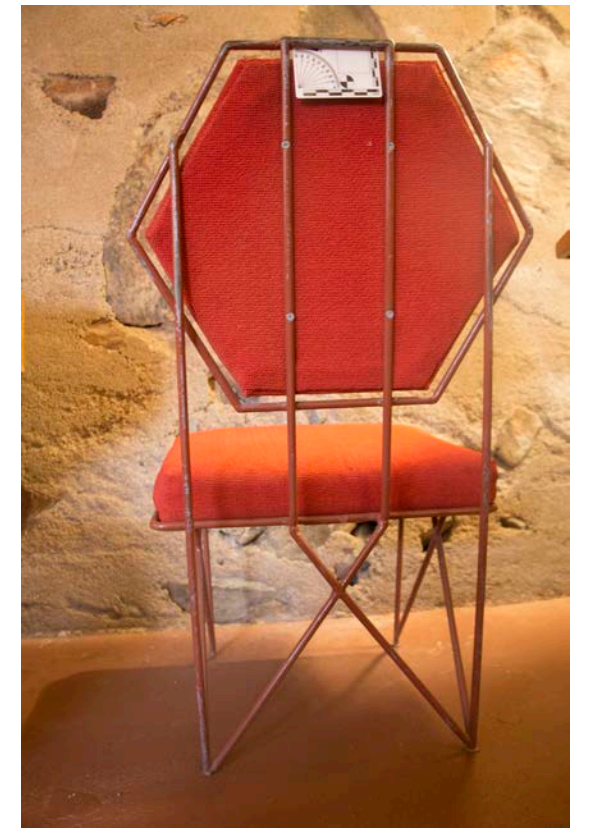
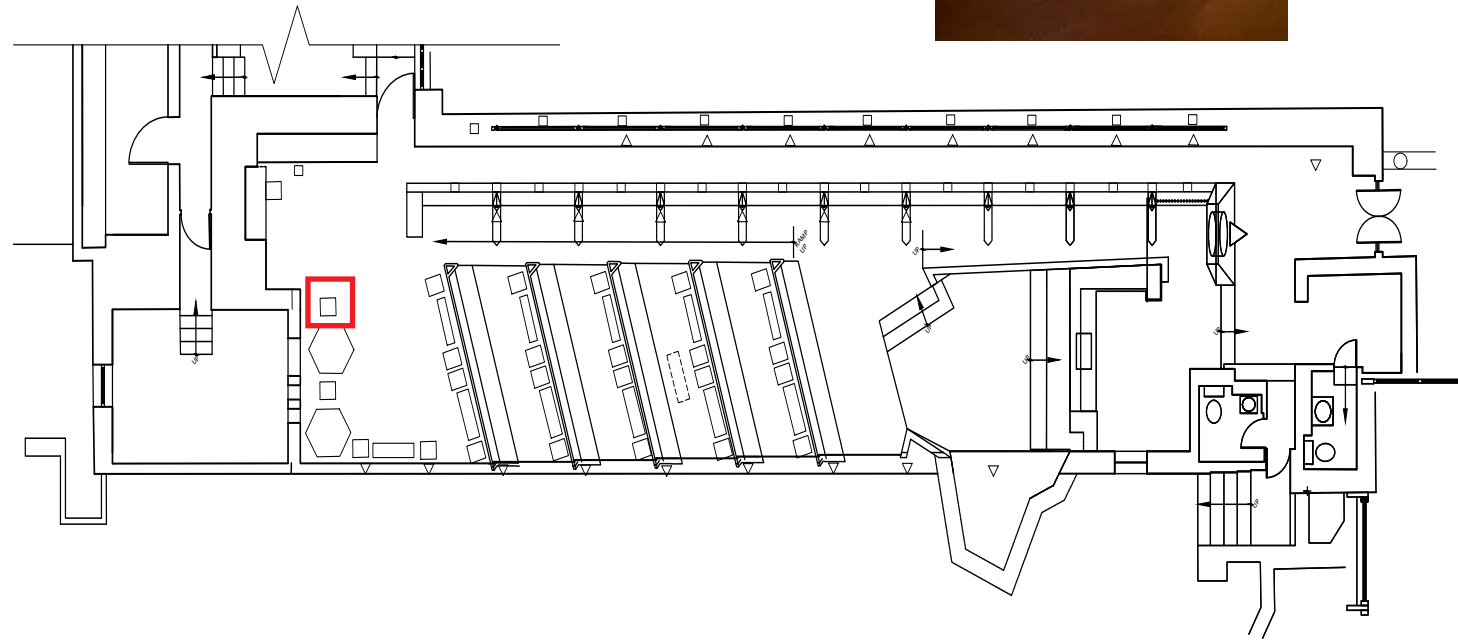
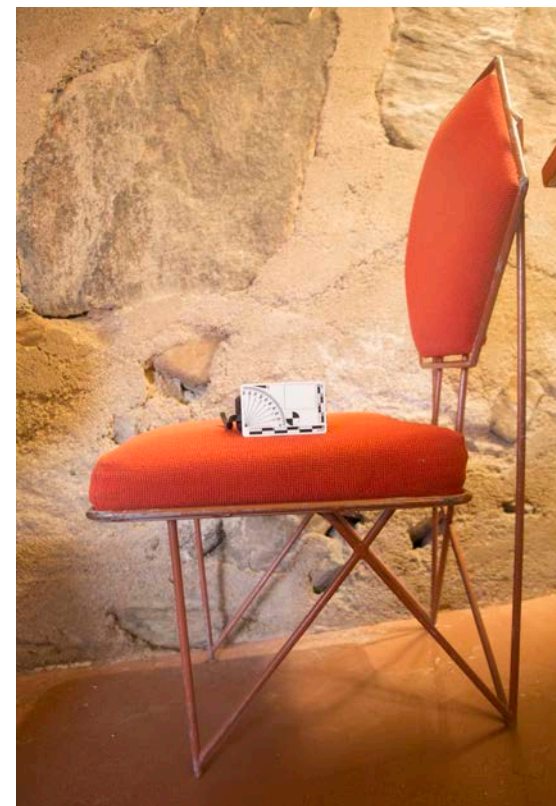
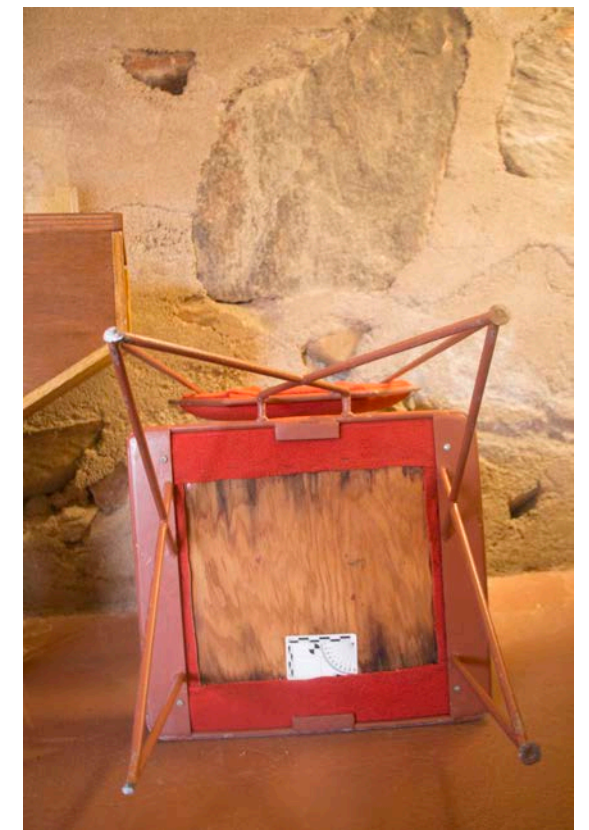
Object Name: Freestanding chairs
 Quantity: 24
 Date of original installation: 1964
 Current Location: Behind each row of benches
 Material : Metal frame and fabric upholstery
 Condition: Generally good. Discoloring of the Red paint on the metal frame is a common problem.

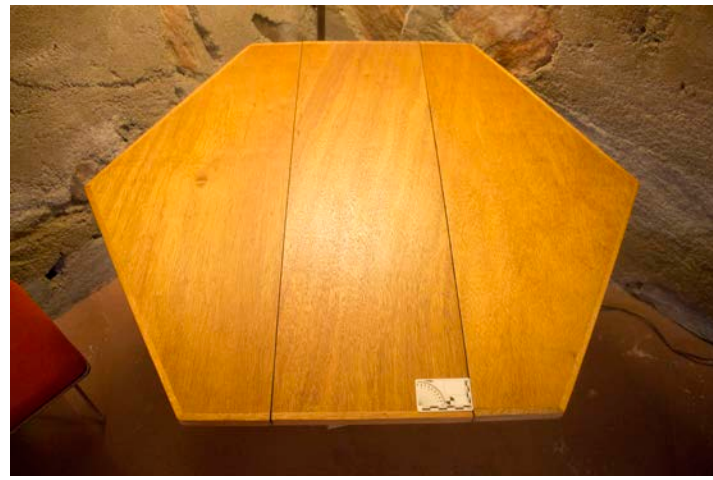
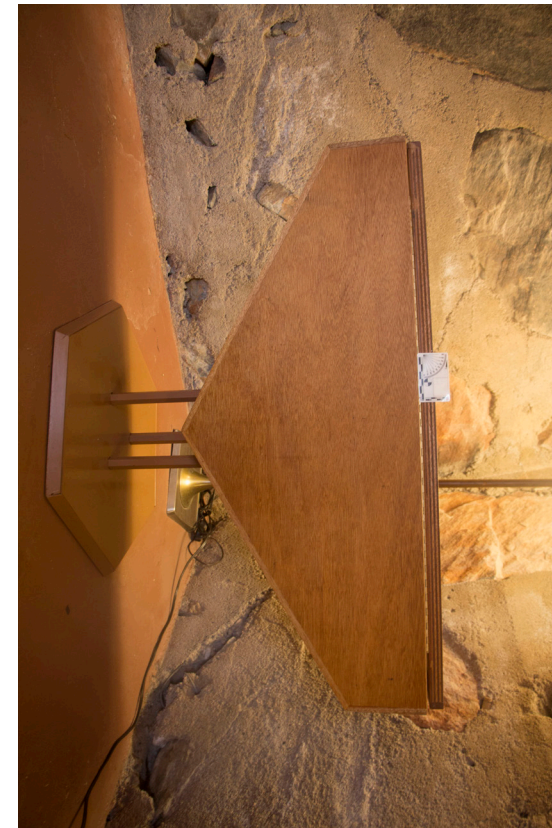
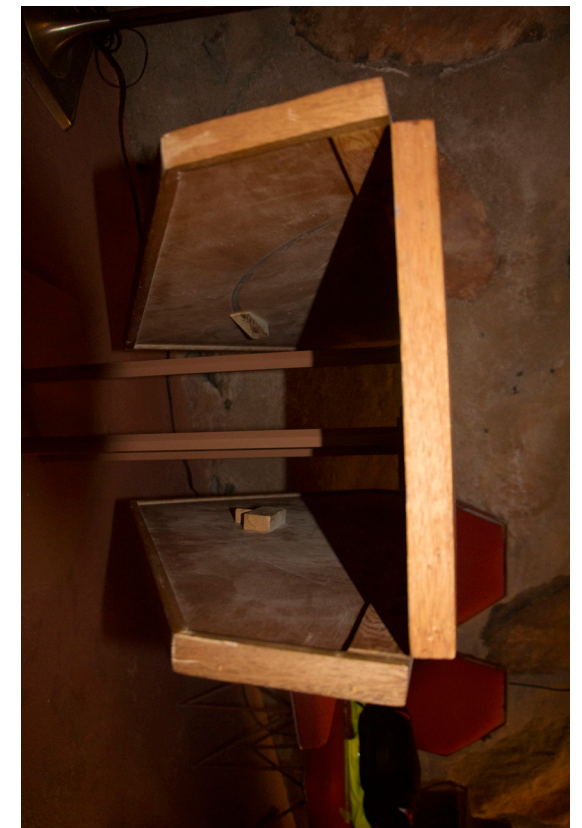
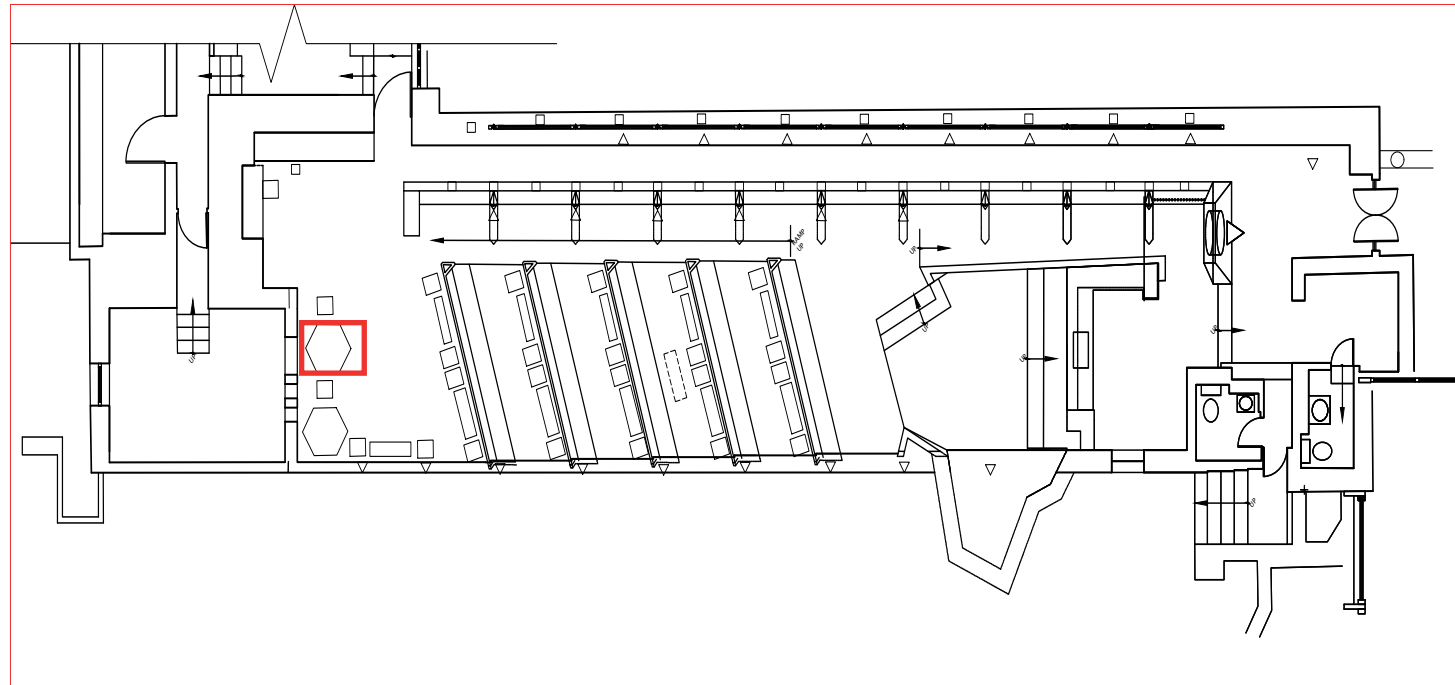
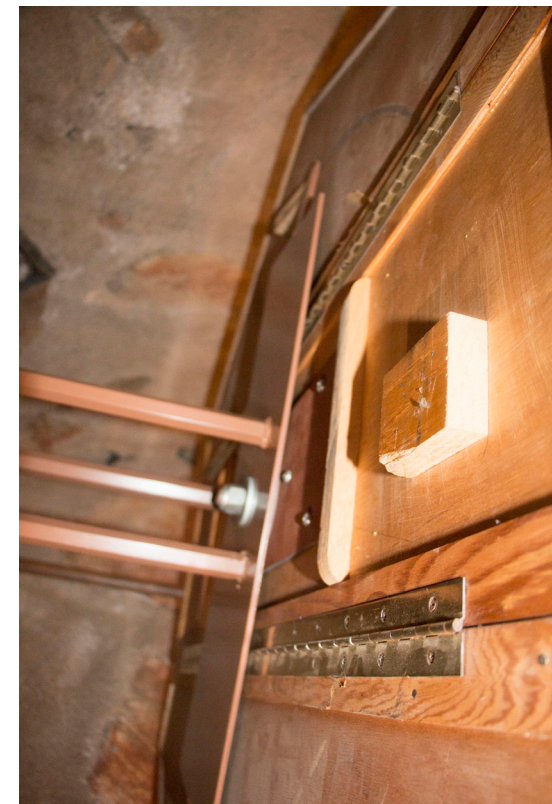
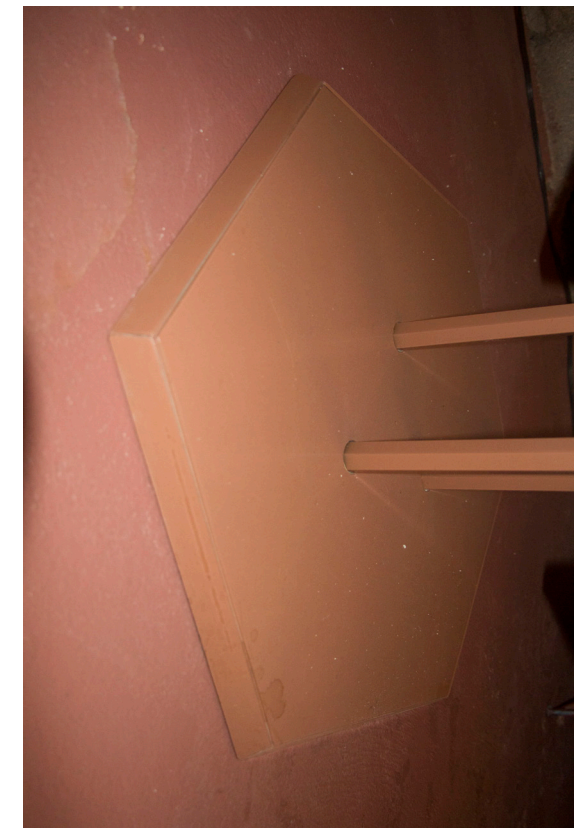
Object Name: Freestanding tables
Quantity: 13
Date of original installation: 1964
Current Location: Behind each row of benches
Material : Plywood table top, metal supporting and base
Condition: Good.

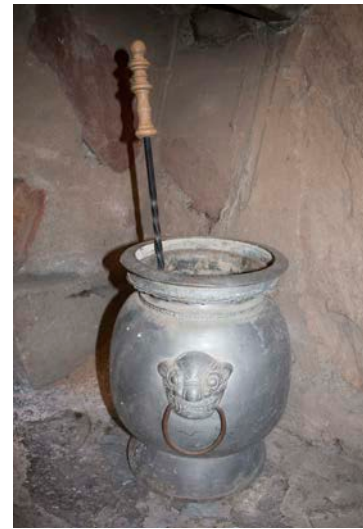
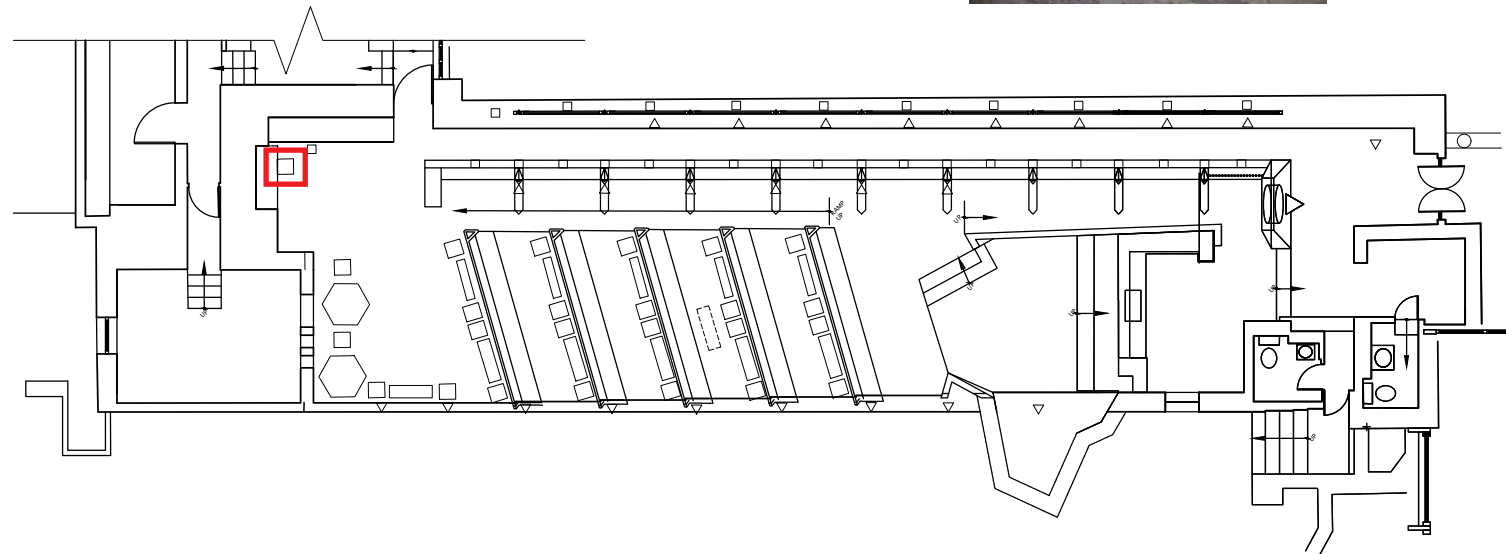
Object Name: Pot and shovel
Quantity: 1
Date of original installation: unknown
Current Location: In the fireplace
Material : Metal pot and wood-handle iron shovel
Condition: Good.
