[First Church of Christ, Scientist]  
**The Rotunda**

Preservation Plan  
HSPV - 701 • Studio • 2011

[The First Church of Christ, Scientist]  
**The Rotunda**

HSPV - 701 • Studio • 2011

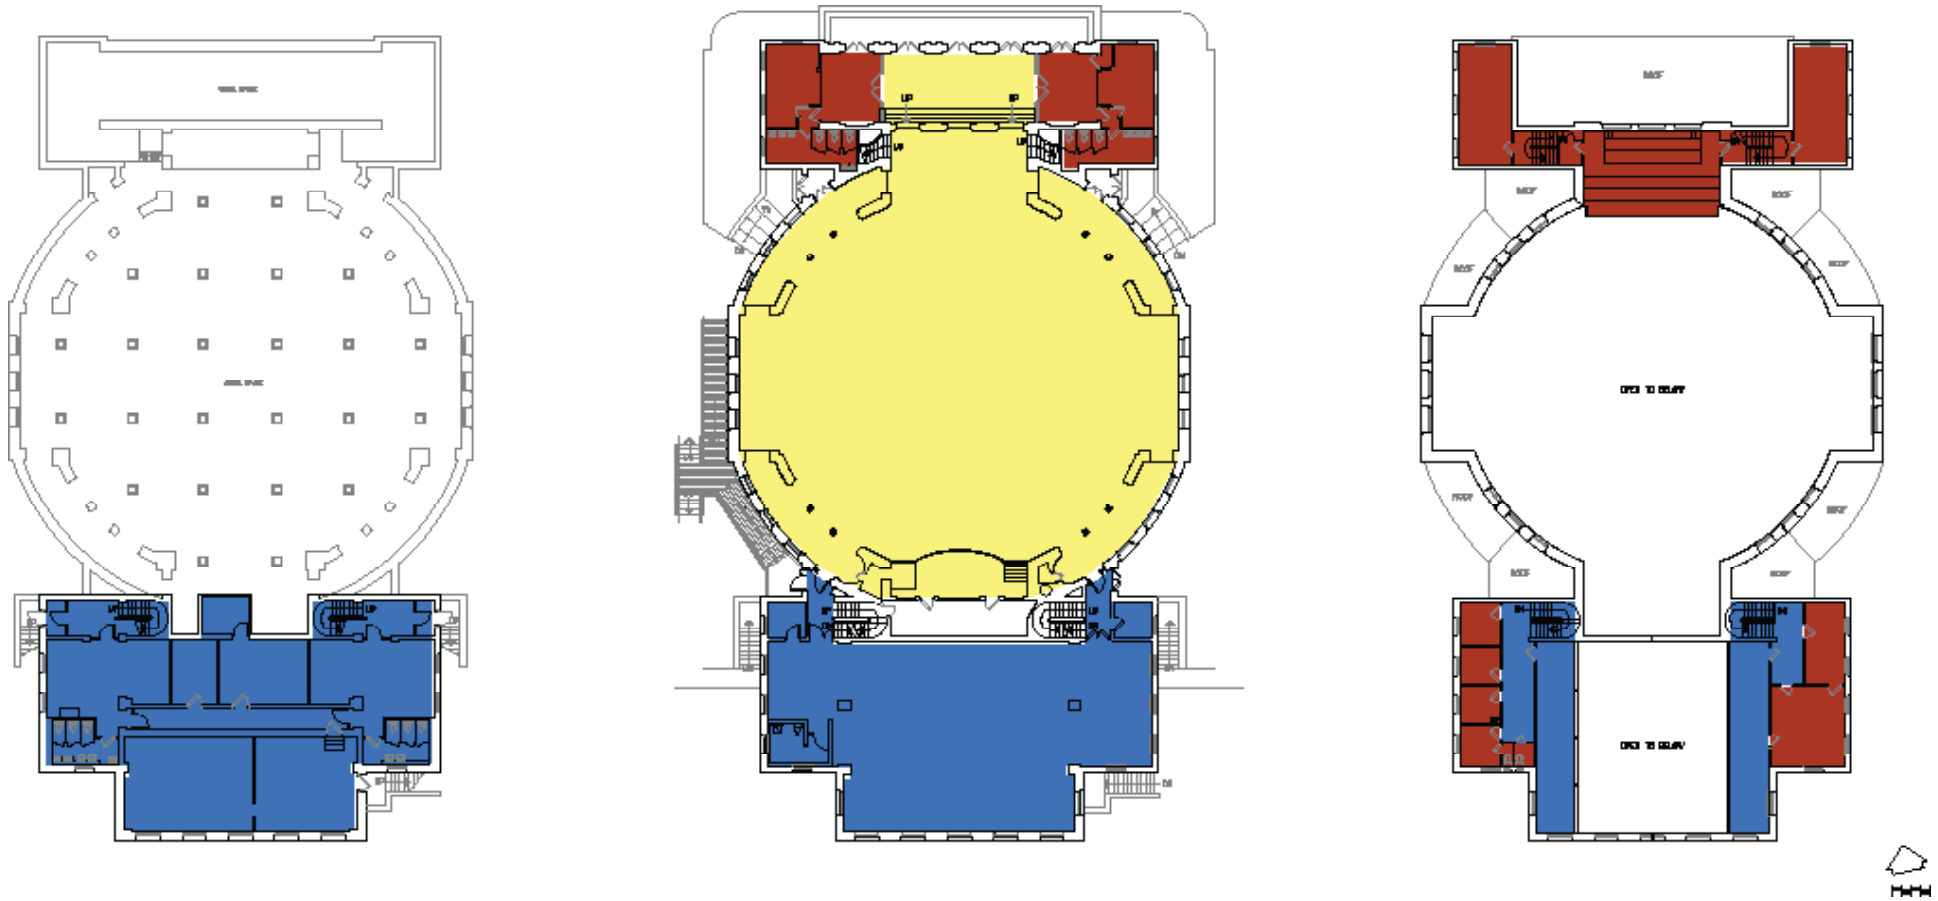
(fig. 3) Existing code work. The blue shows the areas that have been brought into compliance, and lists below many of the components that were implemented to meet accessibility and fire and life-safety requirements. The sanctuary, shown in yellow, is only used through obtaining a Temporary certificate of occupancy, which has much fewer and more lenient restrictions. Other unoccupied spaces in the building have very little to no work completed for code compliance.

- Emergency lighting
- Exit signage
- Smoke detectors
- Manual fire alarms
- Accessible entry and rest room
- Fire rated separation

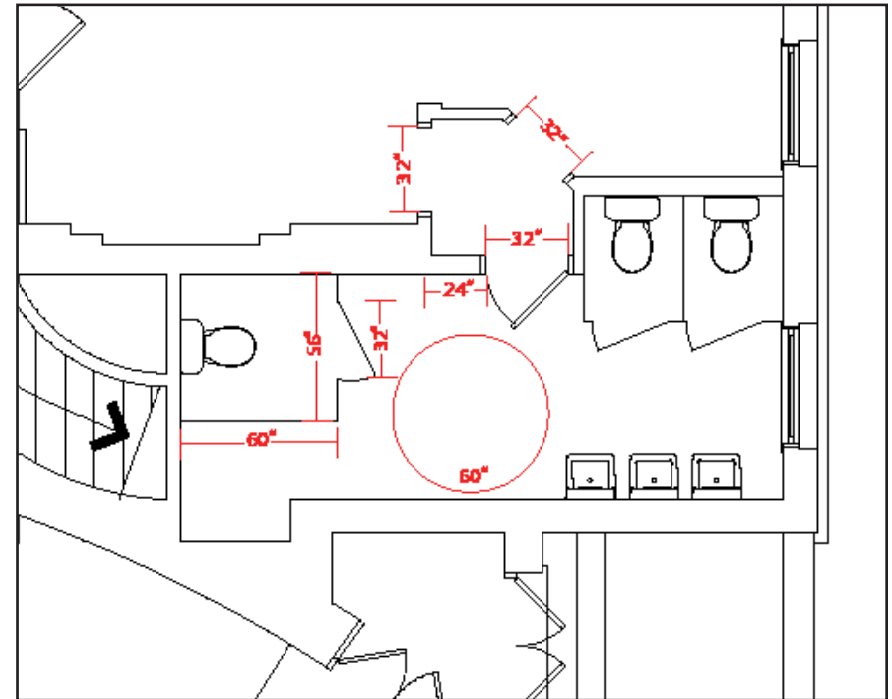
(fig. 10) The proposed rest room is accessible to the main entrance as well as the sanctuary, and adheres to mandatory clearances as determined by ADA.

The final recommendation of the code analysis is to provide a scheme for an ADA compliant rest room. The proposal plans for the conversion of a currently non-functional rest room located at the NE corner of the building (fig. 9)). The rest room is accessible to both the main entrance, as well as the sanctuary, and is adjacent to existing facilities. The scheme widens the bathroom along the exterior wall, but does not interfere with the windows nor change the character of the adjacent rooms and corridors. The increase in area is necessary for the placement of a handicap accessible stall, while maintaining the number of toilet fixtures. Door widths must be

increased, and the plumbing fixtures rearranged. Important clearances are marked in red in the schematic plan provided (fig. 10).

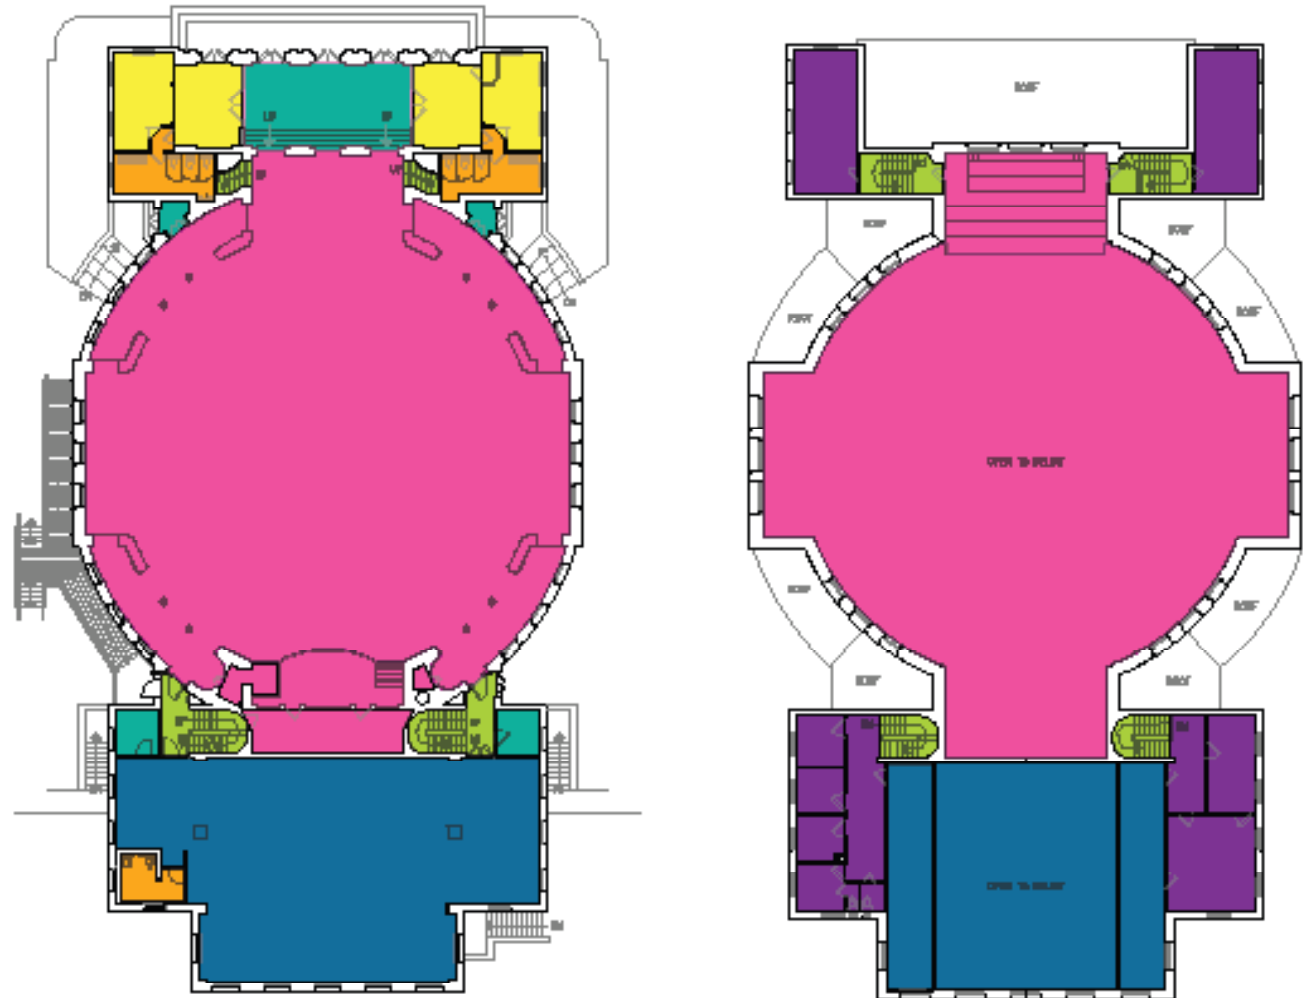
Figure 7

Wide scale paint cracking and delamination was noted in all rooms of the building which are not consistently occupied (see figures 7, 8 and 9). A steam leak which took place nearly a decade ago possibly exacerbated such conditions in the sanctuary. While the failed paint presents a concern in terms of lead content, its failure does not threaten the long term preservation of the building fabric.

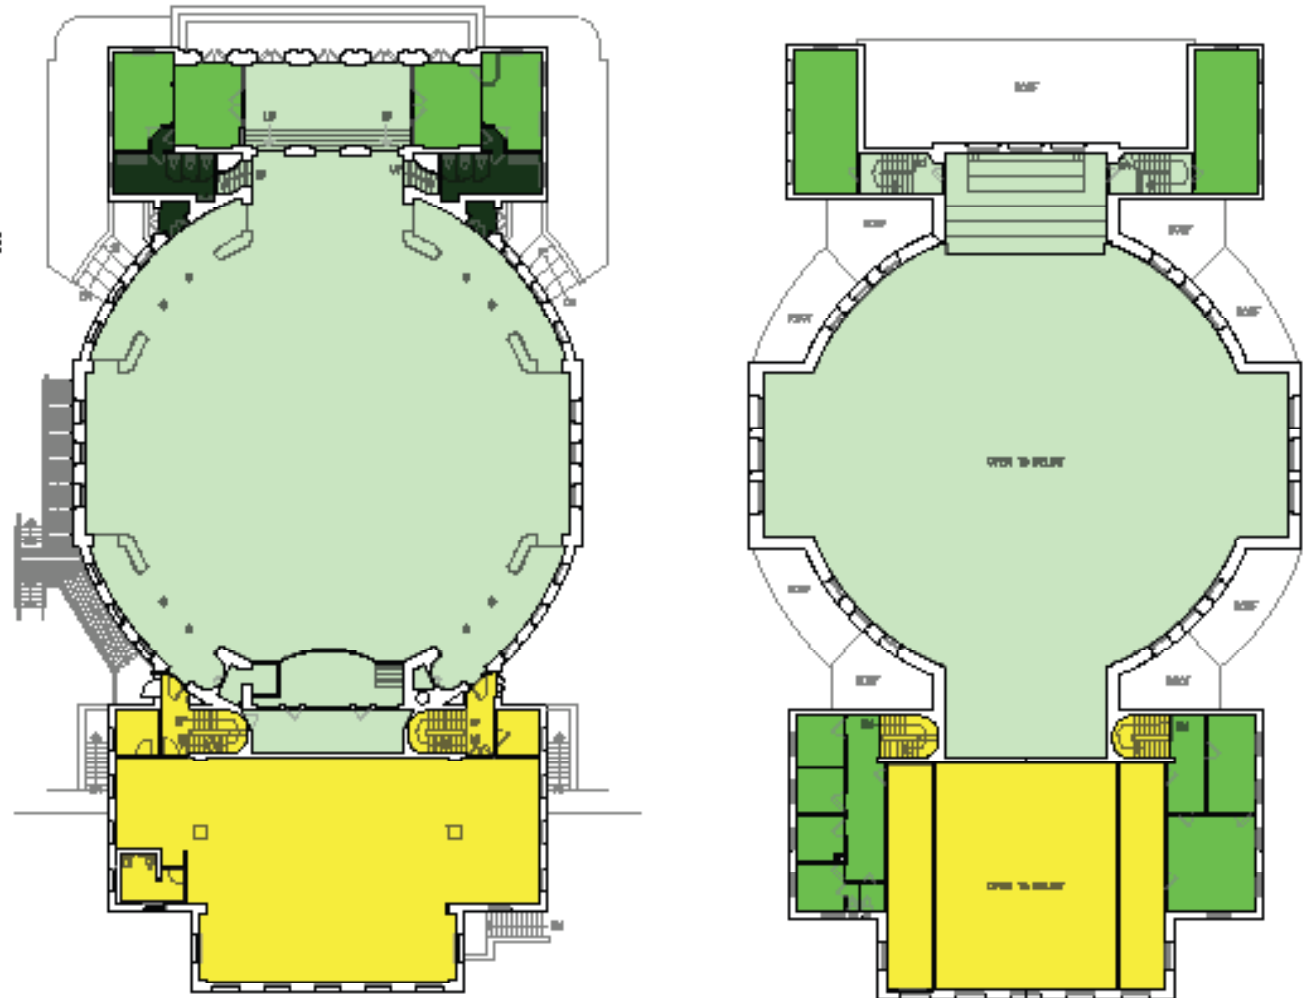
Figure 8

UNUSED/  
DEFERRED MAINTENANCE

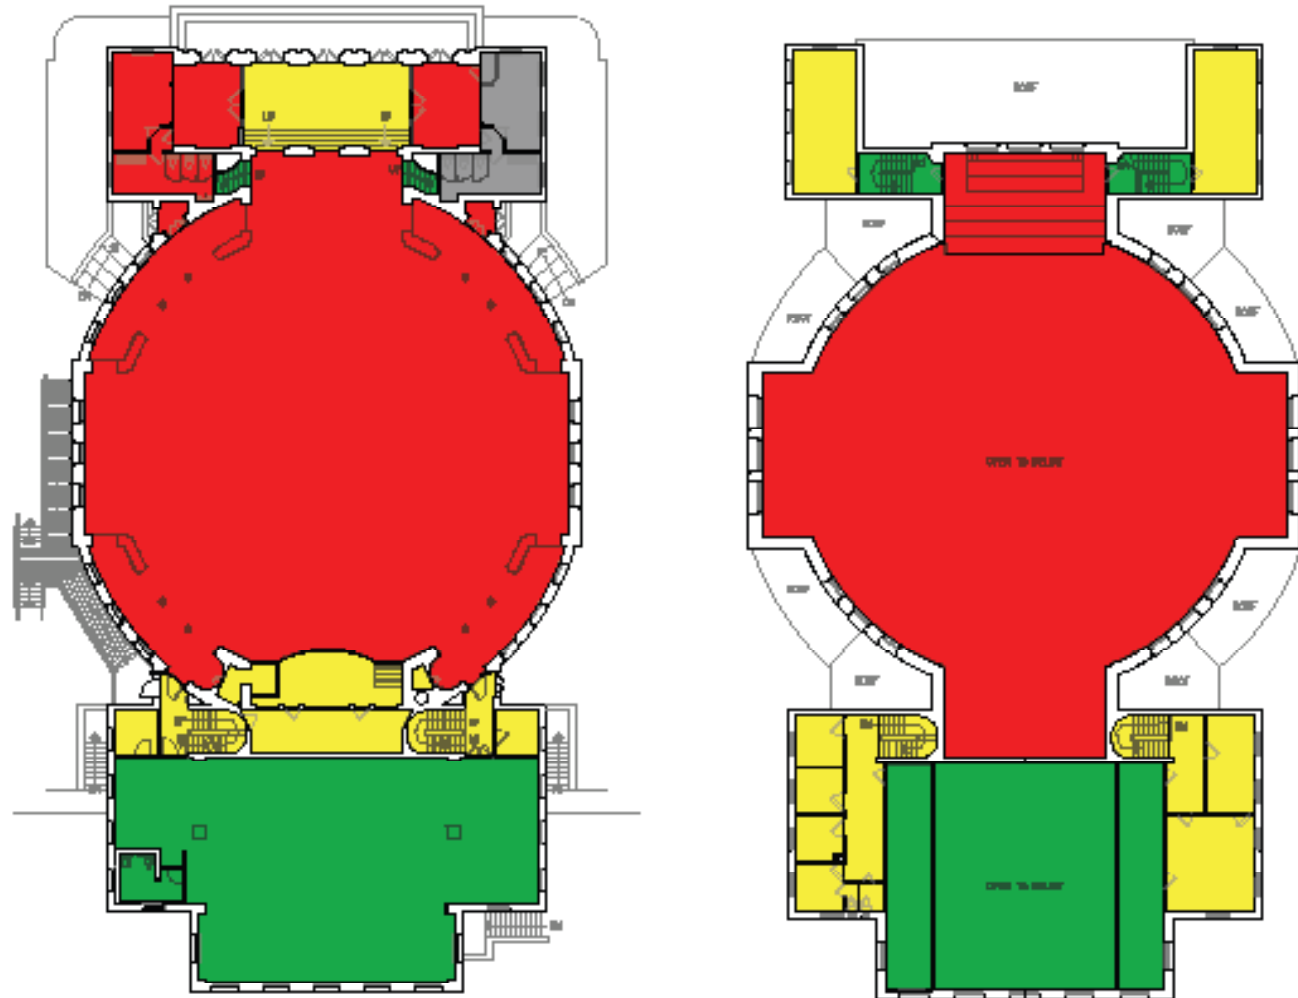
Figure 9

- STABLE**
- DETERIORATING**
- THREATENED**
- NOT SURVEYED**

As illustrated in the conditions diagram (figure 9), the areas which exhibit the most severe deteriorated condition are the sanctuary and the front cloakroom areas, here. These rooms exhibit evidence of water infiltration, total and losses to plaster in areas. The

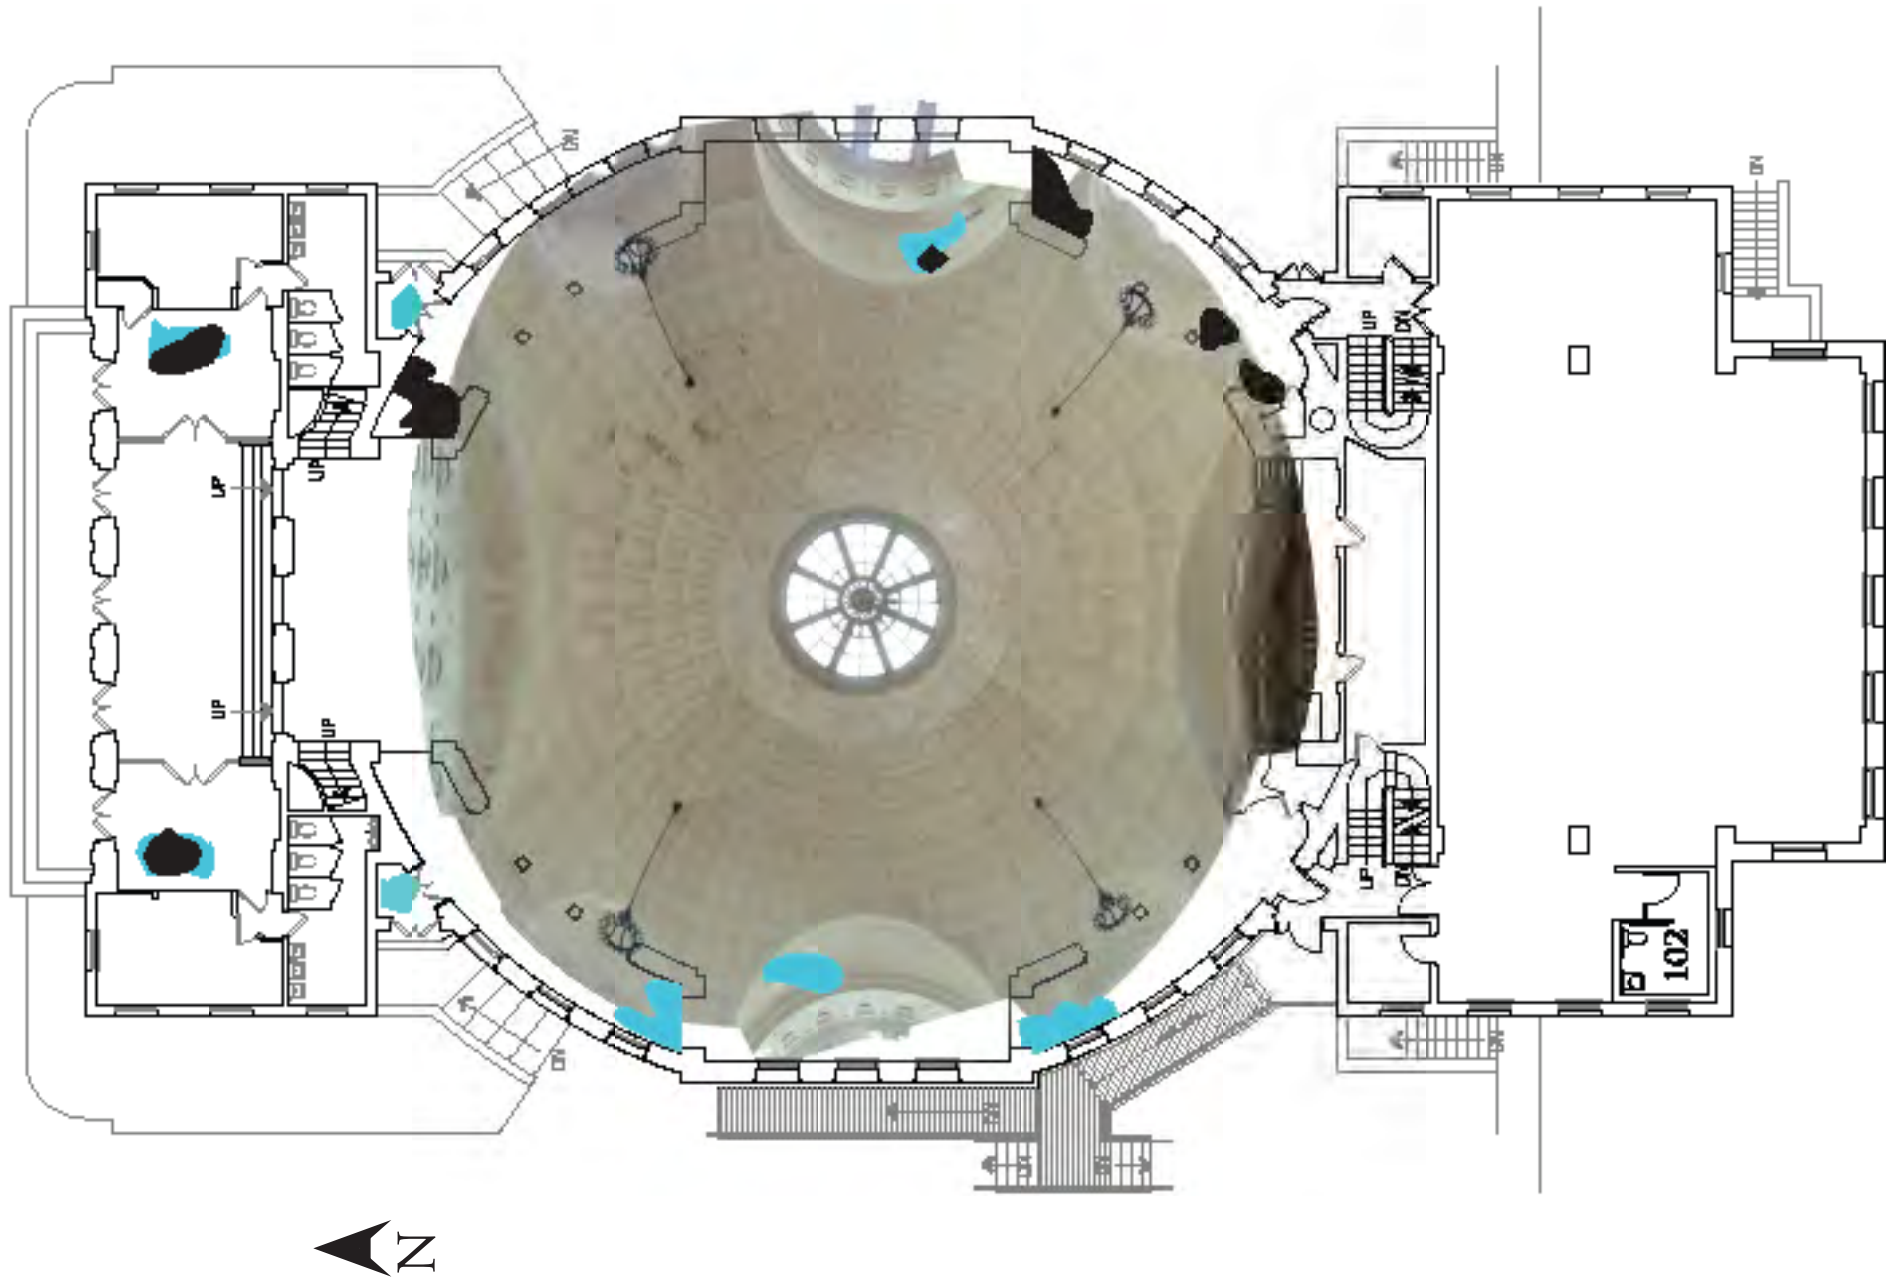
Figure 10

A total of 13 leaks were identified in the Rotunda. These are indicated in detail on the reflected ceiling plan (figure 10). Of these, seven were so advanced that the plaster surrounding the area was lost completely.

The plaster throughout the Rotunda was found to be in fair condition overall. While there were a few localized areas of severe plaster lost noted (figure 10, 11, 12) these areas represent a small percentage of the overall plaster fabric in the building. One area of advanced salt damaged was noted in the balcony of the sanctuary (see figure 11). Some cracks were noted in the coffers of the dome, as indicated in figure 9.
